STATE COMMISSION ON AIRCRAFT ACCIDENTS INVESTIGATION

Final Report

Serious incident

**Simultaneous beginning of take off by the crews of Boeing
737 (OM-NGF) and Boeing 767 (SP-LOA) aircraft on
crossing runways.**

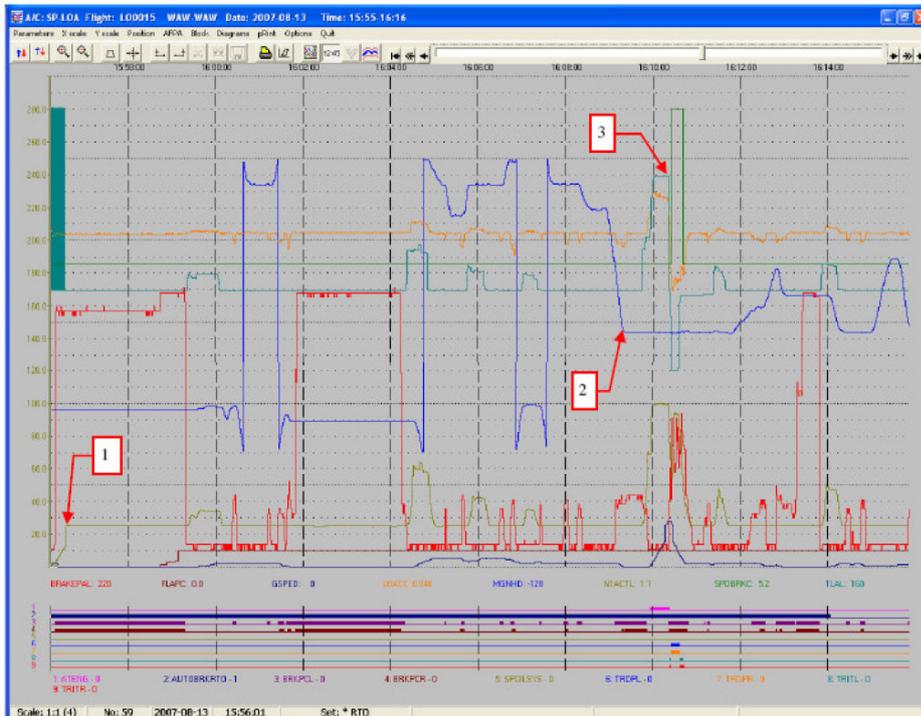
appropriate procedures for takeoff rejection, particularly as the speed was close to V_1 , allowed to stop the aircraft still before the intersection of runways.

1. Start of Engines.
2. Entry into runway.
3. Retraction of throttles and takeoff rejection.

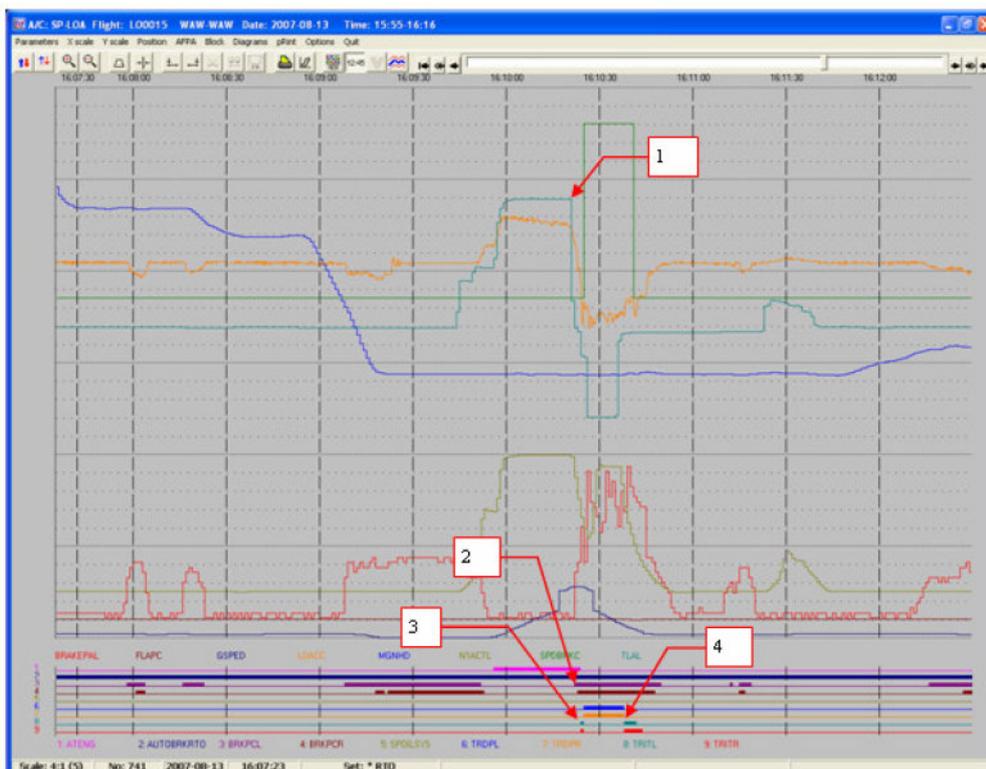
1. Retraction of throttles.
2. Brake usage on the Captain's side.
3. Thrust reversal on.
4. Thrust reversal off.

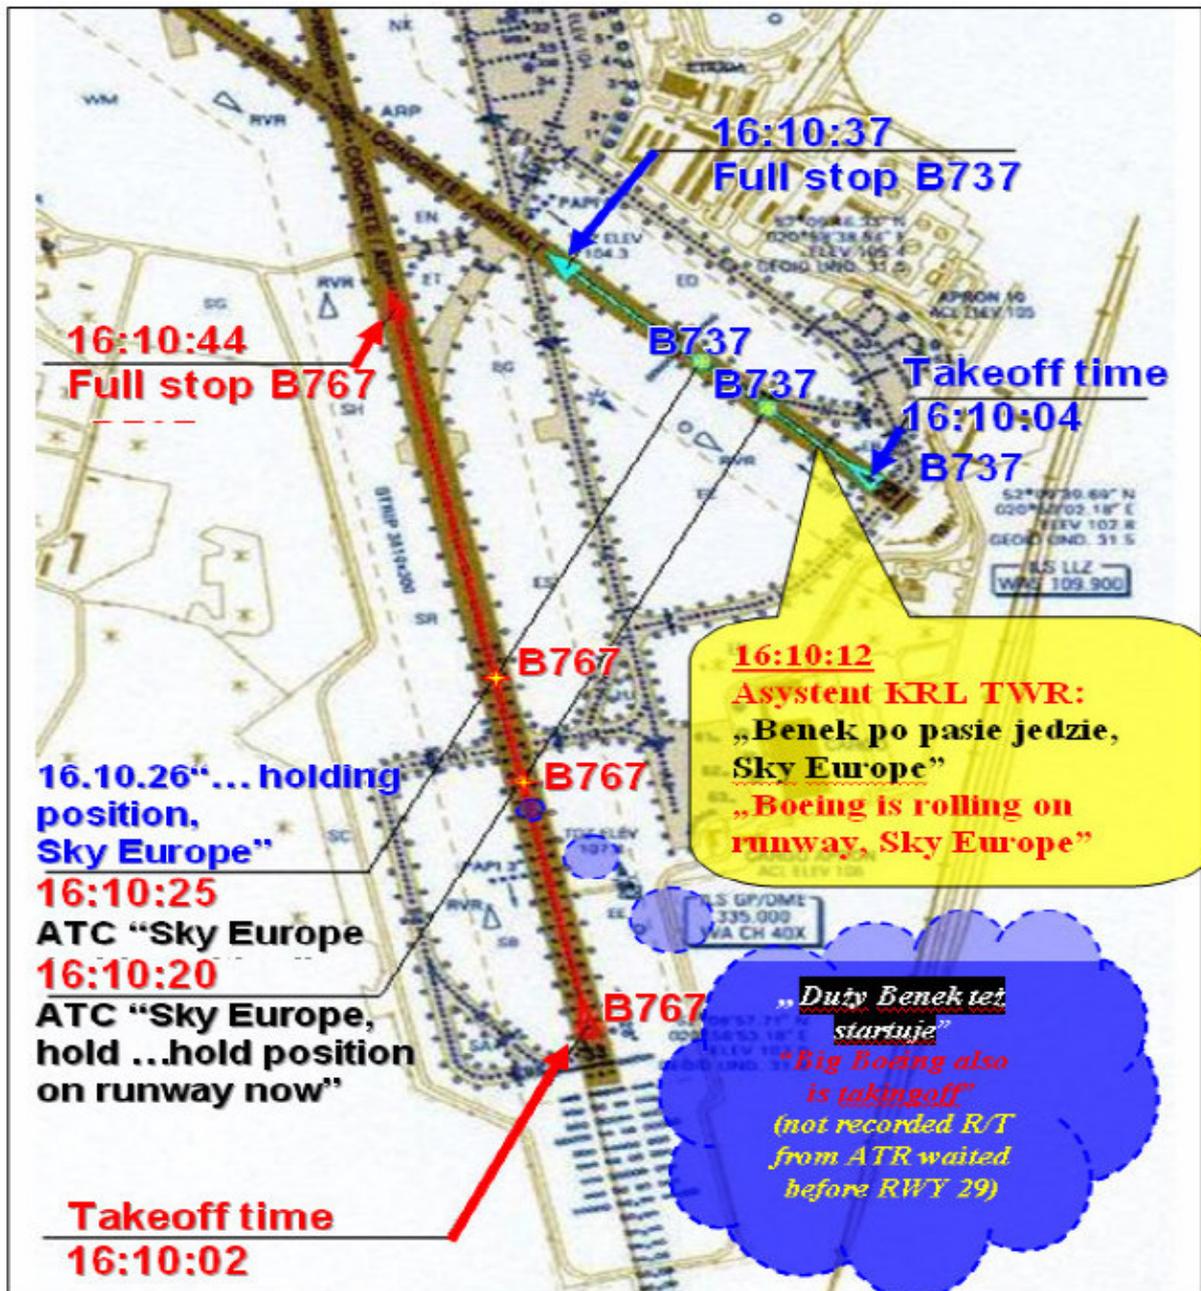
Fragment of an aerodrome diagram featuring the description of the occurrence.
