Aircraft Incident Ref. No.

**129/06**

## **FINAL REPORT ON AIRCRAFT INCIDENT INVESTIGATION**

Beach King Air 350

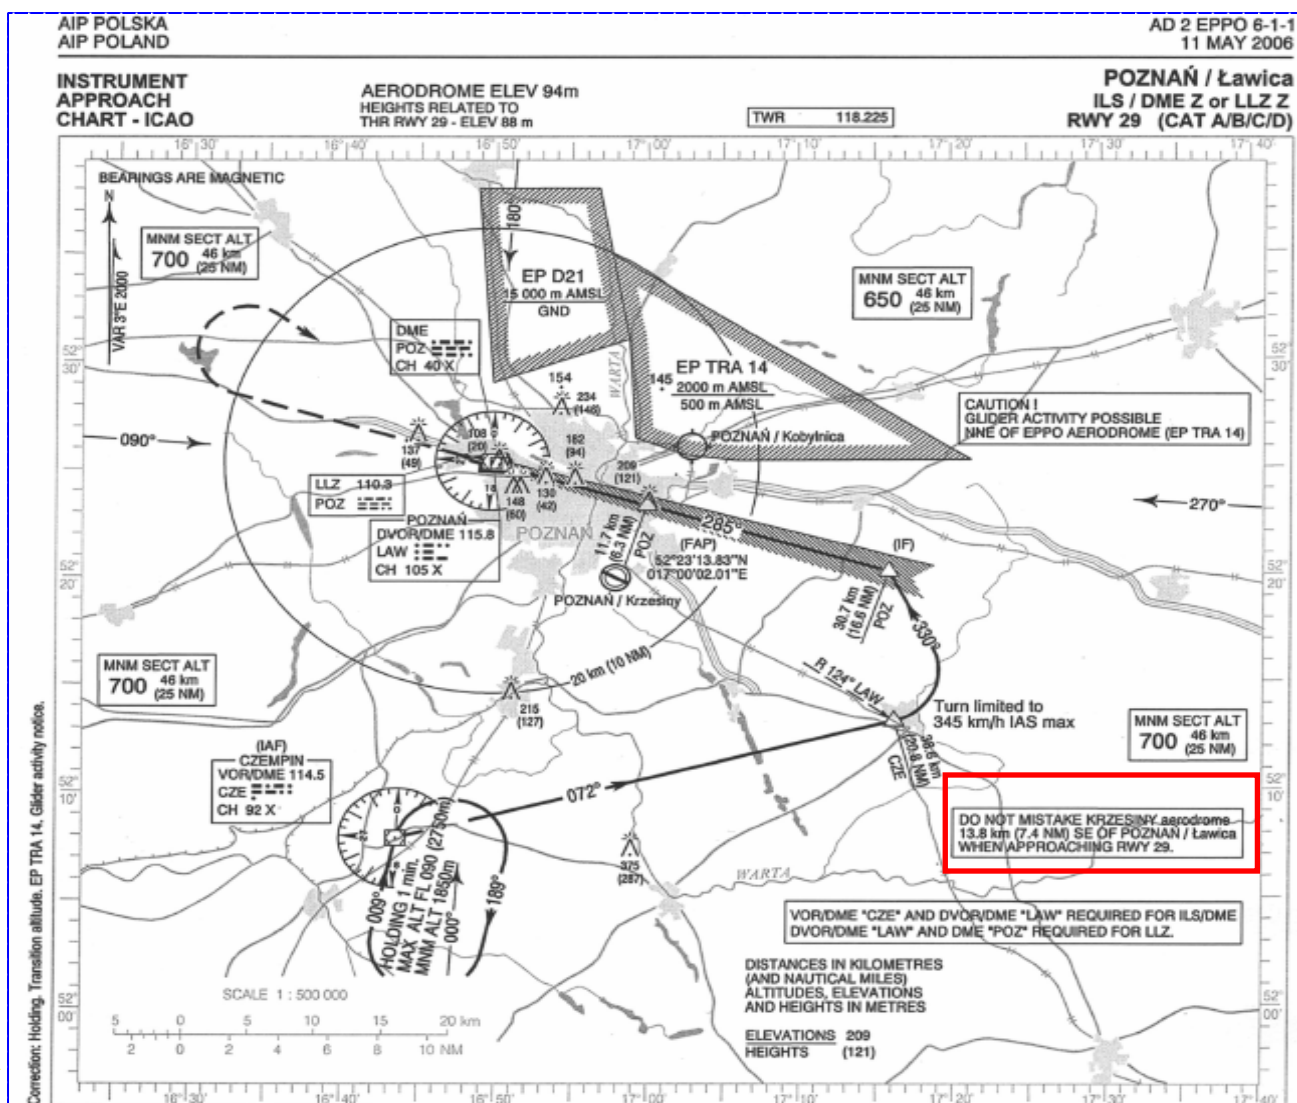
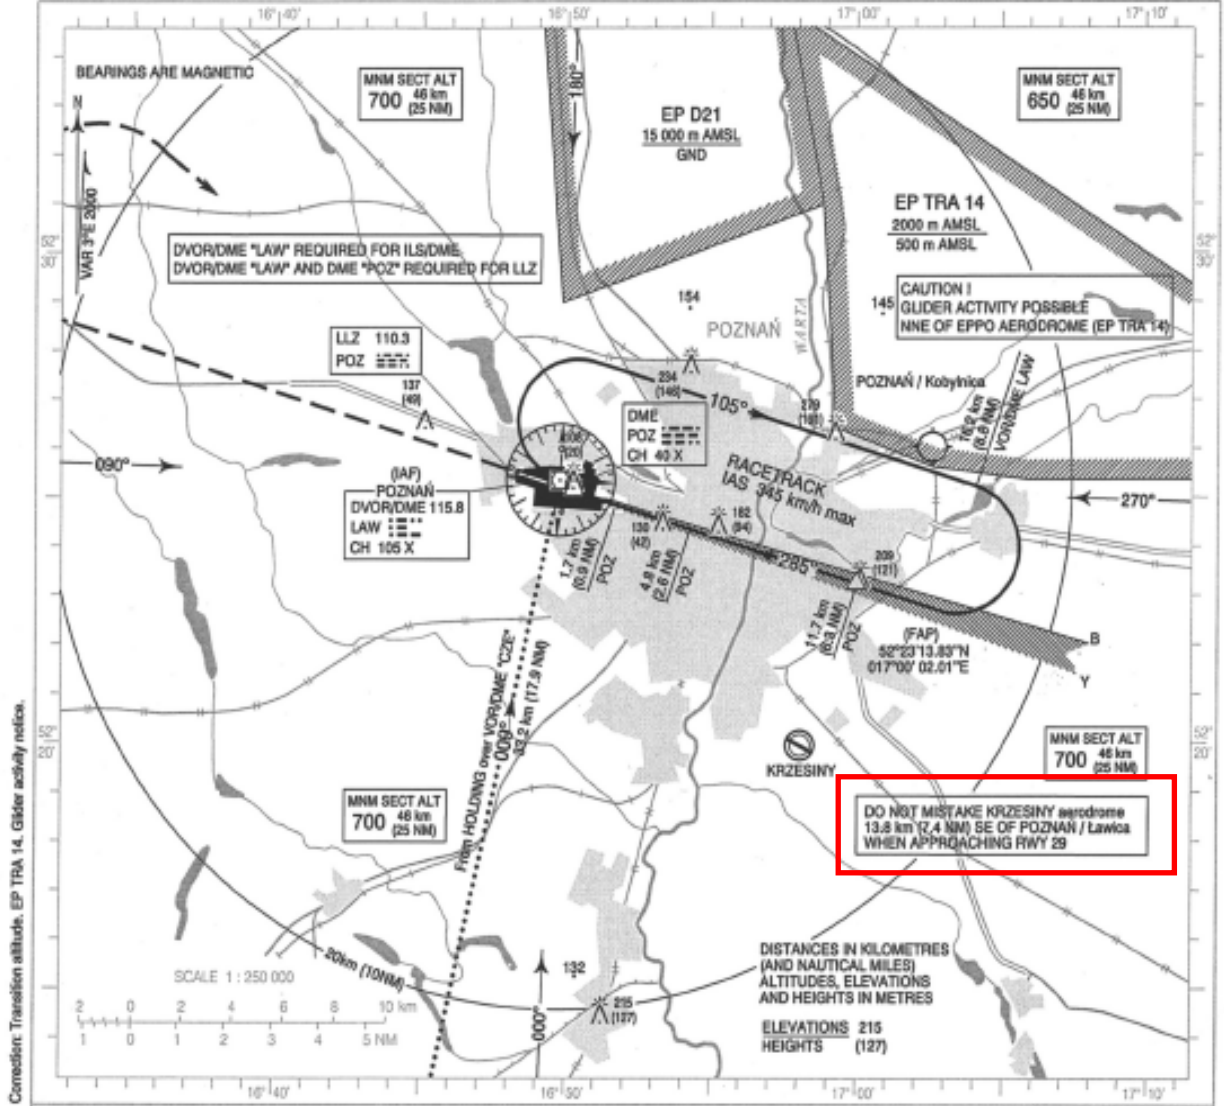
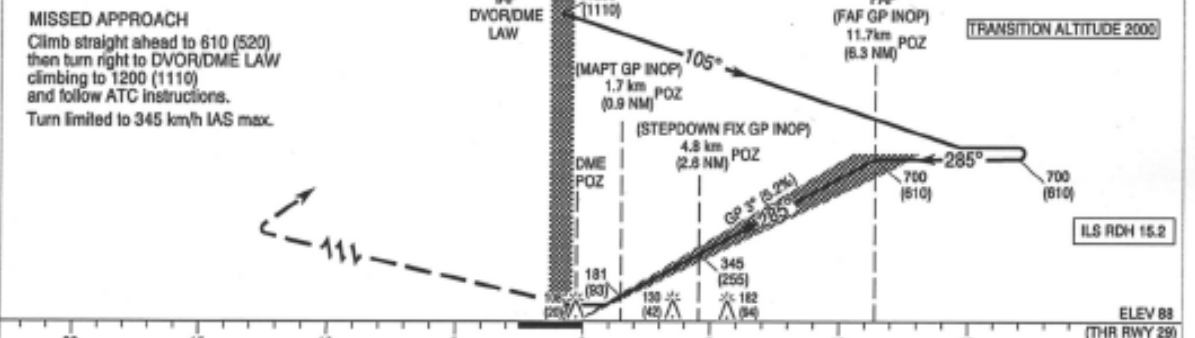
**POZNAŃ / Lawica**  
ILS / DME Y or LLZ Y  
RWY 29 (CAT A/B/C/D)

1. The crew did not sufficiently analyzed the published procedures of approach to landing at EPPO, because – despite the explicit warning on the maps available in the Aeronautical Information Publication (AIP – Poland), as well as in the Jeppesen publication, („DO NOT MISTAKE KRZESINY aerodrome 13,8 km (7,4 NM) SE OF POZNAN/ Ławica WHEN APPROACHING RWY 29” [AIP-Poland]; „Do not mistake Krzesiny 7,4 NM southeast of Ławica when approaching Rwy 29” [Jeppesen]) – they landed by mistake on the closed military aerodrome Poznań-Krzesiny (EPKS).

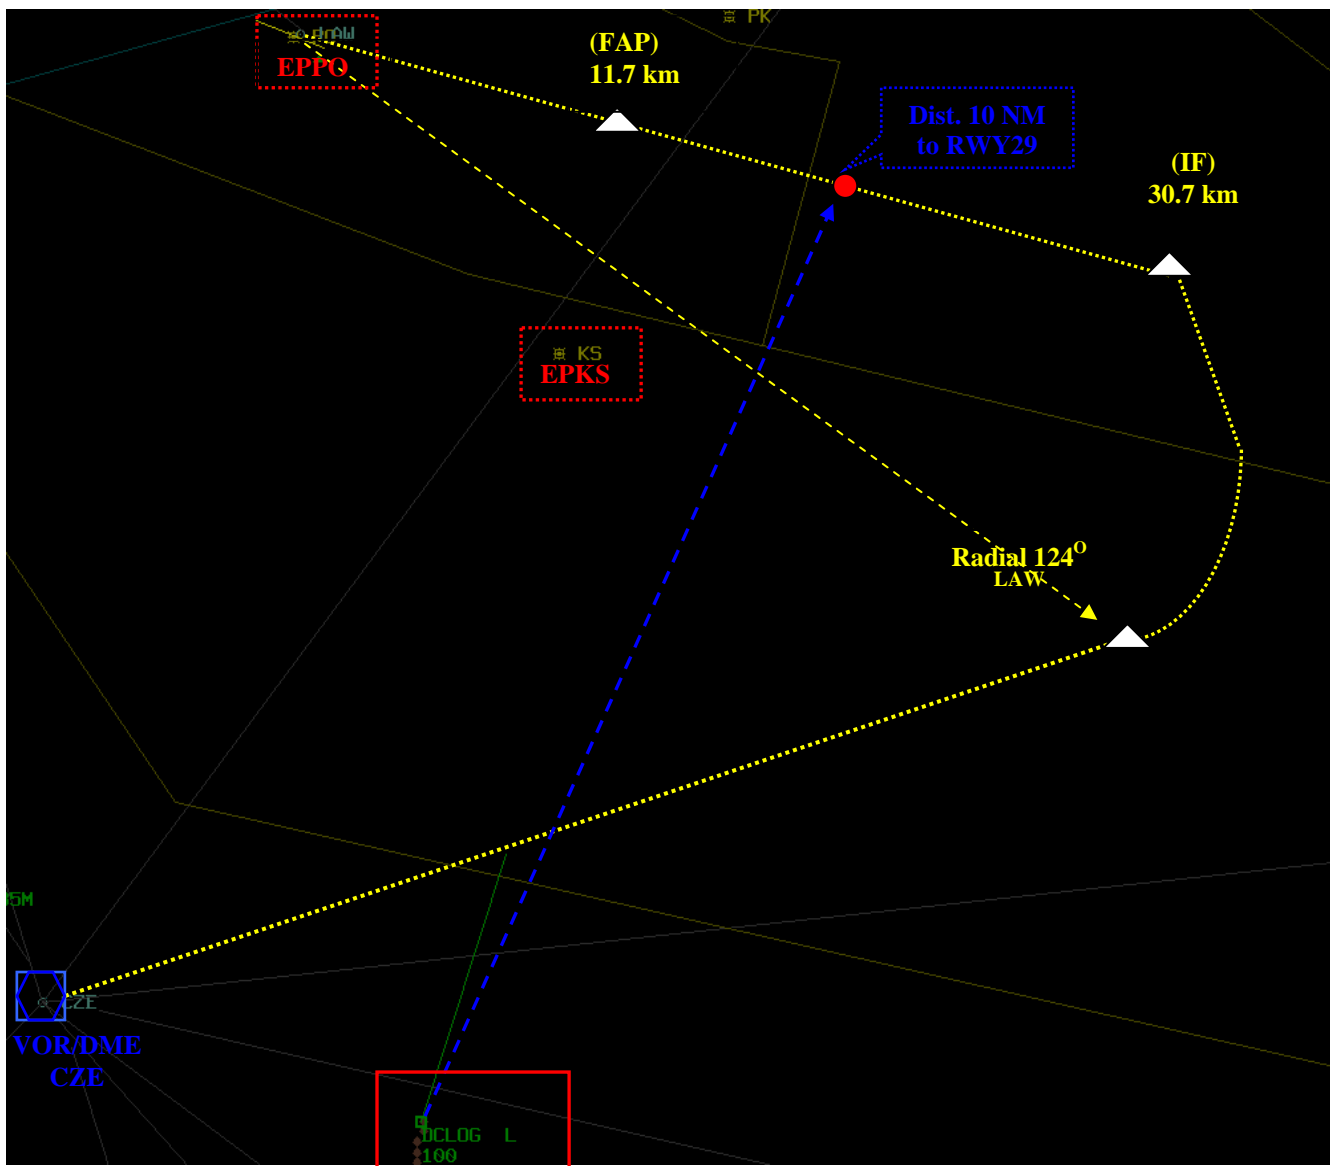
1. Procedure ILS/DME "Z" or LLZ „Z" on RWY29 EPPO

2. Aircraft DCLOG flight path
