MINISTRY OF INFRASTRUCTURE
STATE COMMISSION ON AIRCRAFT ACCIDENT INVESTIGATION

FINAL REPORT

Serious Incident No: 122/08

**CFIT marginally avoided during visual approach
caused by the flight crew of
Boeing 737, registration: EI-DPO
on 10 March 2008
CTR Katowice – Pyrzowice (EPKT).**

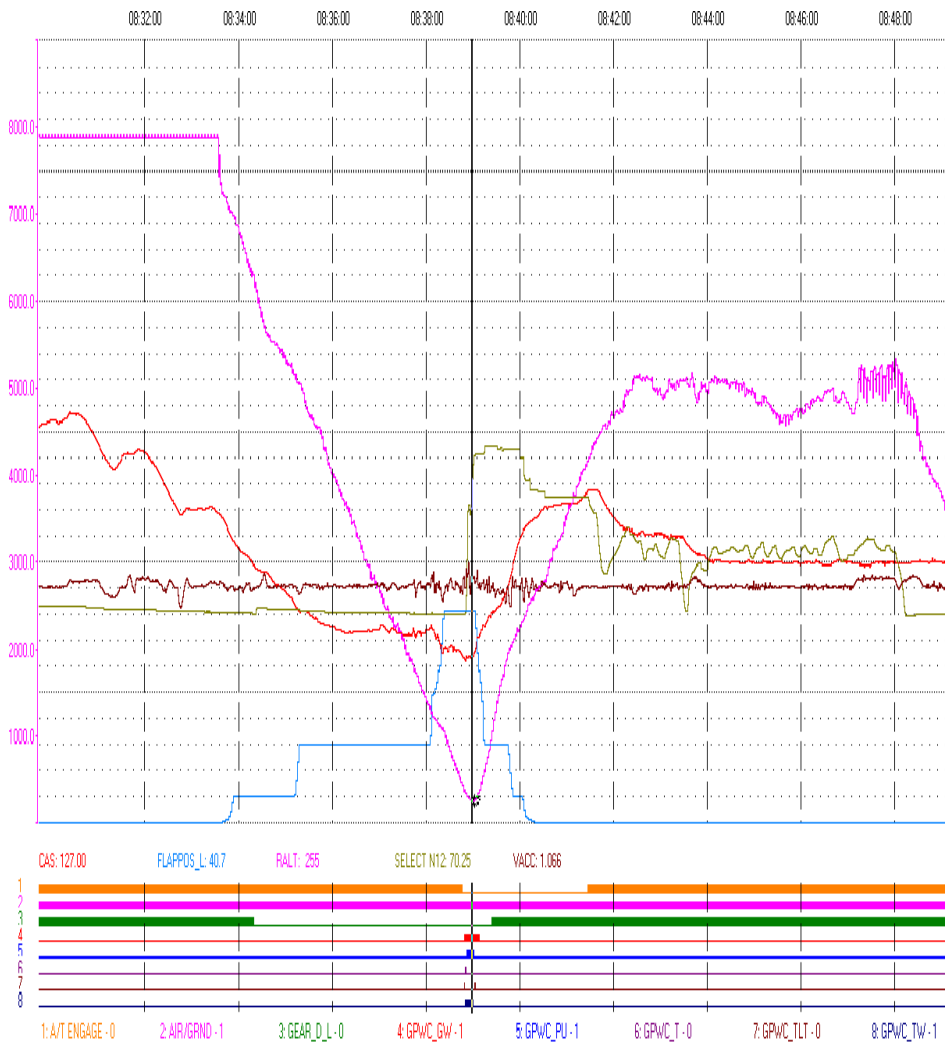
Approach to landing from WQAR record

When the plane was at RALT = 440 [ft], the AT was disengaged, which indicates that the entire descent procedure was performed on “idle” setting.

08:38:47 – AT disengaged, RALT=440[ft],

08:38:49 – beginning of G/A procedure, power increasing by moving thrust lever, PITCH=0,0[deg],

08:38:53 – engines power: N11=70[%], N12=71,88[%],PITCH=3,5[deg],

08:38:59 – minimum terrain clearance RALT=247[ft], CAS=127,75[kts],

08:39:02 – engines power: N11=90,38[%], N12=90,62[%], end of EGPWS warning

Therefore, the engines reached 90 % of power after 13 seconds.

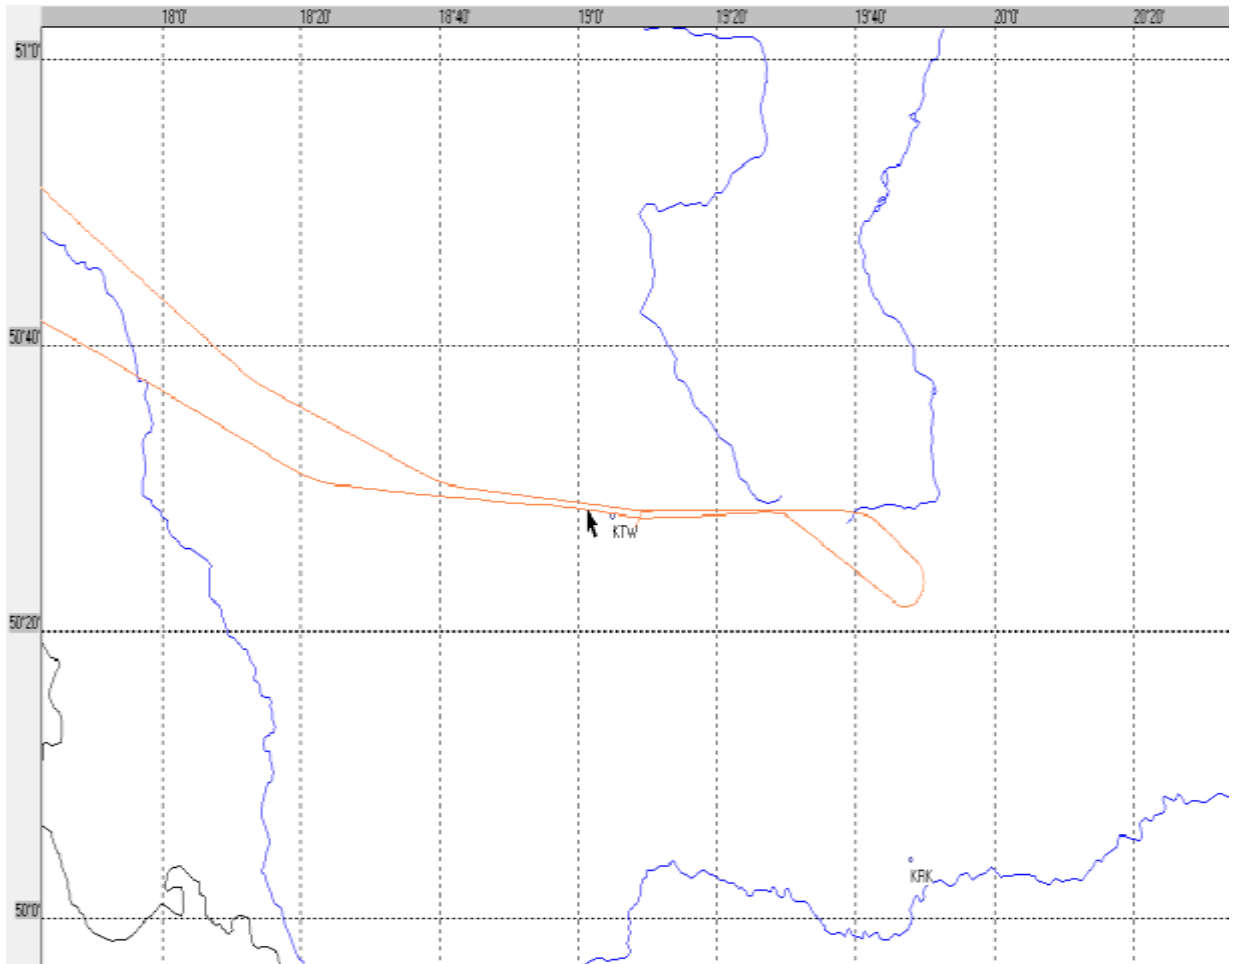
EI-DPO approach on the map.

At RALT = 370 [ft] at a distance of about 3 [NM] from EPKT aerodrome EGPWS system was activated and generated PULL UP warning. The crew performed a Go Around procedure. The lowest recorded RALT was 247 [ft]. The airplane climbed to PRALT = 6200 [ft], and after passing EPKT aerodrome at the distance of approximately 12 [NM] made the procedure turn for approach. After the turn ILS signal was intercepted and the airplane was stabilized on 267 degrees LOC, approximately 18 [NM] from the aerodrome.

About 14 [NM] from the aerodrome, the crew extended flaps at 5 [deg] and continued the flight at PRALT = 4200 [ft]. About 12 [NM] from the aerodrome while still under glide path the airplane started to descend. About 6 [NM] from the aerodrome the flaps and landing gear were extended. About 4 [NM] from the aerodrome the airplane was already in landing configuration with flaps at 40 [deg]. At RALT = 709 [ft] LOC and G/S signals disappeared, probably as a result of ILS receiver turning off or changing its frequency. Approach and landing on EPKT aerodrome RWY27 was performed without problems. After roll the airplane vacated RWY27 and taxied to a parking stand.
