**MINISTRY OF INFRASTRUCTURE
STATE COMMISSION ON AIRCRAFT ACCIDENT INVESTIGATION**

FINAL REPORT

Occurrence No: 562/09

Aircraft: Parachute Black Hawk 265

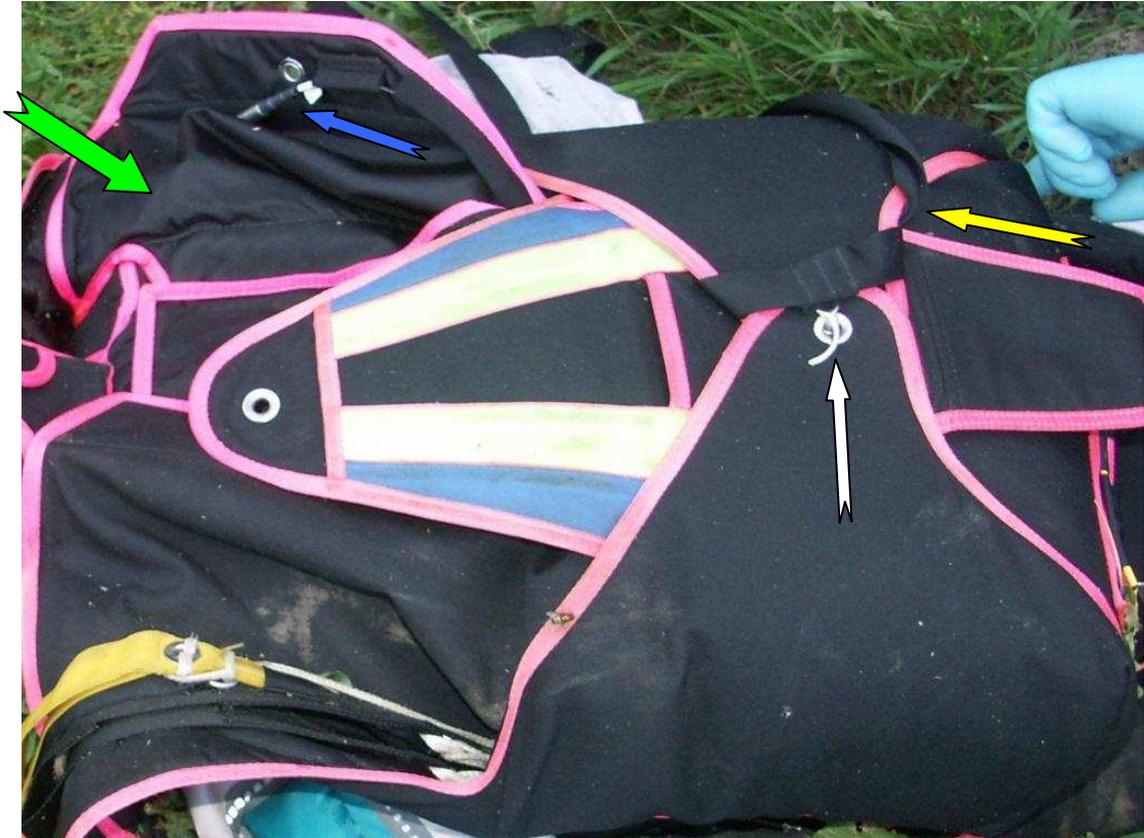
Upon arrival at the accident scene the SCAA I Investigating Team found the student skydiver lying face down, with her right hand in the area of stomach and the fingers clenched around the main canopy pilot chute. The main canopy container was closed by a pin inserted properly, part of the bridle was under the right side flap of the main canopy container, the reserve canopy container was open, and the AAD cutter was

ejected from the flexible holder situated on the flap of the reserve canopy container. (Photo 1).

Photo 1. Outer part of cover.

- *Green arrow points the opened container of the reserve canopy;*
- *Blue arrow points AAD cutter ejected from the flexible holder;*
- *White arrow points the pin closing main canopy container;*
- *Yellow arrow points a part of the bridle situated under side flap of the main canopy container.*

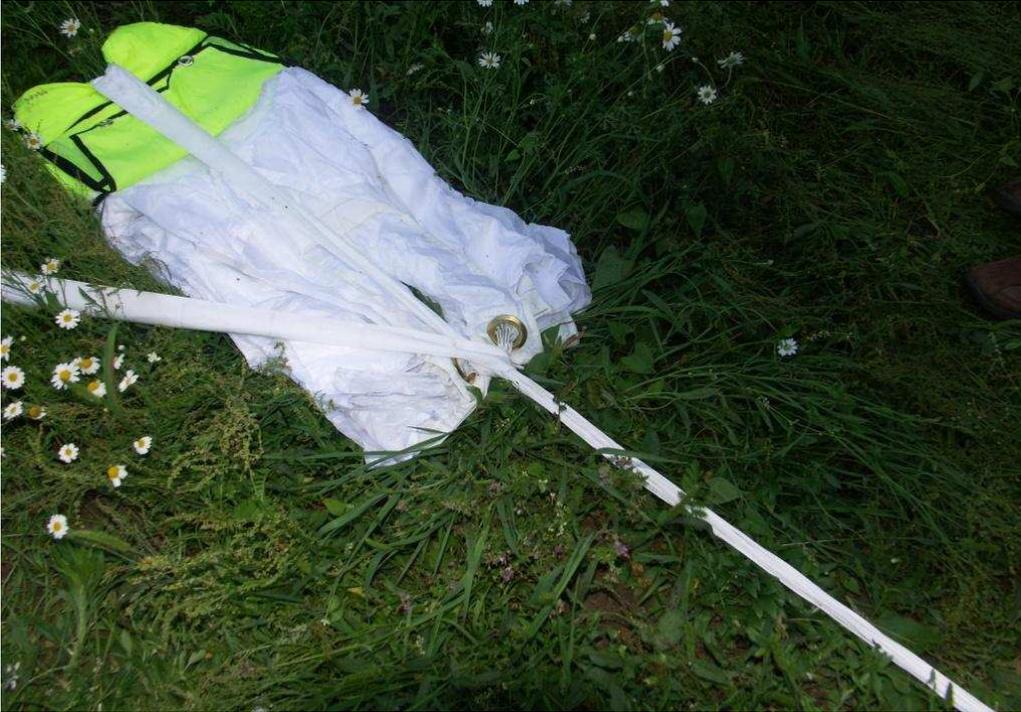
The reserve canopy was outside of the container, partially pulled out of the free bag. The reserve canopy lines were situated in the axis of the student's body. The lines were completely stretched. The reserve canopy slider was in its highest position. The bridle was wrapped around lines near to canopy base. The further part of the bridle turned about 45 degrees left from the direction of lines and canopy. The reserve canopy pilot chute was not damaged, and its spring was not trapped. The reserve canopy did not seem to be inflated even partially during the jump. (Photo 2).

Photo 2. Reserve canopy partially pulled out of a bag and lines wrapped by bridle.

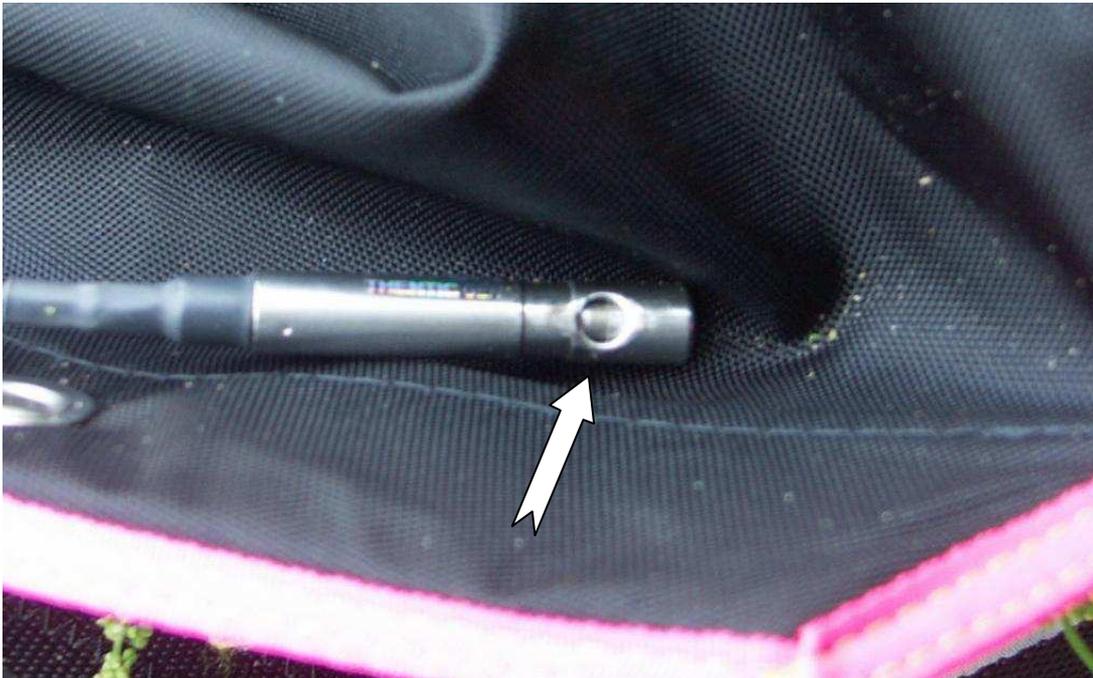
AAD cutter was in its closed position what indicated, that AAD had been activated. The cutter was ejected from the flexible holder which was situated next to the grommet of the flap of the reserve canopy container (Photo 3).

Photo 3. AAD cutter. White arrow points a hole in the cutter body closed by knife.

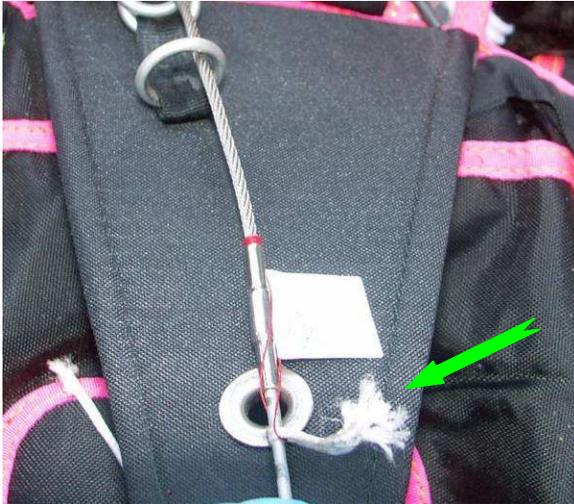
Reserve canopy closing loop was separated (Photo 4 and 5). The upper part of the loop was still on a pin. Photo 4 shows a thread and the rigger seal label. The investigators attention was drawn to the frayed endings of the loop.

Photo 4. Pin of the reserve canopy opening handle and upper part of the closing loop. Green arrow points frayed ending of the separated closing loop.

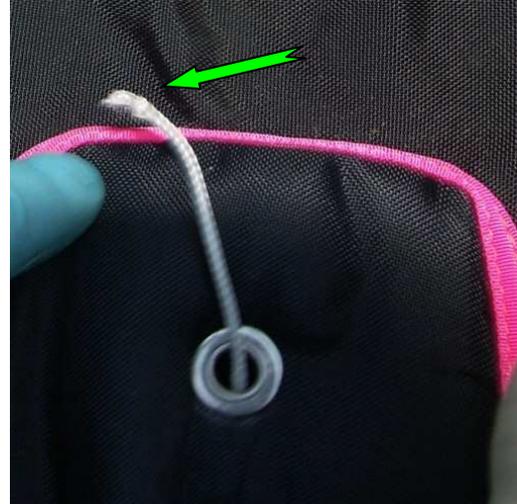
Photo 5. Lower part of the closing loop. Green arrow points irregular, frayed ending of the separated closing loop.

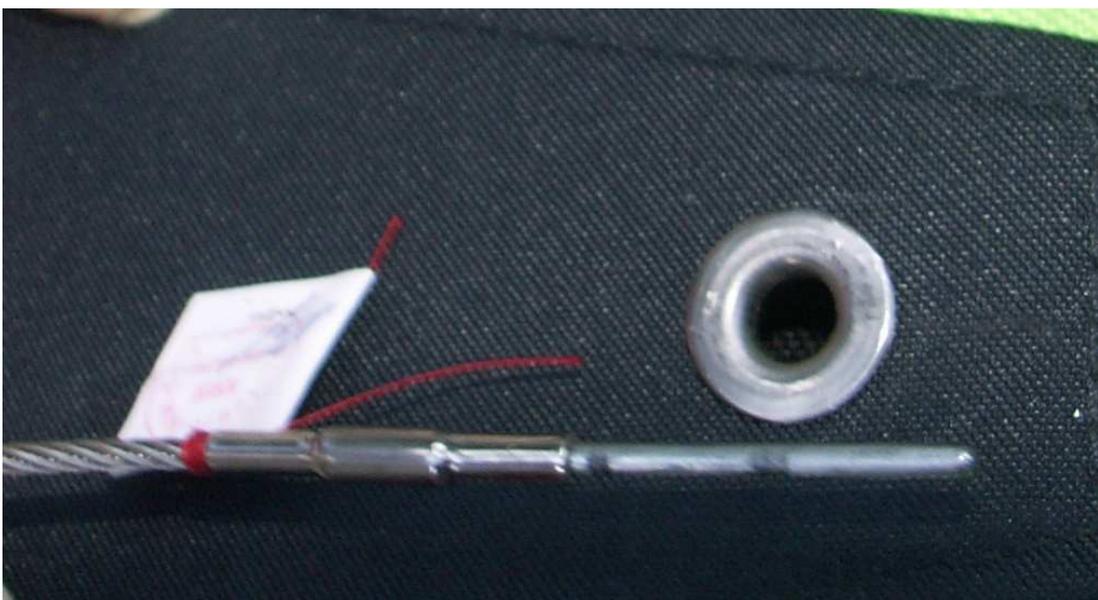
Pin of the reserve canopy opening handle was not bent (Photo 6). The picture was taken after removal of the upper part of the separated closing loop.

Photo 6. Pin of the reserve canopy opening handle.

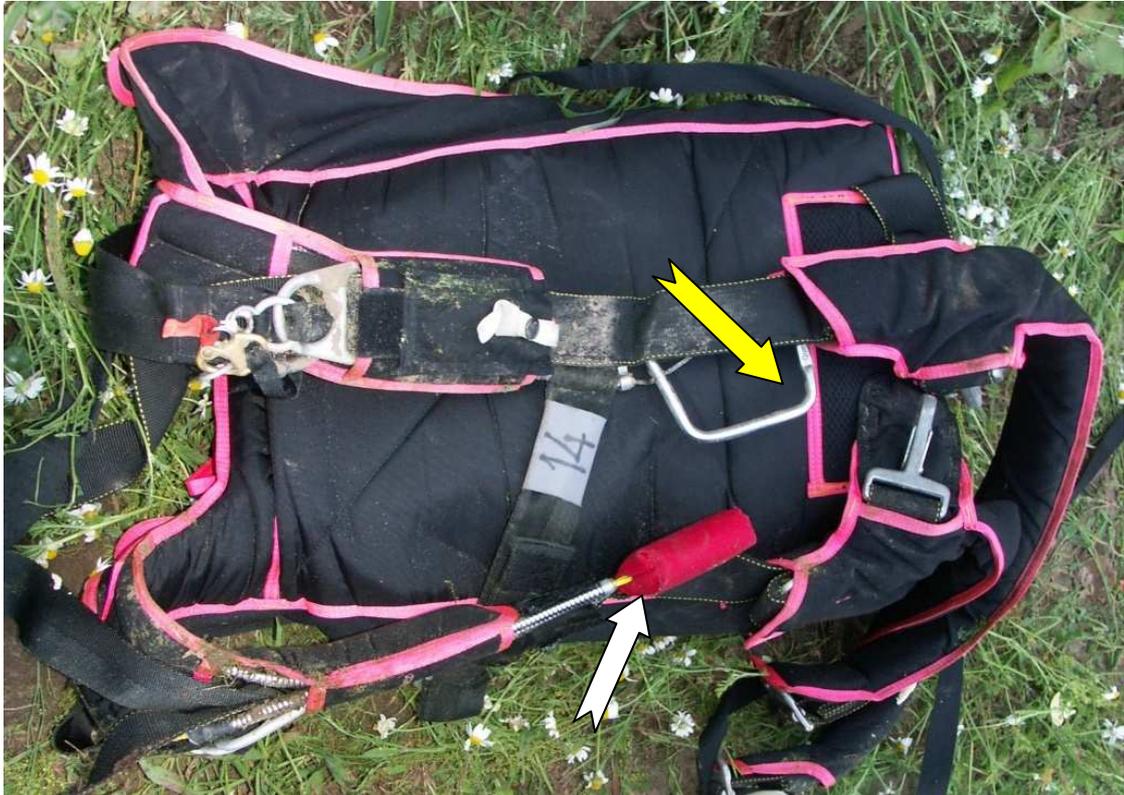
Both - main canopy cut away handle and reserve canopy opening handle were not pulled out (Photo 7).

Photo 7. Back part of the harness/container. Visible main canopy cut away handle (white arrow) and reserve canopy opening handle (yellow arrow) - both not pulled out.

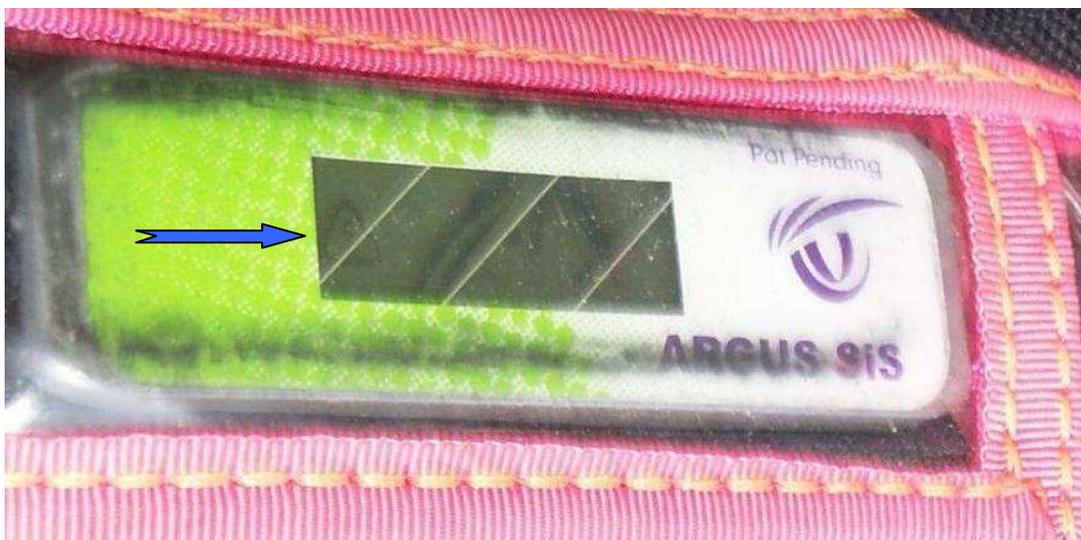
The LCD on the control panel of "Argus" AAD was damaged, but on the side part of the display there was a flashing sign (Photo 8).

Photo 8. LCD damage. Blue arrow points a flashing sign.

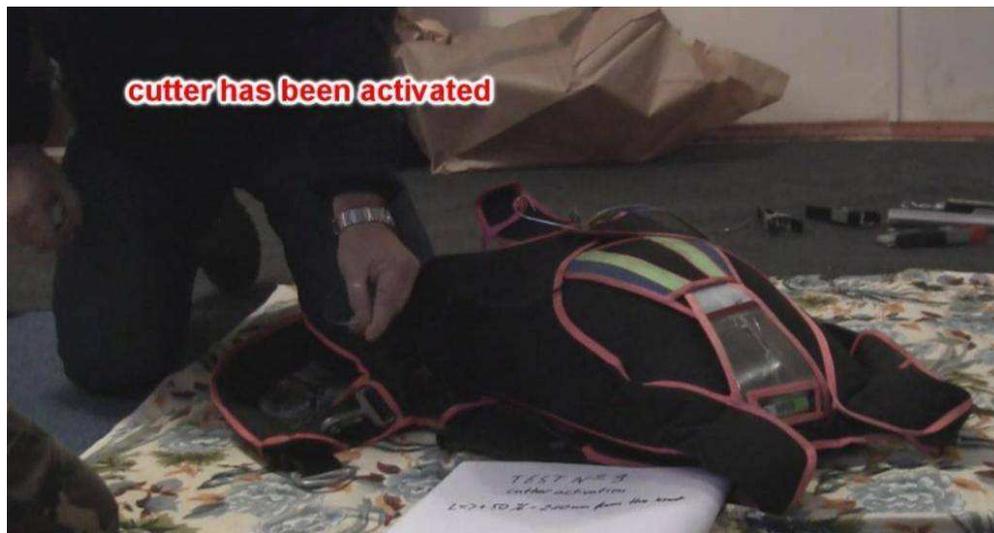
Photo 10. Parachute just after cutter activation. The reserve canopy container was still closed.

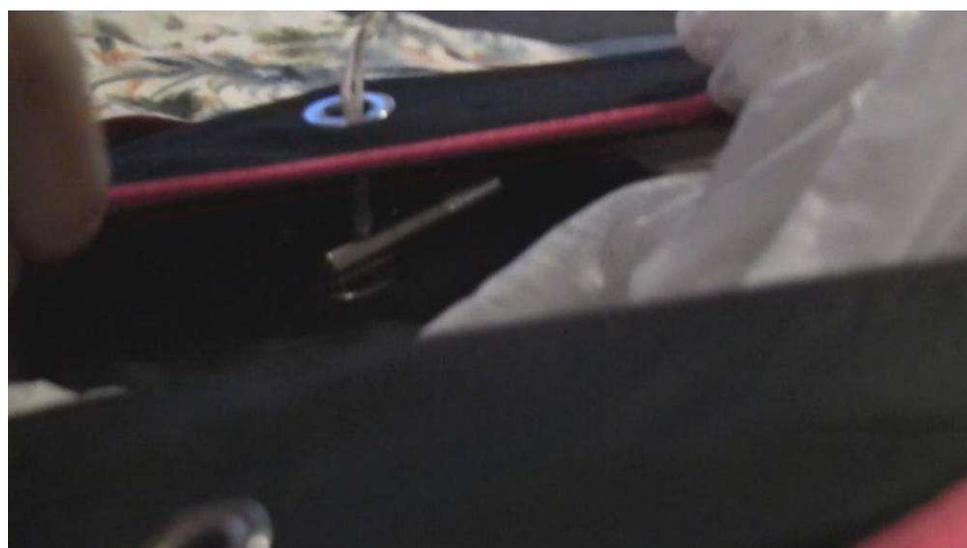
Photo 13. After the last flap was partially pulled aside, it was found that the closing loop was trapped by the cutter, which blocked opening of the container. When flap was being pulled aside the cutter was gradually going out of the holder.

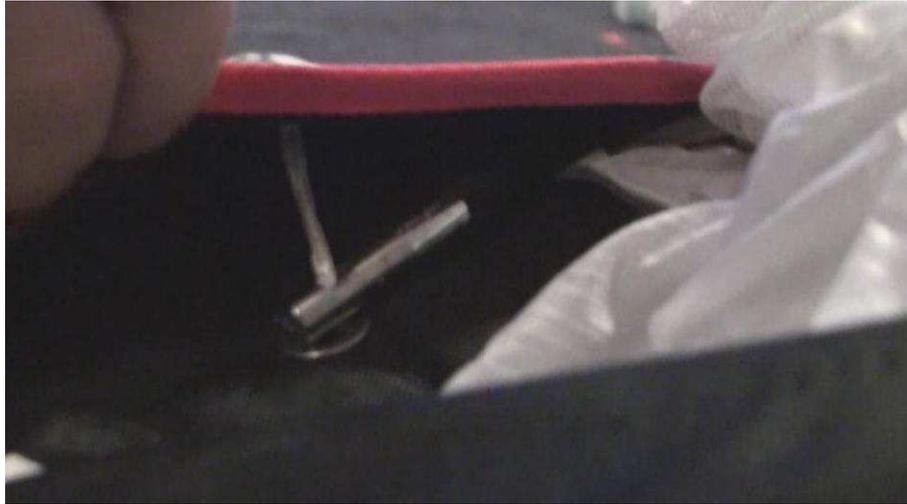
Photo 14. Visible location of the cutter over pilot chute. When the last flap was being pulled aside the cutter was further going out of the holder.

During the trial it was found, that AAD cutter was located directly over the metal grommet at the top of the pilot chute. It follows that location of the cutter holder did not affect the movement of the cutter. Closing loop was blocked by the activated cutter so that removal of the releasing handle pin did not cause opening of the reserve canopy container. When the last flap was being pulled aside the cutter was gradually going out of the holder. The cutter was fastened to this last flap.

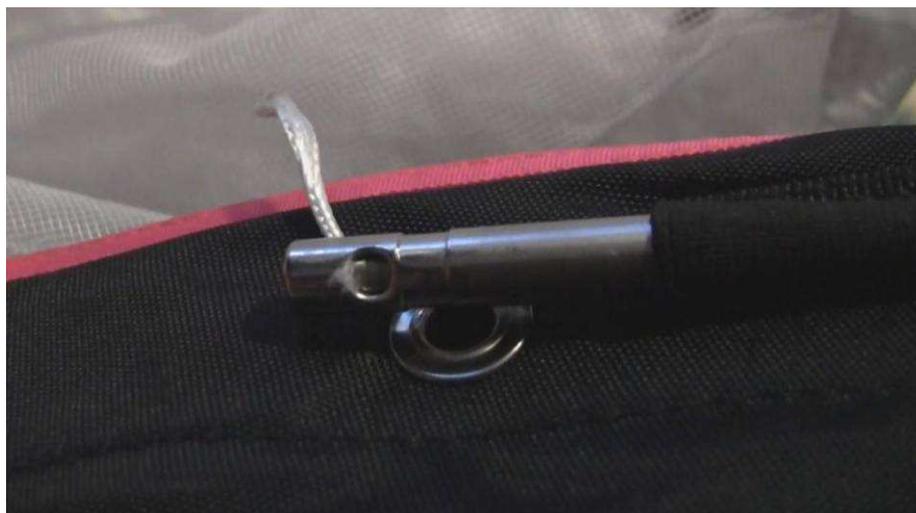
Photo 16. Upper part of of the closing loop, manually broken. The photo shows, that the cutter cut only a part of the fibers.

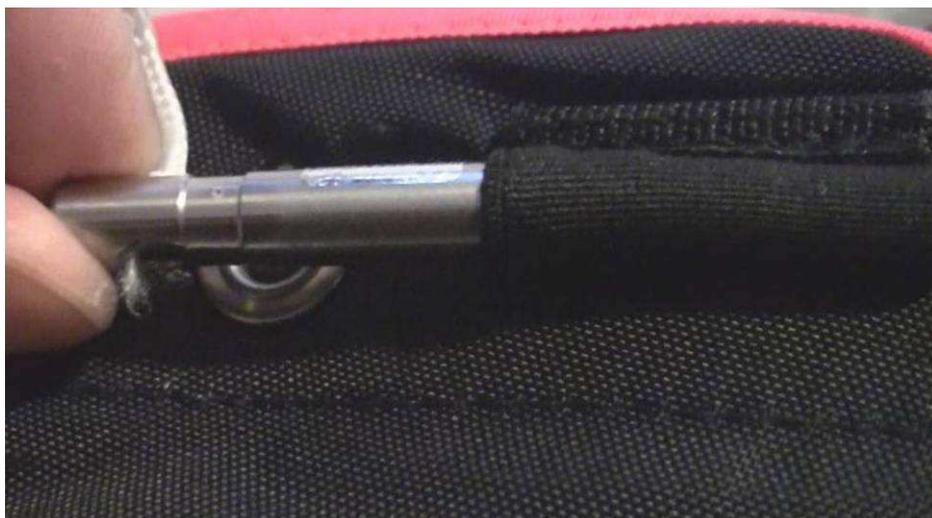
Photo 17. Visible fibers of the upper part of the closing loop, protruding from the zipper.

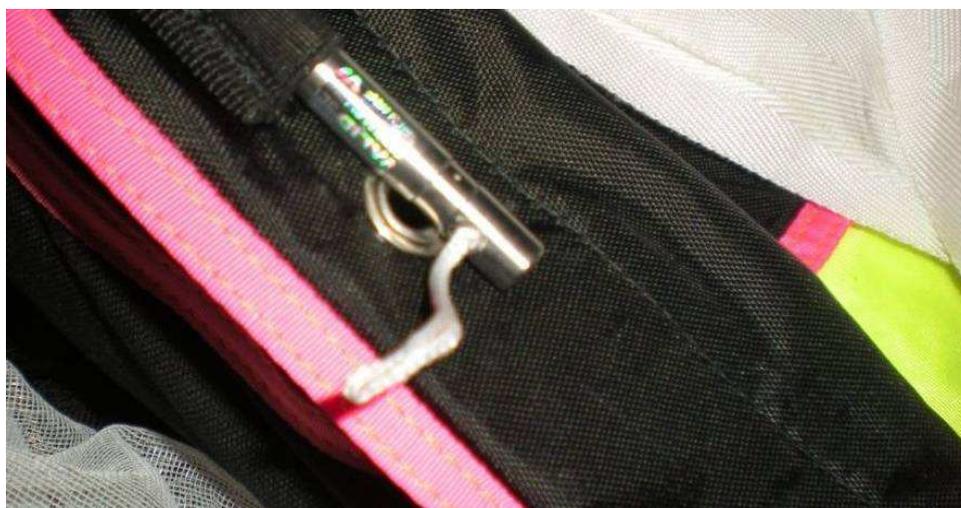
Photo 18. The visible part of the closing loop was trapped inside the zipper.

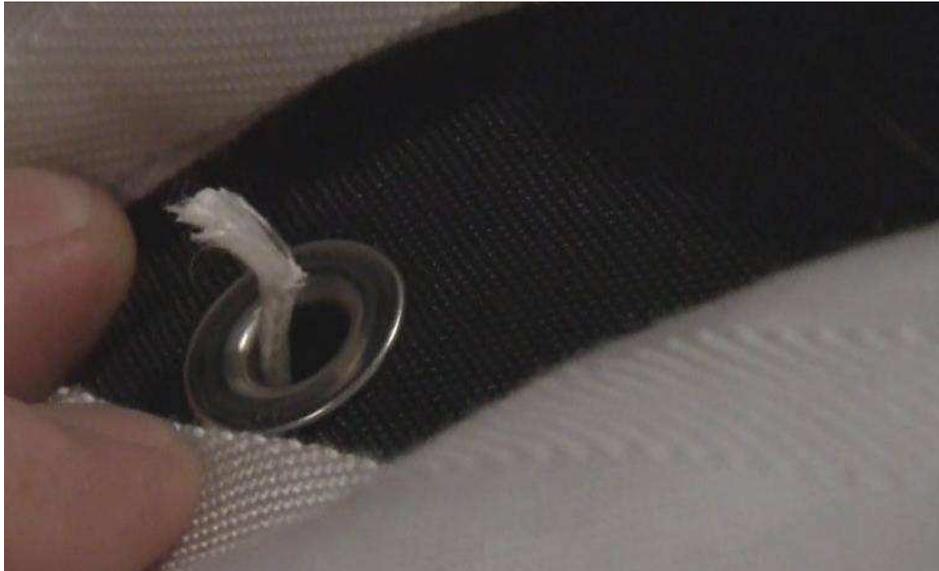
Photo 20. Close-up of the lower part of the closing loop. Frayed fibers endings are clearly visible.

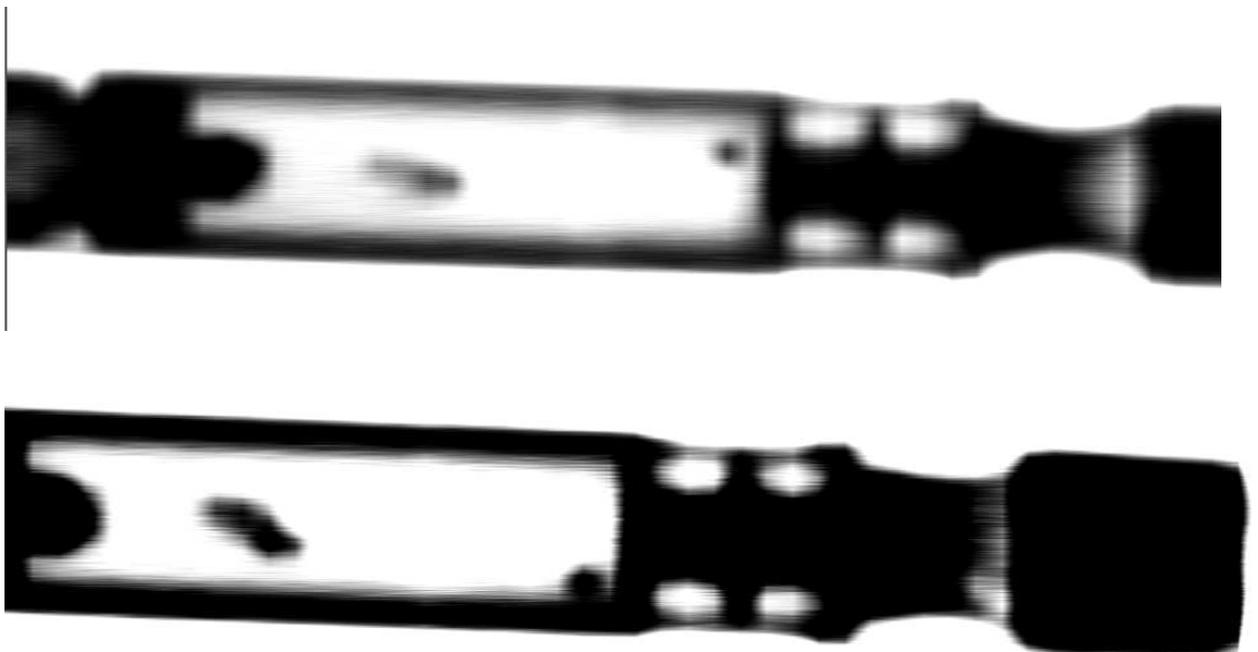
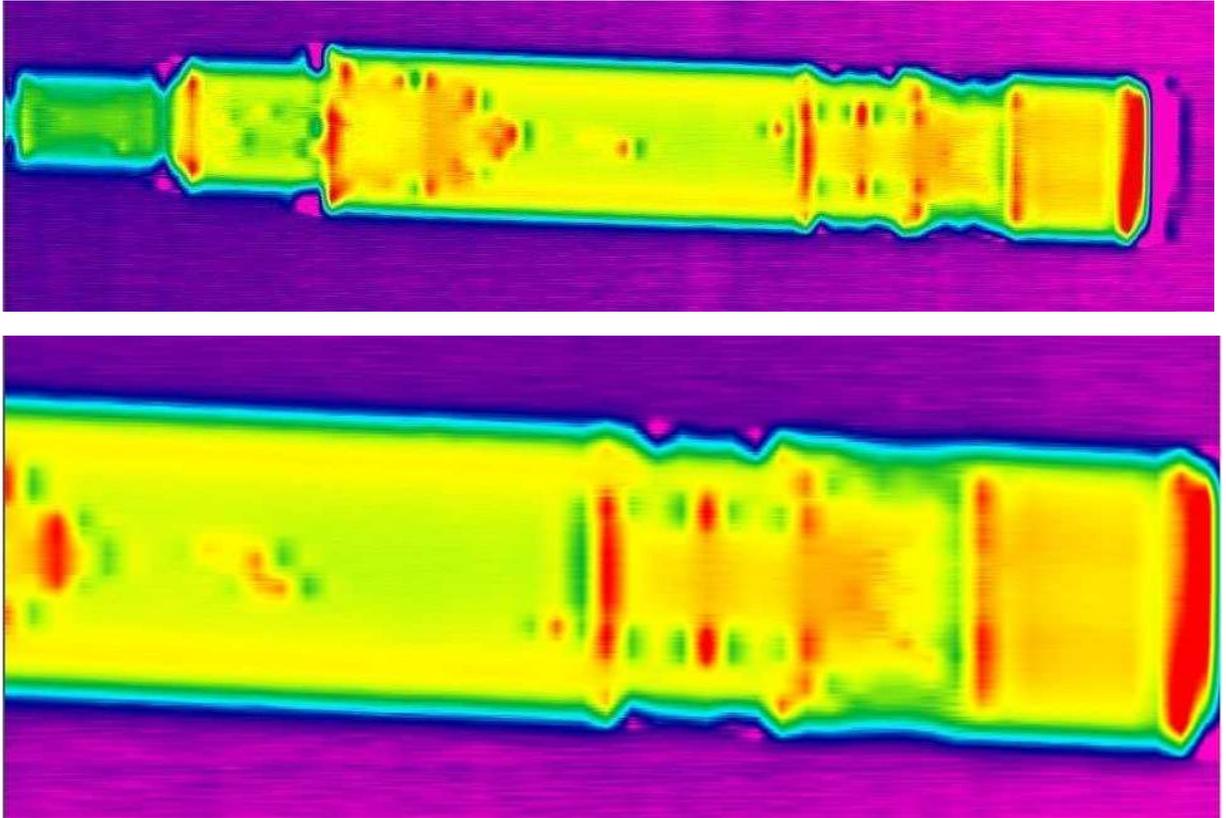
Photos 22-25. X-rays of the cutter secured at the accident site.

No foreign metallic objects were found between the knife and the bottom of the cutter body.

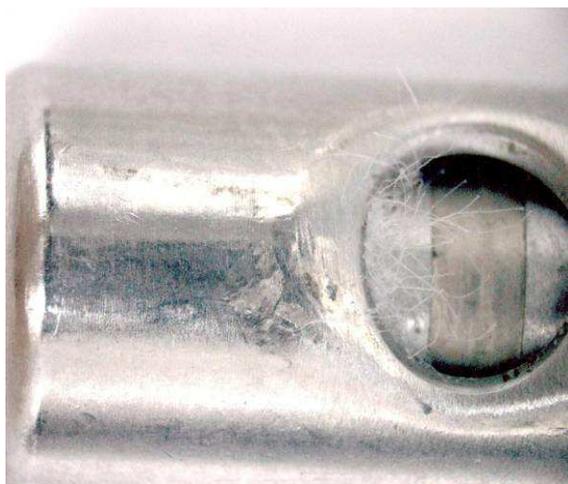
Examination of the loop secured at the scene revealed that the endings of the fibers had been separated into different lengths. Shorter fibers endings had been cut, and the longer torn and molten. It indicated that during operation of the cutter (when its knife was moving) the loop passing through its holes was cut only partially. The rest of the loop was separated by stretching and squeezing them between the knife blade and the bottom surface of the cutter body (Photo 27).

Photo 26. Visible fibers of the closing loop protruding from the hole of the cutter secured on the scene.

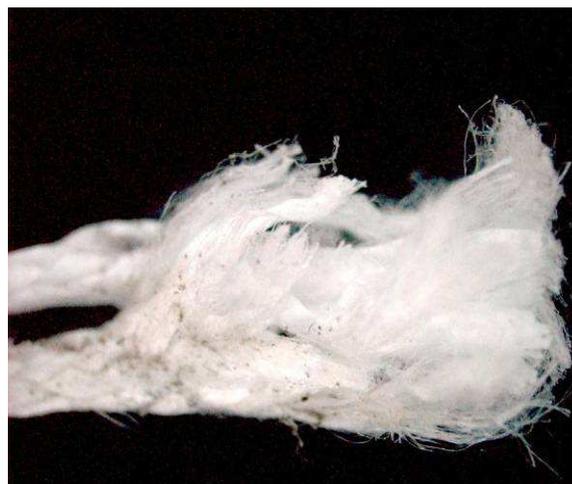
The Commission opinion is that the collision of the student with the ground caused similar course of event as described above (the closing loop only partially cut, was torn as a result of impact).

Photo 27. Closing loop secured on the scene (partially cut and partially torn).

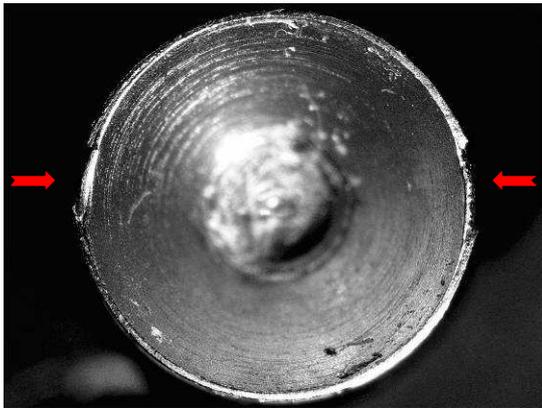
- Examination of the cutter knife secured at the scene revealed that the knife blade is damaged (deformed plastically) in line with the cutter body holes (Photo 28).
- Examination of the knife of the cutter used by manufacturer for demonstration revealed no damage (Photo 29).
- Examination of the cutter used by manufacturer for demonstration revealed on the knife (close to its blade) a material from the inner part of the cutter body (Photo29). Such material was not found on the knife blade secured on the scene, which indicates that in that case the knife blade did not hit the inner part of the cutter body (Photo 28).

Photo 28. Cutter secured on the scene. Knife view from the blade side. Red arrows indicate damage to the cutting edge of the knife blade.

The conducted trials showed that the cutting edge of the knife secured at the scene was damaged during cutting of the loop fibers. However, not all fibers were cut, and the blade did not hit the bottom of the cutter body, as evidenced by the lack of a circular indentation in the bottom. Loop fibers which remained not cut held the reserve canopy container in the closed position. Complete separation of the closing loop occurred due to G-force, that is, at the time when the student crashed into the ground. There was an experimental activation of the "Argus" AAD cutter conducted in the Central Forensic Laboratory of the Polish Police. For the experiment purpose the cutter was marked MP-5. It was from the same production lot as "Jan 07", which was secured at the scene.

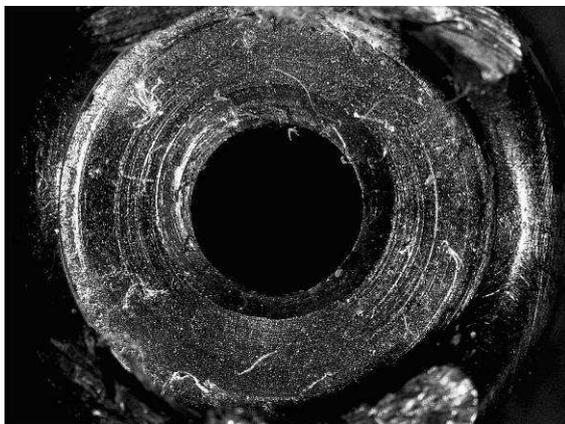
- Examination of the cutter used by manufacturer for demonstration revealed circular indentation on the body bottom corresponding to the knife diameter (Photo 31).
- Examination of the cutter secured at the scene did not reveal circular indentation on the body bottom corresponding to the knife diameter (Photo 30).

Photo 30. Body bottom. Lack of indentation corresponding to the knife diameter.

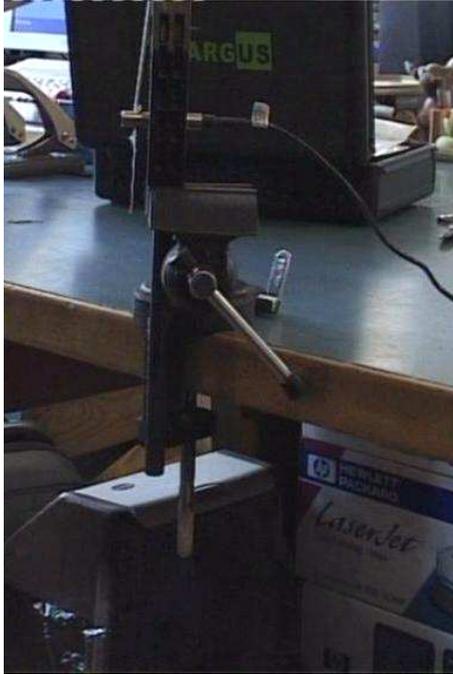
As a result of the cutter operation the weight slid down the loop, but part of the loop fibers were not completely cut.

Photo 37. View of the MP-5 cutter and the loop just after propellant activation.

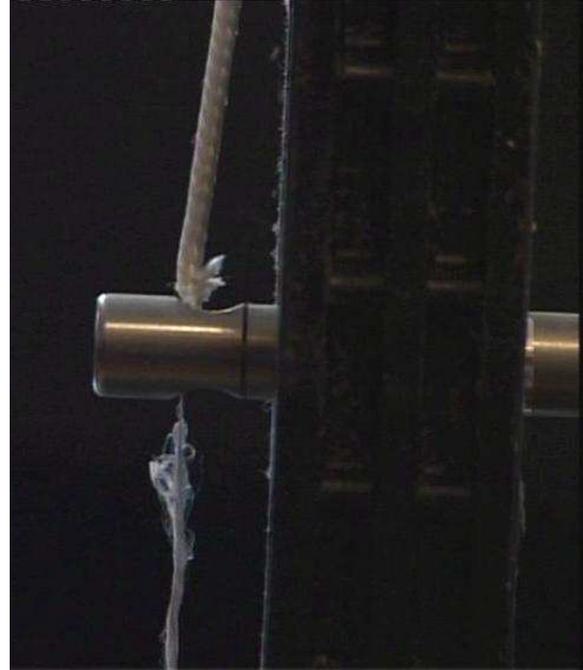
Photo 38. The result of the MP-5 cutter operation.

Based on these experiments it was found that the "Argus" cutter labeled in the same way as the cutter secured at the accident site may not completely cut the closing loop made of the material supplied by the "Cypres" cutter manufacturer, despite the loop tensing force of 5 kG.

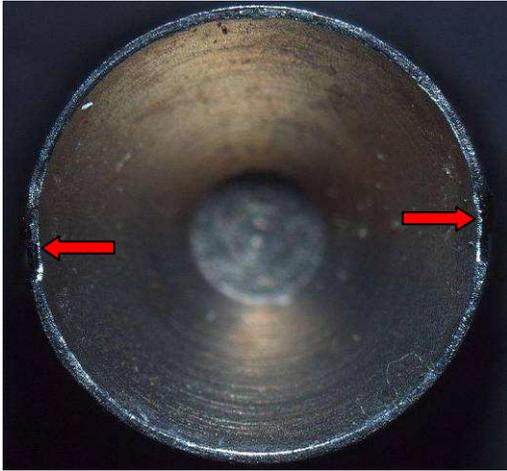
During subsequent examinations of the MP-5 cutter it was found that the cutting edge of the knife blade was damaged in line with the cutter body holes (Photo 40) similarly as the cutting edge of the knife blade secured at the accident site (Photo 28). There was no circular indentation caused by the blade on the body bottom of the MP-5 cutter (Photo 41), similarly as on the body bottom of the cutter secured at the accident site (Photo 30).

Photo 40. Experimental cutter MP-5. Knife view from the blade side. Red arrows indicate damage to the cutting edge of the knife blade.

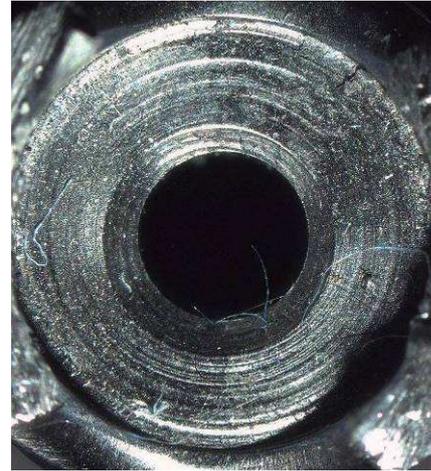
Photo 41. Body bottom. Lack of circular indentation corresponding to the knife diameter.

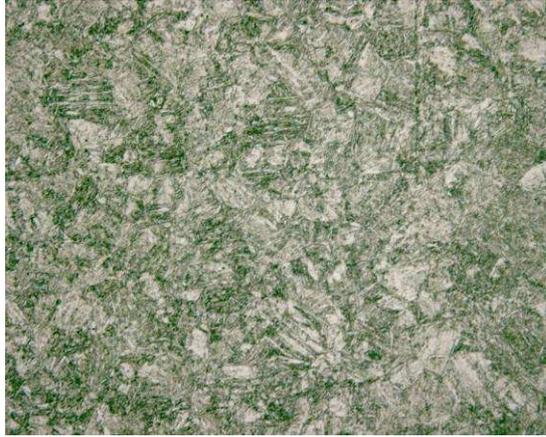
In the knife of the MD-1 cutter (secured on the accident site) the acicular structure was found, characteristic for the martensite (Photo 43).

Photo 43. Structure of the MD-1 cutter knife steel. Magnification 200 x.
