**MINISTRY OF TRANSPORT, CONSTRUCTION
and MARITIME ECONOMY
STATE COMMISSION ON AIRCRAFT ACCIDENT INVESTIGATION**

FINAL REPORT

Serious Incident

Occurrence No:932/10

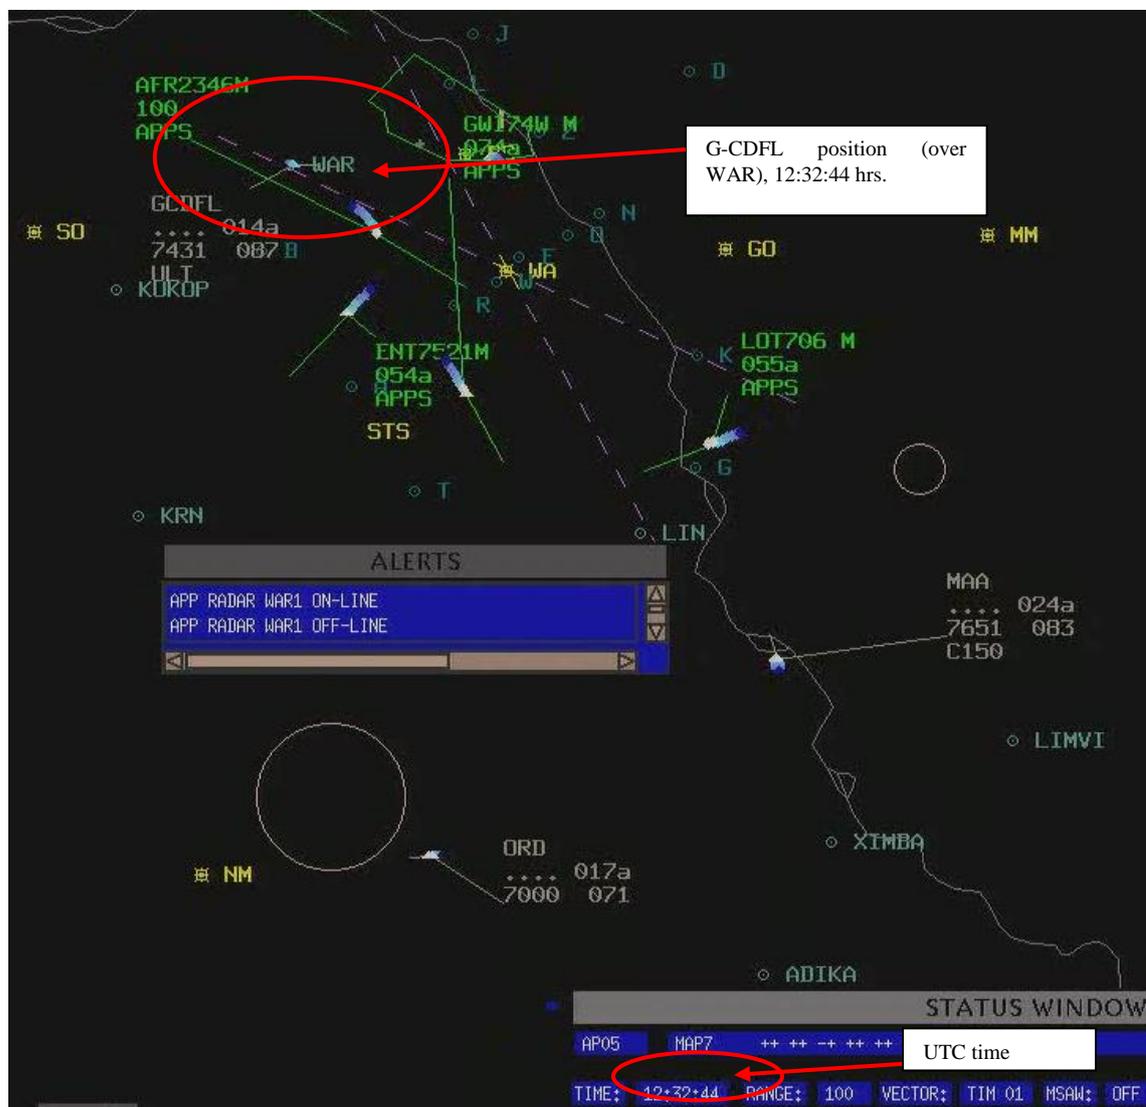
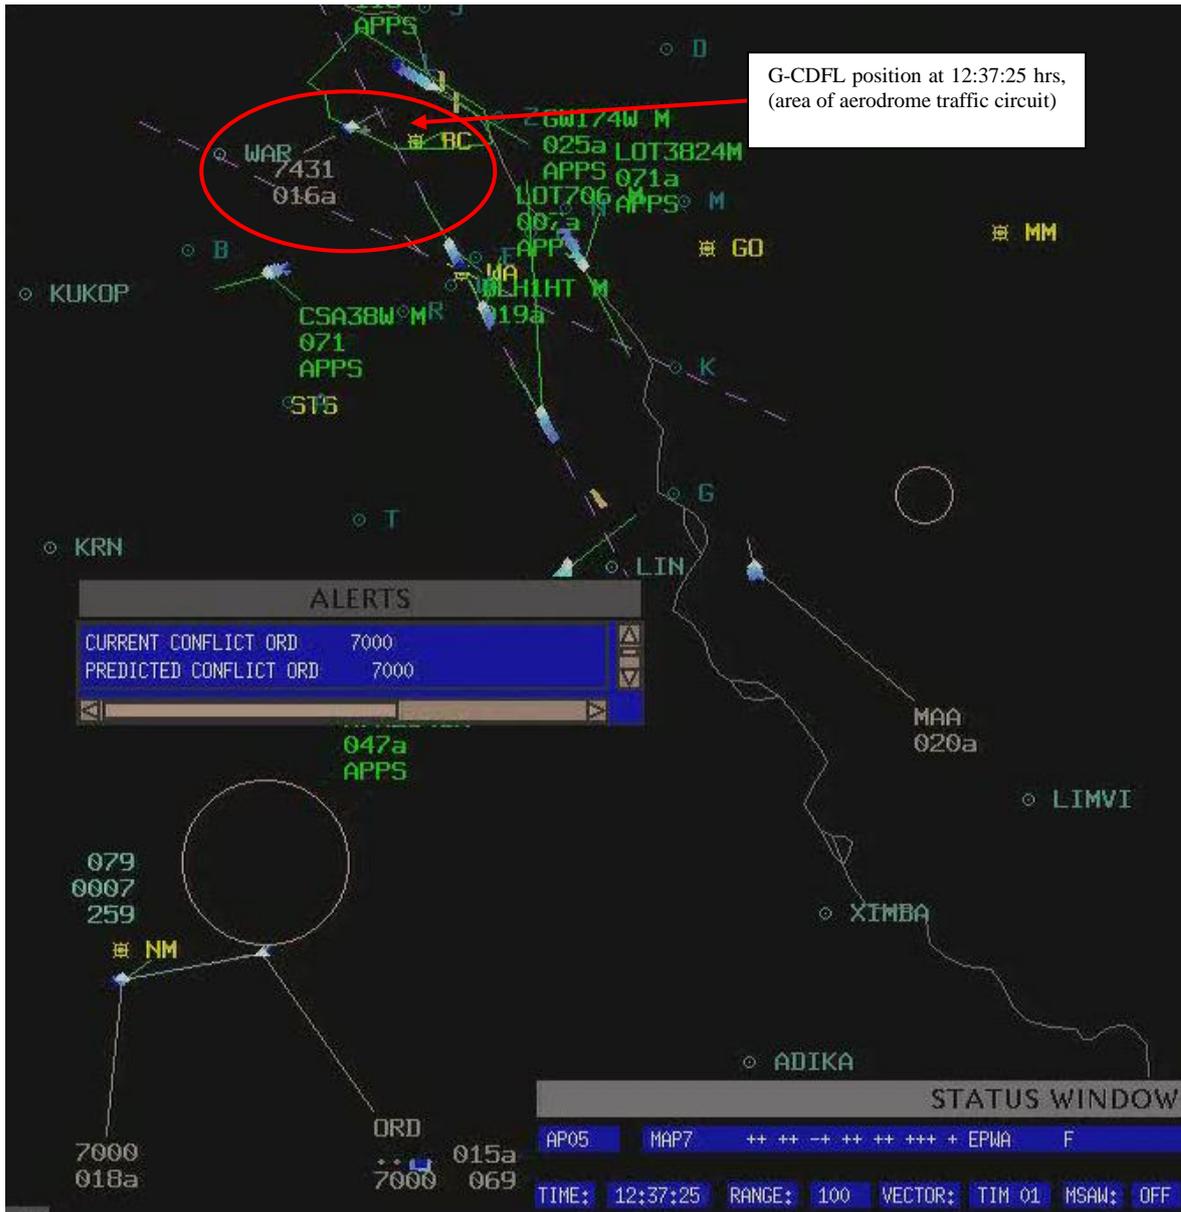
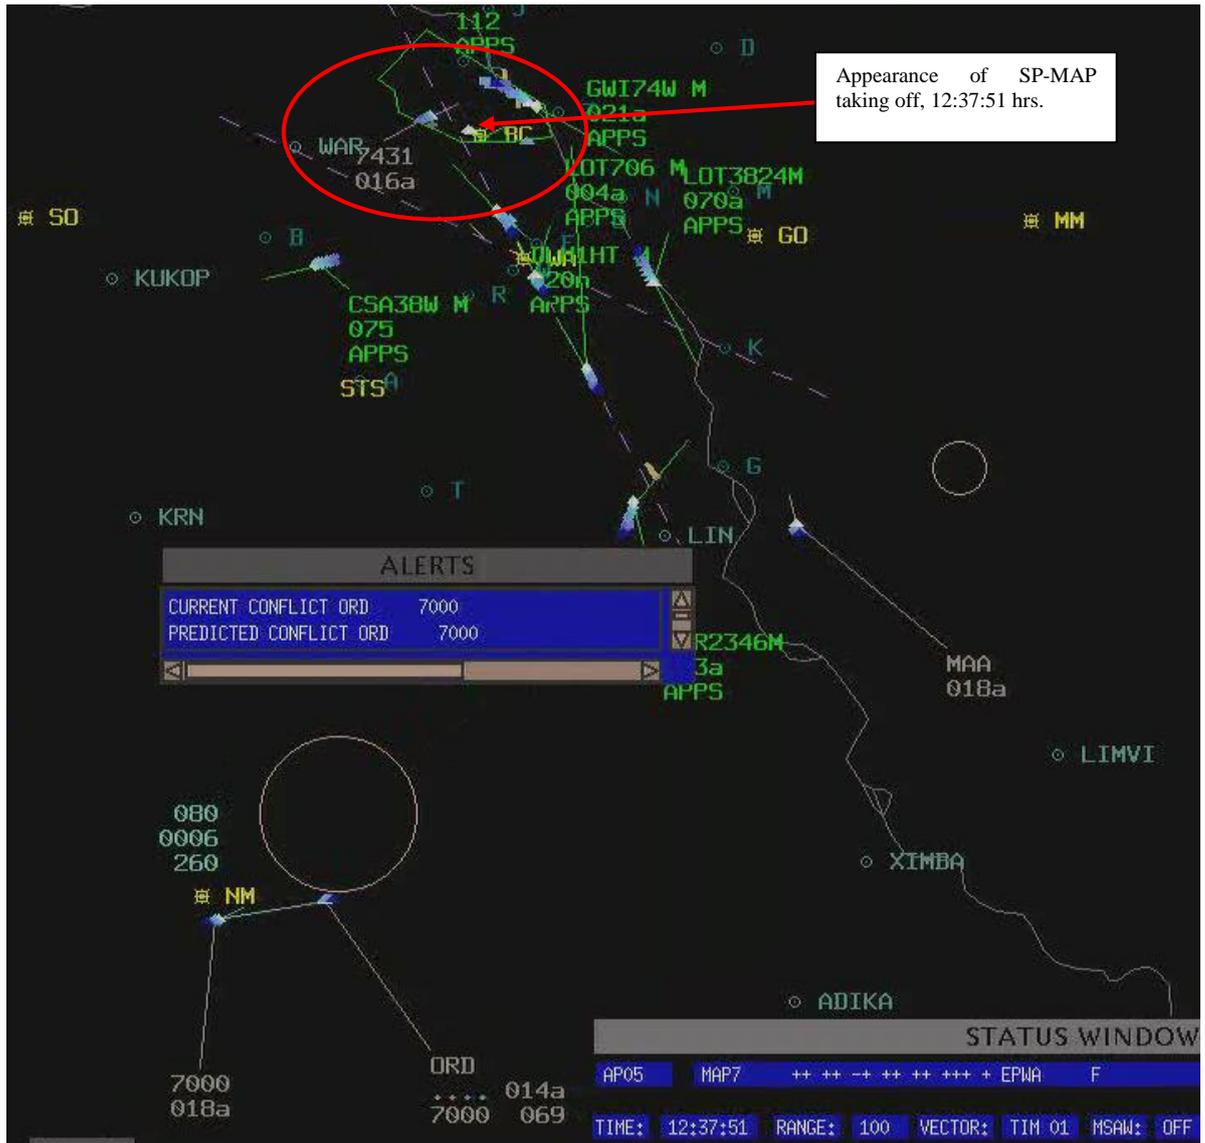
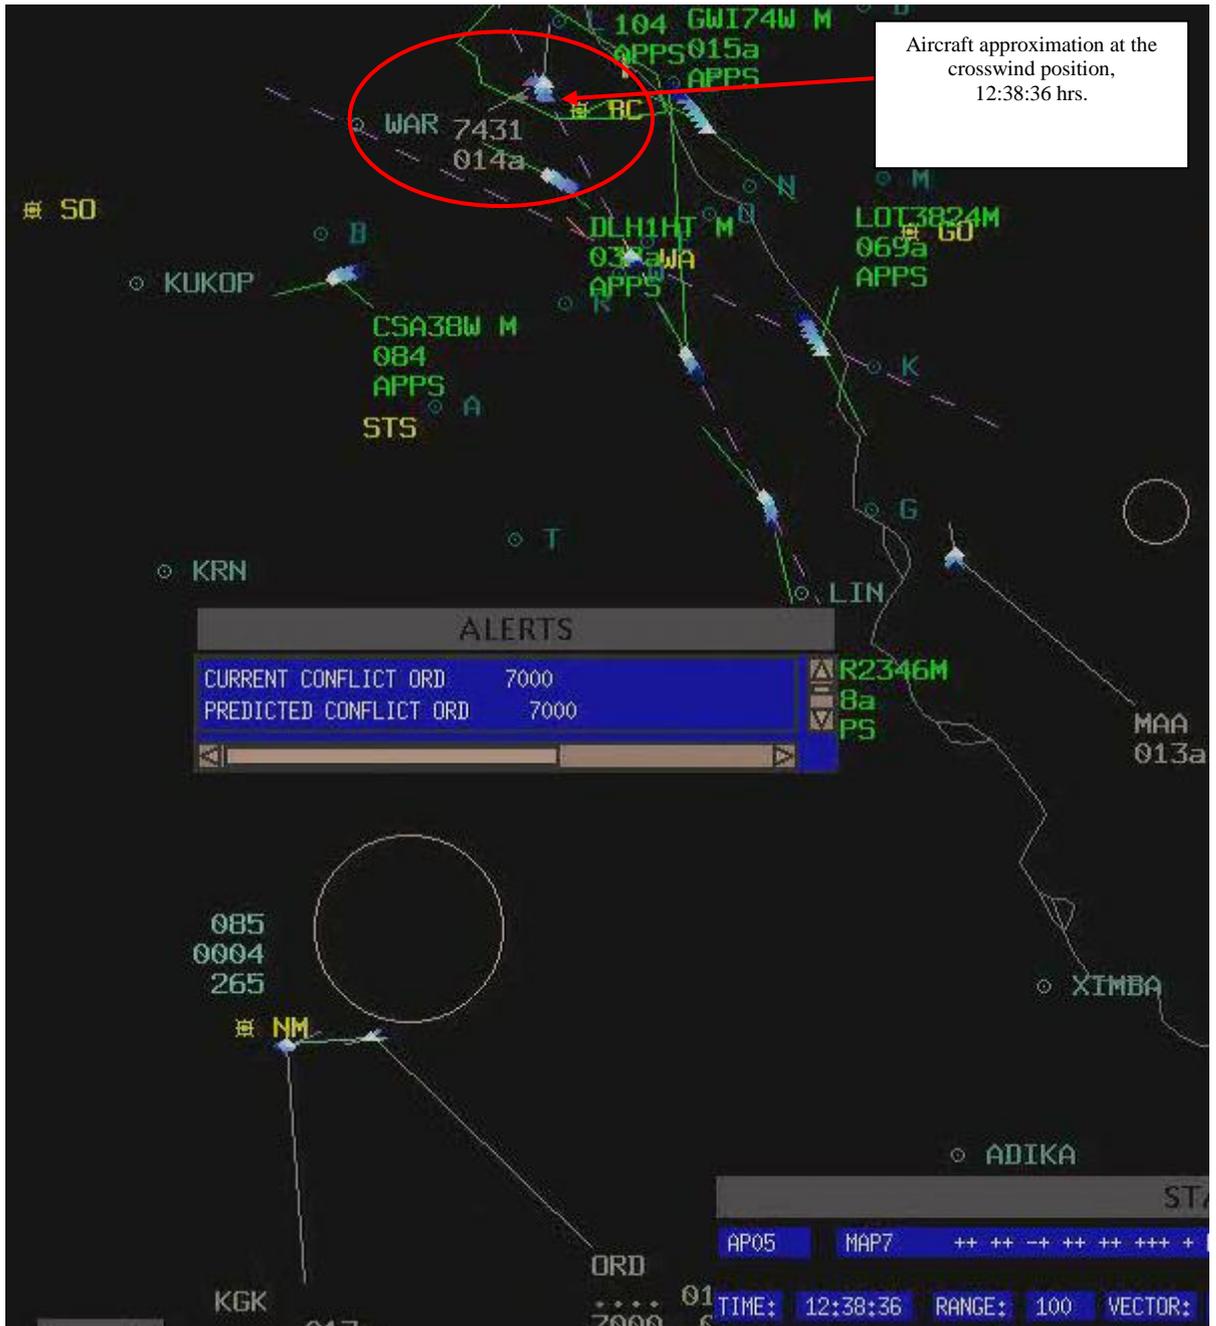
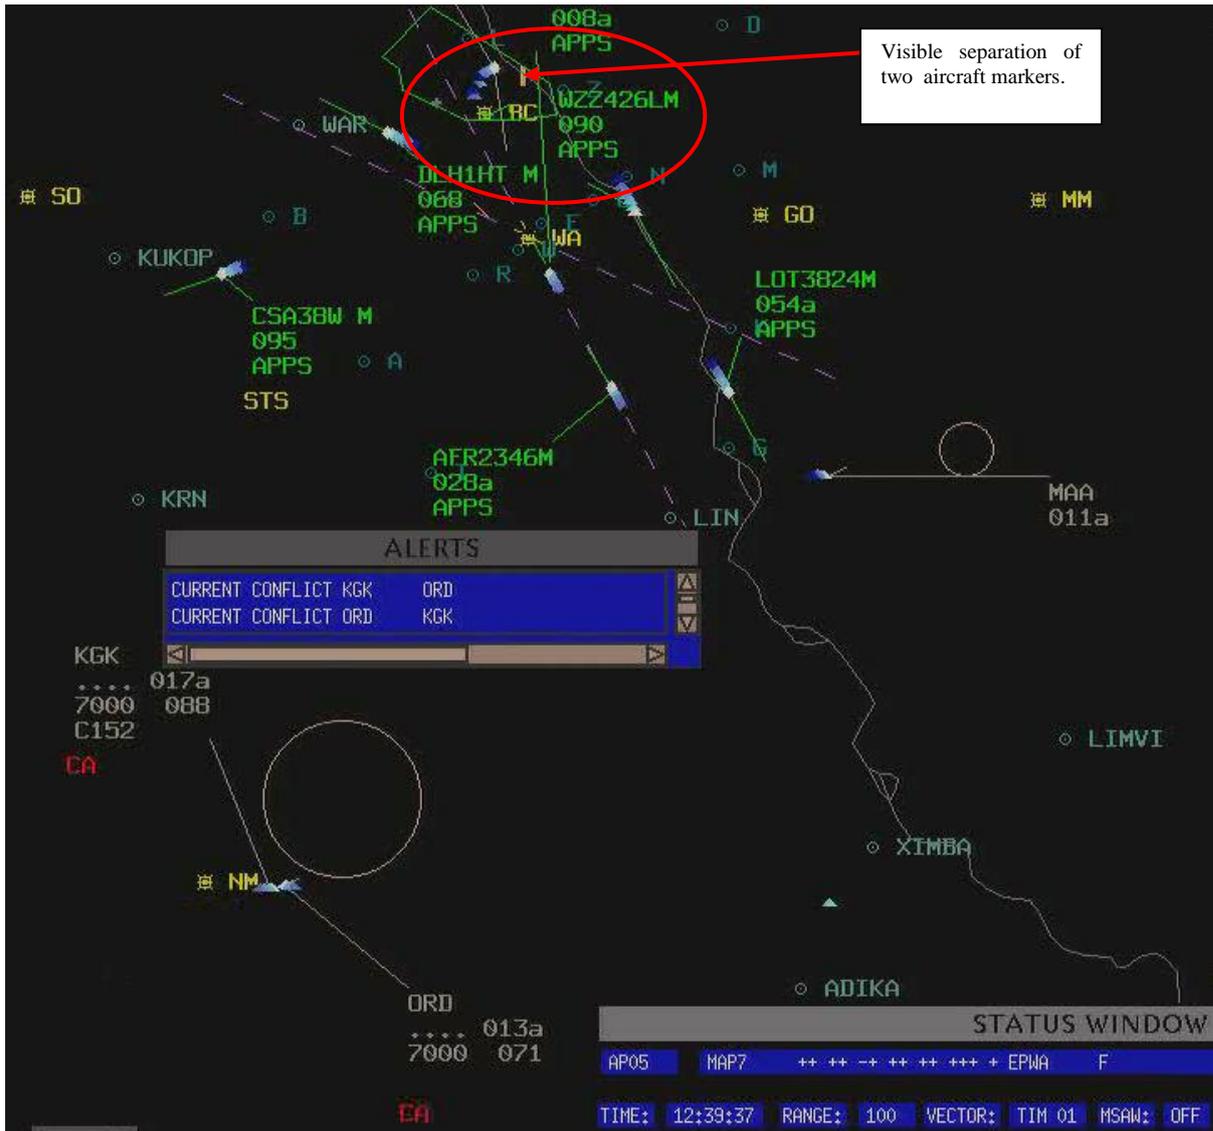
At 12:37:25 hrs (radar recording page 12), according to the instructions and the information about aerodrome traffic, the airplane entered the area of the traffic circuit in the vicinity of the first turn (crosswind position). At 12:37:51 hrs the FIS radar recording shows SP-MAP climbing after take off (radar recording page 13). At 12:38:36 hrs two aircraft approaching each other were recorded (radar recording page 14). It occurred at the crosswind position at the altitude of 1400 feet. Then they went separate ways (radar recording page 15).

In the opinion of the taking off pilot the aircraft passed each other to maintain about 50 meters vertical separation, but “Zodiac” pilot stated that it was about 50 ft (~ 15m). The Commission was not able to determine unambiguously vertical separation between the two aircraft passing each other.

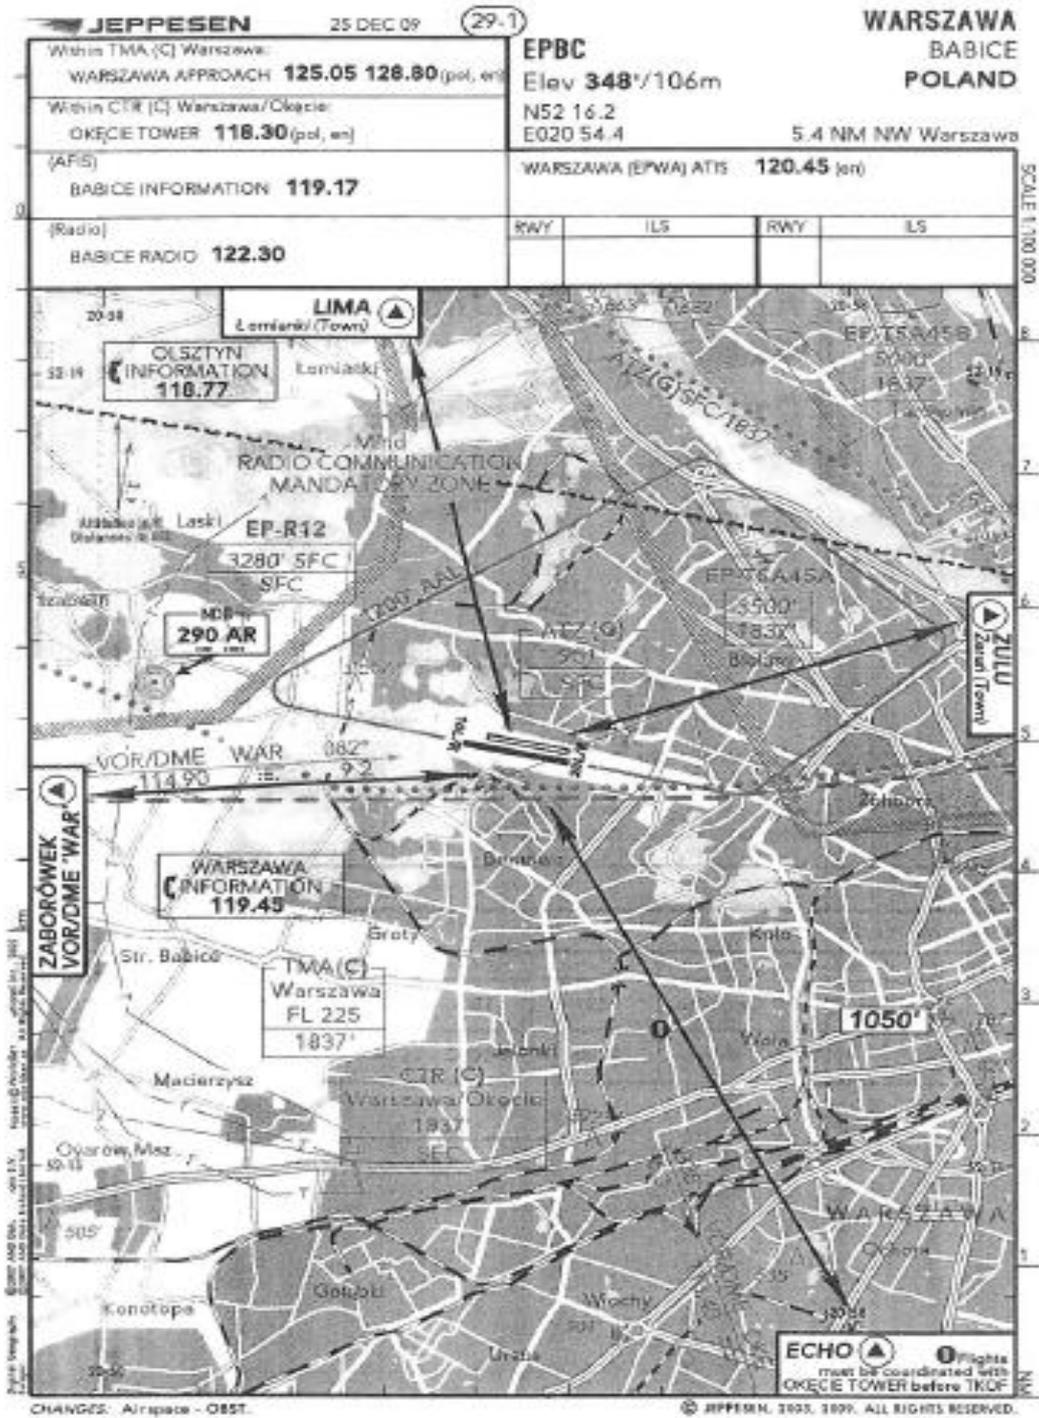
Copy of Jeppesen Publication Card No 29-1 of 25 December 2009 used by "Zodiak" pilot.

“Zodiak” pilot possessed such a formal documentation, published by Jeppesen (copies on pages 18 and 19). In both AIP VFR of Warszawa-Babice aerodrome and

Jeppesen publication there was no information that radio communications could be conducted in English **after prior arrangement with the airport manager.**

Lack of information (in AIP VFR) about the possibility of communication in English limits the aerodrome capability to receive aircraft flown by pilots who do not speak Polish.

1. Enter in AIP VFR information about possibility of radio communication with AFIS officers in English only after prior arrangement with the manager.
2. Consider recording and archiving of radio communication with „Babice Radio” maintained at 122,3 MHz frequency.
