Report A-015/2011

Accident involving
a CIRRUS SR-22,
registration SP-AVD,
on the extension of runway 29
at the Asturias airport,
on 6 June 2011

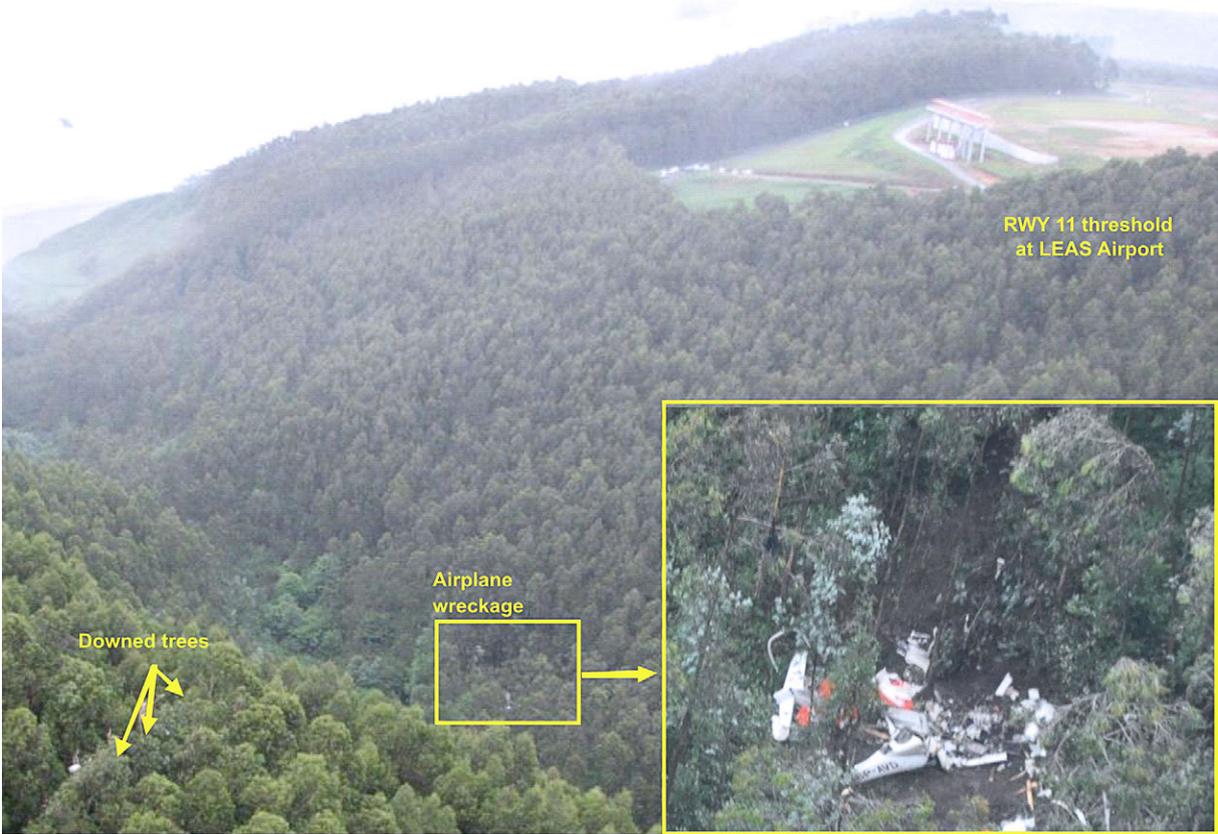
At 15:08, one of the helicopters sighted aircraft SP-AVD on Bayas Mountain, some 450 m to the southwest of the runway 11 threshold. A rescue team was lowered to the crash site and confirmed the death of the two occupants, who were trapped in the wreckage.

Figure 1. Aerial view of accident site

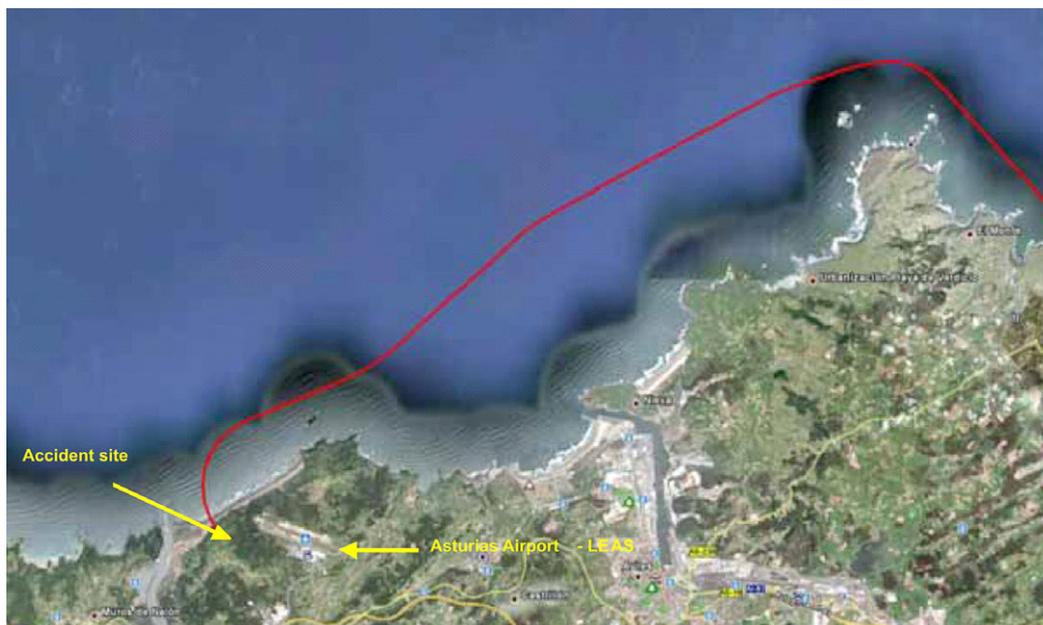
Figure 6. Final moments of the flight taken from the MFD

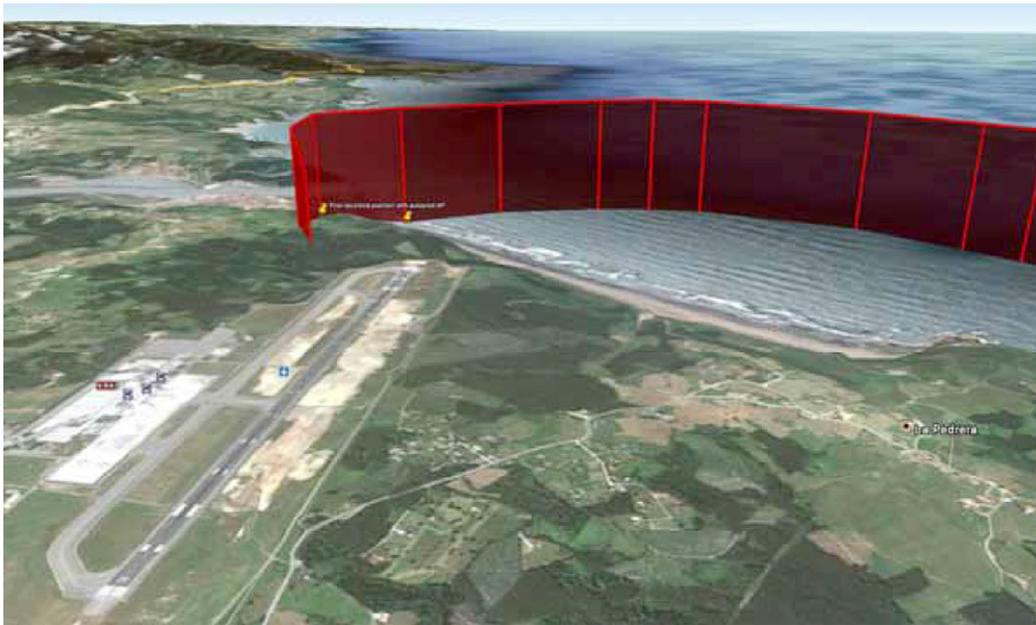
Figure 7. Altitude in the final seconds as recorded by the PFD

- The airplane's parachute (CAPS) was found deployed at the accident site.
- In the final seconds of the flight, the aircraft struck several trees at the top of Bayas Mountain, at an altitude of 500 ft, after which its indicated airspeed and flight attitude dropped sharply.

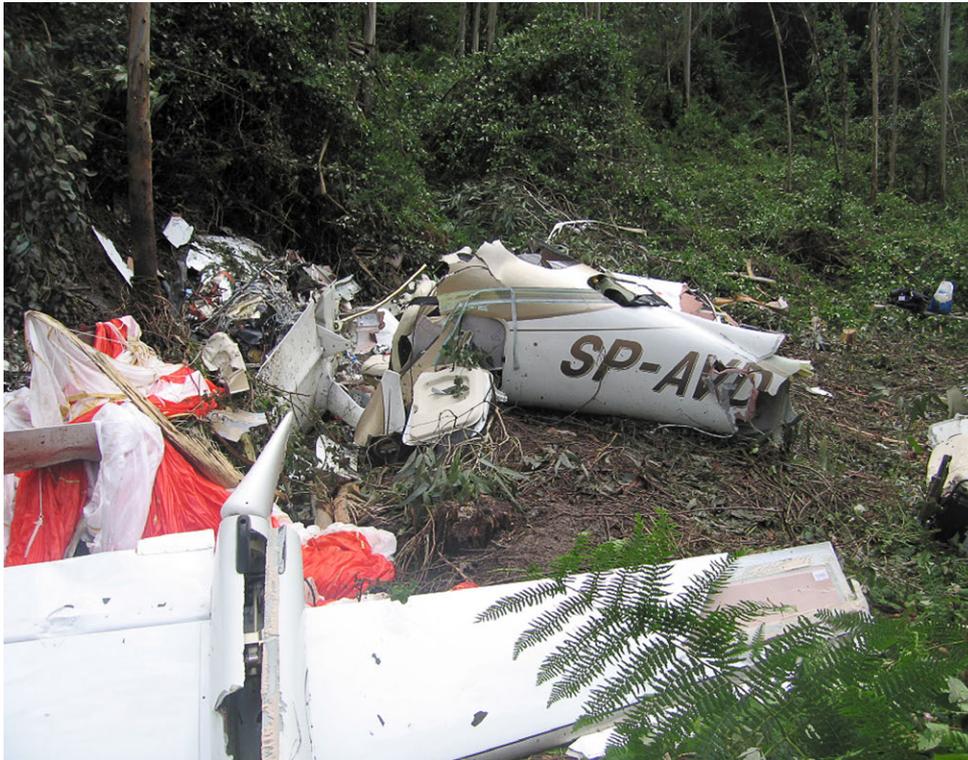
The tail assembly detached and was found 2 m. left of the aircraft. The horizontal stabilizer was lying on the ground (see Figure 8).

The right wing also detached from the fuselage after impact and was found upside down 2.5 m to the right. It broke in two at approximately the halfway point.

The part that was most affected by the crash was the cockpit, which had dug into a depression in the ground. The entire control panel was severely damaged, as was the rest of the compartment.

Figure 8. Photograph of airplane from the left side

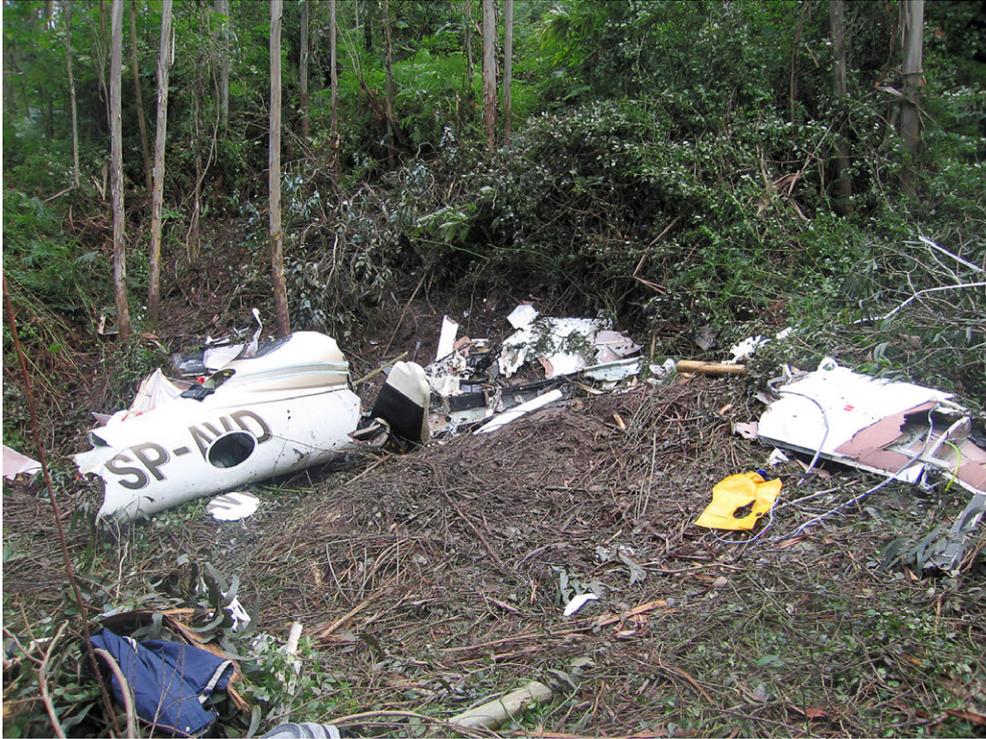
Two of the propeller's three blades⁶ broke and were found detached and partly buried in the ground, though they were not severely damaged.

The airplane's emergency parachute was found deployed and tangled in a tree at the accident site.

Figure 9. Photograph of airplane from right side

The little damage suffered by the propeller blades is explained by the fact that the pilot probably reduced engine power at the last second, meaning that the impact took place with the propellers turning very slowly.
