Final Report No. 2169 by the Swiss Accident Investigation Board SAIB

concerning the accident involving
the Aero AT-3 R100 aircraft,
registration HB-SRA

on 12 August 2011

Worboden, Worb/BE

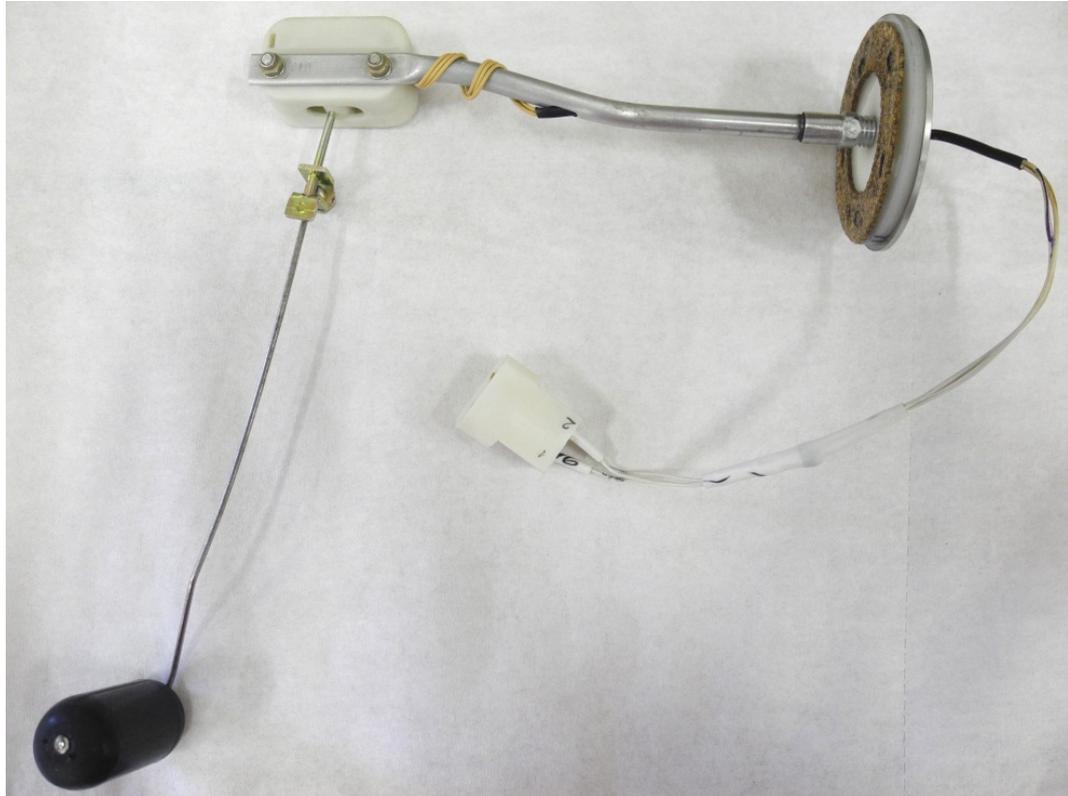
Figure 3: Sensor "Variant IV", P/N AT3.61.460.0 for aircraft up to S/N AT3-053

The sensor consists of a cover which is screwed onto the tank. In the middle of this cover there is a thread with a sleeve. An aluminium tube is inserted into this sleeve. At the lower end of the aluminium tube, a plastic housing in which the potentiometer is located is screwed on. A 21 cm long float is mounted on the axis of rotation of the potentiometer.

The fuel gauge in the cockpit received the signal from a sensor in the tank. The capacitive sensor originally fitted was replaced by the manufacturer with a sensor fitted with a float. This sensor had design shortcomings in that as a result of incorrect insertion of the dipstick the float could be twisted so that it ended up lying on a connecting pipe in the tank, as a result of which the indication in the tank remained blocked at approximately 1/3. Since the "FUEL RESERVE - 10 L" warning lamp also received its signal from the same float potentiometer, the corresponding warning would never be triggered in this situation. It is expected of a system with a low level warning lamp that the corresponding signal is generated by an independent system.

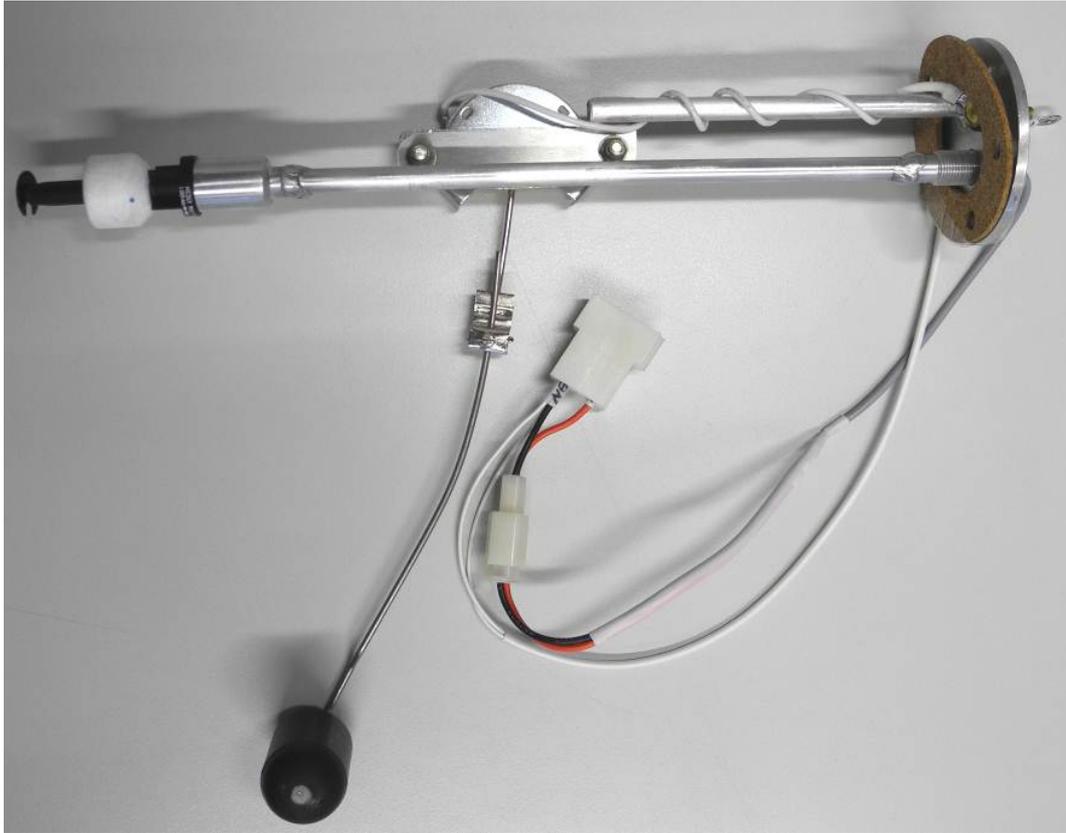
Reference is also made to a third type of sensor, which was stocked by the maintenance company as part of a spare parts order placed by the owner. This sensor also measures the tank level using a float. The signal for the red warning lamp is generated separately.

Figure 4: Sensor "Variant IV", P/N AT3.61.500.0 for aircraft from S/N AT3-054

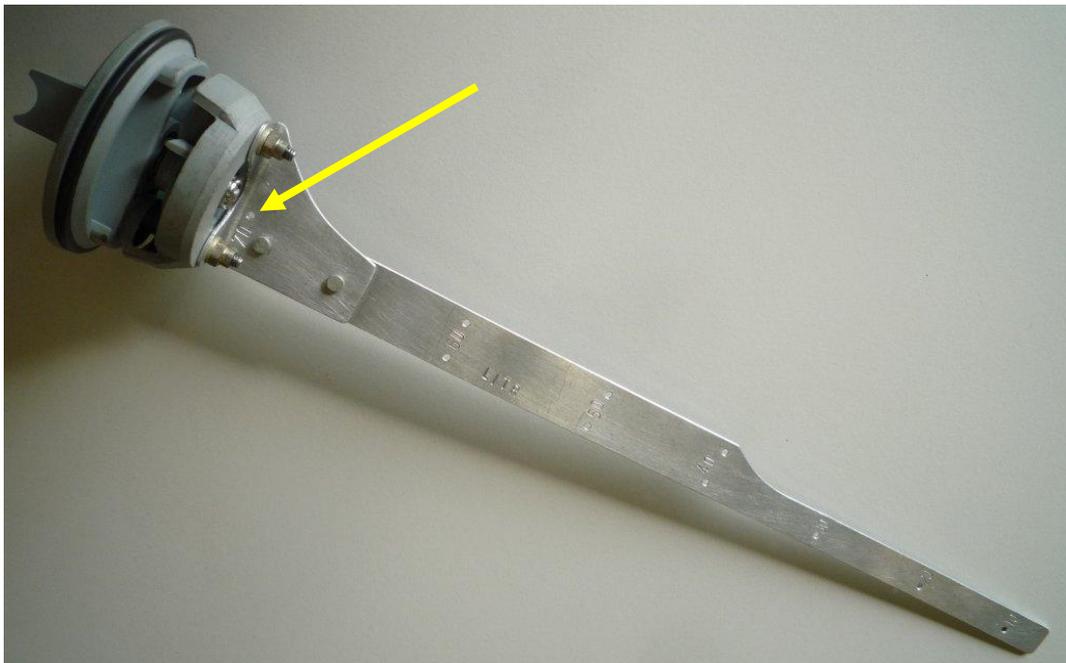
Finally, the fuel content could also be measured by using a dipstick built into the filler cap. There were several holes on this dipstick, representing a scale with 10-liter-steps. The scale ranged from 10 litres up to 70 litres. No definition of the scale could be found in the AFM. The filler cap lock was fixed to the dipstick.

Figure 5: Dipstick with scale up to 70 litres (yellow arrow)

- The effective fuel capacity was 66 litres.
- The dipstick is very inaccurate in the range from the 10 to 30 markings and may indicate up to seven litres more than the actual value.
- As a result of the movement of the dipstick in the fluid, caused by insertion, closing and opening of the filler cap to determine the fuel level, a measurement may indicate up to 10 litres more than the actual value.
- It took at least three consecutive measurements to achieve a respective tolerance of 5 mm.
- When a value of 22 litres was measured using the dipstick, there were actually 18 litres of fuel in the tank.
- When a value of 25 litres was measured using the dipstick, there were actually 22 litres of fuel in the tank.

- A measurement with the dipstick could indicate up to 10 litres more than the actual value.
- The fuel measurement sensor had design deficiencies. If the filler cap was closed incorrectly, the dipstick could twist the float of the sensor over the connecting pipe in the tank.

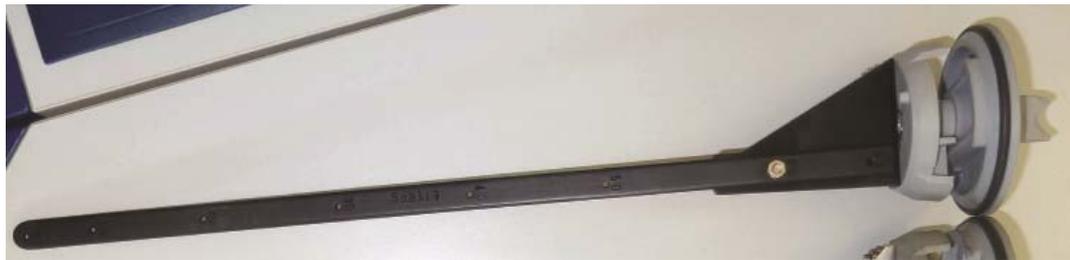
Another type of gauge with a scale up to 65 litres was found in the spare parts inventory of the maintenance company. It can be assumed that this dipstick was intended for use with fuel tanks with a 68.5 litre capacity.

Figure 6: Dipstick with scale up to 65 litres

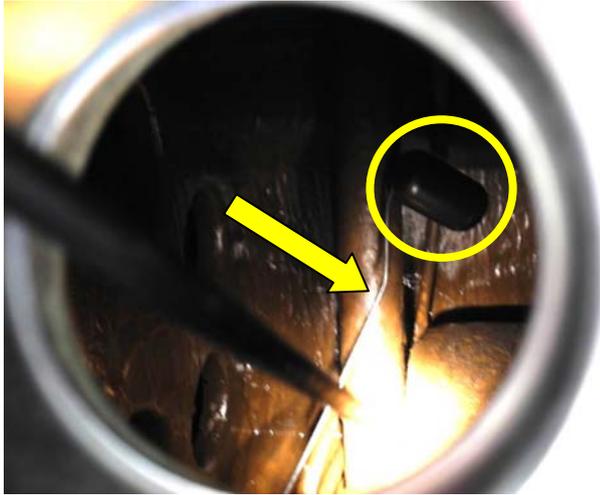
On the measuring sensor of the fuel tank, it was found that the aluminium tube to which the float is attached could be twisted clockwise, without any significant force, by up to 40° from its original position.

It was also found that as a result of this twisting, the float was resting in the tank on the connecting tube which carries through the throttle linkage of the pilot sitting on the right in the cockpit. The float was able to move freely upwards and was able to indicate fuel levels from full down to one-third.

Figure 7: Float (yellow circle) on connecting tube (yellow arrow)

- The signals for gauging the fuel level and triggering the "FUEL RESERVE - 10 L" warning lamp were generated by the same sensor.
- If the float is lying on the connecting pipe, the indication in the cockpit remains at approximately 1/3 and the "FUEL RESERVE - 10 L" warning lamp does not light up. This corresponds to the situation found after the accident.

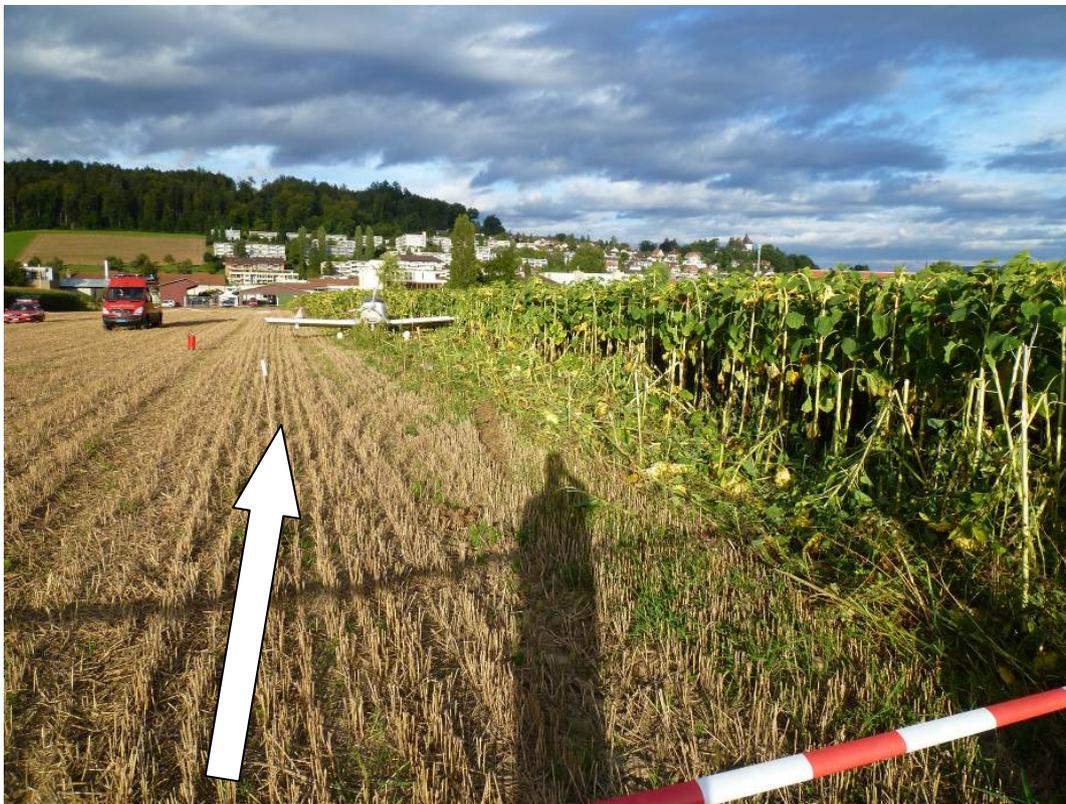
The aircraft initially touched down normally on the emergency landing site. Because of the diagonal approach, the right wing collided with the sunflower field in the roll-out phase. As a result, HB-SRA was rotated clockwise around its vertical axis by almost 180° and rolled backwards to come to a halt after approximately 25 m.

The scene of the accident was a harvested grain field, which was chosen as the emergency landing site. This field bordered directly onto a field of sunflowers.

Figure 8: Scene of the accident – white arrow = direction of flight

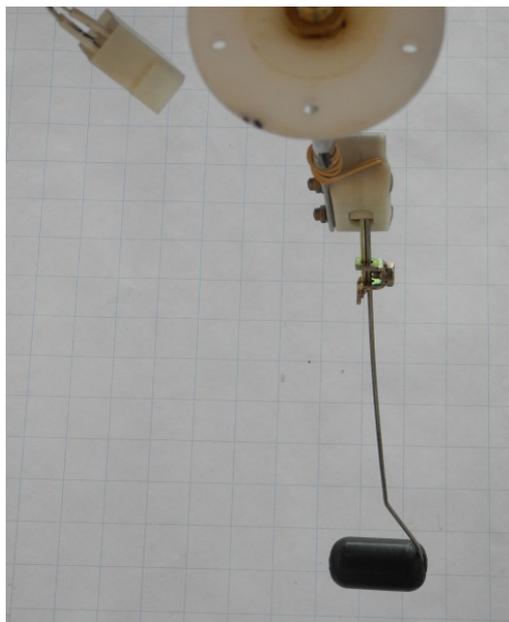
Figure 9: Float in normal position

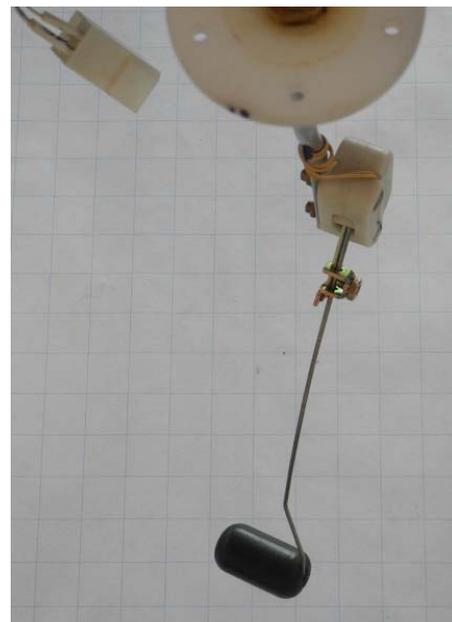
The twisting of the float due to the dipstick was able to be reproduced. To do this, the following conditions had to apply:

- The tank had to be more than half full.
- The dipstick was not inserted correctly.

If the dipstick was inserted into the left half of the tank, it could come into contact with the left side of the float linkage. When the tank filler cap was closed, the aluminium tube of the float was twisted clockwise to such an extent that the float was brought above the connecting tube and rested on it as the level dropped.

This incorrect state may persist even if the dipstick is subsequently inserted correctly.

Figure 10: Float in skewed position
