SCAAI-1400/2011-EPWA-SP-LPC (rev.1)

Accident Description

Status: **Preliminary Report (rev.1)**

Type: **Boeing B-767-300**

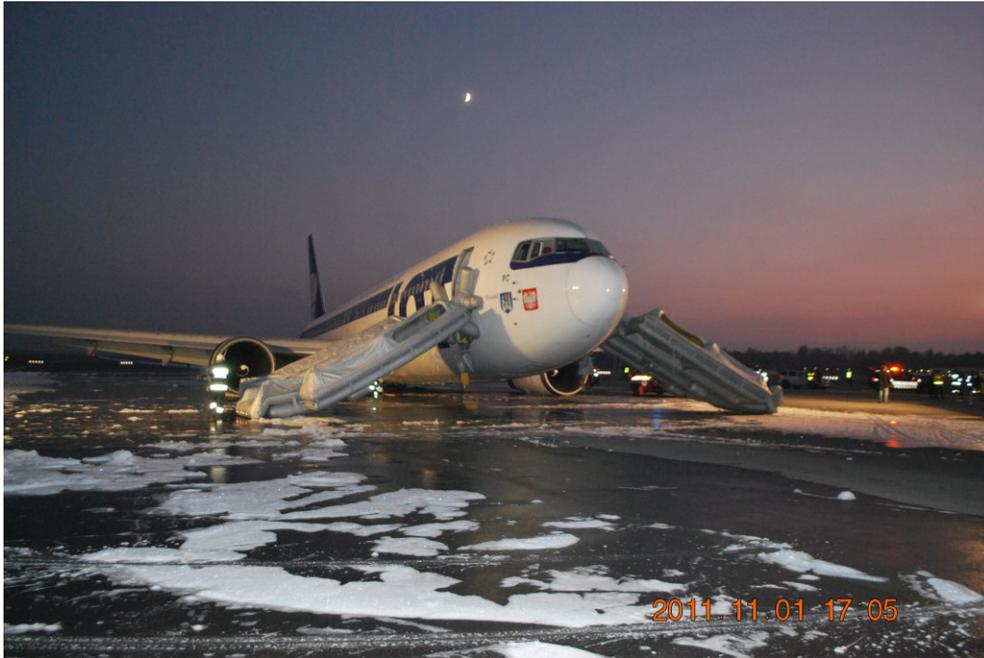
Photo1. General view of SP-LPC after emergency landing.

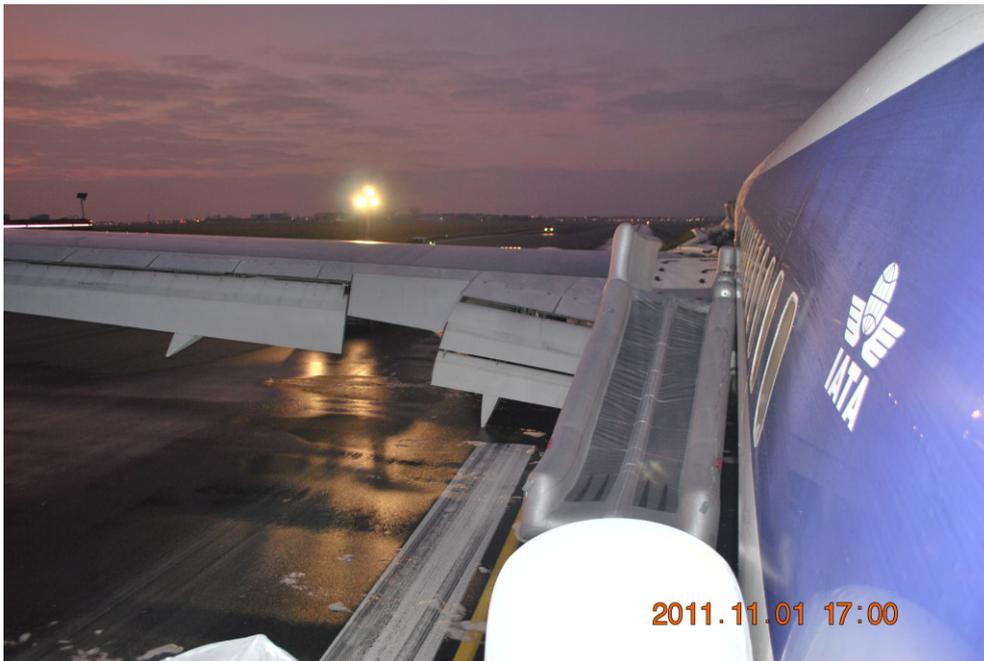
Photo 2. View on the left wing of the airplane from the rear main door.

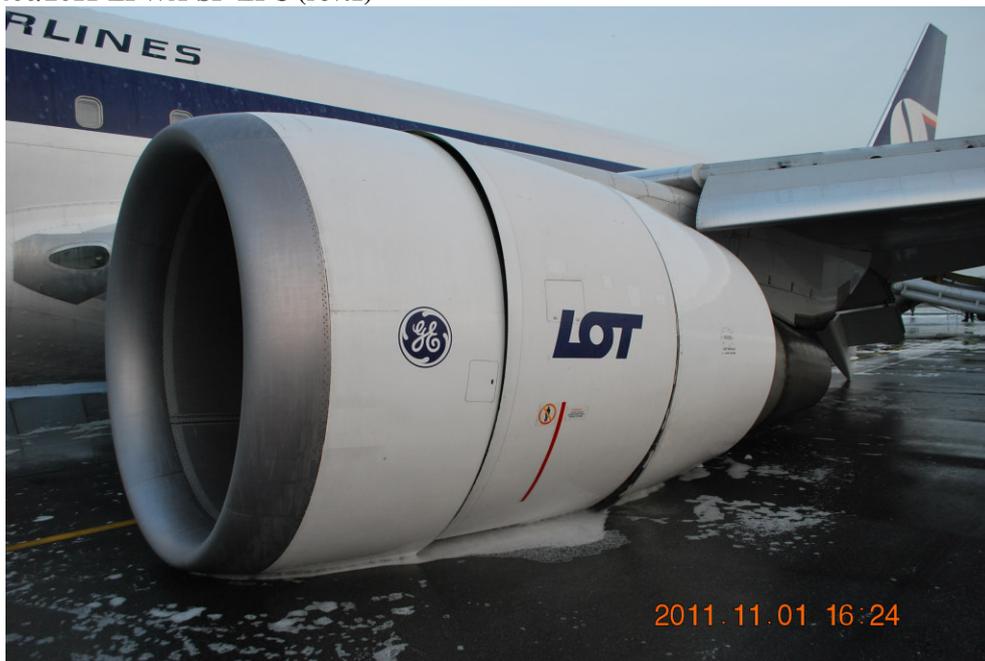
Photo 3. Left engine of SP-LPC airplane

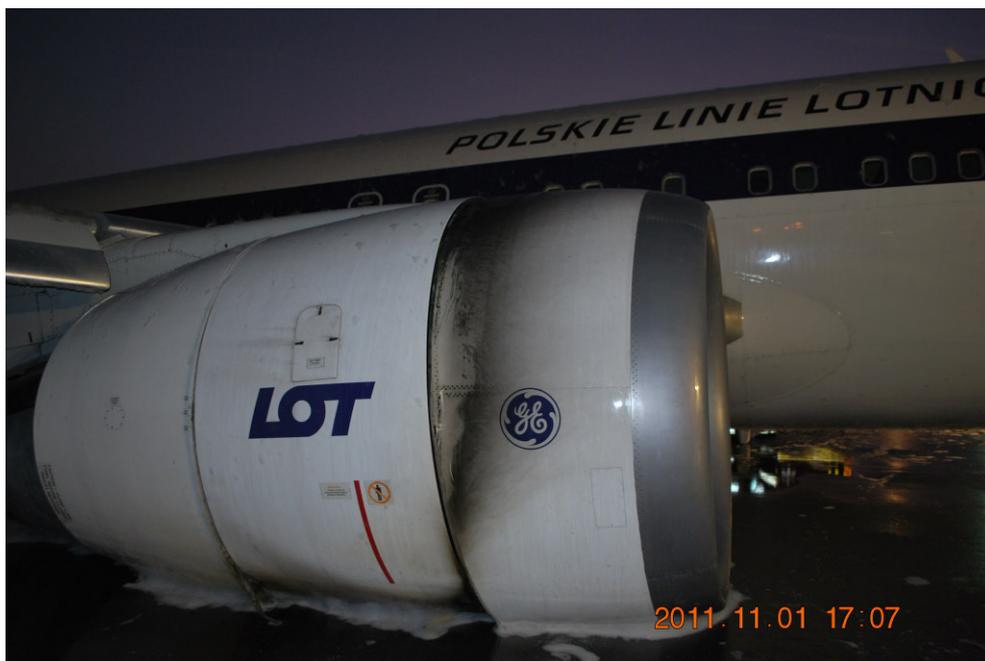
Photo 4. Right engine of SP-LPC airplane.

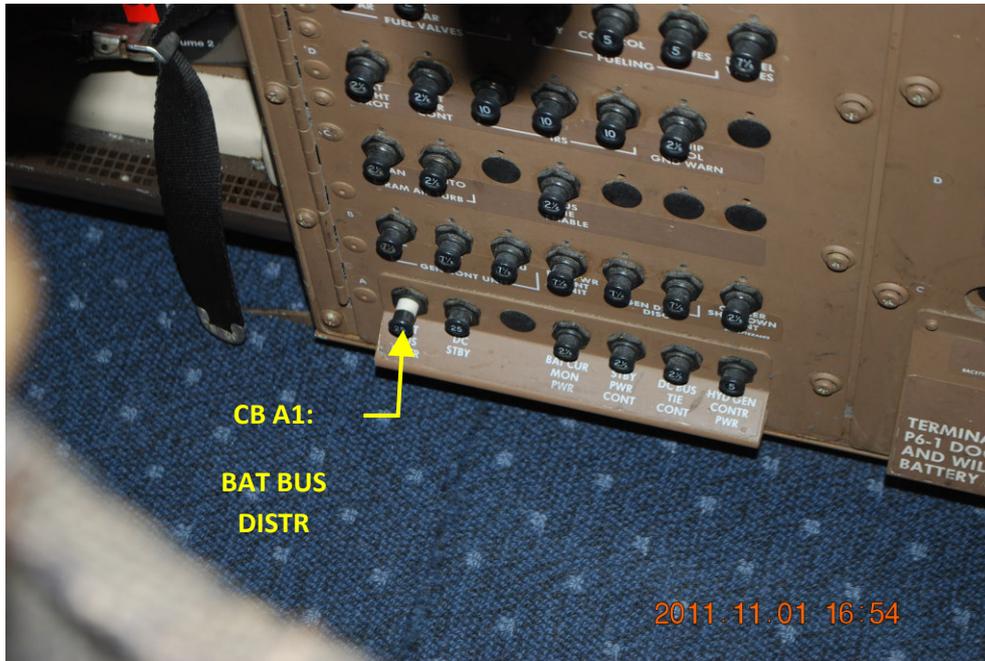
Members of the State Commission on Aircraft Accident Investigation arrived at the aerodrome about 15-20 minutes after the evacuation of passengers and crew. They carried out the initial inspection of the aircraft and found that in the cockpit, on P6 panel, the circuit breaker C829 BAT BUS DISTR (on A1 position) was in the position „Off”, while the circuit

breaker C4248 LANDING GEAR - ALTN EXT MOTOR (on F6 position) was in the position „On”. Records of on-board recorders (CVR - Cockpit Voice Recorder, FDR - Flight Data Recorder and QAR - Quick Access Recorder) were protected and photographic documentation was made.

Photo 5. P6-1 circuit breakers panel in the cockpit.

The circuit breaker C829 (BAT BUS DISTR) indicated on Photo 5 protects several airplane systems including the alternate landing gear extension system. The „Off” position of the circuit breaker was not recorded or indicated by the airplane systems (FDR - Flight Data Recorder and EICAS - Engine Indications and Crew Alerting System).

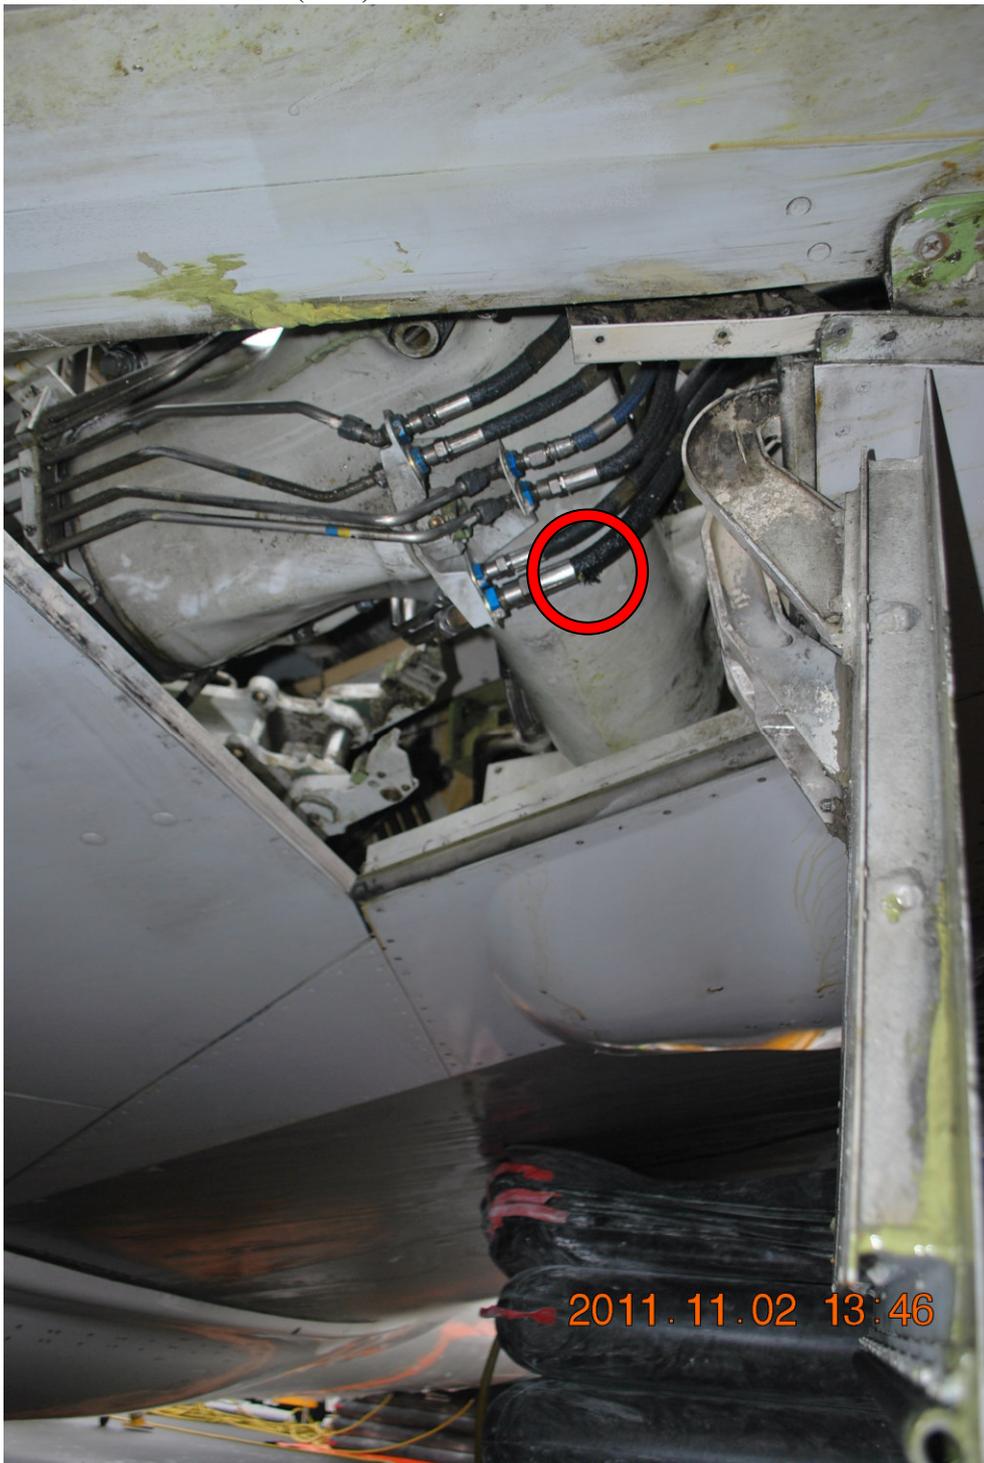
The electrical systems connected with C829 (A1) „BAT BUS DISTR” circuit breaker
On 2 November the place of hydraulic fluid leakage was identified (see Photo 7 and 8).

Photo 7. View of the hydraulic hoses of the right main landing gear of SP-LPC airplane

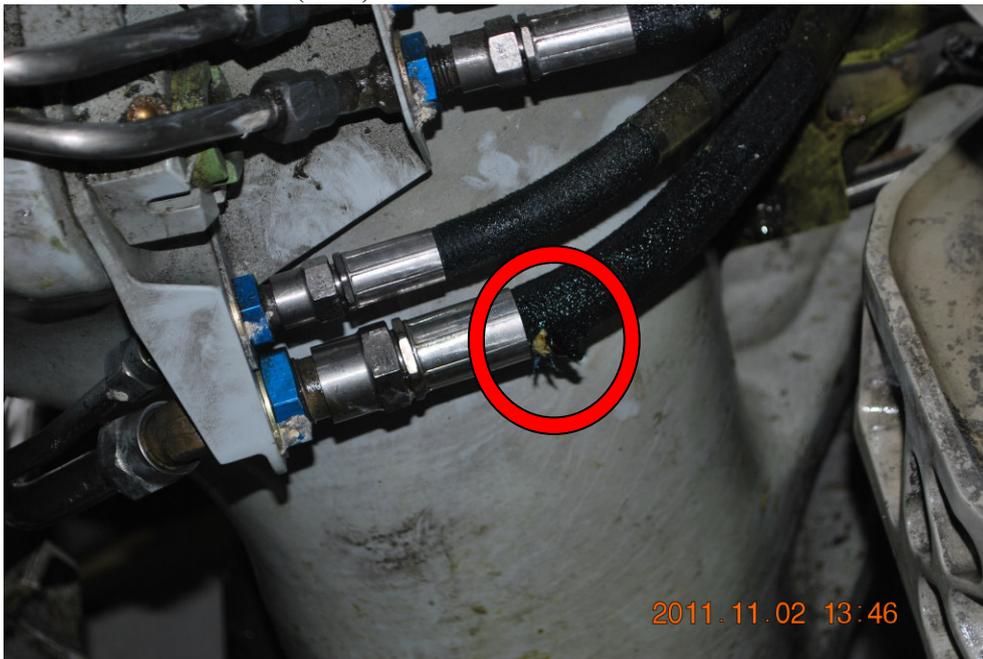
Photo 8. Damaged hydraulic hose of the right main landing gear of SP-LPC airplane.

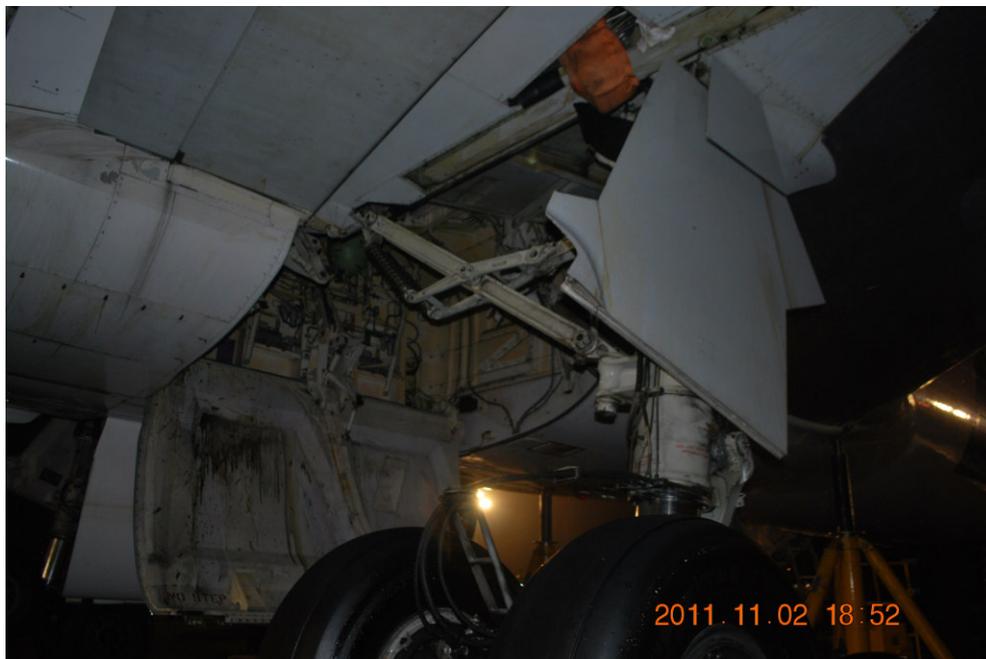
After lifting the aircraft from the runway, in agreement with this operation manager, a test of the landing gear extension with the alternate landing gear extension system was carried out. After connecting the ground power unit, setting C829 (A1) BAT BUS DISTR circuit breaker in the position „On” and activation of the alternate landing gear extension system, the landing gear was extended. The aircraft was towed to the operator's technical base.

Photo 11. Extended right main landing gear after lifting SP-LPC airplane.

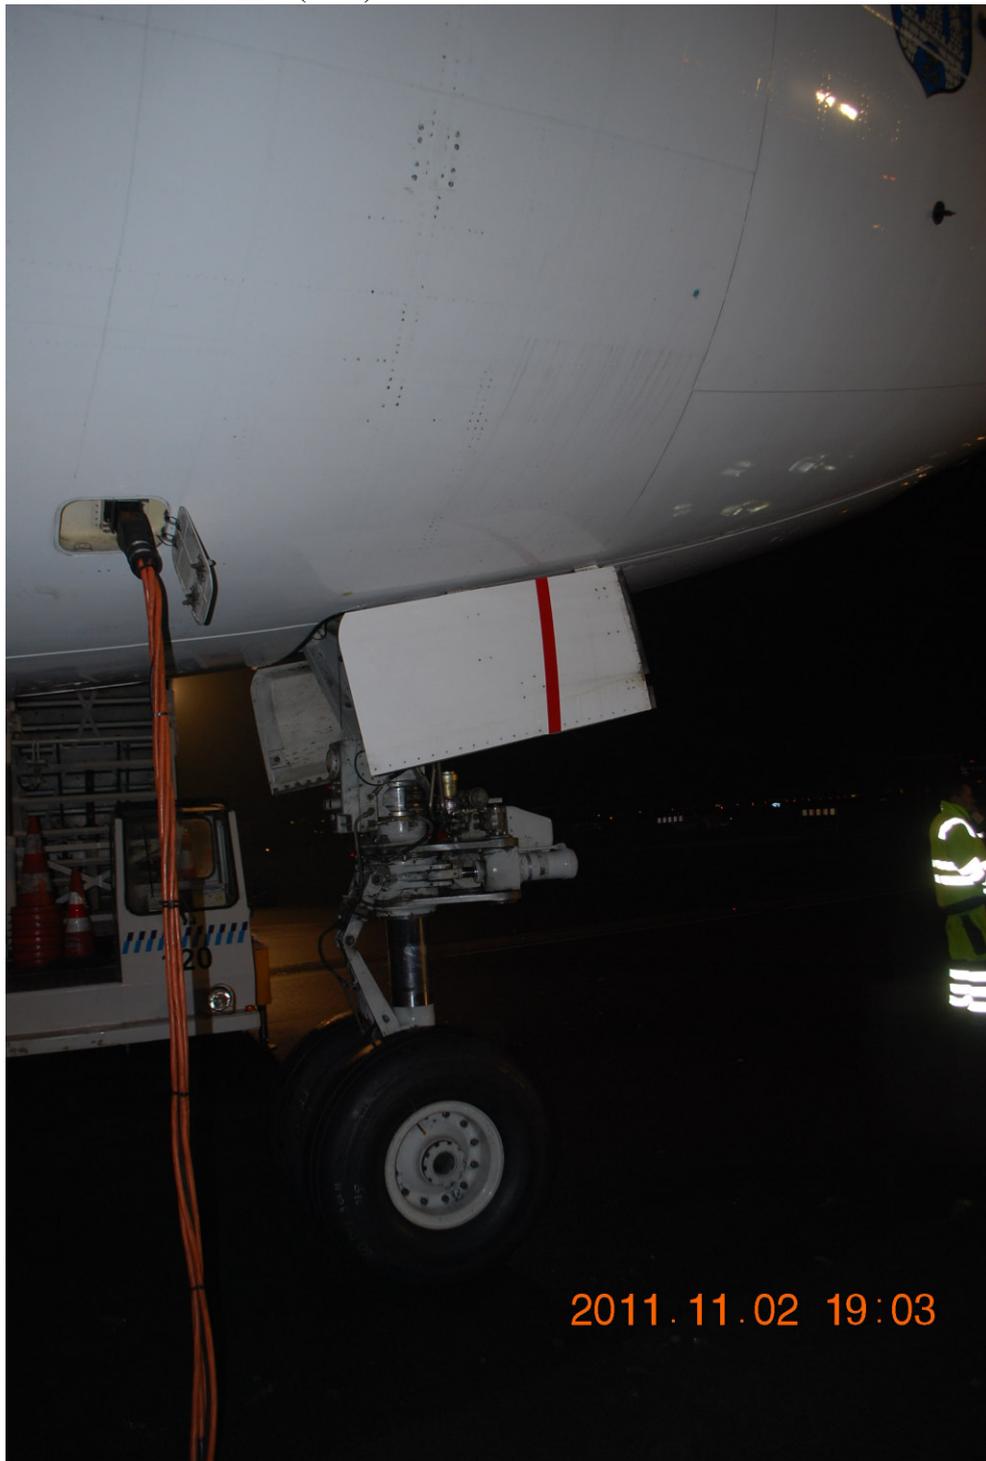
Photo 12. Extended nose landing gear of SP-LPC airplane.

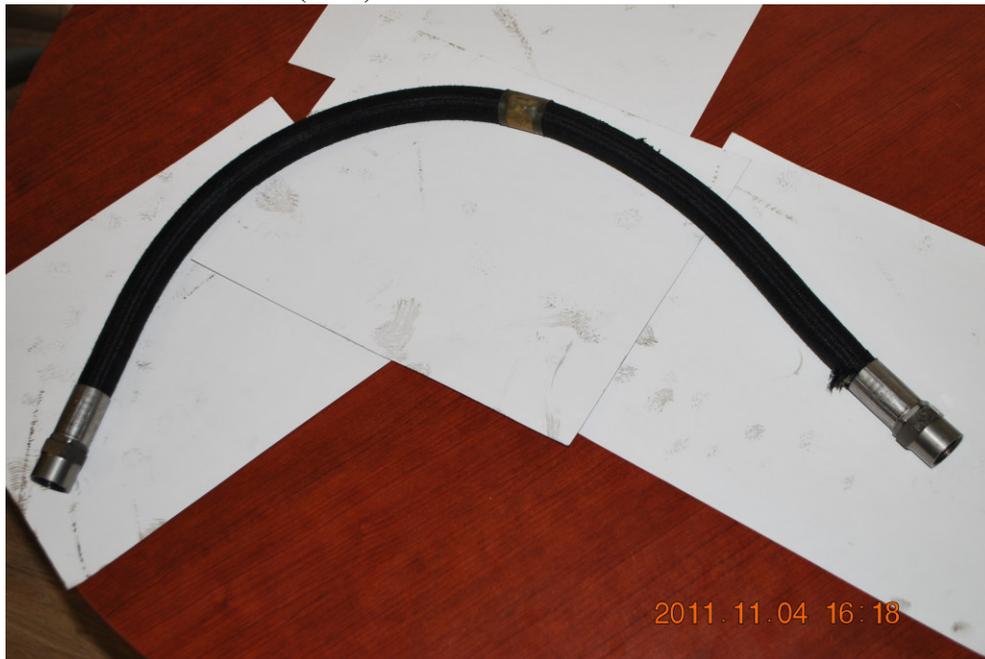
On 4 November members of SCAAI Investigating Team participated in disassembly of the damaged hose of the hydraulic system „C” (central) and secured the hose to carry out tests. The hydraulic hose together with photographic documentation was sent to the laboratory of National Transportation Safety Board (NTSB).

Photo13. Damaged hydraulic hose of the landing gear extension system of SP-LPC airplane.

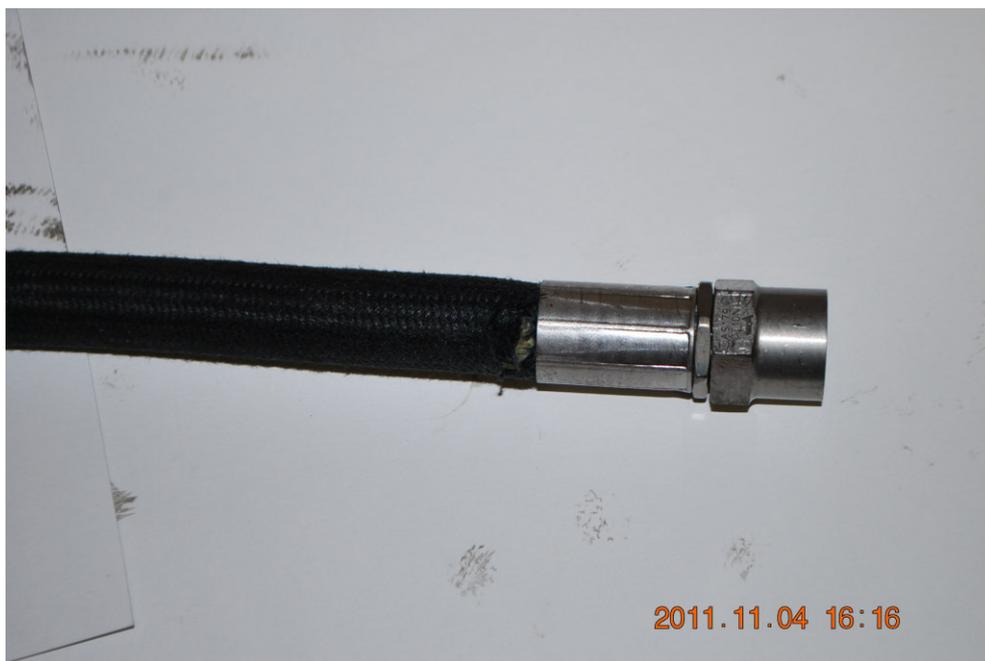
Photo14. Damage to the hydraulic hose of the landing gear extension system of SP-LPC airplane.

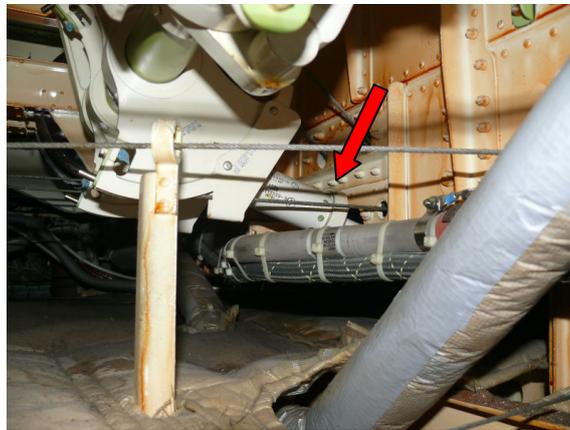
Visual inspection of individual elements of the alternative system of landing gear extension was made. Condition of all load limiters (indicators) of this system did not raise any objections (NLG / MLG LOAD limiters).

Photo 15. Load Limiter of the nose alternate landing gear extension system.

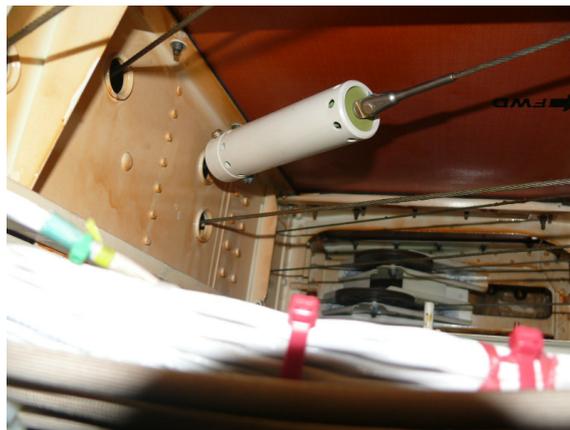
Photo 16. Load Limiter of the main left alternate landing gear extension system.

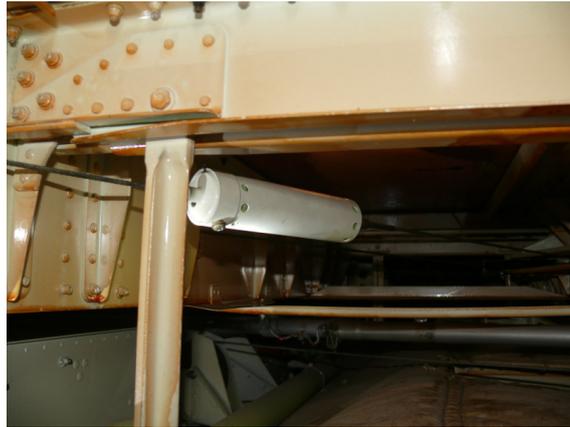
Photo 17. Load Limiter of the main right alternate landing gear extension system.

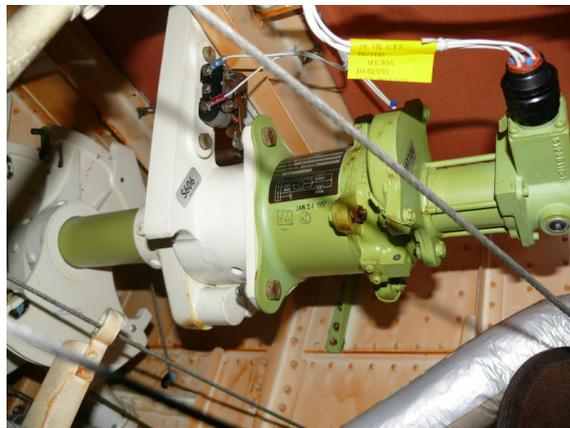
Photo 18. Electric motor of alternate landing gear extension system.

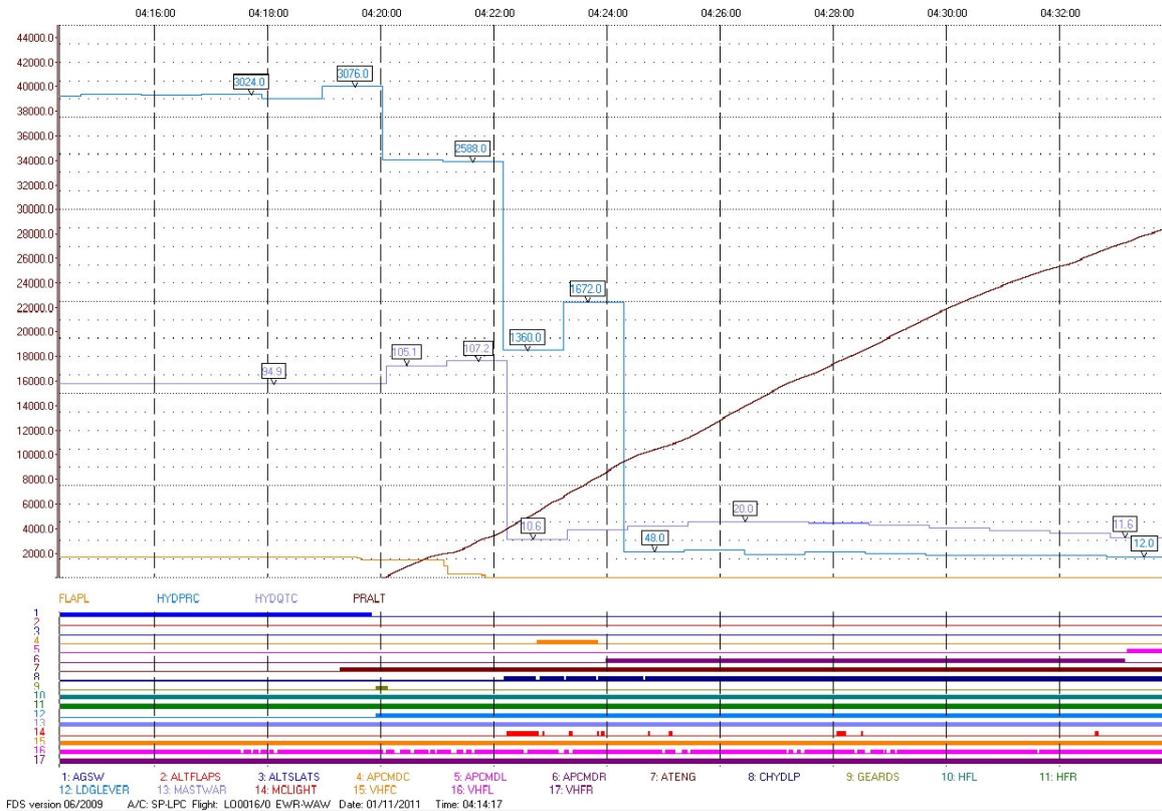
04:21:51 – flaps in position 0,
04:22:11 – indication of low pressure in the central hydraulic system, PRALT=3852[ft], gross weight of the airplane GW=162,57[t], geographical coordinates: N40 48 42, W74 5 17

04:22:14 – drop of hydraulic fluid quantity in hydraulic system „C”, HYD QTC =10.6 [%] (parameter registered in interval 1/64Hz)
04:36:28 – cruise altitude FL310,

Pressure drop in SP-LPC central hydraulic system after take off – based on FDR recording
