STATE COMMISSION ON AIRCRAFT ACCIDENTS INVESTIGATION

764/13

FINAL REPORT **on investigation into air occurrence** **to aircraft of a maximum mass equal to or below 2250 kg¹**

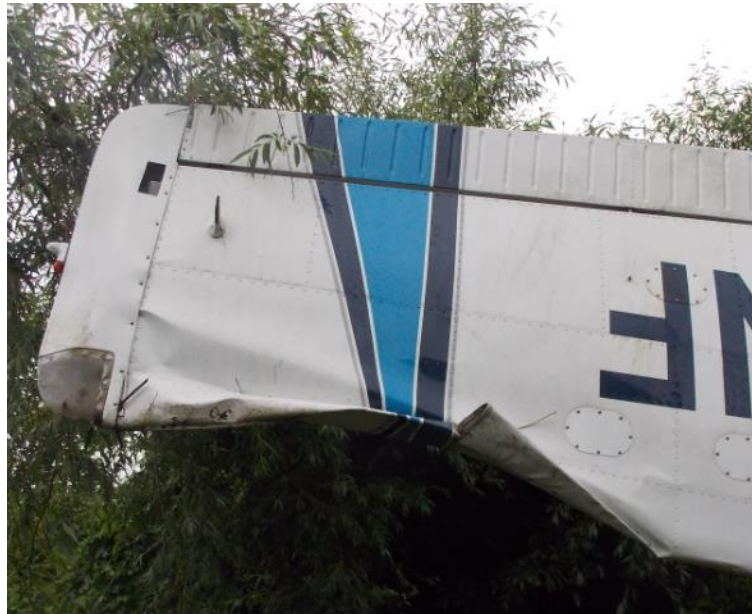
➤ *left wing – leading edge tip*

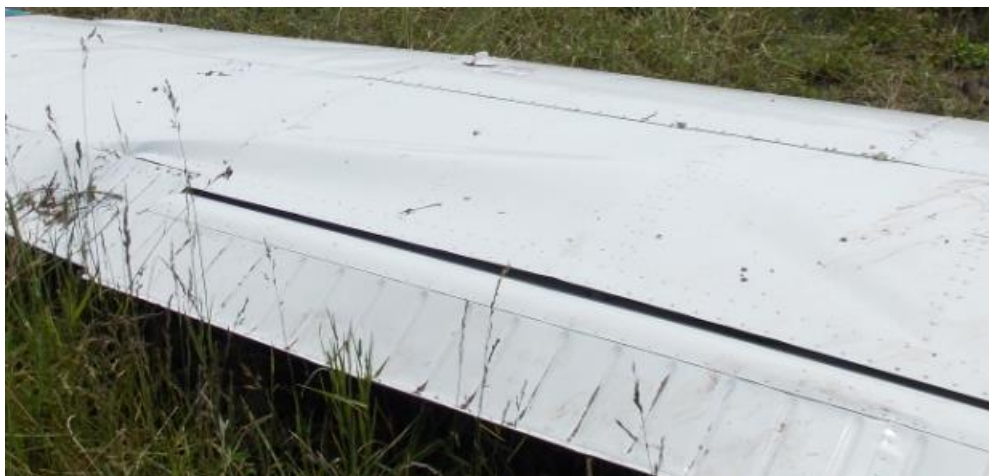
➤ *left wing skin*

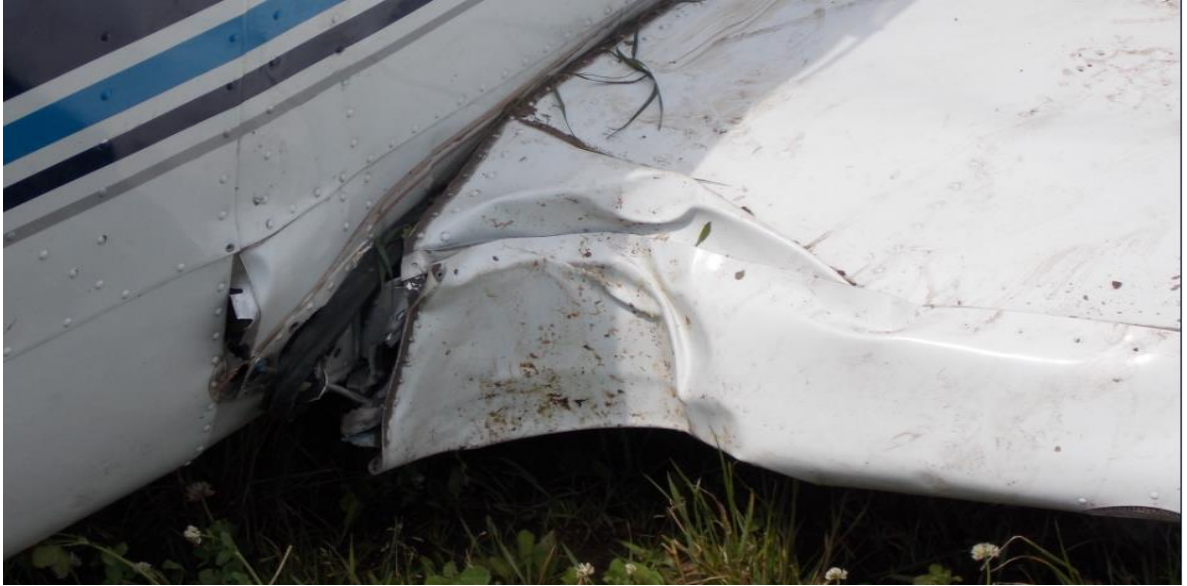
left wing – area close to the fuselage

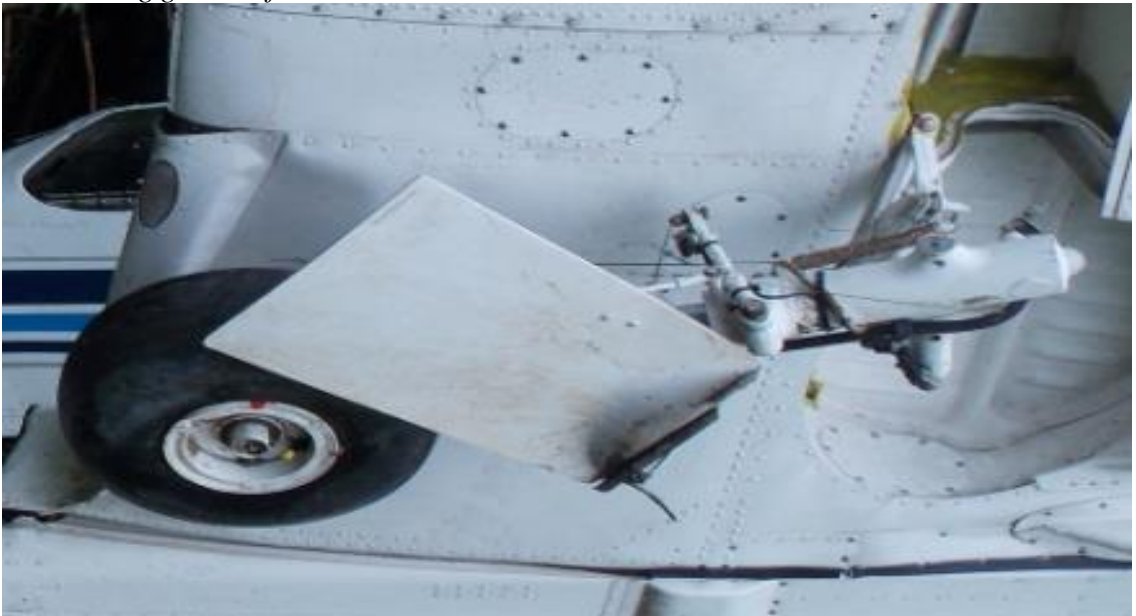
➤ *main landing gear – left strut broken*

Breaking of the left strut of the main landing gear caused leakage of fluid from the brake system, nevertheless during an experiment it was possible to determine that the brake system worked properly and a resistance was perceptible when pushing the brake pedals.

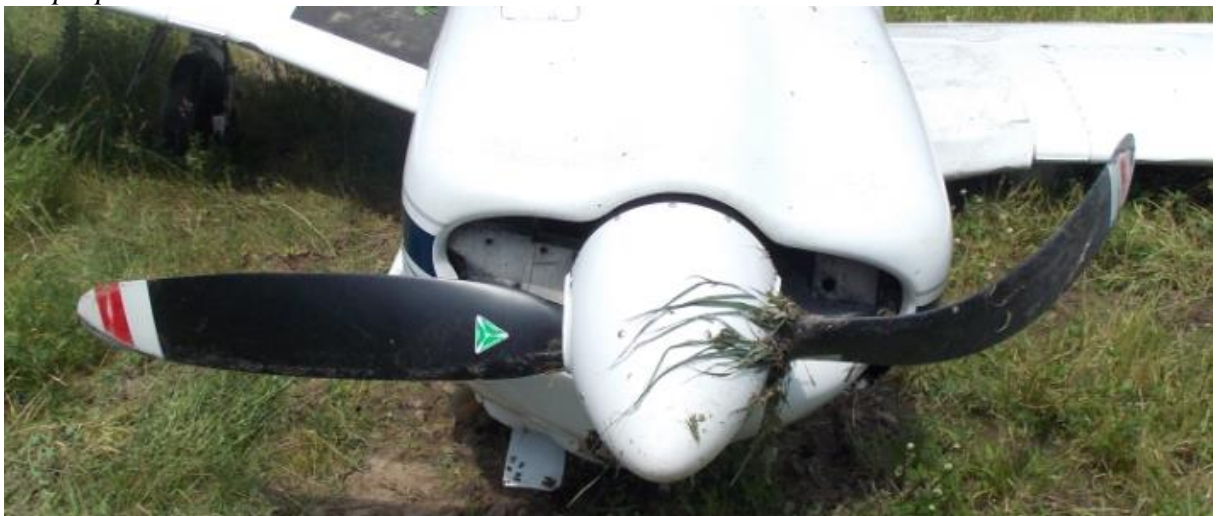
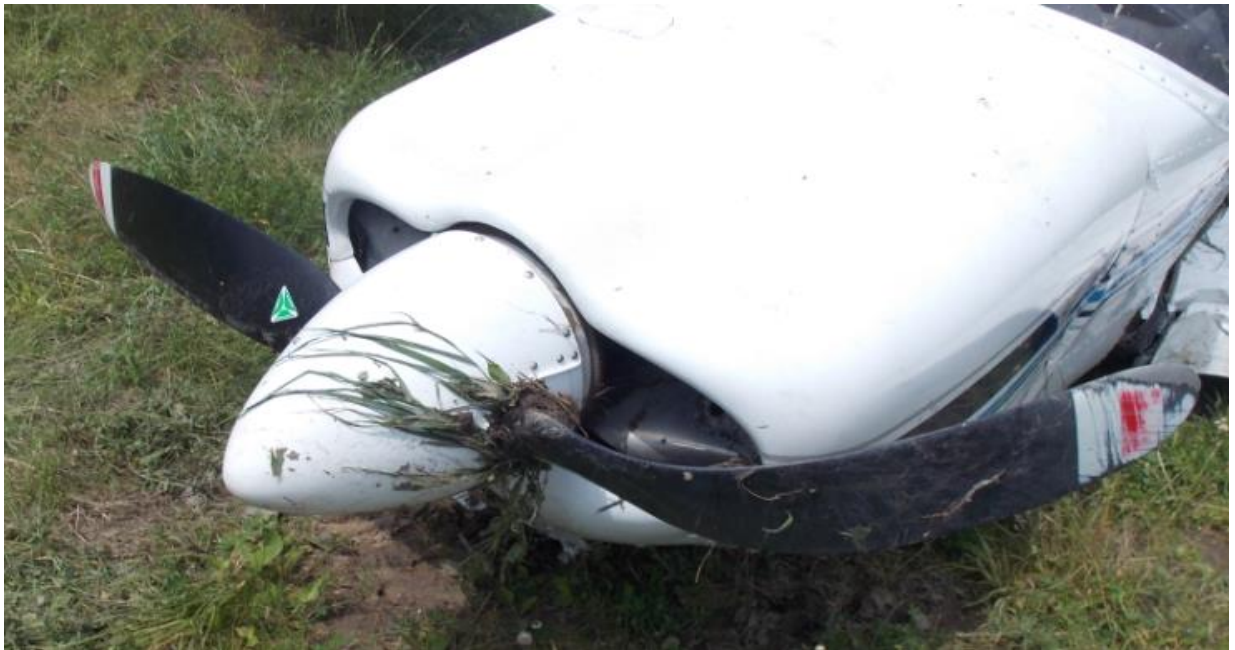
➤ *propeller*

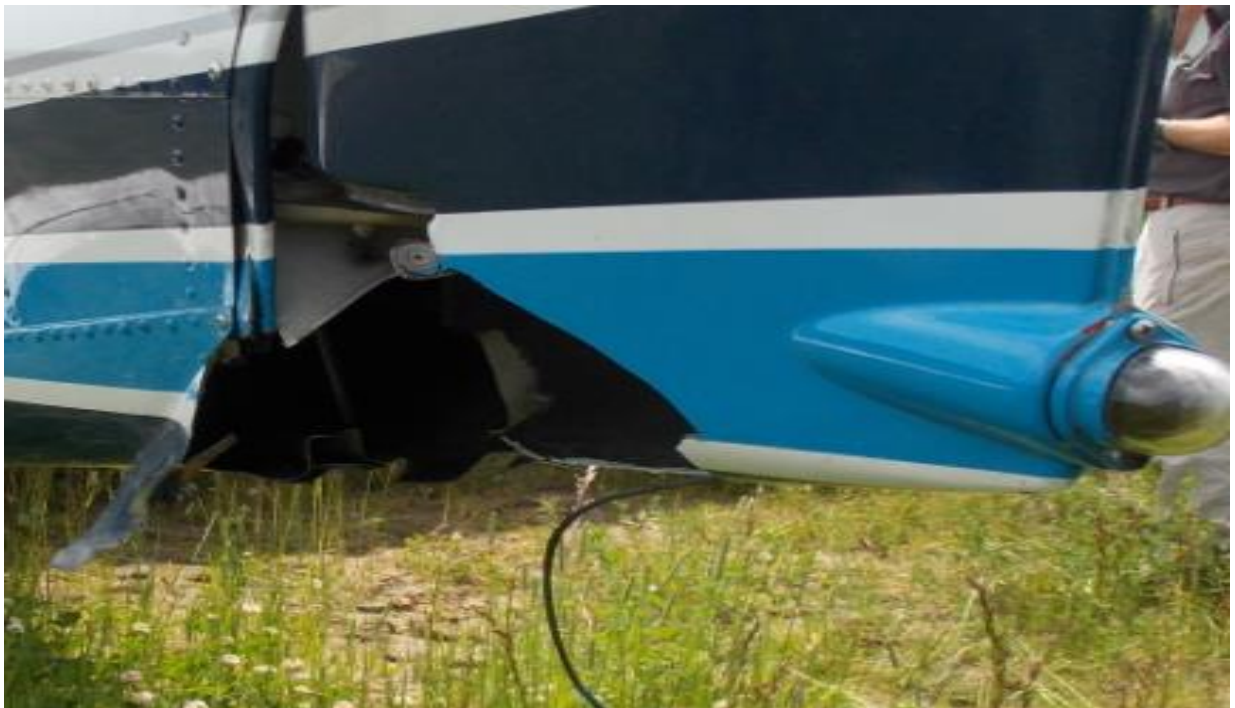
➤ *skin of the lower tail part and rudder*

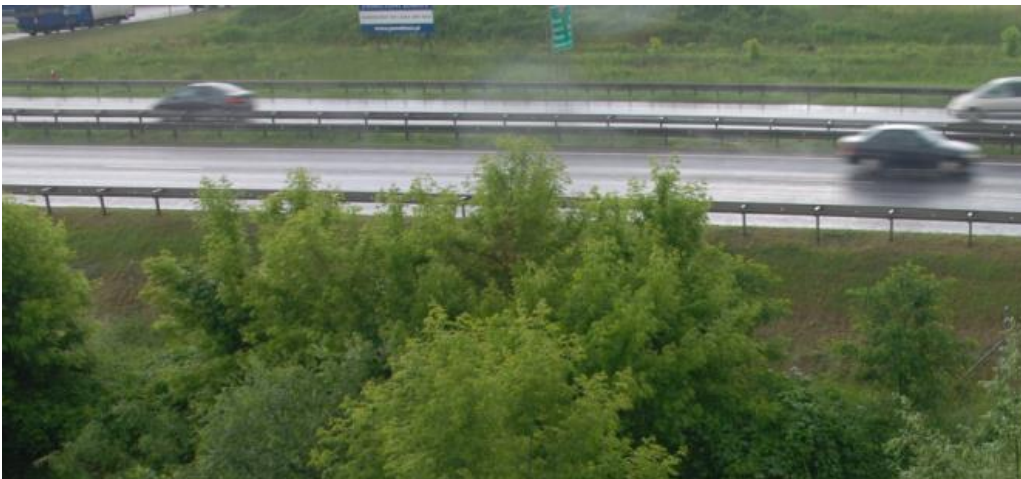
The EPZE landing field is a “difficult” one due to the length of its runway, even if it is hardened with a concrete paving blocks. However, as shown in analysis in the section 16.4 of this Report, the occurrences which took place at this landing field were caused by “human factor” and not by the landing field infrastructure. The length of the Runway 24 is limited by a scarp at the end, which is located in close proximity of the S11 expressway.

S11 expressway – photo taken from the scarp at the end of the Runway 24

Acquisition of the land adjacent to the landing field is recommended. This would allow to extend the Runway 24 length and improve the safety of flight operations.

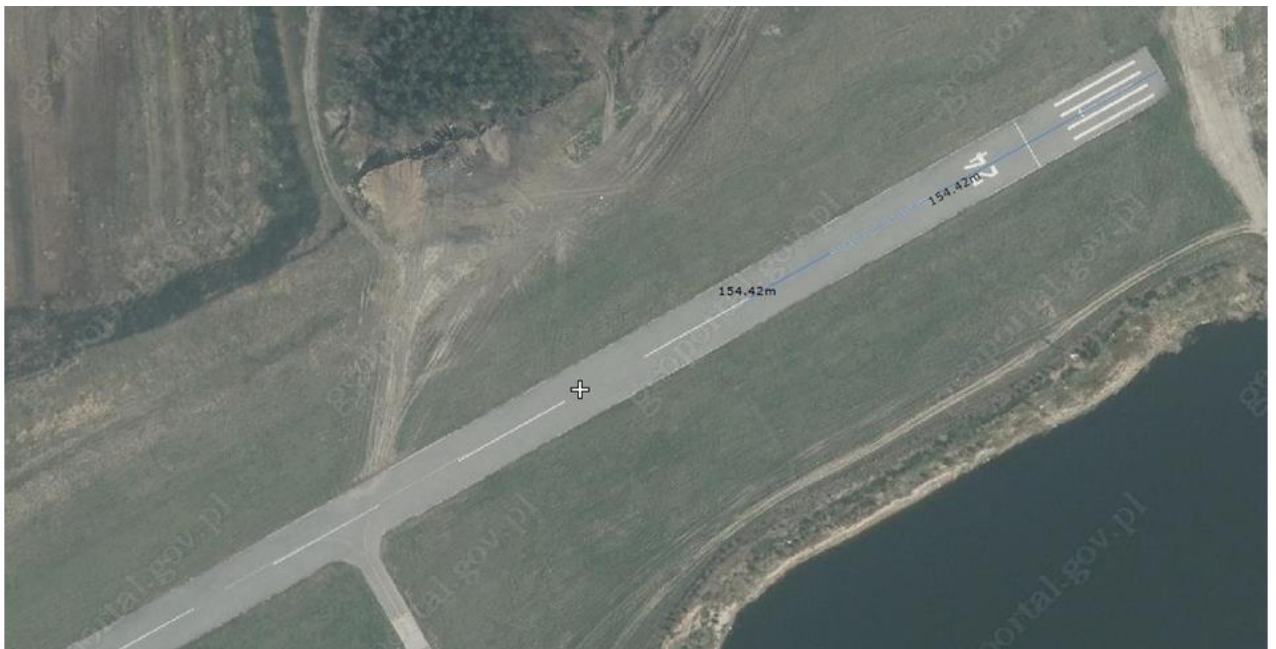
A few minutes before the landing there was a heavy rainfall at the landing field resulting in wet runway with the local puddles. After entering the EPZE area the pilot began landing approach procedure by performing a turn on the short approach. A short distance to the runway threshold resulted in lack of stabilization on the final and improper planning of the touchdown point. The touchdown occurred at the distance of about 100 meters from the Runway 24 threshold i.e. about 150 m from the beginning of a paved surface.

Touchdown point distance from the beginning of a paved surface on the direction of 239 degrees.

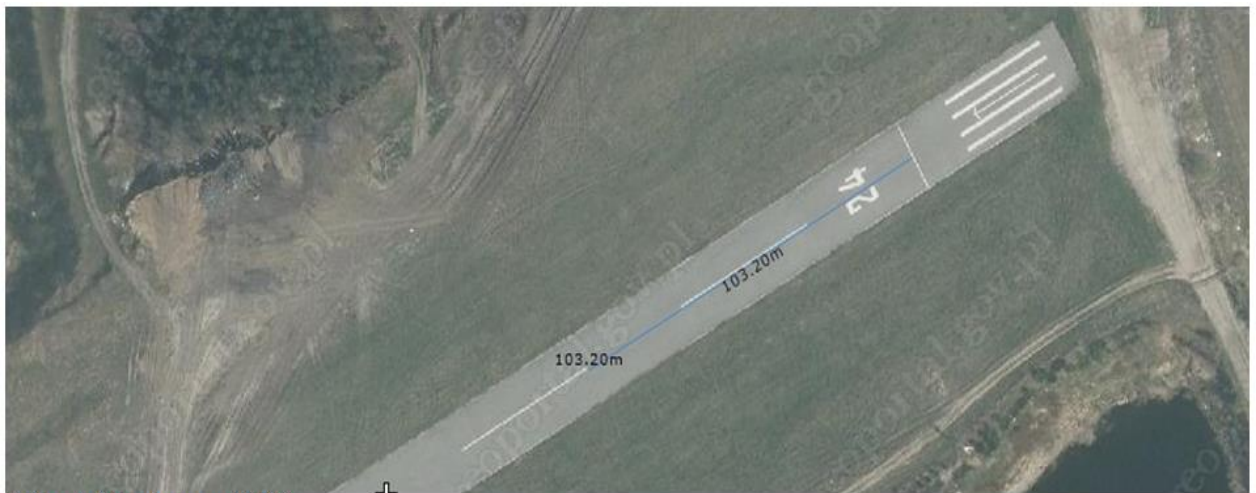
Touchdown point distance from the Runway 24 threshold

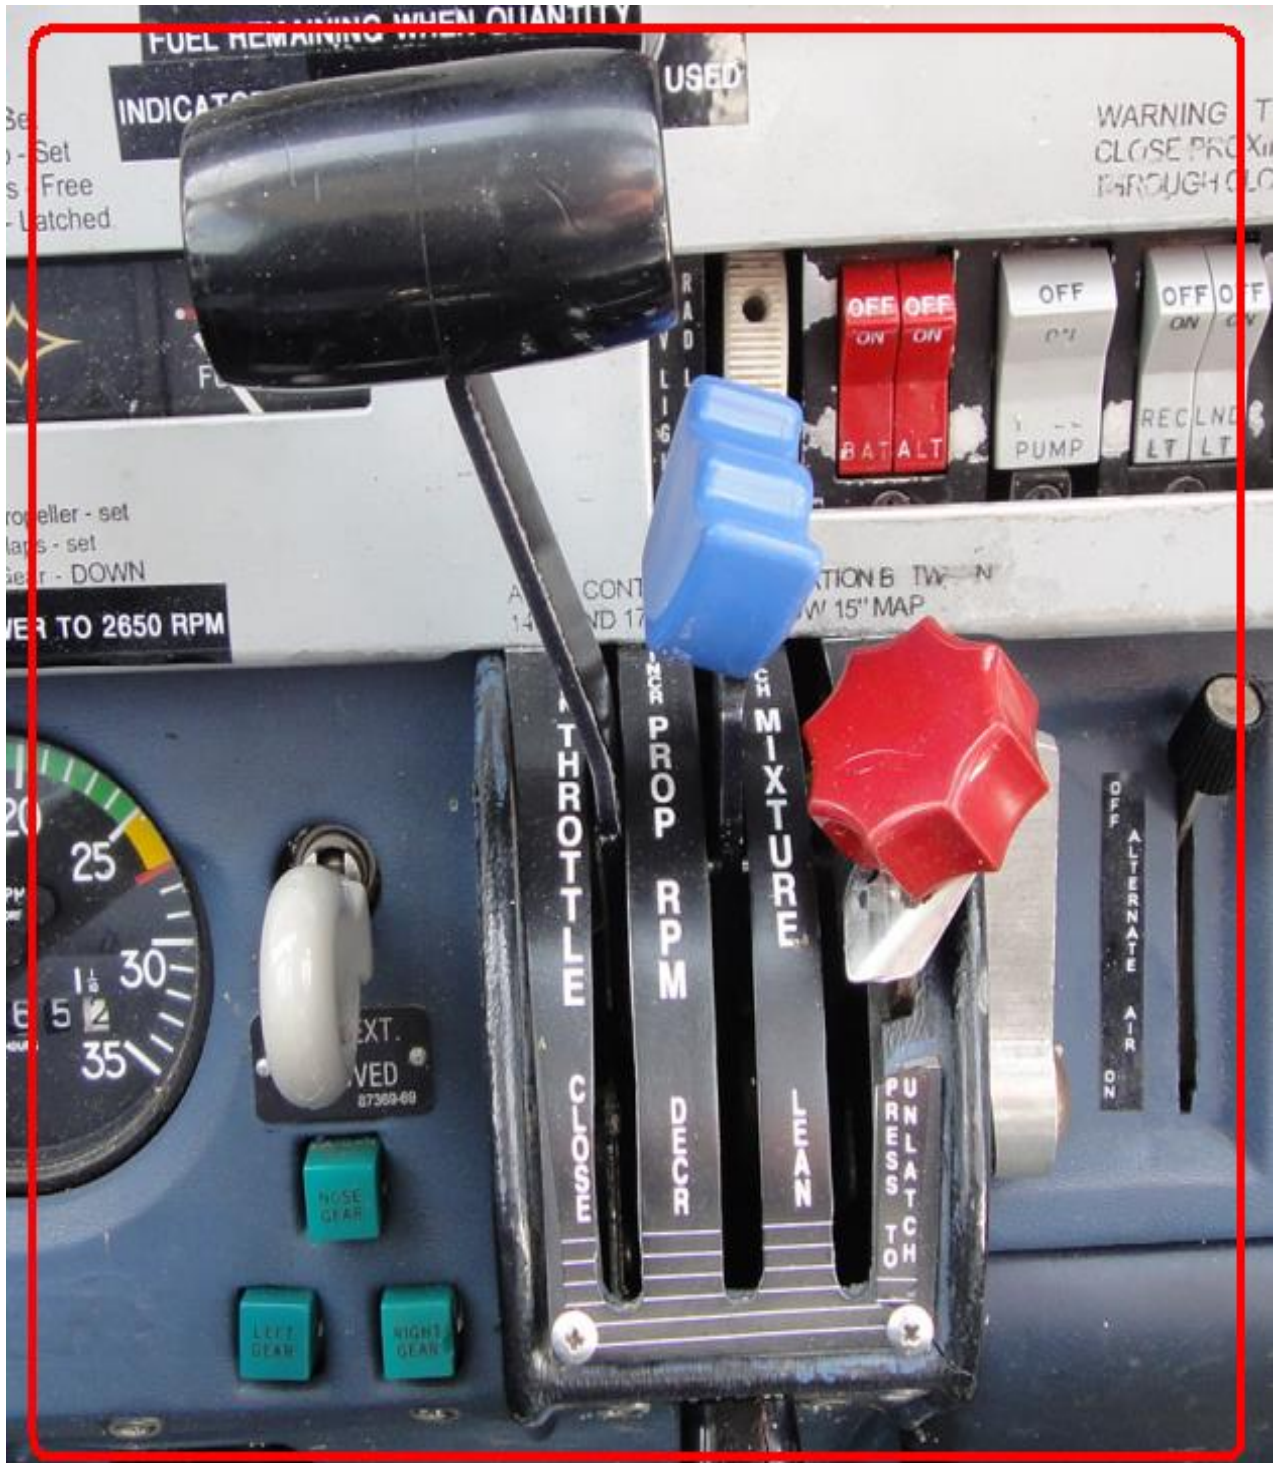
Probably due to the short distance to the runway threshold the pilot had little time for the proper procedure before landing. He failed to execute the following actions prescribed in the Flight Manual:

- turn on the electric fuel pump;
- set the propeller at about 2600 rev/min - it is necessary to provide sufficient thrust if there is a need to go-around as well as to protect the propeller against excessive speed if the throttle would be suddenly opened;
- set mix on "rich" in order to guarantee maximum acceleration in the event of necessity to re-open the throttle.

View of the engine control levers and the fuel pump switch in the "OFF" position

The above actions, if executed, would have allowed a safe go-around.

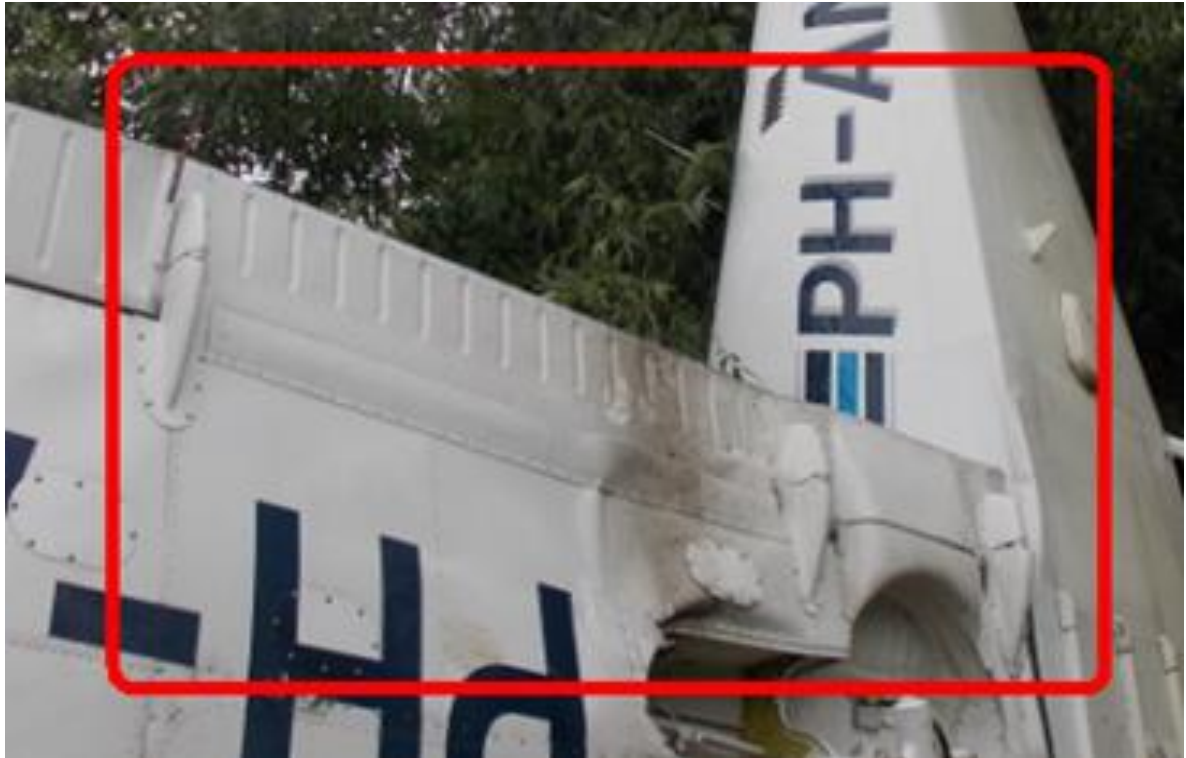
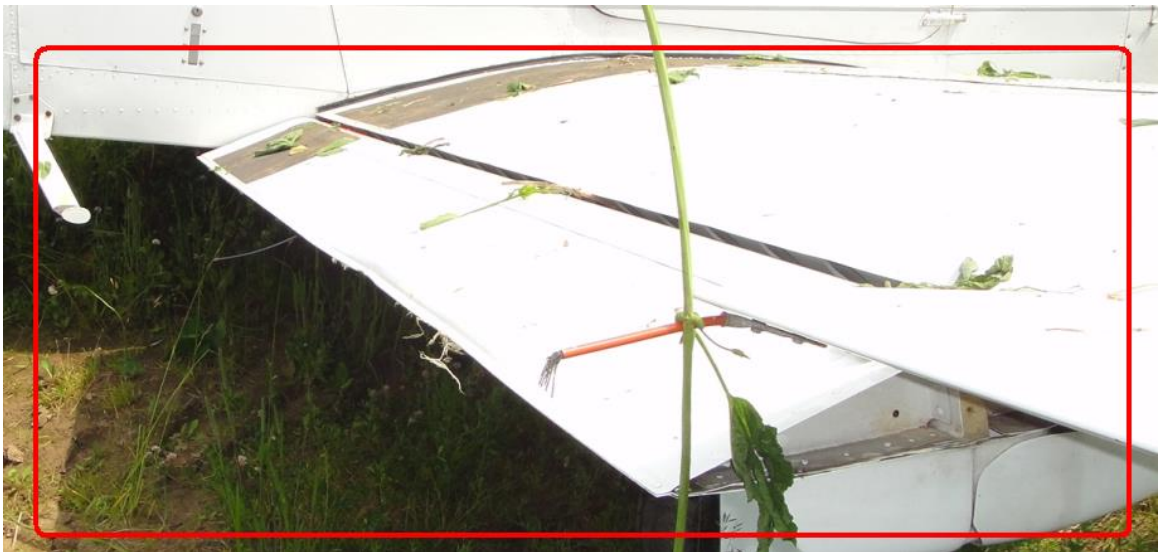
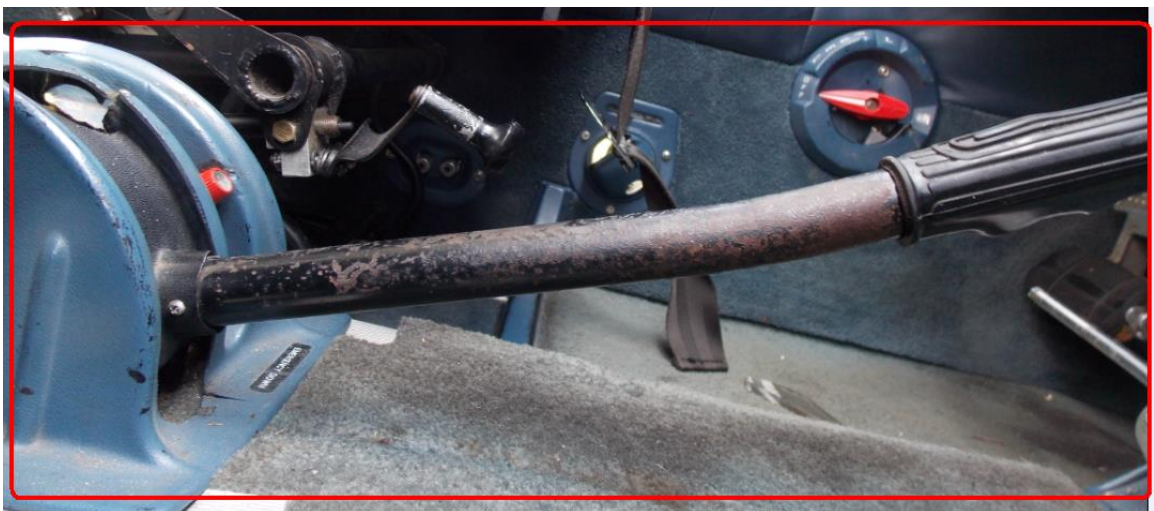
The pilot executed the landing approach with flaps retracted which is shown on the three photos below:

The aircraft touchdown was performed at a high speed (on three points) which caused that the pilot could not apply the control wheel (move elevator up) to increase the wheels pressure on the ground and thereby increase braking efficiency. The pilot stated that he applied a pulse braking, but SCAAI materials show that after touchdown, which occurred approximately 100 m from the beginning of the runway the airplane was not slowing down for about 200 m and was moving at a speed of about 125 km/h.

Taking into account that the runway length was 618 and the fact that it was wet, the pilot should have performed landing with the flaps extended to 40 degrees. The best technique for landing on a short runway is landing with full flaps at low speed and power setting allowing the required approach profile. As mentioned above mix must be “rich” and the fuel pump must be turned on. Air speed must be reduced in the flare phase and the airplane contact with the ground should be at a speed close to the stalling speed. After touching the ground the nose wheel should be held off the ground. When the airplane decelerates, the front wheel should be gently lowered to the ground, and then brakes should be applied. Braking is the most effective when the control wheel is pulled but the nose wheel is still on the ground. In this way the pressure on the main landing gear wheels increases.

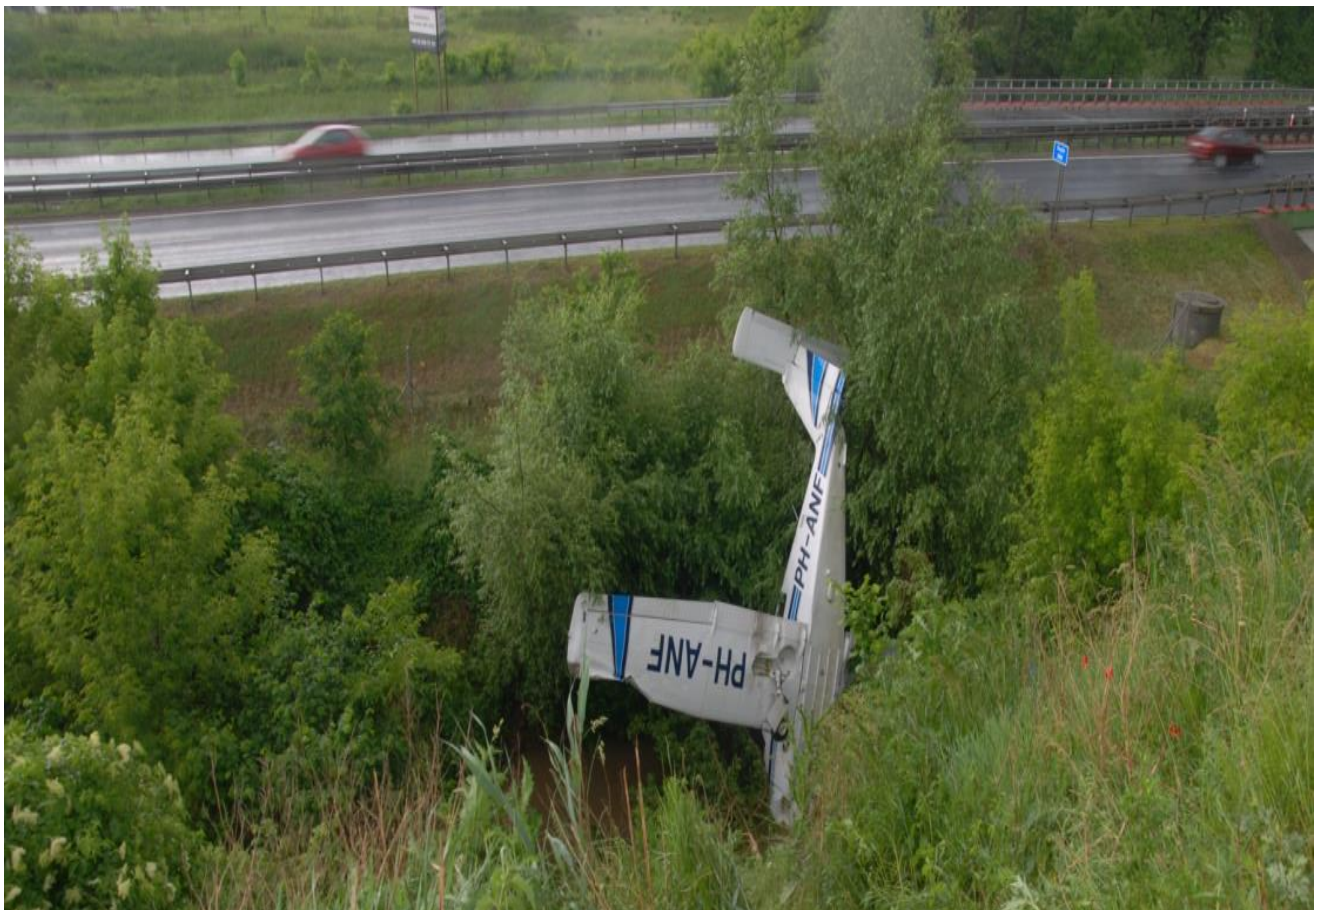
In the last phase of the landing roll the pilot attempted to pull the control wheel in order to push down the main landing gear wheels as well as to pull over to the right, short of the end of Runway 24. However, due to a relatively high roll speed the airplane travelled through a strip of land and hit the edge of the scarp with its nose wheel and the left strut of the main landing gear. As a result the airplane was rotated in the direction of the runway axis and fell down the slope located between the landing field and the S11 expressway – photo below (SCAAI).

Traces of continuous braking on locked brakes are visible on the runway surface: the left tire track - 77 m long, beginning 46,5 m from the Runway 06 threshold, the right tire track – 55 m long, beginning 29 m from the Runway 06 threshold.

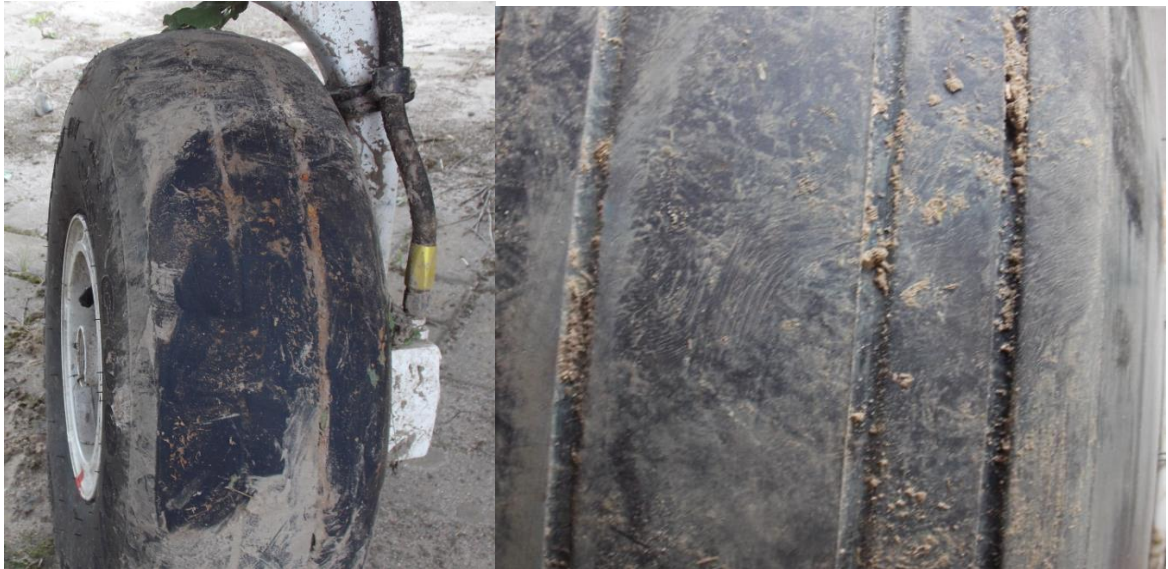
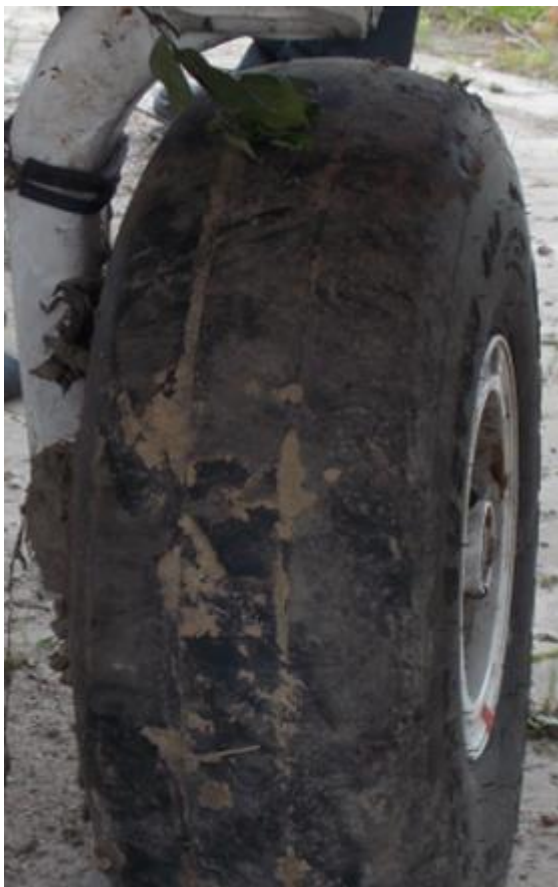
Due to information from the pilot that the airplane had problems with the brake system, it was checked, as well as condition of the tires. Visual inspection of the tires did not show any signs of improper condition, as well as the condition of the brake pads was within permissible limits.

Left tire of the main landing gear

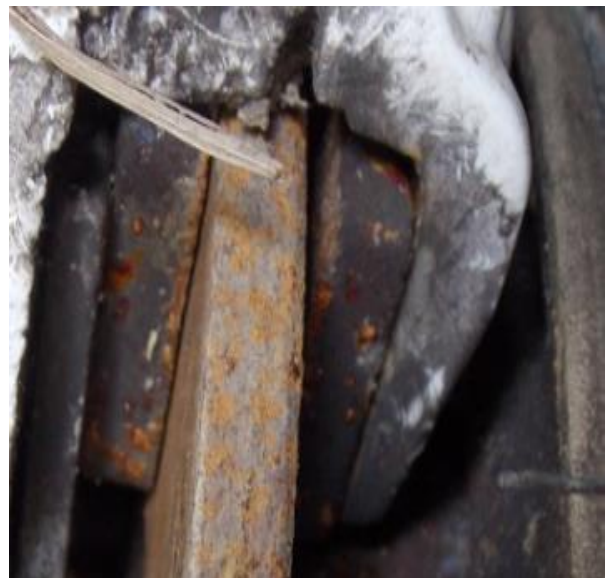
Brake pads
