# FINAL REPORT

**Occurrence No: 970/13**

**Thunder & Colt 240 A; SP-BAM**

**3 July 2013 – Troks near Olkusz**

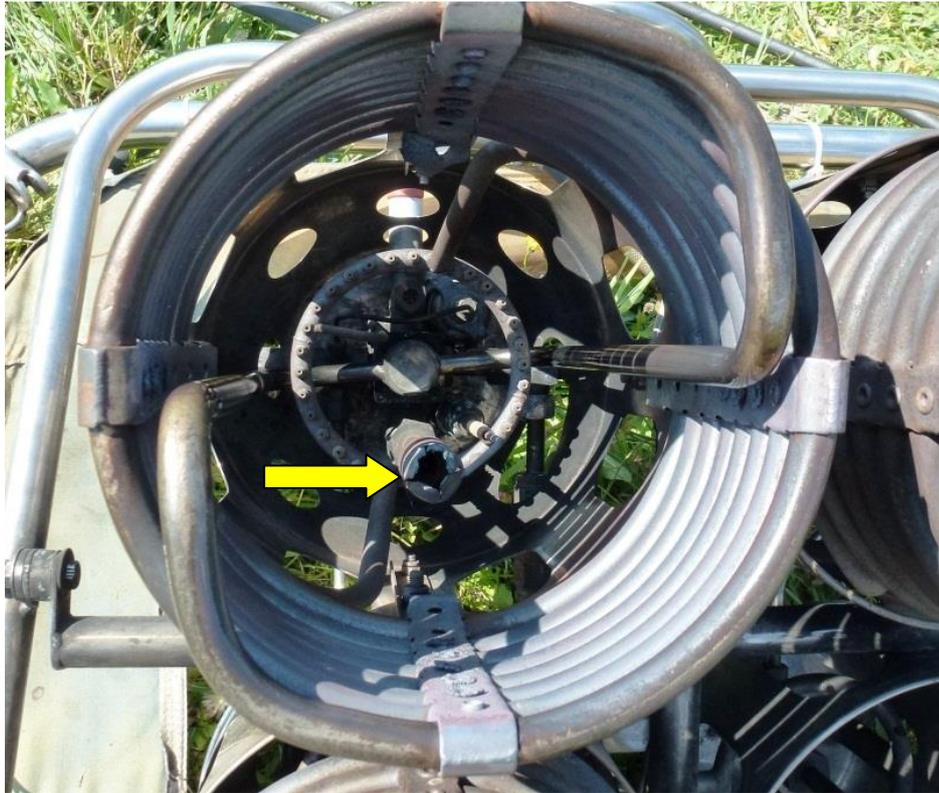
The pilot stated that prior to the accident the balloon was airworthy. The visual inspection of the balloon conducted by the Investigating Team did not show any damage caused by the accident. However, during the inspection it was found that three fuel cylinder straps other than those approved by the manufacturer were used. Two of the four burners showed symptoms of excessive wear. In one of the burners it was found melted top part of the pilot light burner (Photo 1), and in the other non-standard gap in the upper part of the pilot light burner and lack of one of the main burner jets (Photo 2). In addition, there was found corrosion on the crossflow ball valves of the burner gas installation (Photo 3). However, in the Commission opinion the above abnormalities had no influence on the accident occurrence.

*Photo 1. The yellow arrow indicates melted top part of the pilot light burner. Photo: SCAAI*

- c. The pilot stated that the balloon was airworthy at the time of flight;
- d. The Commission found that three fuel cylinder straps other than those approved by the manufacturer were used and the burner showed symptoms of excessive wear. It did not affect the occurrence of the accident;

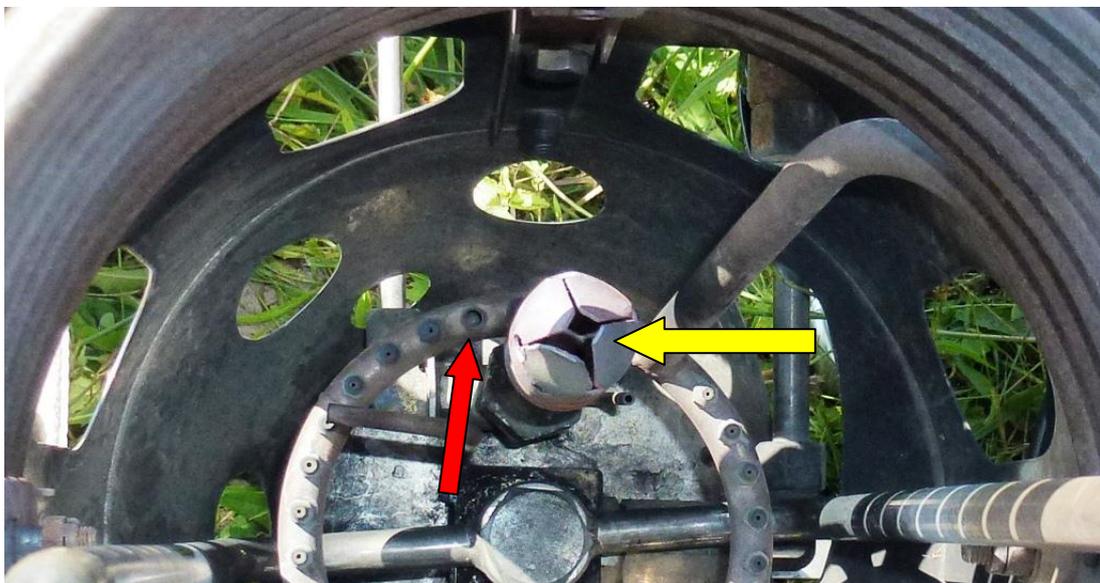
*Photo 2. The yellow arrow indicates non-standard gap in the upper part of the pilot light burner. The red arrow indicates place of the missing jet of the main burner. Photo: SCAAI*

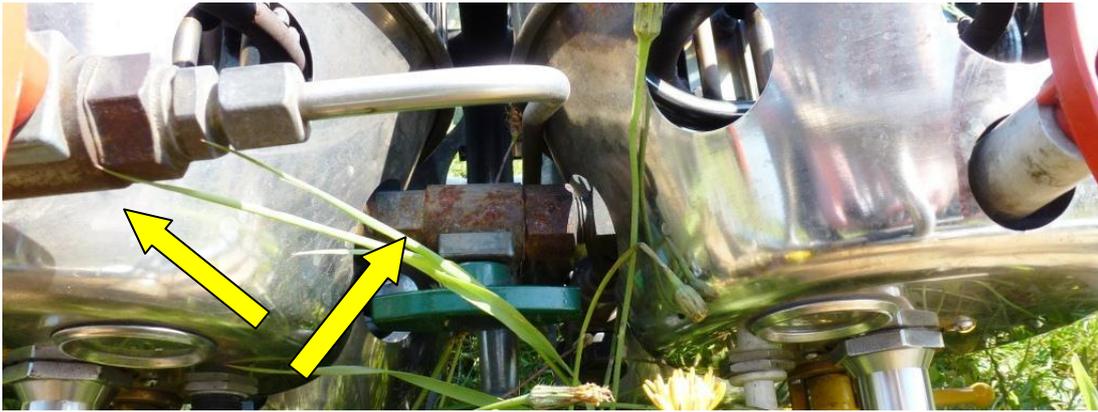
Photo 3. Arrows indicate corrosion on the burner crossflow ball valves. Photo: SCAA

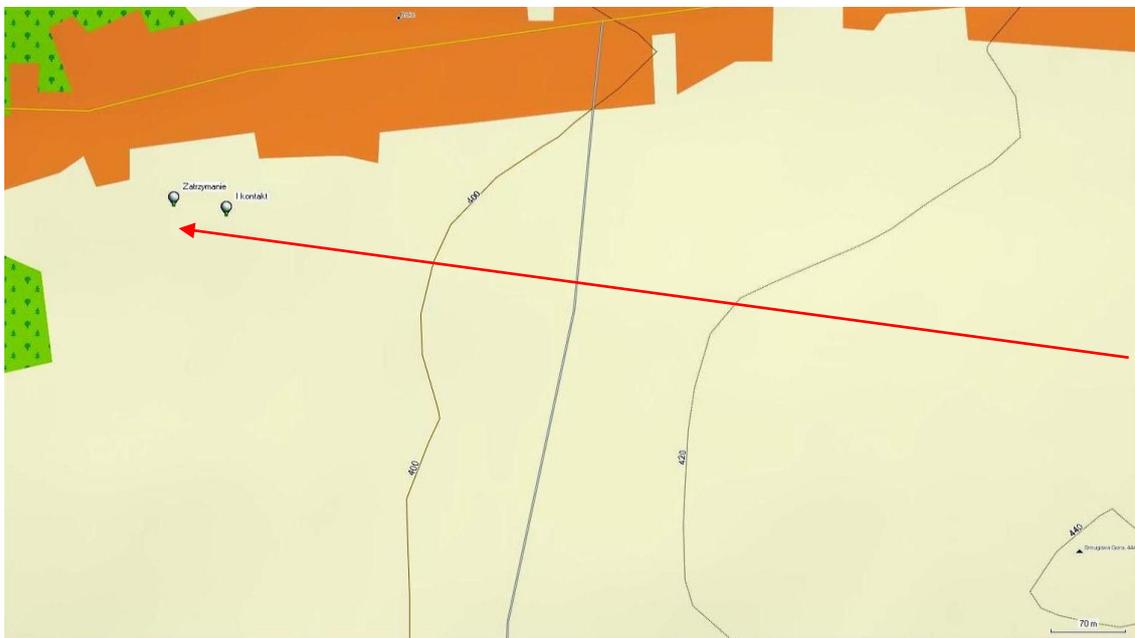
*Fig.2. Landing area. The red line indicates the approximate direction of the last phase of the flight. There was downslope of about 40 meters at the distance of about 800 m. There was a forest on the Eastern side of the landing site. Map source: GPMapa TOPO 2009.*

In such a diverse terrain updrafts and downdrafts might have occurred despite the imminent sunset. This is due to the fact that during the day such areas as meadows and fields with crops are heated by the sun faster than, for example wood. Areas that quickly heat up, also cool down quickly. Areas which slowly heat up also cool down slowly.

In the evening unstable equilibrium of the air created during a sunny day was replaced by the constant equilibrium but only over the places which quickly heated up and quickly cooled down. In contrast, the unstable equilibrium persisted over the areas which heated up and cooled down slower. This caused the air to rise up from these places. This resulted in the situation that the air rising from above the forest descended on adjacent areas cooled down faster, causing a local downdraft. It should be noted that descent of the air does not occur in the same place continuously. For this reason, it was difficult to be predicted by the pilot. In addition, the balloon landing was made on the leeward of the hill, where the air also descended. According to the Commission, the balloon descent faster than intended by the pilot during the approach to landing was probably due to accumulation of the two factors described above: to a greater extent by the downdraft and to a lesser extent by the descending air on the leeward of the hill.

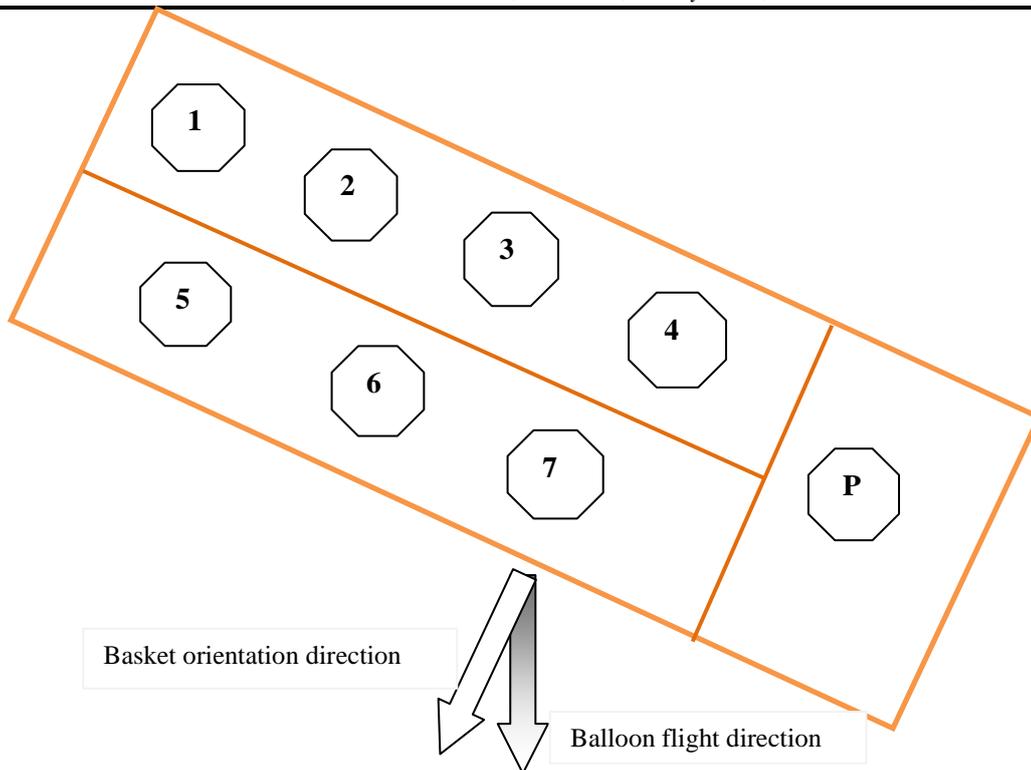
*Fig.3. Placement of passengers and the pilot in the balloon basket and basket orientation relative to the direction of flight during the first touchdown. The passengers marked with numbers from 1 to 7. The letter "P" indicates the pilot.*

There were seven passengers and the pilot in the basket of the balloon. Only passengers marked with “1” and “2” suffered serious injuries during the landing. The passenger number “2” claimed that during landing all the time she was holding to the handles. However, according to the passenger number “3”, after the second contact of the basket with the ground the passengers number “1” and “2” fell at each other and at him or he fell at passengers number “1” and “2”. In the Commission opinion, the nature of injuries of the passengers “1” and “2” indicates that they resulted from falling persons on each other and not from hitting the side or floor of the basket. As described above, the balloon touchdown occurred at a rate of descent higher than planned by the pilot. Tracks of landing indicate that during the first contact with the ground the long side of the basket was orientated about 25° to the right from the upwind direction. During touchdown, probably the second contact of the basket with the ground caused sudden rotation of the basket to the left of about 25 degrees. In the Commission opinion, it had an influence on the movement of passengers “2” and “3” who fell on the passenger “1”. The fact that the other passengers did not fall on each other indicates that they held on to the handles more firmly and the resultant of the vertical and horizontal speed during landing was not too high. This is also indicated by the fact that the passenger number “7”, who held on to the handle with just one hand neither fall on the passenger number “6” nor was thrown out of the basket .

planned by the pilot. Despite using all three burners, the rate of descent was not reduced to the planned by the pilot value which was about 0,5 m/s. The need to operate three burners and open the parachute valve and Velcro rip panel prior to touchdown made it impossible for the pilot to orientate the basket long side exactly upwind. Imprecise orientation of the basket and touchdown with a rate of descent higher than planned caused that two passengers suffered serious injuries.
