Incident reference No: 906/14

RESOLUTION OF THE STATE COMMISSION ON AIRCRAFT ACCIDENTS INVESTIGATION

Information/Report on the occurrence

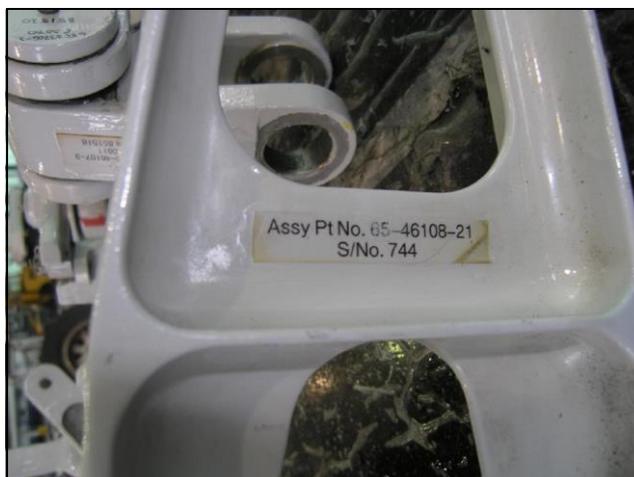
Part identification.

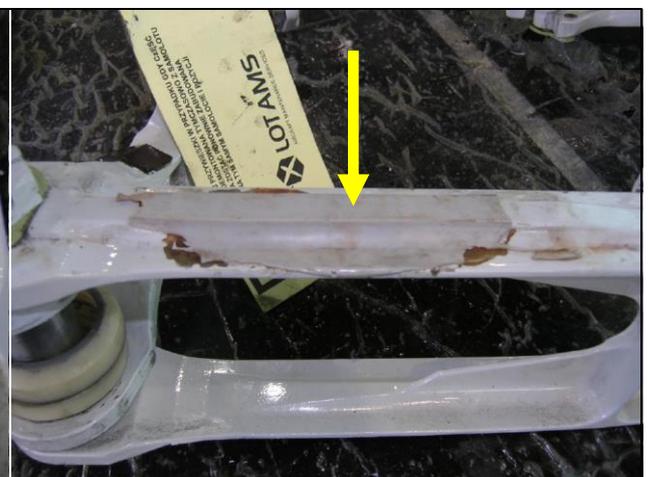
During the planned replacement of landing gear, after removing the left main landing gear, maintenance personnel found corrosion on the part named: LH MLG WALKING (ACTUATOR) BEAM, P/N 65-46108-21, S/N 744. The corrosion was covered with a thick, exfoliated layer of paint and a layer of rubber sealant (gray RTV). The part belongs to the rotating assembly of the landing gear and is a property of the AEM LIMITED (UK) repair organization. It was installed on the airplane on 1 February, 2014. Condition of the corrosion shows that the sealant and the paint at this place could have been applied before the last installation on the airplane. The certified maintenance organization informed the Commission about the occurrence by sending Technical Occurrence Report, SCAAI reference No. 2014.22.

Place of application of sealant and paint.

An attempt to hide the part defect or to effect its unauthorized repair in unknown circumstances outside the organization of the notification sender.

1. Notification of operator about the occurrence;
2. Forwarding information about the occurrence to managers of service areas to inform the staff;
3. Forwarding information about the occurrence to the Section of Technical Personnel Training for the use during refresher training in the fields of human factor and aircraft type.

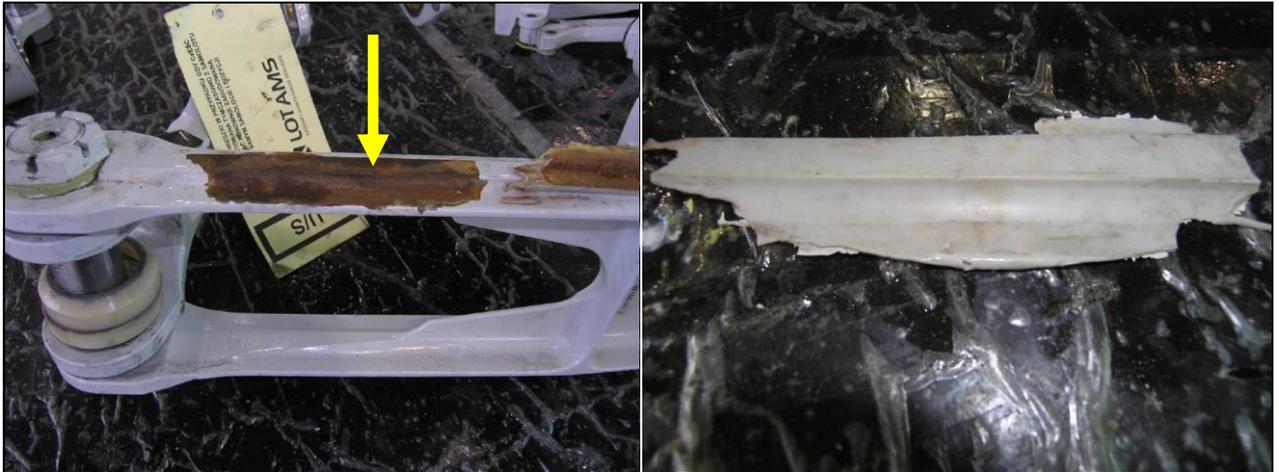
The same place after removal of paint and sealant - clearly visible corrosion on the part surface.

Exfoliated portion of the sealant with a layer of paint, "masking" corroded surface of the part.
