STATE COMMISSION ON AIRCRAFT ACCIDENTS INVESTIGATION

1804/14

FINAL REPORT

airplane, Cessna U 206F, registration marks: HA-ERA, owner: AVIA-Rent Ltd., user: Seven Rights Sp. z o.o.

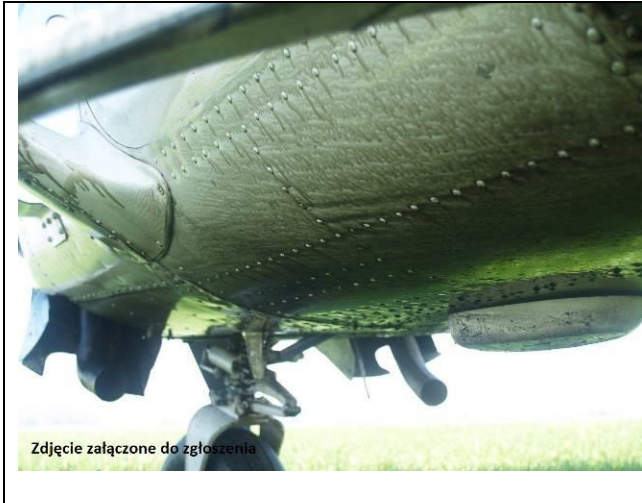
After about 20-minute flight the pilot noticed the decreasing temperature of cylinder No. 2 (UBG-16 instrument). The pilot turned the plane in the direction of the take-off aerodrome and continued the climb monitoring the temperature indicator. The temperature of cylinder No. 2 was slowly but continuously decreasing. Approximately at FL 80 the pilot and the skydivers clearly smelled fuel in the cabin. The pilot decided to make a precautionary landing at the aerodrome, reduced engine boost and enriched mixture. Heading towards the aerodrome the pilot declared his intention of dropping the skydivers at FL-70. At this moment the engine started running roughly and lost power. The pilot reduced the engine boost to 14 inches of Hg and reached the aerodrome where at FL 70 the skydivers exited the aircraft (landing at a designated place). The pilot started the descent, the engine still was running roughly. Without changing the flight parameters the pilot executed the aerodrome traffic circuit and landed on Runway 09. After landing he taxied in front of a hangar. After leaving the cockpit the pilot found a significant oil leak from the engine (Figure 1), and during an initial inspection it turned out that the engine block was cracked in two places.

Figure 1. Lower surface of the fuselage covered with the leaking oil.

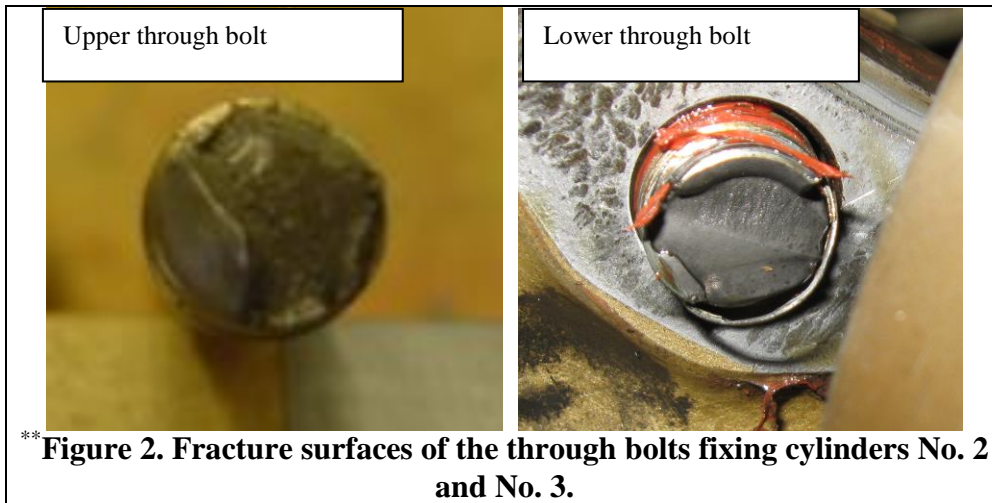
During a detailed visual examination of the *Continental* six-cylinder injection engine executed in a hangar in the presence of the SCAAI representative the following damages were found: fatigue crack of the two through bolts fixing cylinders No. 2 and No. 3 (Figure 2), crack of the engine block in the area of cylinders No. 2 and No. 3 and rupture of the fuel line before fuel injector of cylinder No. 2 (Figures 3 and 4).

Cracks of the engine block on both sides originated in the holes, through which the top through bolt goes. After analyzing the nature of the bolts fractures, the Commission concluded that the cracking process started at the threaded portion and progressed gradually (numerous beach marks visible in Figure 2). The fracture of the final phase of the cracking process has a sudden nature.

According to the Commission, when mounting the cylinder after replacement of sealing, the nuts on the through bolts were not tightened to the proper torque, which initiated their process of cracking. The resultant backlash, combined with cyclic thermal loading, caused the bending forces on the screw joint, which initiated the development of cracks of the through bolts. It was found that there was no nut at the upper through bolt of cylinder No.2. This shows that the crack of this bolt occurred earlier than the crack of the lower one. Due to a longer period of vibration and rotation of the bolt in the hole the nut unscrewed and fell away. On the lower bolt, on the same side, the nut remained on the threaded portion.

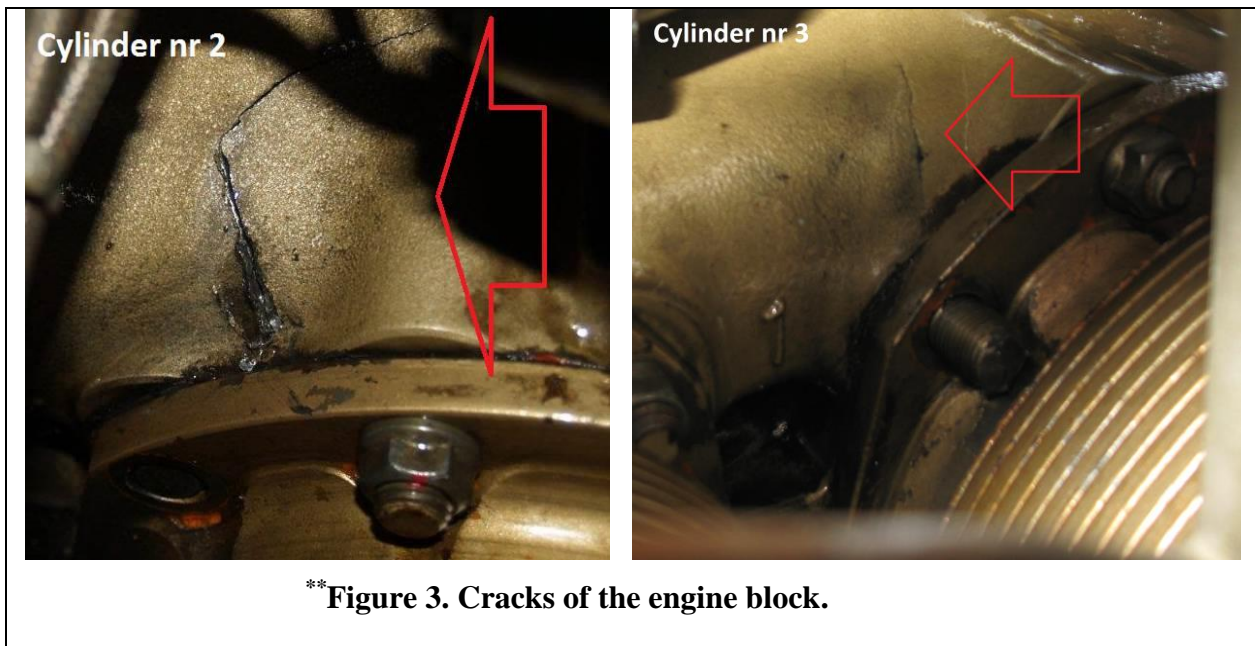
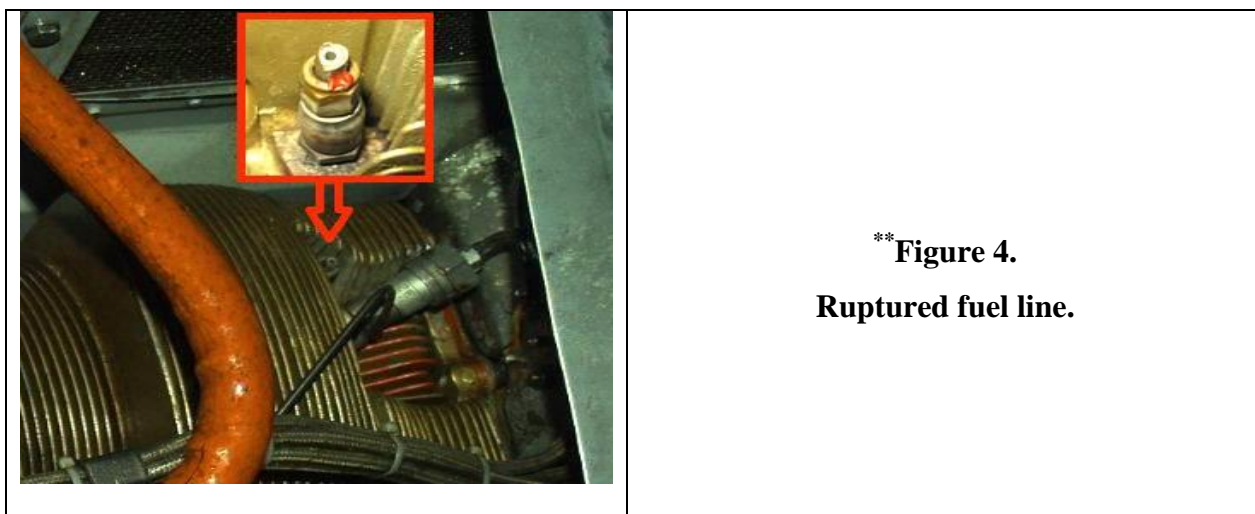
The rupture of the fuel line before fuel injector of cylinder No.2 occurred due to the vibration of the cylinder which resulted from the cracking of the second through bolt.

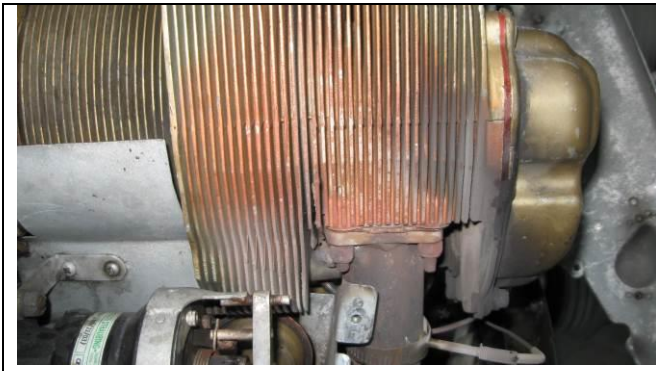
Visual examination of the engine during disassembly additionally showed the crack of the exhaust manifold on cylinder No. 6 (Figure 5) and local discoloration of heat-resistant paint on all cylinders.

**** Figure 5.
Cylinder No. 6. Visible blowthrough
from the cracked exhaust manifold.**

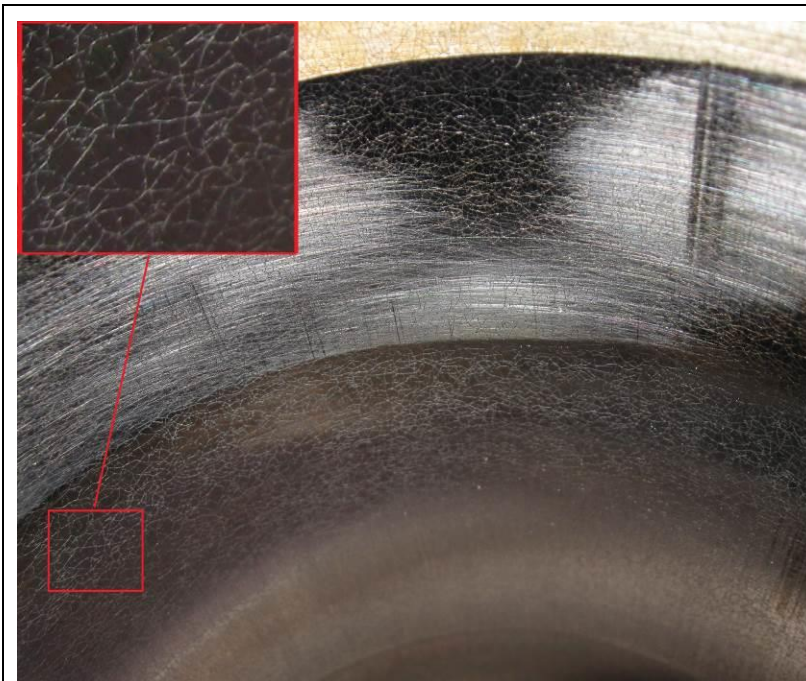
After removal of cylinder No. 3 it was found that the whole surface of the cylinder barrel showed microcracks. In the Commission opinion, such a damage occurs after exceeding of the compressive stress in a nitrided surface layer. Those damages existed on the whole perimeter of the cylinder barrel, and not only in the areas of the side pressure from the piston, so they could only be caused by the cyclic thermal loads. In addition, the surface of the cylinder barrel in the area of mating with the piston rings was dark, which proved its overheating. Due to high temperature (which significantly deteriorated lubrication conditions) the honing in this area had been almost completely worn, which further deteriorated lubrication conditions of the cylinder barrel (longitudinal scratches from the piston rings) and its further overheating (Figure 6 below).

**** Figure 6.
Microcracks on the
cylinder surface. Visible
longitudinal scratches
caused by poor
lubrication of the engine.**

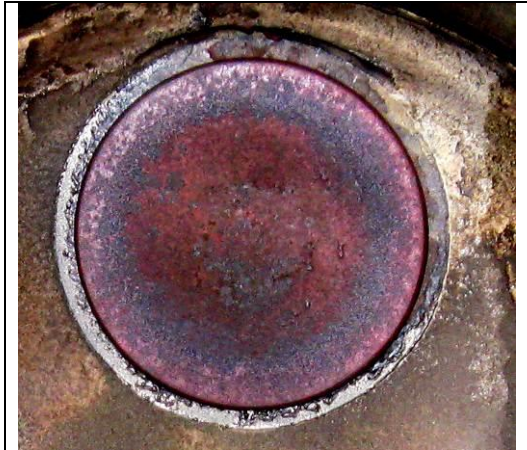
****Figure 7. Exhaust valve.**

A ring of light purple color was visible on the head of the exhaust valve. It indicated a slight overheating, while a small amount of carbon deposit indicated a good combustion (Figure 7).

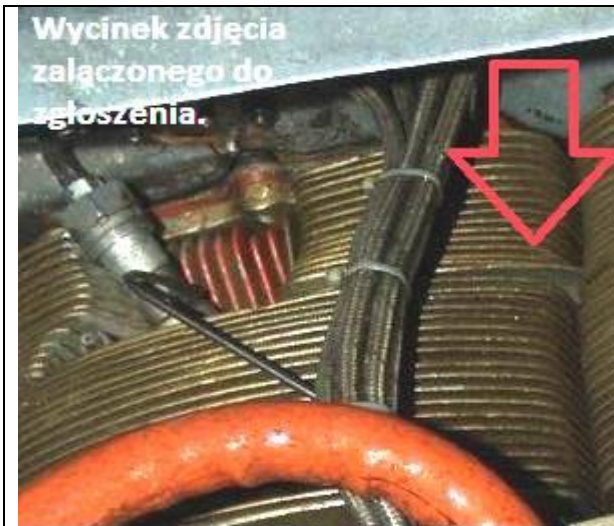
In addition, during the analysis of photos attached to the Notification of Air Occurrence, the Commission noted incorrect position of one of the cooling fins of cylinder No. 2. This proved its crack due to overheating (Figure 8 below).

Figure 8. Section of the photo showing change of the position of cylinder No. 2 cooling fin.

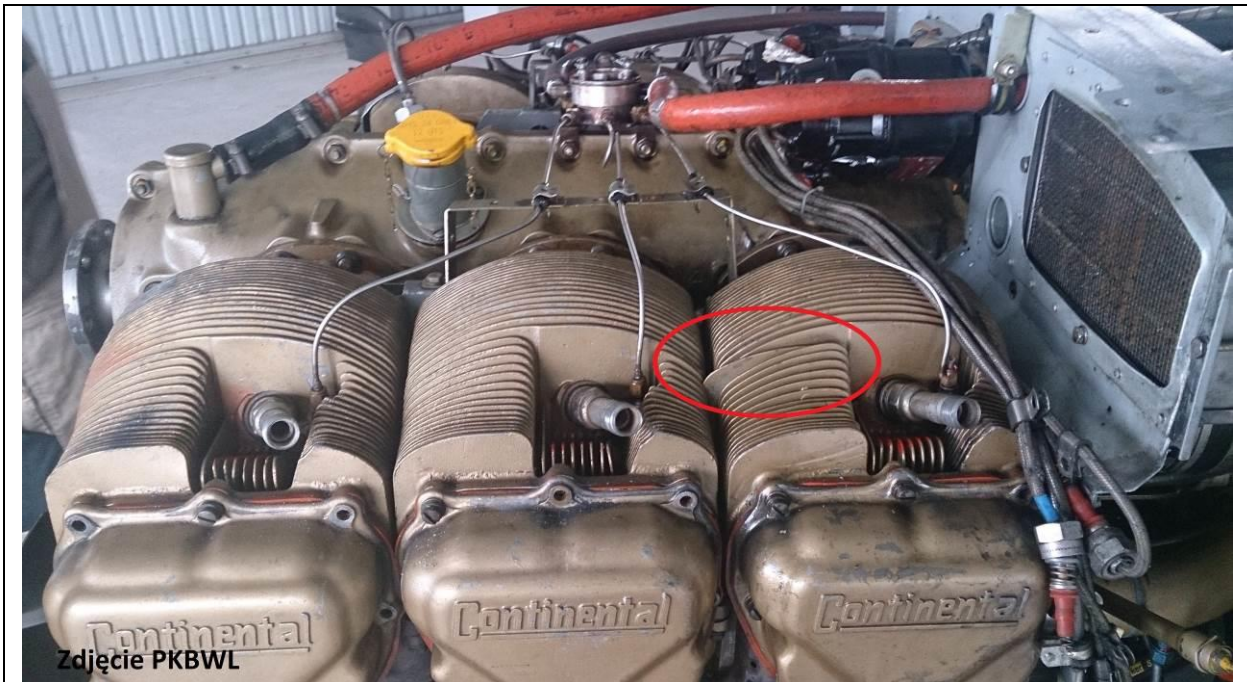
This damage is more visible in the photo taken during the disassembly of the engine (Figure 9).

Figure 9.
Damaged cooling fin of cylinder No. 2.
Photo taken during the disassembly of the engine.
