STATE COMMISSION ON AIRCRAFT ACCIDENTS INVESTIGATION

Final Report

Occurrence reference number:	<i>1877/14</i>			
Type of occurrence:	<i>ACCIDENT</i>			
Date of occurrence:	<i>20 July, 2014</i>			
Place of occurrence:	<i>Brazilia, Saõ Paulo State, Rio Claro</i>			
Type and model of aircraft:	<i>balloon: Cameron TR 70</i>			
Aircraft registration marks:	<i>SP-BBP</i>			
Aircraft User/Operator:	Aero Club of Włocławek			
Aircraft Commander:	<i>balloon pilot</i>			
Number of Victims/Injuries:	<i>Fatal</i>	<i>Serious</i>	<i>Minor</i>	<i>None</i>
			2	
Investigator-in-Charge:	<i>Tomasz Kuchciński</i>			
Investigation Authority:	<i>PKBWL</i>			
Composition of Investigating Team:	<i>Tomasz Kuchciński, Edward Łojek</i>			
Recommendations:	<i>NONE</i>			
Recipient of recommendations:	<i>NOT APPLICABLE</i>			
Date of completion of the investigation:	<i>13 October, 2015</i>

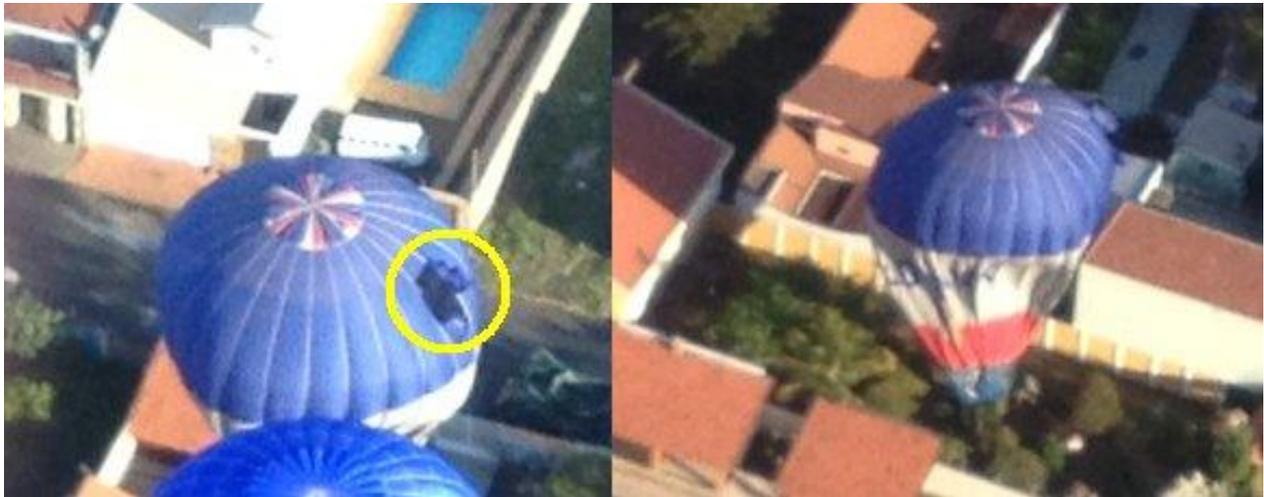
During a flight performed in the framework of Hot Air Balloon World Championship two balloons collided. SP-BBP TR 70 Cameron balloon was flying below Kubicek BB22 balloon of unknown registration marks. The basket of the Kubicek BB22 balloon hit the upper part of the SP-BBP envelope and caused its extensive rupture. The damage was so serious that the pilot of the SP-BBP balloon could not continue the flight and made an emergency landing. Touchdown occurred in the backyard of a residence in the locality of Rio Claro.

The left photo shows the damage to the upper part of the SP-BBP envelope. The right photo shows SP-BBP landing with the envelope only partially inflated.

A tear strength test of the SP-BBP envelope fabric showed that it was three times stronger than the required minimum. Examination of the basket of the balloon which flew higher showed some elements with sharp edges protruding outward. According to the Championship Event Director's personal opinion, if the elements with sharp edges had not protruded outside the basket, the collision probably would not have led to tearing of the envelope of the other balloon.

Failure to keep separation between the two balloons.

1. Participation in competitive sports, which resulted in high focus on achieving a result.
2. Probably the presence of sharp elements outside the basket of the balloon flying higher.

During the Women's World Hot Balloon Championship in Poland, in September 2014, the Event Director informed the pilots that the Safety Officer would check the balloons baskets for components with sharp edges. It was recommended that if such elements were present, they were to be covered with strong material, and locks of straps for fastening competition numbers on the baskets were to be placed inside the baskets.

The Commission draws attention to the fact that balloon pilots should regularly check the baskets for protruding, sharp edges. The protruding pieces of wicker should be cut, and any other protruding parts should be covered. This applies to each flight, not just participation in sport event.
