**Accident reference No: 335/15**

**RESOLUTION  
OF  
THE STATE COMMISSION ON AIRCRAFT ACCIDENTS INVESTIGATION**

On 2 April 2015, the Commission examined information on circumstances of the air occurrence to SZD-30 PIRAT glider, registration marks: D-2835, which occurred in Łazy near Jarosław. The information was submitted by an owner - user in the form of notification. The State Commission on Aircraft Accidents Investigation, acting under **Article 5 par. 3 of the Regulation (EU) No 996/2010 of the European Parliament and of the Council on the investigation and prevention of accidents and incidents in civil aviation and repealing Directive 94/56/EC<sup>1</sup>** regarded the information contained in the notification as sufficient and decided to conclude the investigation.

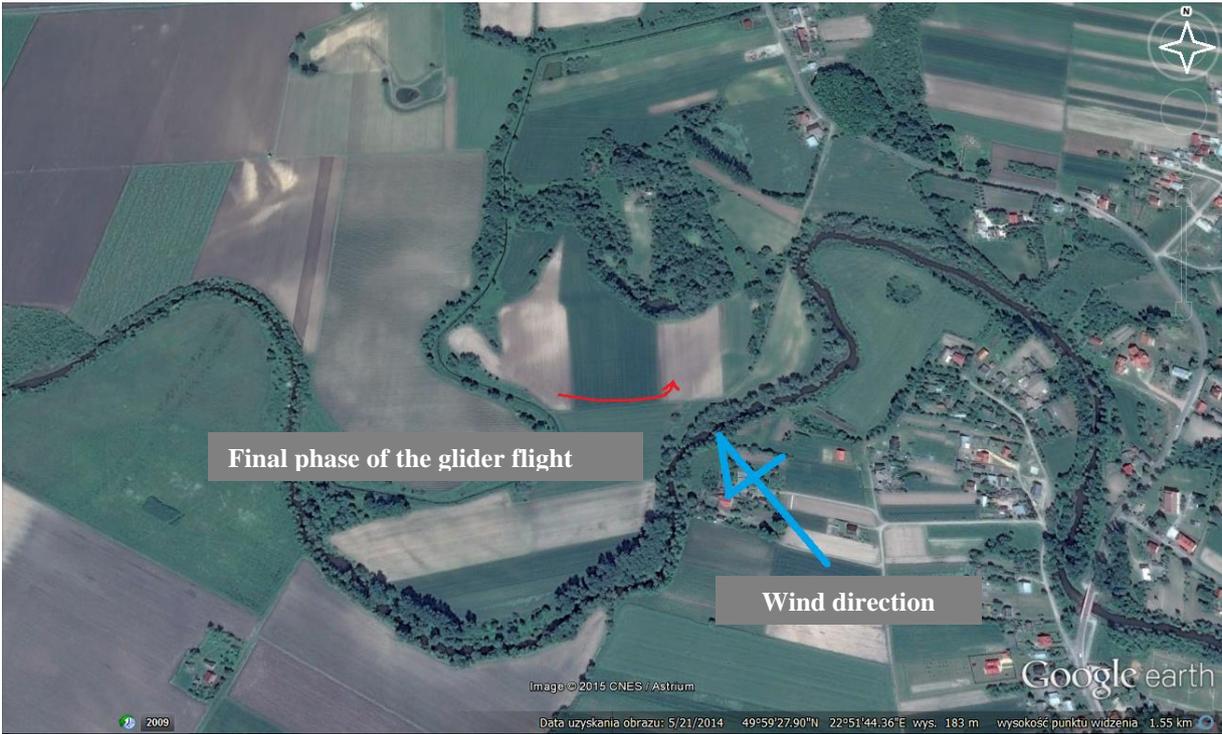
approximately 5 m the glider, having tail-cross wind (Figure 1), suddenly lost the height hitting the ground with the left wing and the front part of the fuselage (Figure 2).

**Figure 1. The landing area of the glider. Large fields suitable for landing visible on the direction from which the glider arrived.**

- Lack of knowledge about the flight area, which contributed to the loss of geographical orientation;
- Late decision on landing in random area, which resulted in the loss of opportunity to choose a field suitable for landing;
- An attempt to omit obstacles on a critically low altitude and a turn with tail-cross wind, which caused the glider stall and collision with the ground.

The flight organizer familiarized pilots with the circumstances of the occurrence and reminded the principles of resuming orientation and the rules of selecting the landing field as well as the rules of conduct in the case of landing in a random area.

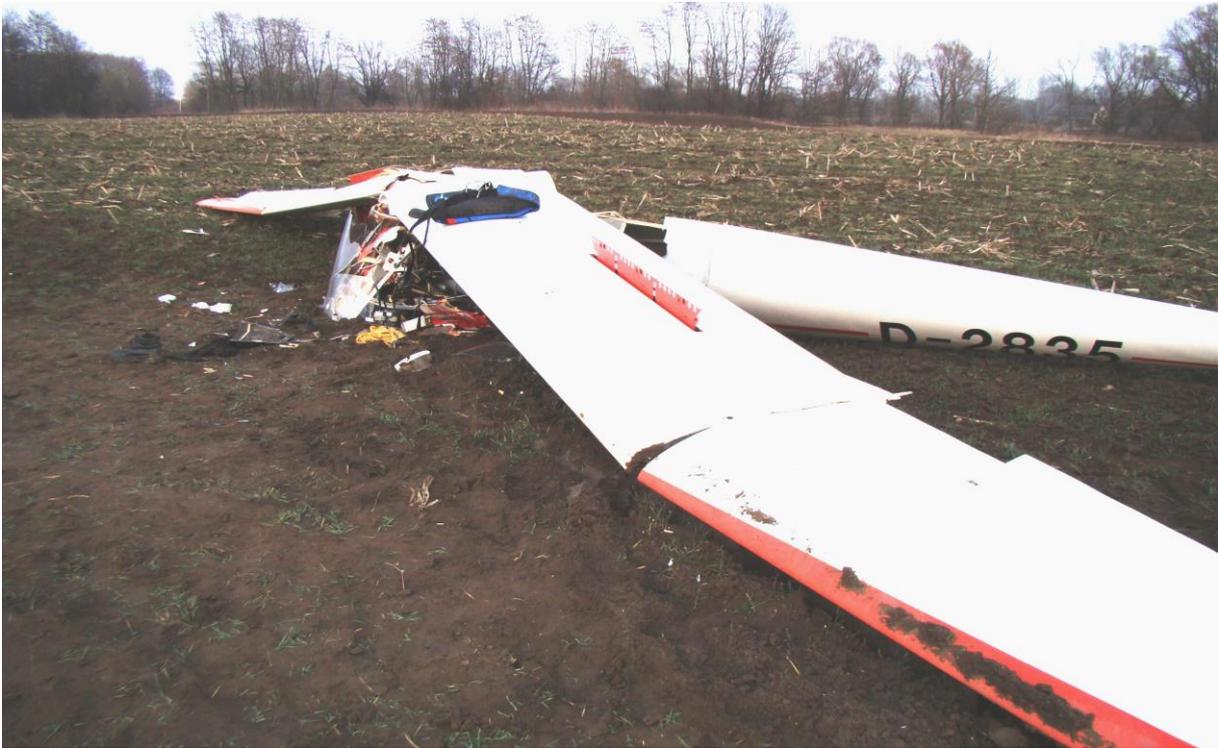
**Figure 2. The glider after the accident. Visible the front part of the fuselage - completely destroyed.**

As a result of the collision the pilot suffered injuries to the legs and the head, and the glider was completely destroyed. The pilot taken to hospital. During visual inspection of the accident site no traces of the landing roll were found.
