## State Commission on Aircraft Accidents Investigation

### ACCIDENT 2015/1220

### RESOLUTION

<b>Type and model of aircraft:</b>	Powered paraglider: SNAKE 18 wing Parajet Zenith with Polini THOR200 engine
<b>Registration marks:</b>	Not applicable
<b>Date of occurrence:</b>	4 July 2015
<b>Place of occurrence:</b>	Legnica, Poland

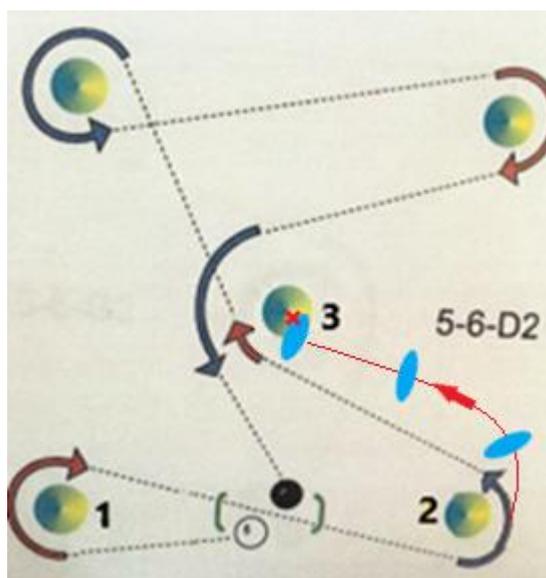
Fig. 1. 5-6-D2 competition scheme.  
The approximate flight path of the accident  
paraglider  
[source: flight catalogue – appendix to the  
competition regulations]

The right side of the wing of the powered paraglider flown by an experienced pilot (representative of the Republic of Lithuania) hit the pylon no. 3 (fig. 1) at high speed, while making a right turn at a height of about 10 m. As a result, the paraglider collided with the ground and the pilot suffered serious injuries.

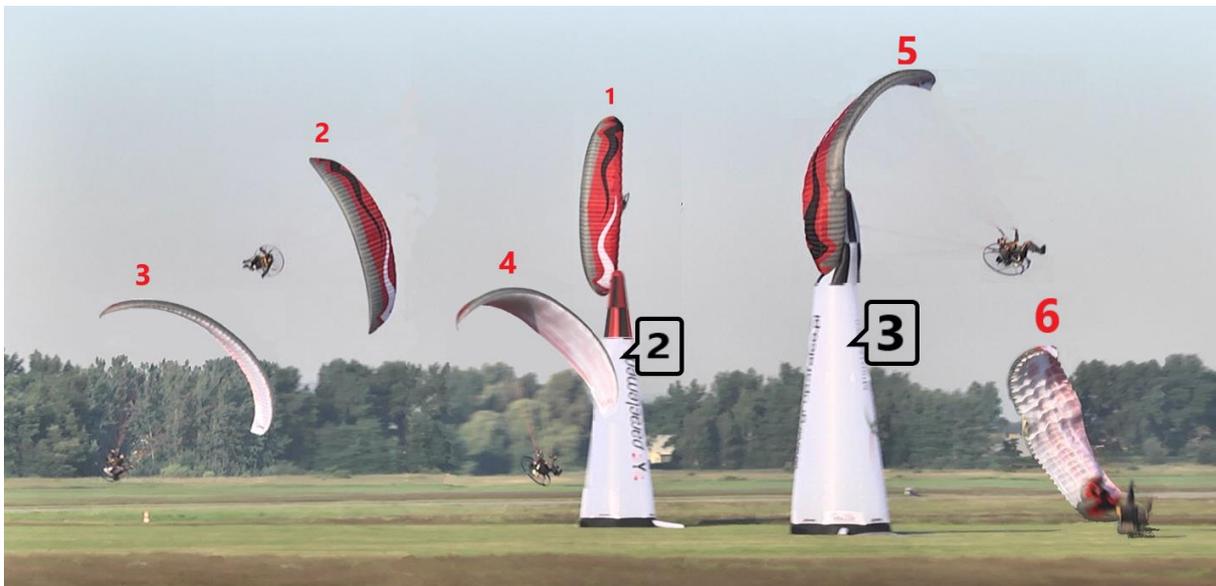
The analysis of the video material (fig. 2) allowed to determine the course of the occurrence. When making a dynamic turn around pylon no. 2, the pilot deviated from the optimal flight path and then too early initiated the turn to avoid pylon no. 3. During the turn, the right side of the wing collided with pylon no. 3 and the wing was suddenly stopped. The pilot with the powerplant was thrown to a height of about 15 m, then he fell on his back (on the engine), bounced, and after rotation in the air, fell down facing the ground.

Fig. 2. The last phase of the flight in time-lapse photos – the turn around pylon 2 and collision with pylon 3 [source: film recording of the accident flight]

In that situation, abortion of the flight would have allowed to avoid the collision with the pylon.

- 1) Lack of decision to abort the flight after errors made during the turn around pylon no. 2.**
- 2) Entering the right turn (in order to avoid pylon no. 3) too early.**

After the occurrence the rules of powered paraglider slalom competitions were changed. Currently, to increase the safety of competitors, slalom competitions are held over water bodies.
