## STATE COMMISSION ON AIRCRAFT ACCIDENTS INVESTIGATION

### Final Report

Occurrence reference number:	<b><i>1252/15</i></b>			
Type of occurrence:	<b><i>SERIOUS INCIDENT</i></b>			
Date of occurrence:	<b><i>3 July, 2015</i></b>			
Place of occurrence:	<b><i>Skotniki near Szczecinek</i></b>			
Type and model of aircraft:	<b><i>Kubicek BB-S balloon, Fish model</i></b>			
Aircraft registration marks:	<b><i>OK-1209</i></b>			
Aircraft User/Operator:	<b><i>private</i></b>			
Aircraft Commander:	<b><i>balloon pilot</i></b>			
Number of Victims/Injuries:	<i>Fatal</i>	<i>Serious</i>	<i>Minor</i>	<i>None</i>
				<b><i>3</i></b>
Investigator-in-Charge:	<b><i>Tomasz Kuchciński</i></b>			
Investigation Authority:	<b><i>SCAAI</i></b>			
Composition of Investigating Team:	<b><i>T. Kuchciński, E. Łojek</i></b>			
Recommendations:	<b><i>NONE</i></b>			
Recipient of recommendations:	<b><i>NOT APPLICABLE</i></b>			
Date of completion of the investigation:	<b><i>3 June, 2016</i></b>

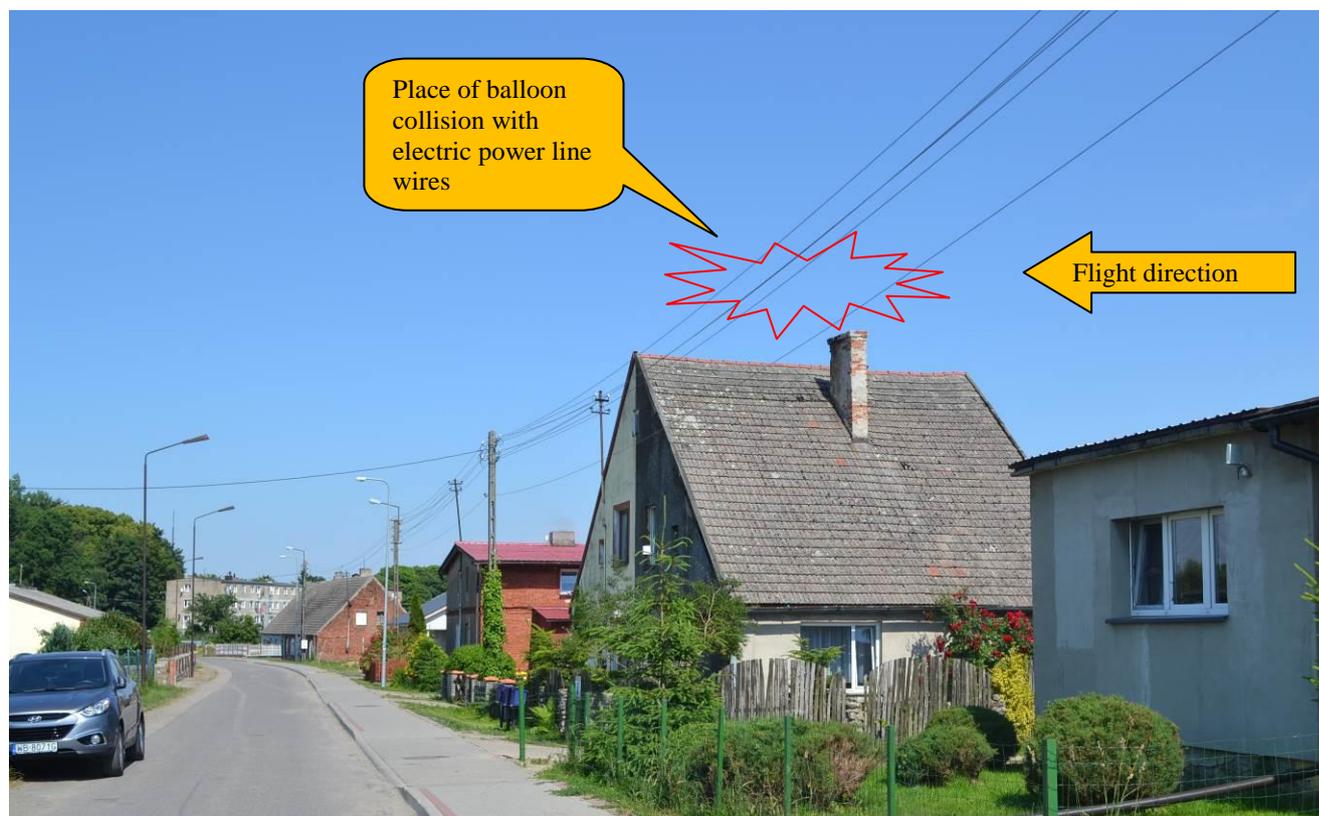
Flat area. Buildings of Skotniki village are one-storey or two-storey. The power line run along a street perpendicularly to the flight path of the balloon. The line wires were slightly below the roof of the building next to which the balloon flew.

*View of the place of balloon collision with electric power line wires. Source: SCAAI*

The collision with the electric line was above the burner, probably at the level of the balloon envelope wires. After the collision basket of the balloon remained under the wires and the envelope over the wires. Electric power was cut off automatically due to the wires short circuiting.

The Commission did not have the possibility of objective verification of the balloon flight parameters. Taking into account the circumstances of the serious incident, the Commission assumed that during approach to landing the pilot probably flew so low that the basket of the balloon was below the roof of a one-storey building. In this phase of the flight the electric line poles could have been be invisible to the pilot, and spotting wires is usually possible only from a very short distance. This led to the situation that after spotting the wires the pilot was not able either to fly over the line or to land before it. In the Commission opinion, terrain, weather conditions and indicated by the pilot intended landing site did not justify such a low flight.
