# FINAL REPORT

**Occurrence No: 2970/16**

**Aircraft: Piper PA-31aeroplane, D-IFBU**

**24 November 2016, Przylep near Zielona Góra (EPZP)**

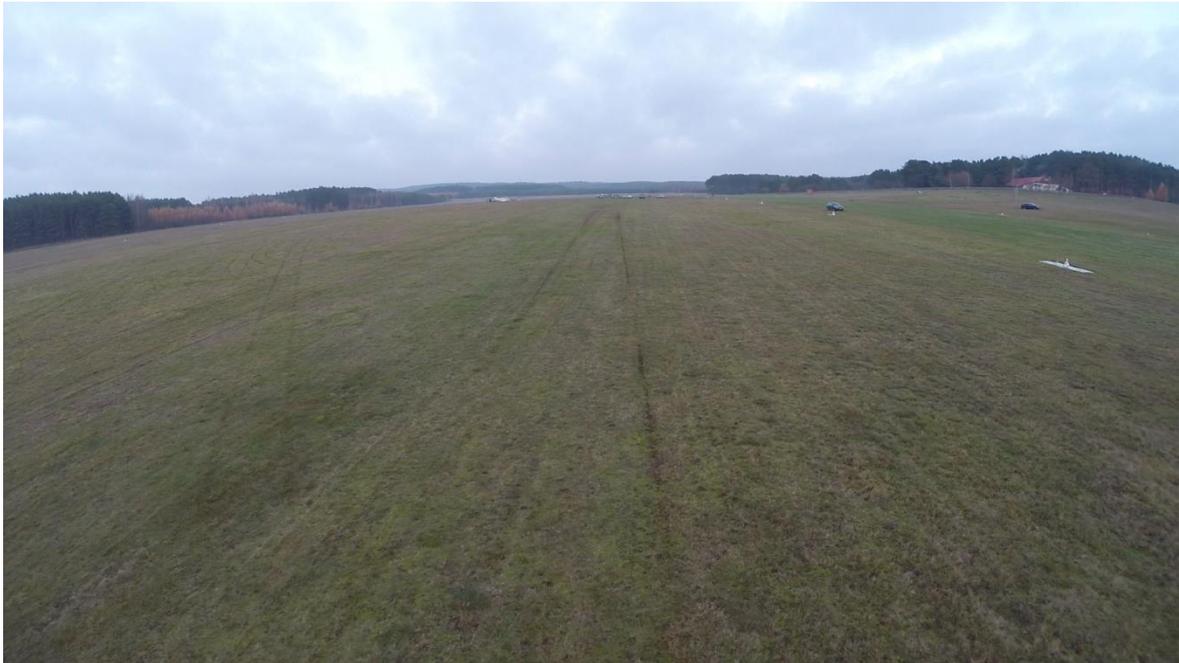
At about 12:05 hrs the airplane started the take-off run. The course of the run was recorded from the aerodrome tower until the accident. A sketch of the take-off run is shown in Annex 1 to this Report. The first tracks of the main landing gear on the surface were found about 500 m from the threshold of RWY 06 (Figure 1, below).

**Figure 1.** *First tracks of the main landing gear left on RWY 06 grass after the take-off run.*

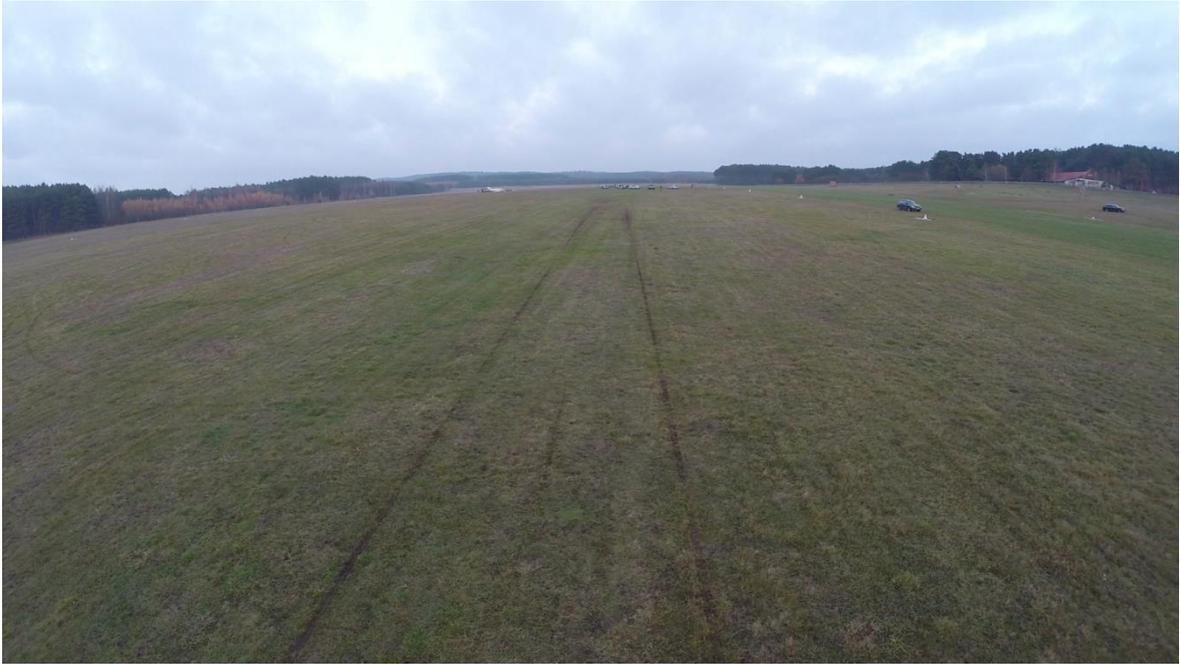
In the Commission opinion, after approximately 500 m of the take-off run, during the rotation and a momentary aircraft lift-off, the pilot moved the landing gear control lever to the “retracted” position. However, a while later the airplane touched down again. The main landing gear was braked in the soft wetland and produced a nose down pitching moment. The nose landing gear wheel in the retracting phase collided with the ground, leaving the tracks shown in Figure 2. Then the blades of both powerplants also collided with the ground (Figure 3). They left traces in the form of several dozen transverse cuts in the grass. Even then the pilot was continuing the take-off.

**Figure 2.** *First track of the nose landing gear on RWY 06 grass.*

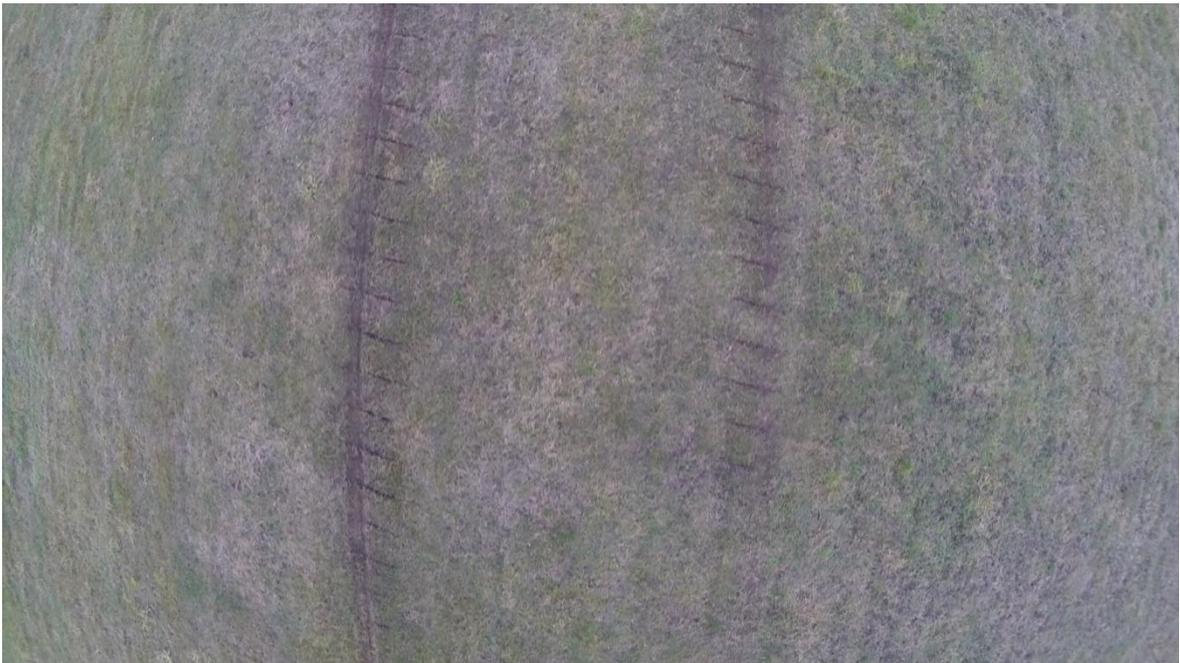
**Figure 3.** *Traces of the main landing gear and both propellers. Visible traces of the propellers collision with RWY 06 surface, but lack of the nose wheel track indicates that the nose landing gear was in the final phase of retraction.*

Due to the fact that the left main landing gear was retracting faster than the right one, the airplane was rolling to the left and the left propeller went down earlier (visible deep prints in the grass) than the right one.

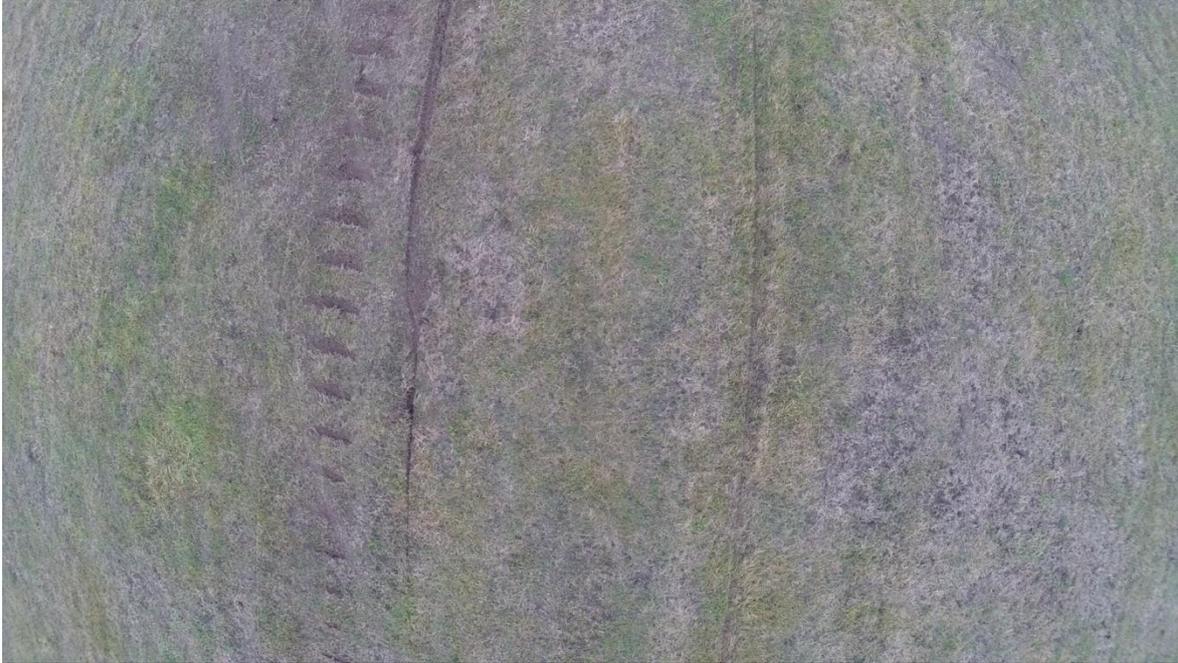
After several dozen metres of the take-off run the left wheel well door also touched the ground leaving a deep track on the grass (Figure 4). The right wing went up and only a disappearing track of the right wheel was left on the RWY surface. The right propeller lost contact with the RWY surface.

**Figure 4.** *Traces on RWY 06 in the final phase of the take-off run. On the left visible a deep print of the inner door of the left wheel well and a trace of the left propeller. On the right only a disappearing track of the right wheel is visible.*

The inner door of the left wheel well touched the ground leaving a deep track on the grass. Due to the propeller damage the left powerplant had no thrust. The right powerplant produced thrust because deformation of its propeller was less significant and as a result the right wing went up.

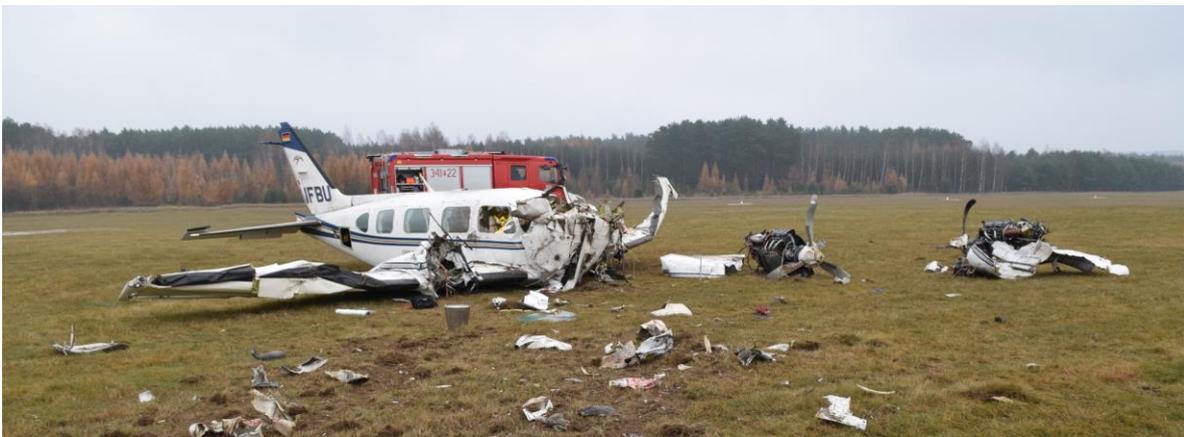
After several dozen meters of the take-off run the plane lifted-off with the left bank and from a height of over a dozen meters, rolling to the left, collided with the ground. The left wing tip and the left engine contacted the ground and later the nose part of the fuselage, the right engine and right wing also contacted the ground.

**Figure 5.** *The airplane at the scene directly after the accident. The engines are on the right. The right engine is closer to the airplane the left one is farther. [Photo Police]*

Both engines were separated from the wings. After the roll the fuselage fell on the grass and came to rest in the direction of approximately 90 degrees as shown in Figure 5. The nose part of the fuselage and the cockpit were totally destroyed. Fuel was leaking from unsealed wing tanks.

A dynamic contact of the rolling aircraft with the aerodrome surface resulted in extraction of both engines from their nacelles as shown in Figure 5. The nose part of the fuselage and both wings were completely destroyed. The tip of the left wing was clearly deformed and bent upward because that element of the airframe contacted with the ground first. The rest energy of the taking-off aircraft was lost during extraction of the left engine from its nacelle and destruction of the nose part of the fuselage, the right wing and the right engine.

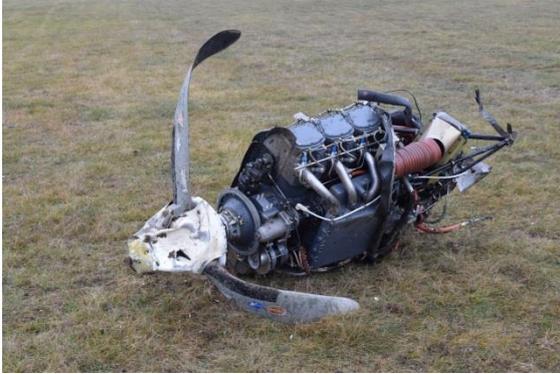
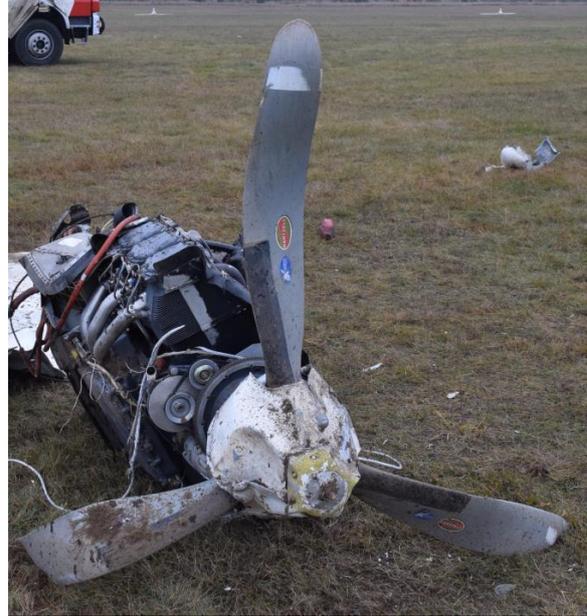
The condition of the propellers is shown in Figure 6. All blades of the left propeller were bent backwards in the form of so called "tulip" because they had relatively long lasting

contact with RWY during the take-off run. The blades of the right propeller, except one, were much less deformed because they did not penetrate so deeply into RWY surface and when the right wing went up, they lost contact with the ground.

*Figure 6. The above photo shows the condition of the left propeller blades (“tulip”). The right photo shows the less deformed blades of the right propeller.*  
[Photo Police]

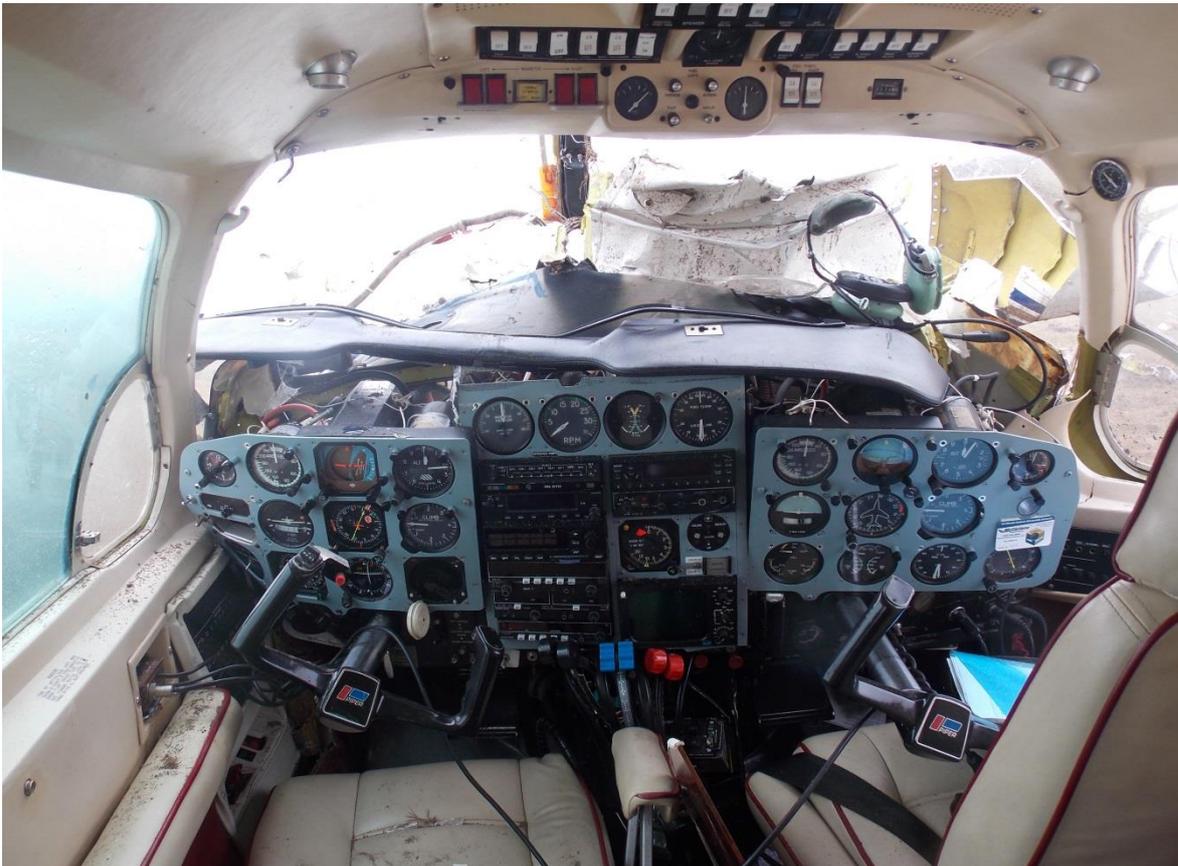
*Figure 7. Condition of the instrument panel after the accident.*

The instrument panel was extracted from its mountings and displaced in the direction of the seats, but board instruments had no visual signs of damage (Figure 7). Visual inspection of the instrument panel showed among other things, that the landing gear control lever was in the up position (“gear retracted”), and the levers of throttles, propeller pitch and composition of the air-fuel mixture were in the forward position, as shown in the photo below (Figure 8).

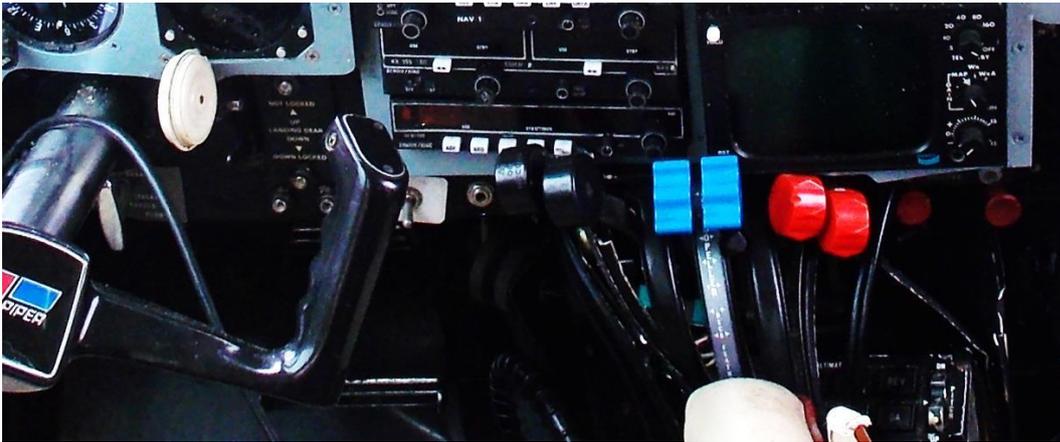
**Figure 8.** *A section of the instrument panel. Visible: the landing gear control lever (white) in the up position (“gear retracted”), the levers of throttles (black), propellers pitch (blue) and composition of the air-fuel mixture (red) in the forward positions – full power. [photo: SCAAI]*

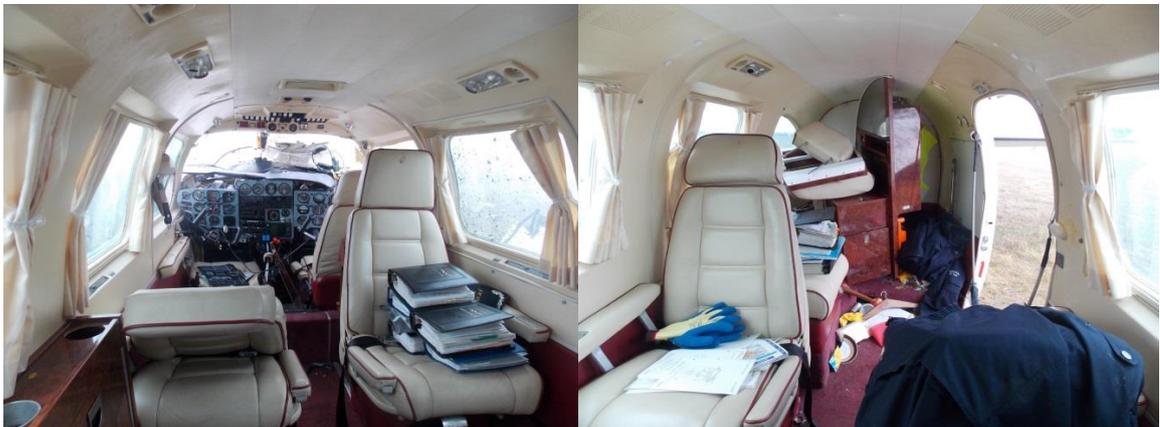
The cockpit condition is shown in Figure 9. The photo was taken next day after the accident. Dislocations of some items in the cockpit are not excluded. They resulted from rescue and protective operations.

**Figure 9.** *The cabin after the accident. Photo on the left was taken in the forward direction and shows lack of pilot’s seatback which was removed during rescue operation. Photo on the right was taken in the backward direction.*

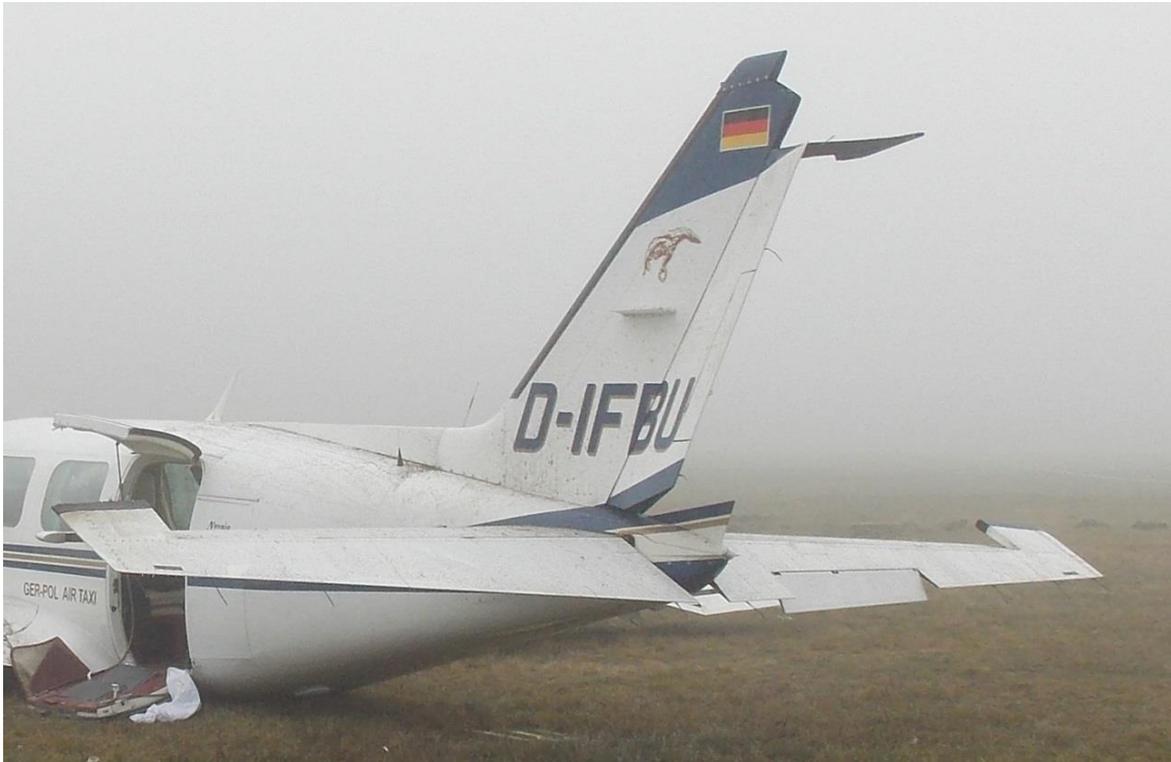
The horizontal empennage did not show any signs of damage but the upper part of rudder with aerodynamic balance was bent by about 90 degrees. This is shown in Figure 10.

**Figure 10.** *Damage to the upper part of rudder. Visible the bent upper part of rudder with aerodynamic balance.*

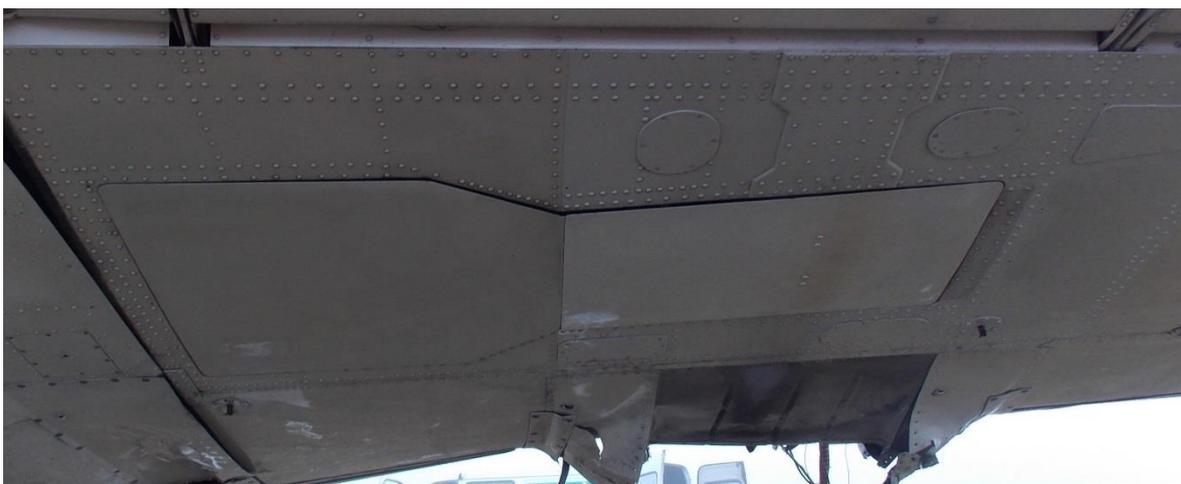
A visual inspection of the wreckage at the scene showed that both the main and the nose landing gears were retracted and the wheel well doors were closed.

**Figure 11.** *The right main landing gear after the accident – “gear retracted”, both doors of the wheel well “closed”.*

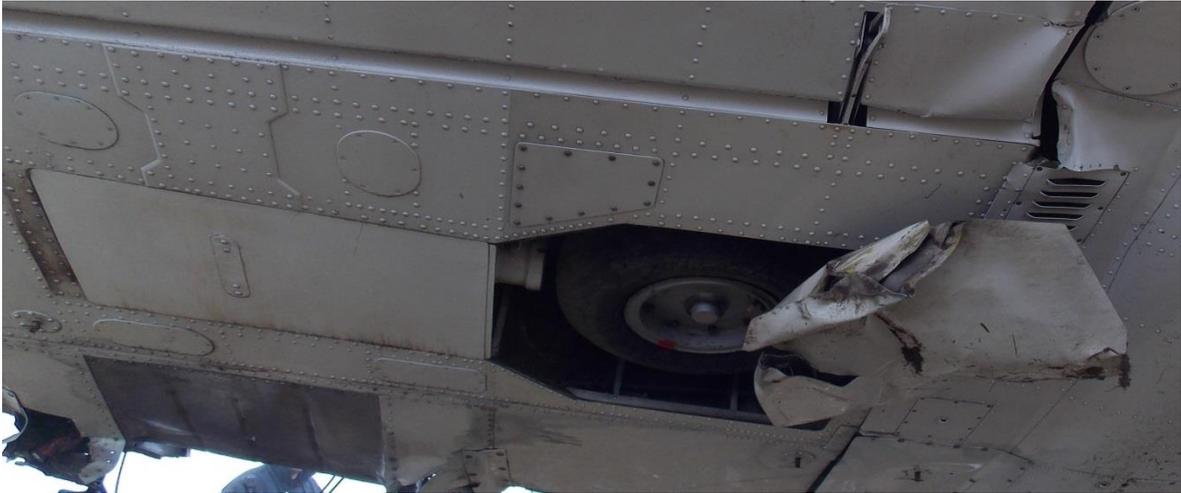
**Figure 12.** *The left main landing gear after the accident – “gear retracted”. The inner door of the wheel well deformed and not fully closed due to the collision with the aerodrome surface. The outer door closed.*

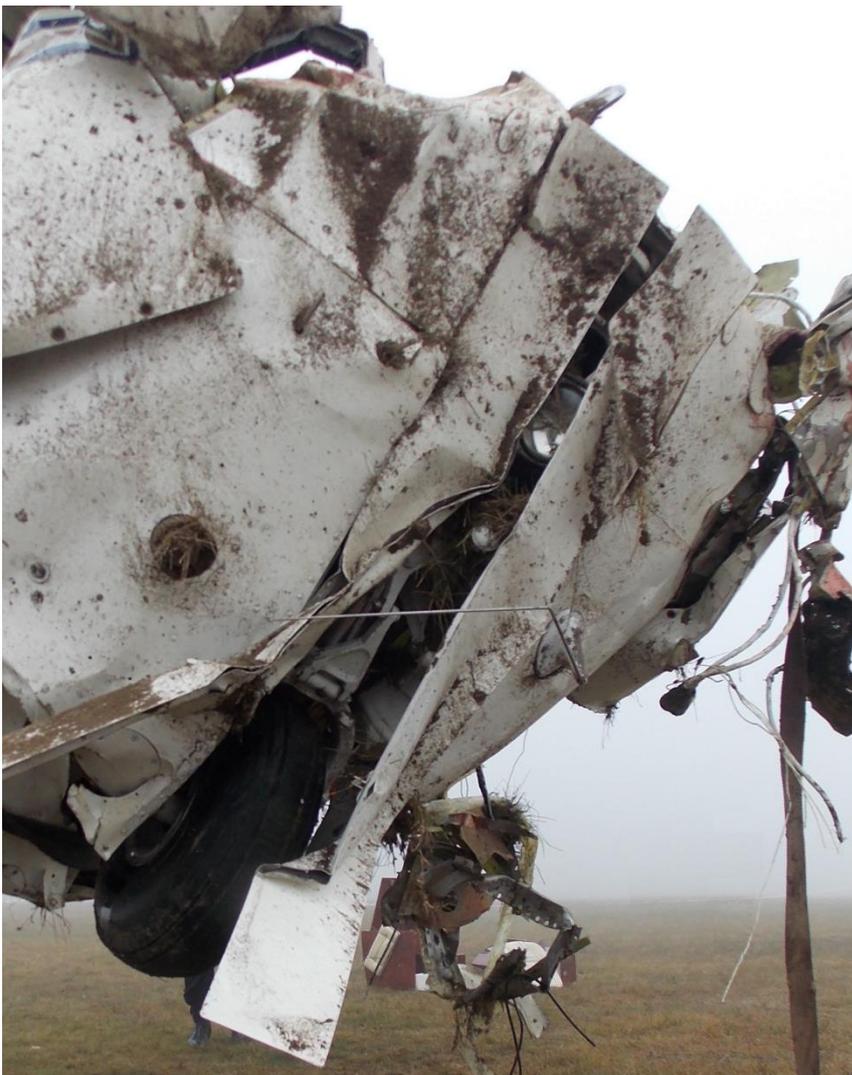
**Figure13.** *The nose landing gear after the accident in the “retracted” position. Visible deformations of the doors resulted from the collision of the nose part of the fuselage with the ground in the final phase of the rolling.*

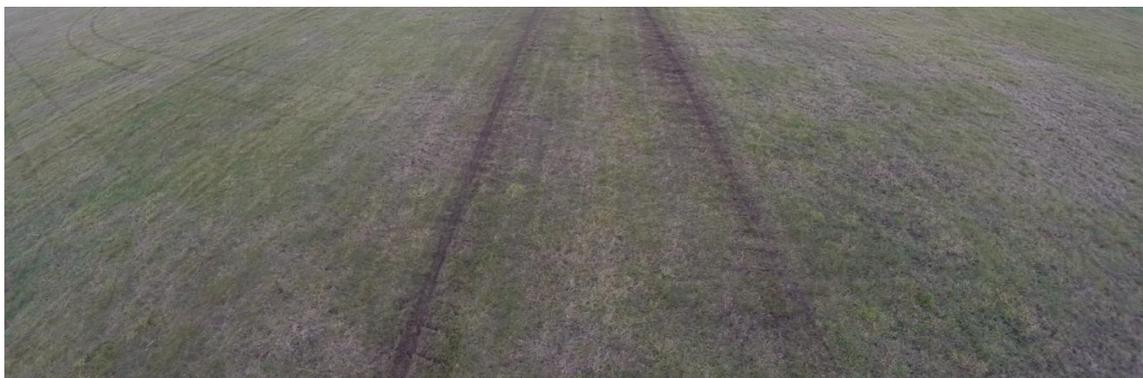
The active part of RWY 06/24 is a grassy surface of 950x180 m. The hardness of the RWY surface changes along its length, particularly in the middle, where the land is lower and after precipitation a local decrease in bearing strength of the surface may occur (Figure 15 below).

*Figure 15. Wheel tracks and propeller traces in the middle part of RWY 06/24 after take-off run.*

This results in increased rolling resistance on this section (track forming), which requires longer take-off run.

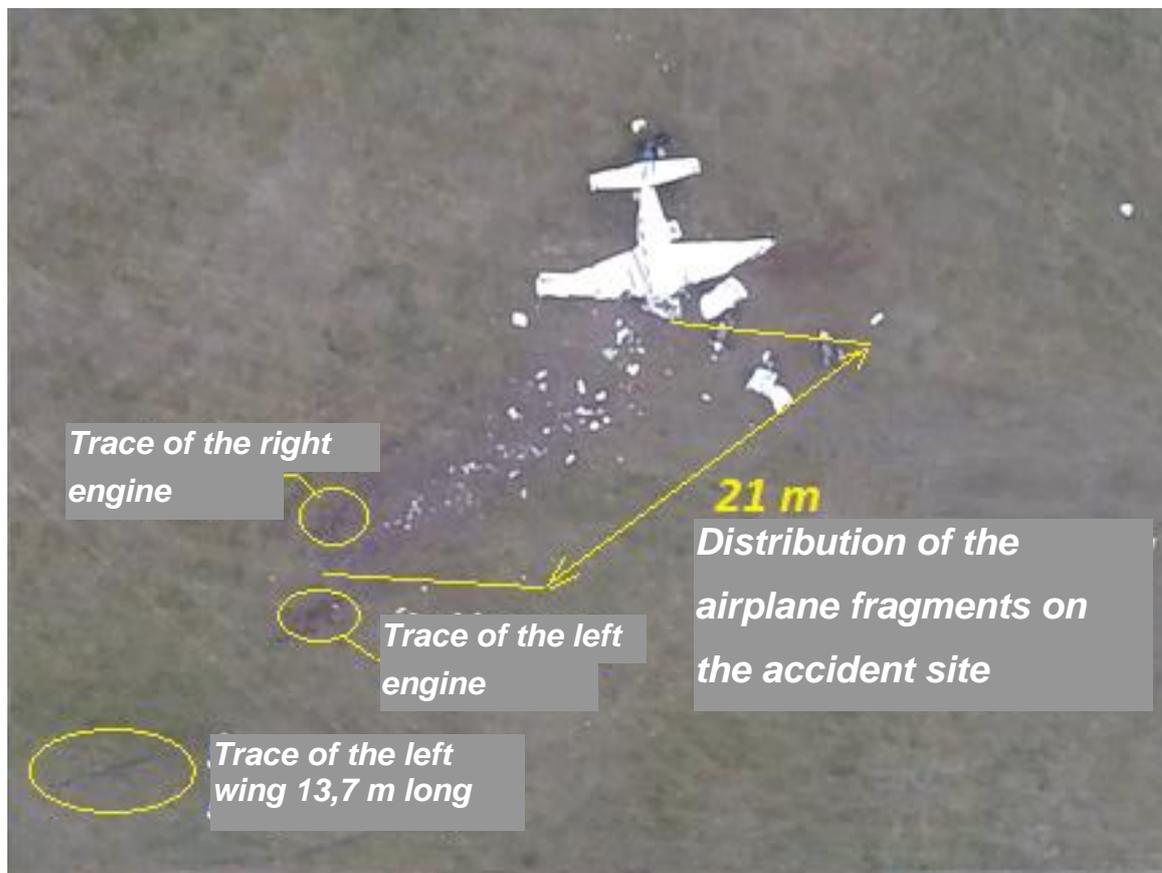
The first small fragments of the structure separated from the aircraft during the autorotation phase, when the left wing tip contacted the aerodrome surface (Figure 16).

Figure 16. Distribution of the airplane fragments on the accident site. [photo AZL]

Then the left engine collided with the ground and separated from the wing leaving a deep trace on the grass. When the plane was in almost vertical attitude, the nose part of the fuselage collided with the ground, which caused its crushing. The plane tilted to the right wing during rotation in a vertical attitude.

After collision with the ground the right engine also separated from the wing and produced a deep trace. The plane moved about 21 m and fell on the ground.
