FINAL REPORT

INCIDENT 498/18

AIRCRAFT – Airbus A-330-200, C-GTSL

DATE AND PLACE OF OCCURRENCE – 16 March 2018, EPWA

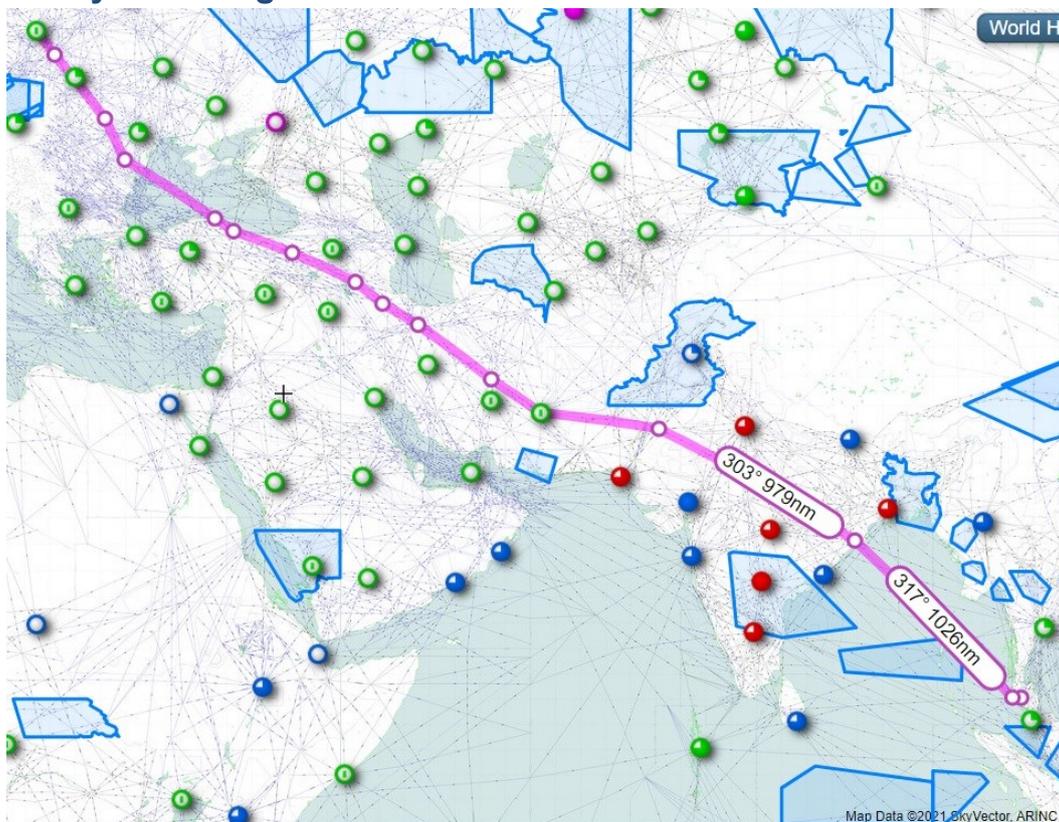
Fig. 1 Flight TVP7617 – visualization of the flight path from VTSG to EPWA.

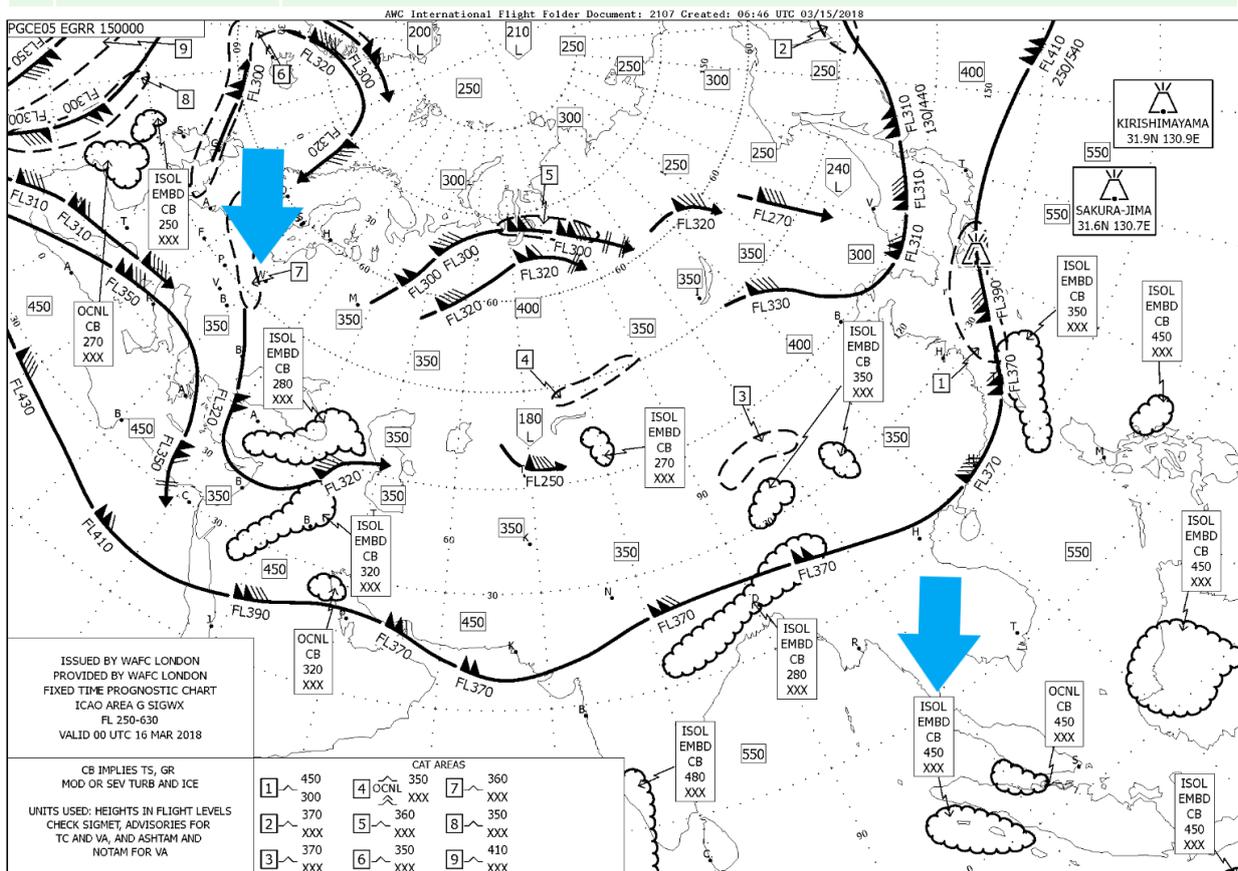
Fig. 3 Significant Weather Chart - Forecast Map issued with validation dated as of 16 March 2018 at 00:00 hrs. The blue arrow marks the departure aerodrome in Krabi (lower right corner of the map) and the destination aerodrome in Warsaw (upper left corner).

The current Forecast Map (Fig. 4) and the flight route, taking into account the curvature of the Earth, shows the initial part of the route to the west coast of India was without

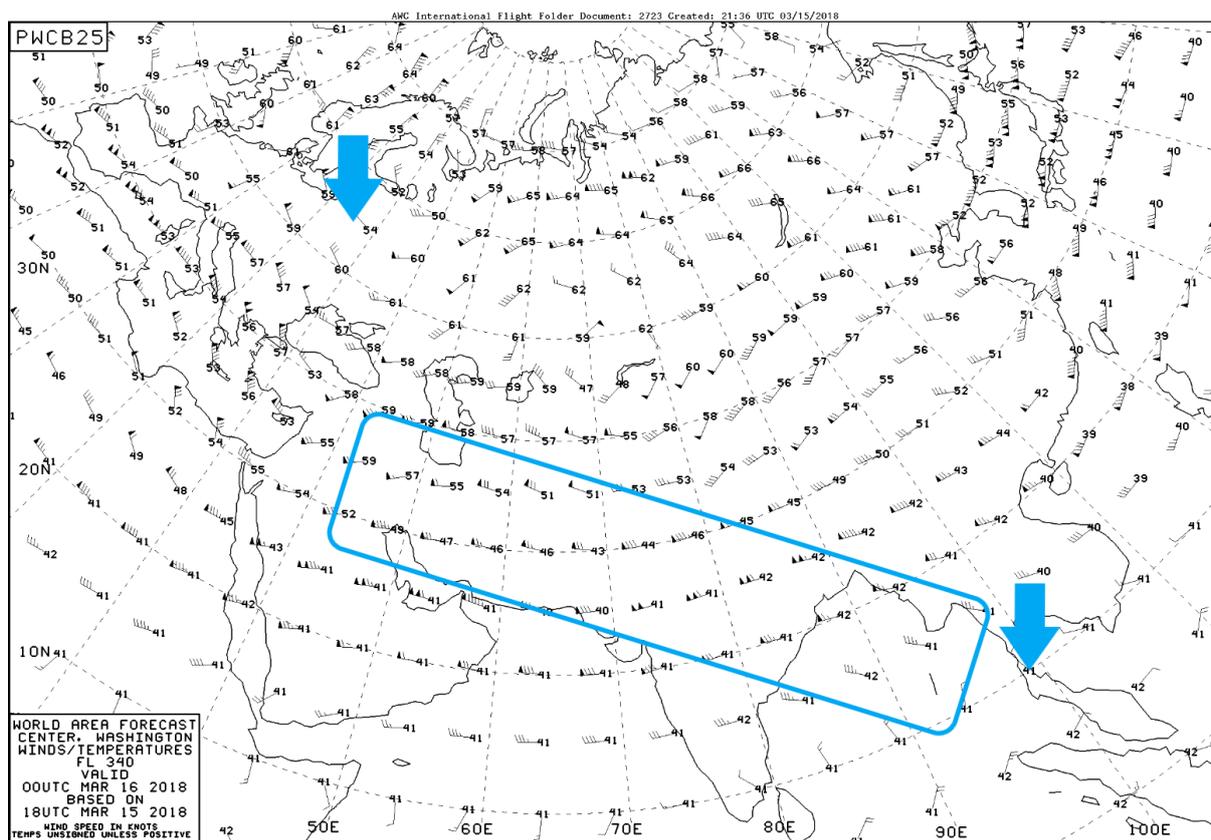
Fig. 4 Map of the Upper Winds on FL 340 based on data of 15 March 2018 at 18:00 hrs, valid for 16 March 2018 at 00:00 hrs. The blue arrows mark the departure aerodrome in Krabi (lower right corner) and the destination aerodrome in Warsaw (upper left corner).

As part of the investigation, the meteorological conditions at the cruising level were analysed. In the map of the Upper Winds (Fig. 4) on FL 340, the sector in blue represents the first part of the flight. On a north-westerly direction of the flight, the airplane was flying upwind, which was blowing at a speed of 50 to 130 kt. The ambient temperature was in the range of -4°C to -59°C .

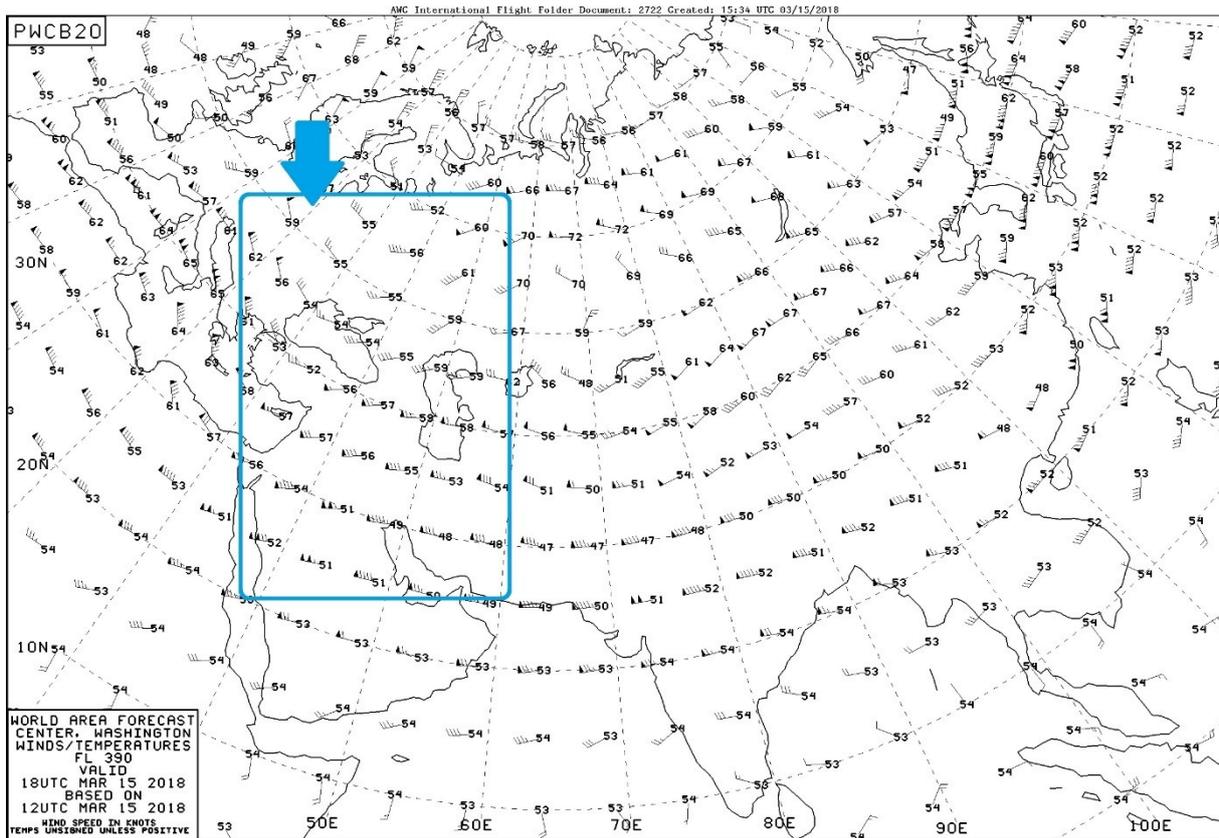
Fig. 5 Map of the Upper Winds on FL 390 based on data of 15 March 2018 at 18:00 hrs, valid for 16 March 2018 at 00:00 hrs. The blue arrow marks the destination aerodrome in Warsaw (upper left corner). Additionally, a blue rectangle marks the sector of the second part of the flight.

The flight records show that at 10:47 hrs (7 h and 7 min after take-off from Krabi) the airplane reached FL 380. 35 minutes later, at 11:22 hrs, the airplane reached the maximum flight level of FL 400. Total airtime during the flight from Krabi to Warsaw was 12 h and 13 min. In the map of the Upper Winds on FL 390, (Fig. 5), the sector marked in blue represents the second part of the flight. In the initial phase of the flight in this sector, the airplane was flying in the north-north-west (NNW) direction with the wind blowing from the left side. The direction of the wind changed in the second part of the sector to headwind. The wind speed in this phase of the flight was in the range from 45 to 120 kt. The ambient temperature was -52°C to -63°C .

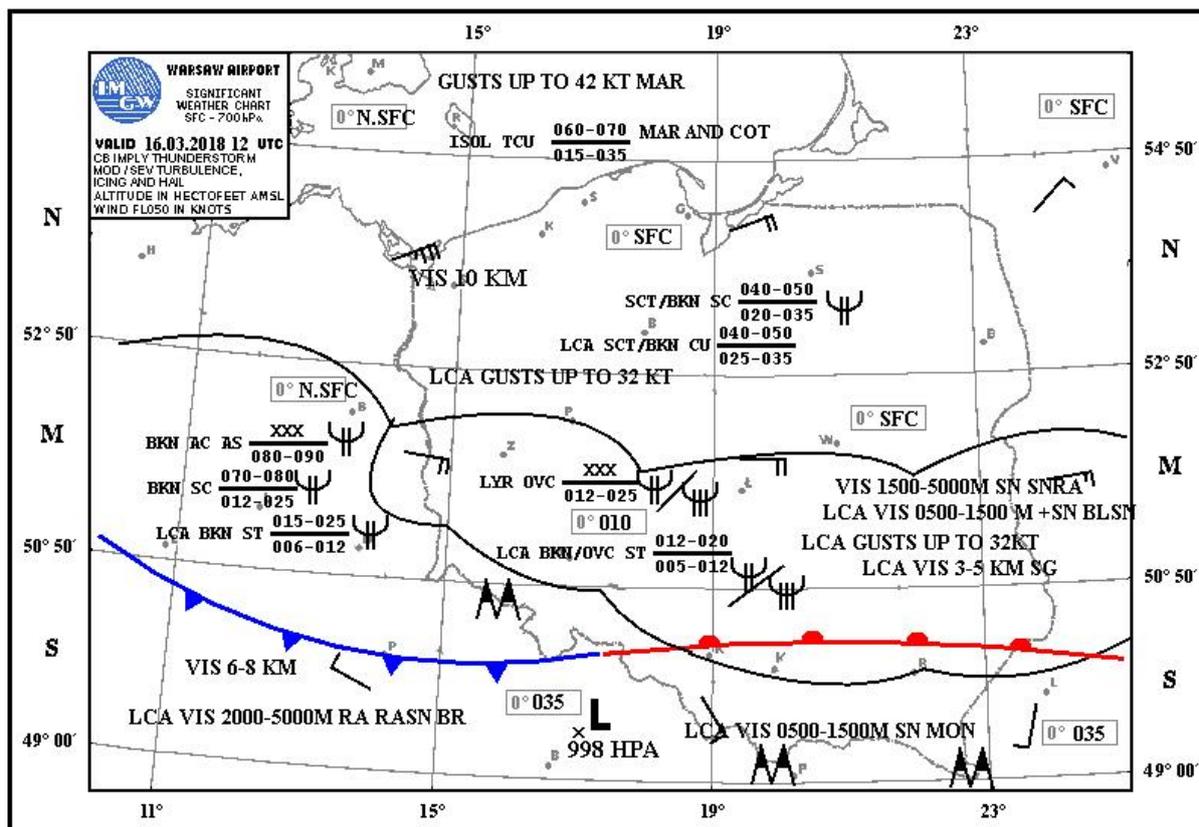
Fig. 6 Significant Weather Chart for the area of Poland, valid as of 16 March 2018, at 12:00 hrs.
[source: IMGW]

Based on the Significant Weather Chart, the meteorological conditions in the arrival sector to EPWA are presented. The warm front is visible in the south-eastern part of the area (aircraft arrival zone).

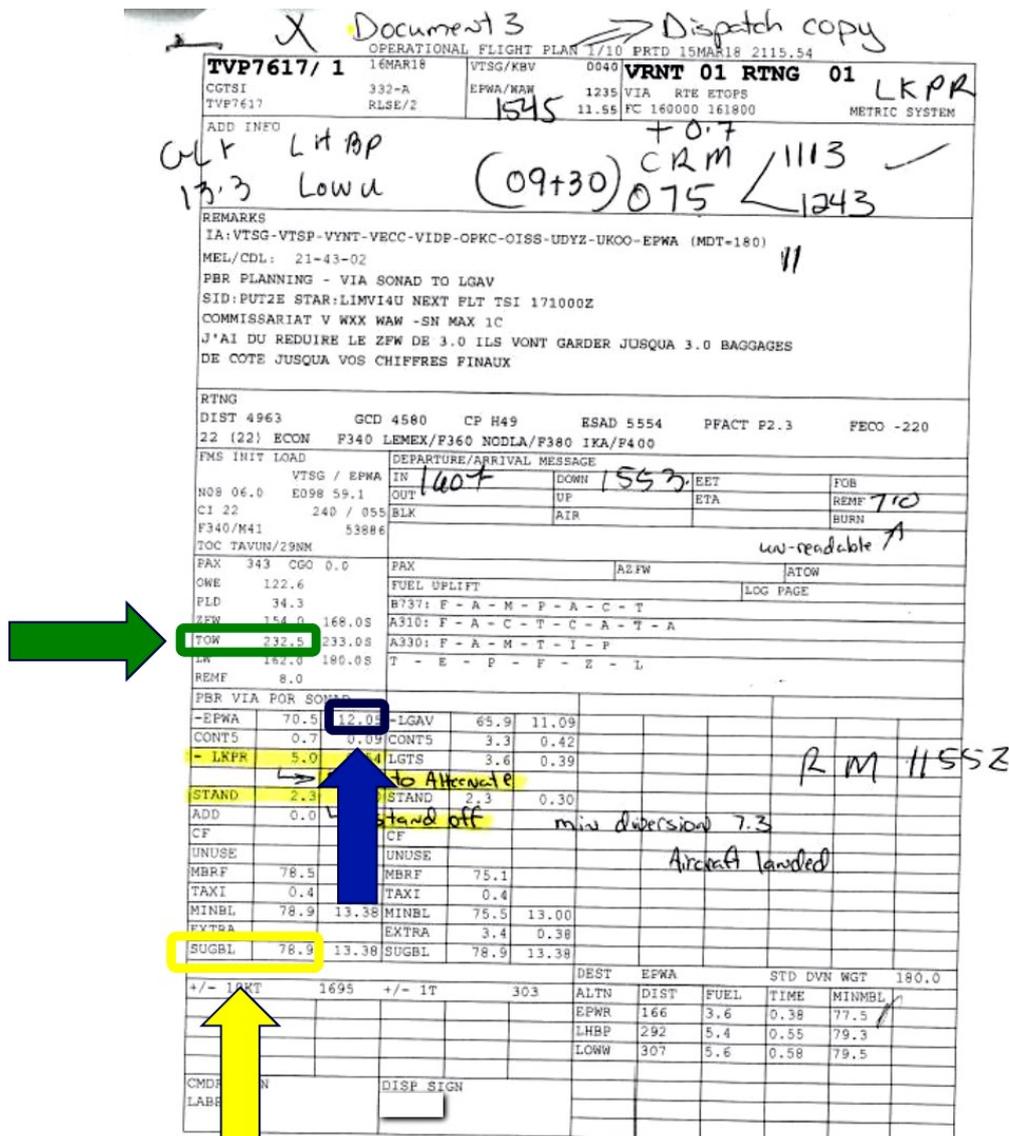
Fig. 7 Operational Flight Plan 1/10 (OFP 1/10).

The flight documents, including *Operational Flight Plan 1/10 (OFP 1/10)*, printed on 15 March 2018 at 21:15 hrs (Fig. 7), show the expected airplane masses for individual assumptions, as well as fuel quantity that was required to perform the flight on the VTGS-EPWA route.
