ACCIDENT 2019/3918

State Commission on Aircraft Accidents Investigation (PKBWL)

AIRCRAFT – Airplane Cessna 172-S, SP-COM

EVENT DATE AND PLACE – 31 August 2019, Kikity landing field (EPKI)

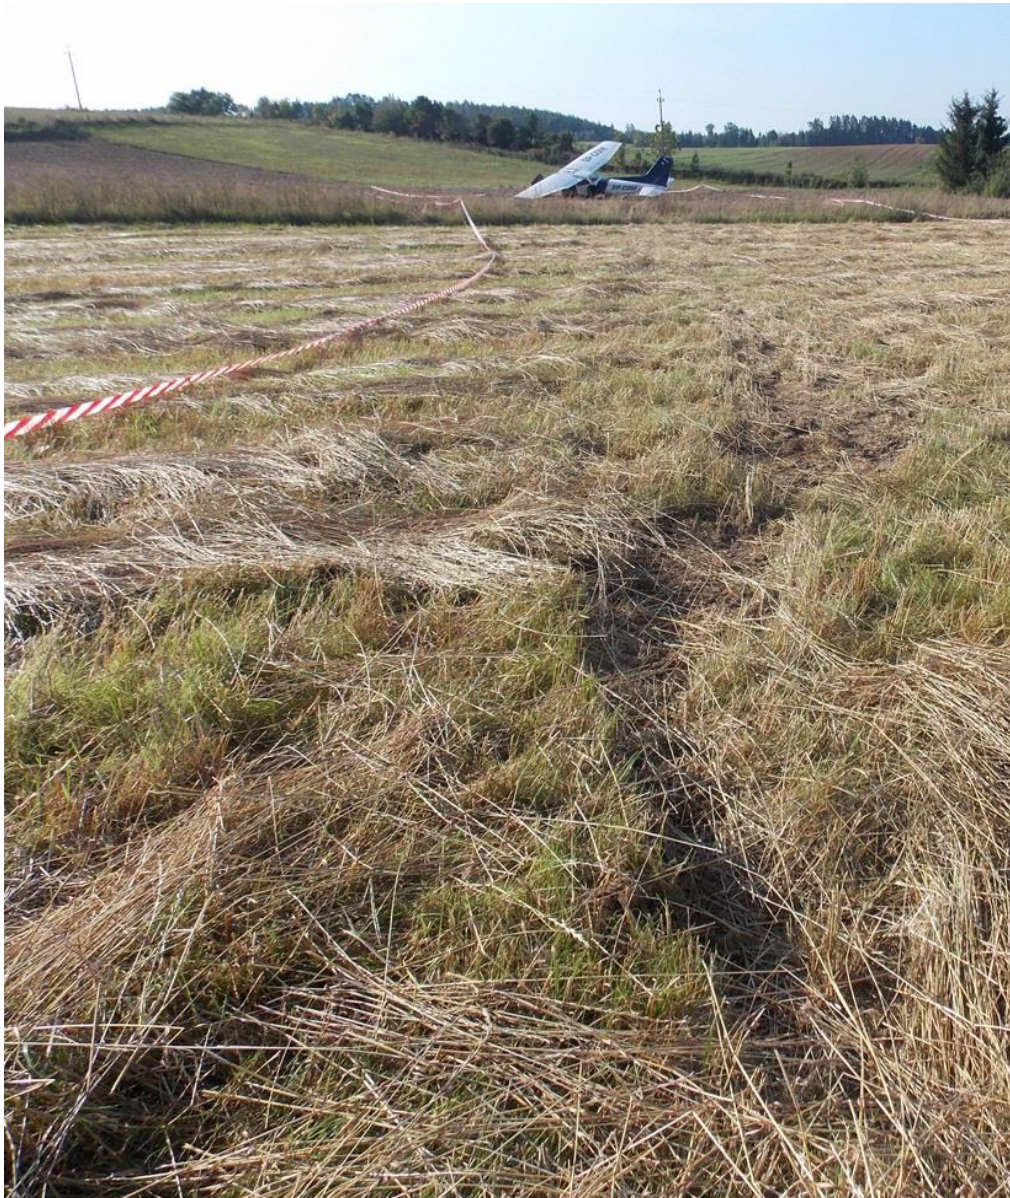
Fig. 2. Place of the first touchdown [source: PKBWL]

The first contact with the ground took place about 400 m from the runway threshold with a deviation to the left from its centre line (Fig. 2). After the first contact the plane bounced and after over a dozen meters, another touchdown occurred. During the first

touchdown, the left main landing gear was damaged, and the left wheel was separated from the landing gear leg, the fuselage structure behind the cockpit was deformed and the windshield was damaged. Elements of the landing gear and parts of the windshield were found several meters from the place where the plane came to rest. After the second touchdown, the plane moved over a dozen meters and, with the left slip, it came to rest several dozen meters from the place of the first touchdown. The nose landing gear was broken, the propeller was damaged, the nose part of the fuselage in the area of engine mount was damaged (Fig. 3).

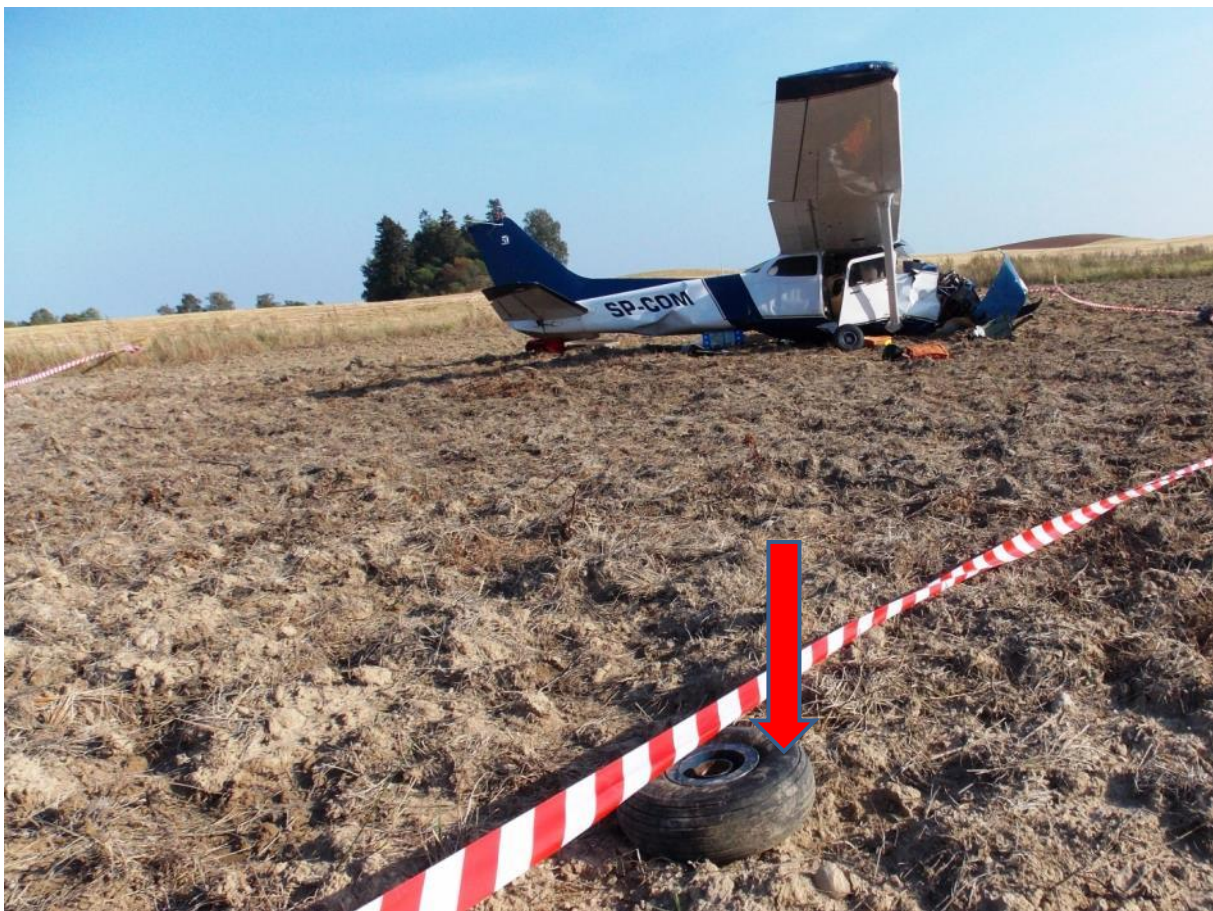
Fig. 3. The plane after stopping, red arrow shows the separated nose wheel [source: PKBWL]

After the first contact with the ground the plane bounced and after over a dozen meters, another touchdown occurred. The second touchdown resulted, among other things, in the breaking of the engine mount and damage to the propeller and the other elements described previously.

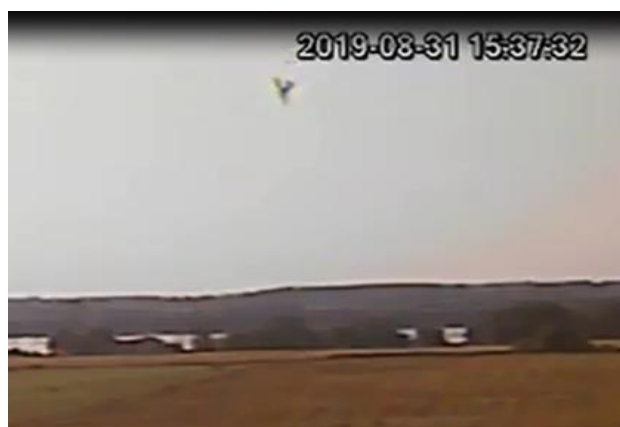
When analyzing the available CCTV footage, the Commission found that the climb during the accident flight was performed at a much greater climb compared with the previous flights. About 22 sec after lift-off at a height of about 80 m (based on the calculations of the assumed climb rate of the aircraft), the aircraft stalled. In the first phase the plane rolled on the left wing with simultaneous transition to a dive at an angle of approximately 90° (Fig. 4).

Fig. 4. The moment of stalling the plane [source: landing field CCTV camera]

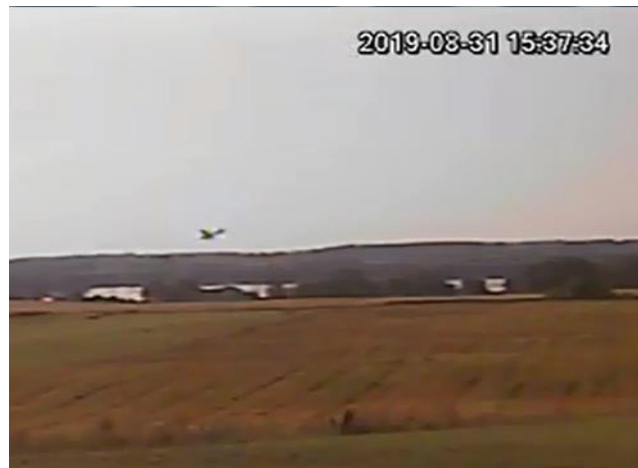
Fig. 5. The plane before the collision with the ground [source: landing field CCTV camera]

After a half of spin turn the rotation was stopped and the plane with a high dive angle was flying to the ground. The CCTV recording shows that during the descent the pitch angle was decreasing (Fig. 5).
