FINAL REPORT

SERIOUS INCIDENT 2019/4685

AIRCRAFT – Airplane, Embraer ERJ 190-200 LR., SP-LNO

DATE AND PLACE OF OCCURENCE – 11 October 2019, EPWA

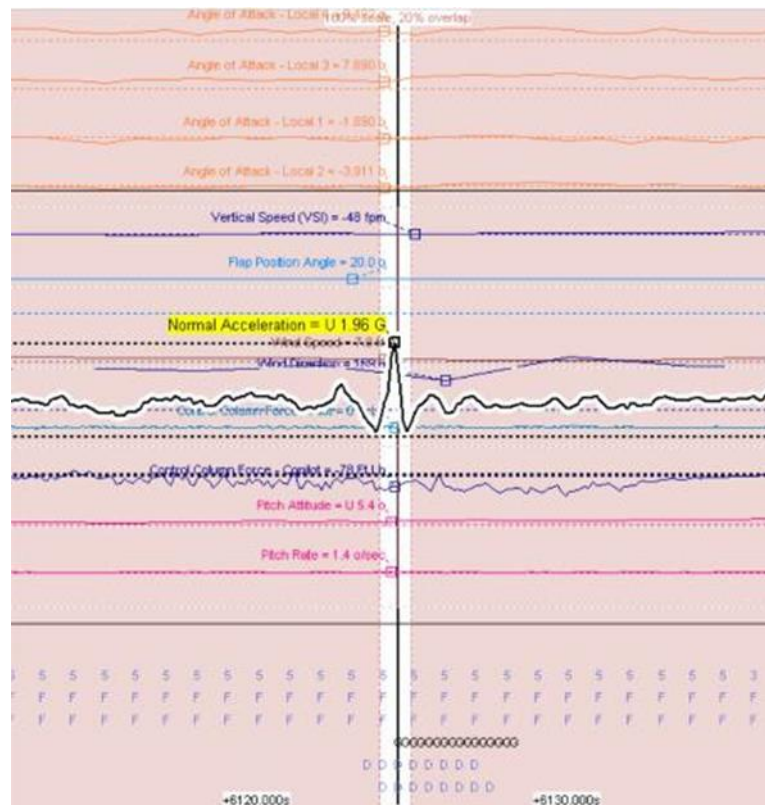
Fig. 6. Aerobytes screenshot.

assessment of the sink rate, which resulted in a hard landing. That error during landing and the PIC failure to properly monitor the PF response led to the aircraft bounce. The PM did not recognise a hazard and did not react timely to prevent the hard landing.

The plot based on the data recorded (Fig. 6) shows the moment of touchdown which took place with g-load of 1.96 g.

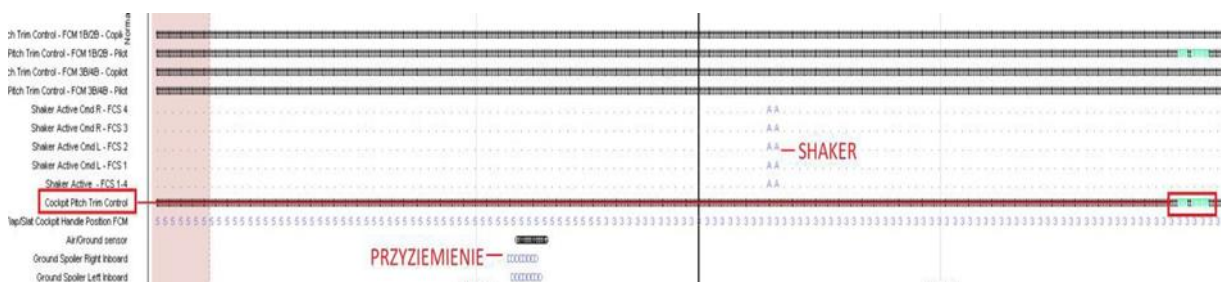
Fig. 8. Usage of pitch trim. Source: PLL LOT's Special Report of the EMB Fleet, page 10.

An analysis of the recorded data shows that the crew used the pitch trim only after initiating the Go-Around at the altitude of 3,000 ft. This is illustrated in the figure (Fig. 8). In the diagram bottom right corner, the green entry in red framing indicates the pitch trim activation.

Failure to change the pitch trim' setting in combination with the change in the aircraft configuration and increased engine thrust created conditions favourable for the increase in the aircraft positive pitch angle.

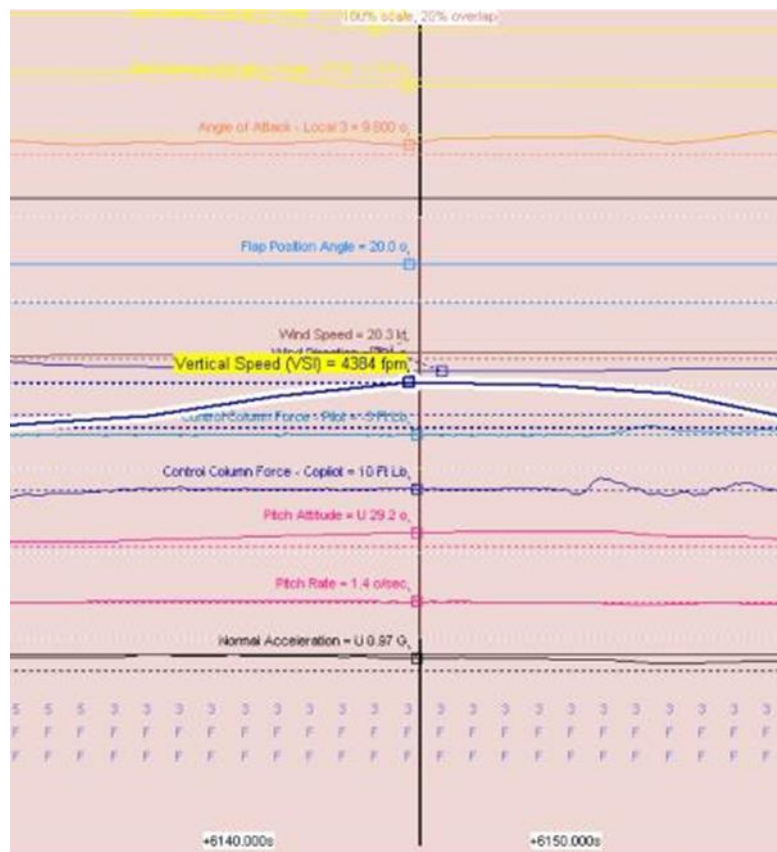
Fig. 11. Aerobytes screenshot. Source: PLL LOT's Special Report of the EMB Fleet, page 3.

The crew’s lack of reaction to the increasing positive pitch angle caused the aircraft to lose speed rapidly. The correct positive pitch angle during the initial Go-Around phase should be 8°. The quickly changing flight conditions made the PF, who had low experience, incapable of controlling the aircraft, which led to reaching the positive pitch angle of 32.2° and the vertical speed of 4,384 ft/min. This is illustrated in the plot below (Fig. 11), which is an excerpt from the objective flight control analysis in the Aerobytes system (value highlighted in yellow).

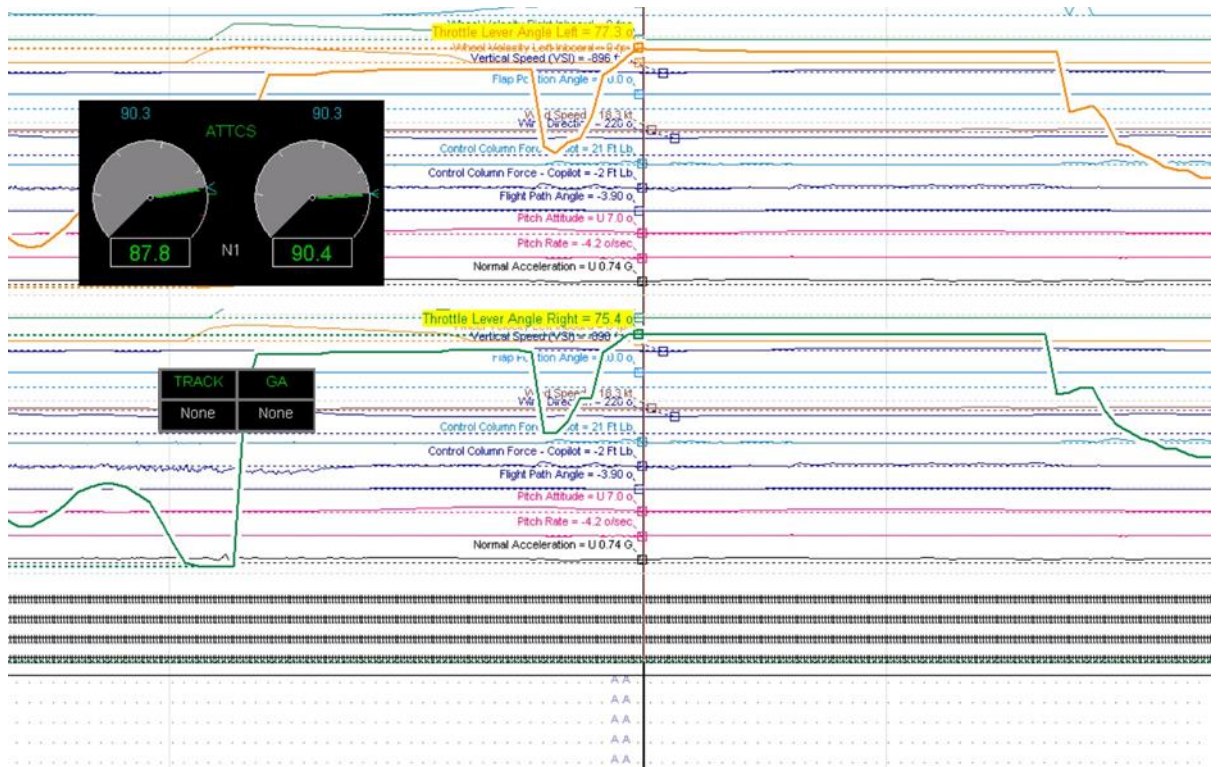
Fig. 14. Special Report of the EMB Fleet, page 12. Source: PLL LOT.

The analysis of the objective flight data monitoring showed that during the “Stall Recovery” procedure, the crew used the engine thrust necessary to carry out the “Go-Around” procedure. The crew set 75° TLA for engine #1 and 77° TLA for engine #2 accordingly, which correspond to N1: 87.1% for engine #1 and N1: 90.4% for engine #2 (diagram below in Fig. 10, which shows the thrust lever position in degrees, highlighted in yellow, and the cockpit screenshot: N1 in %). According to the aforementioned procedure, the pilots should use both engines' full thrust (MAX) during this manoeuvre (marked in red frame in Fig.13).

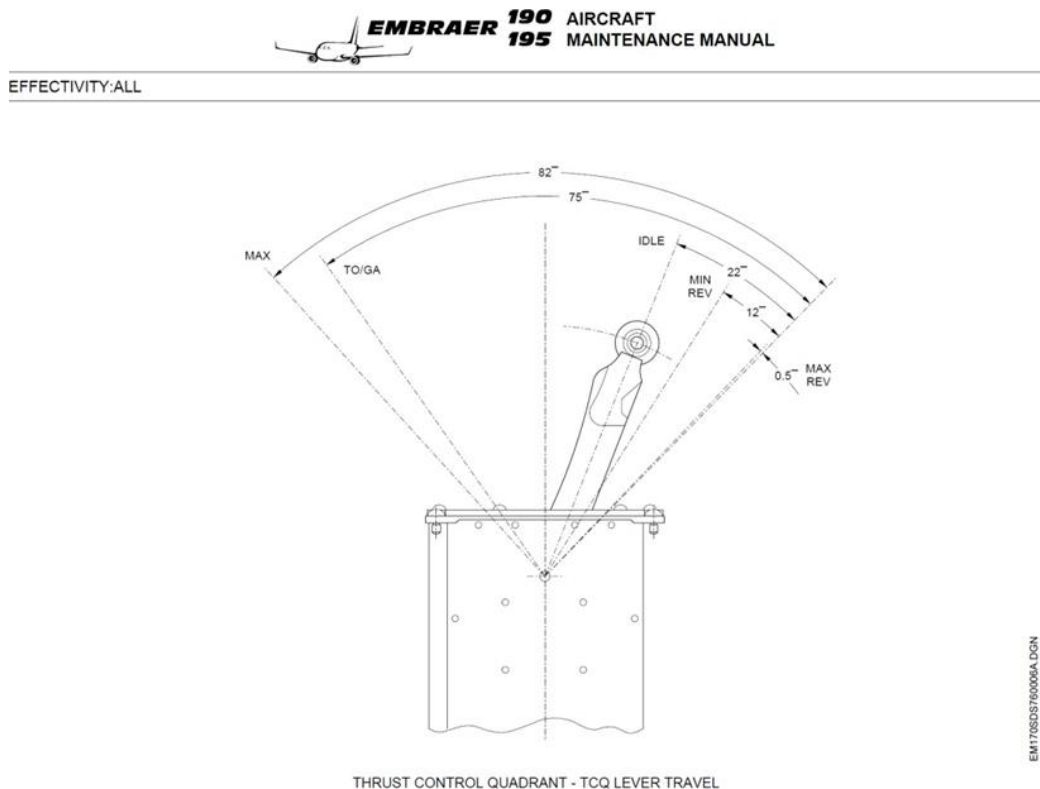
Fig. 15. Special Report of the EMB Fleet, page 13. Reprint from: Aircraft Maintenance Manual. Source: PLL LOT.

To illustrate this fully, Fig. 15 shows the thrust lever positions scaled up according to the setting angle.
