FINAL REPORT

State Commission on Aircraft Accidents Investigation (PKBWL)

OCCURRENCE NO – 2021/1037

AIRCRAFT – Tecnam Astore, I-C326

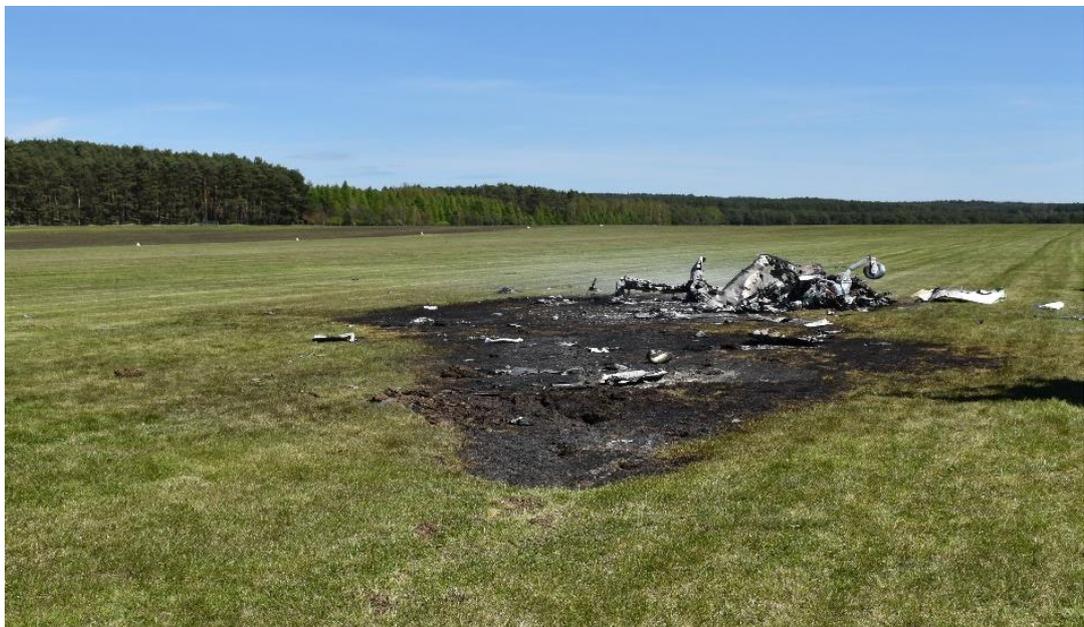
The airplane was destroyed as a result of the collision with the ground and fire. A major part of the airframe structure burned down (Fig. 2), while the engine was damaged to a much lesser extent.

Fig. 2 Wreckage at the place of collision with the ground [source: PKBWL]

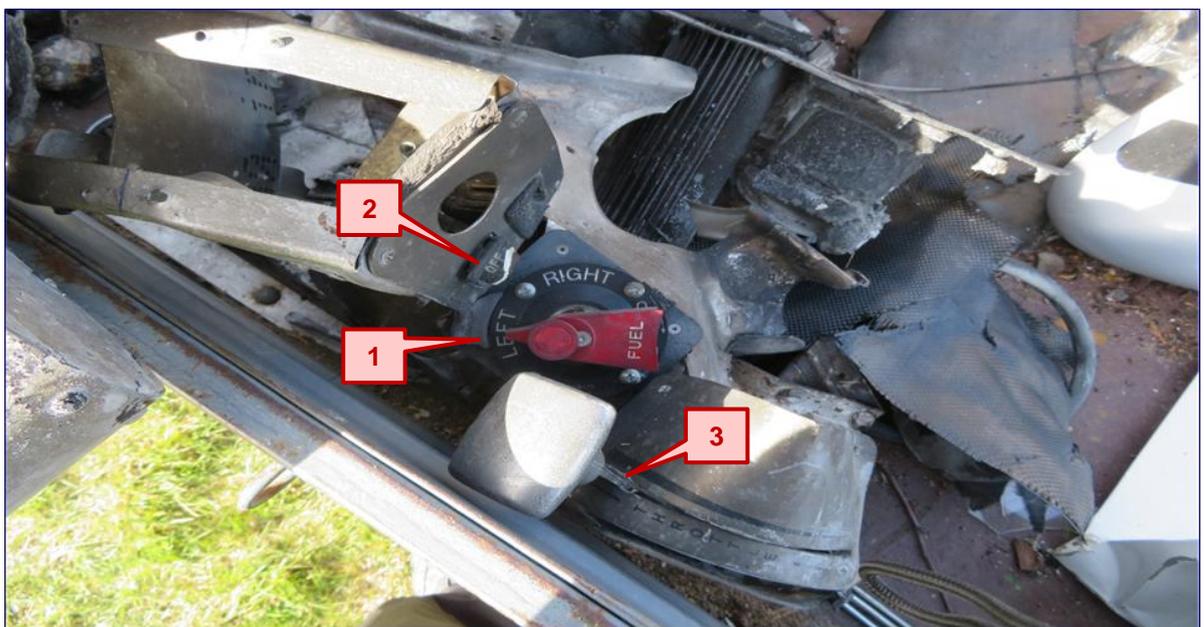
Fig. 6 Settings of: fuel valve (1), electric fuel pump switch (2), throttle lever (3) [source: PKBWL analysis].

During the examination of the elements from the airplane cabin found at the accident site, PKBWL determined the position of the following elements: fuel valve (left tank), electric fuel pump switch (off), throttle control lever (in the maximum rotation position). The propeller blades (wooden-composite wrapped) were broken off due to the collision with the ground and have been found at the scene.

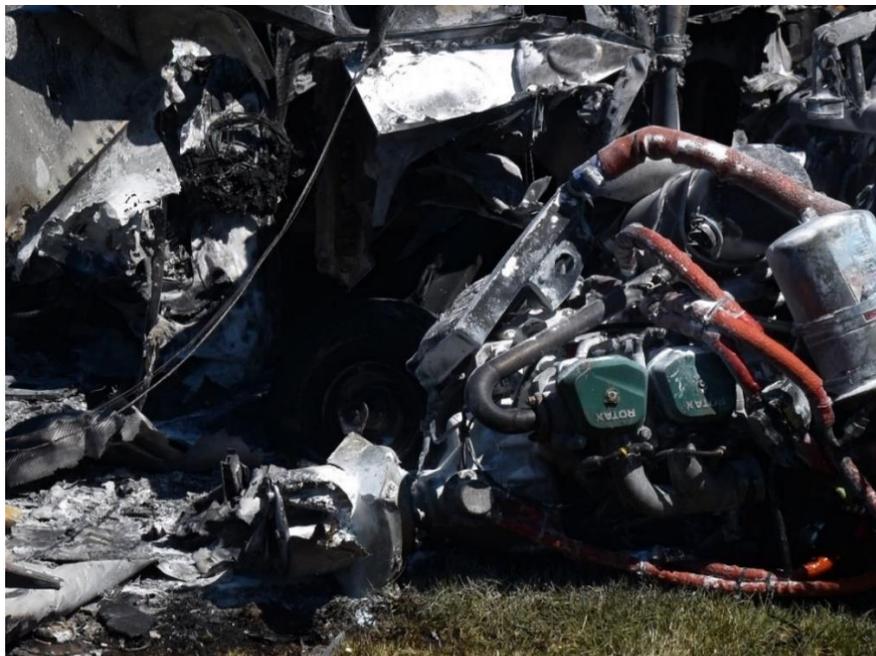
During the visual inspection of the accident site on 9 May and 13 May 2021, it was determined that parts of the engine and its components sustained numerous mechanical damages as a result of the collision, whereas the electrical wires and elements of the ignition system were destroyed due to the fire. The main part of the engine, visible from outside, was only slightly damaged.

Fig. 7 Engine view [source: PKBWL].

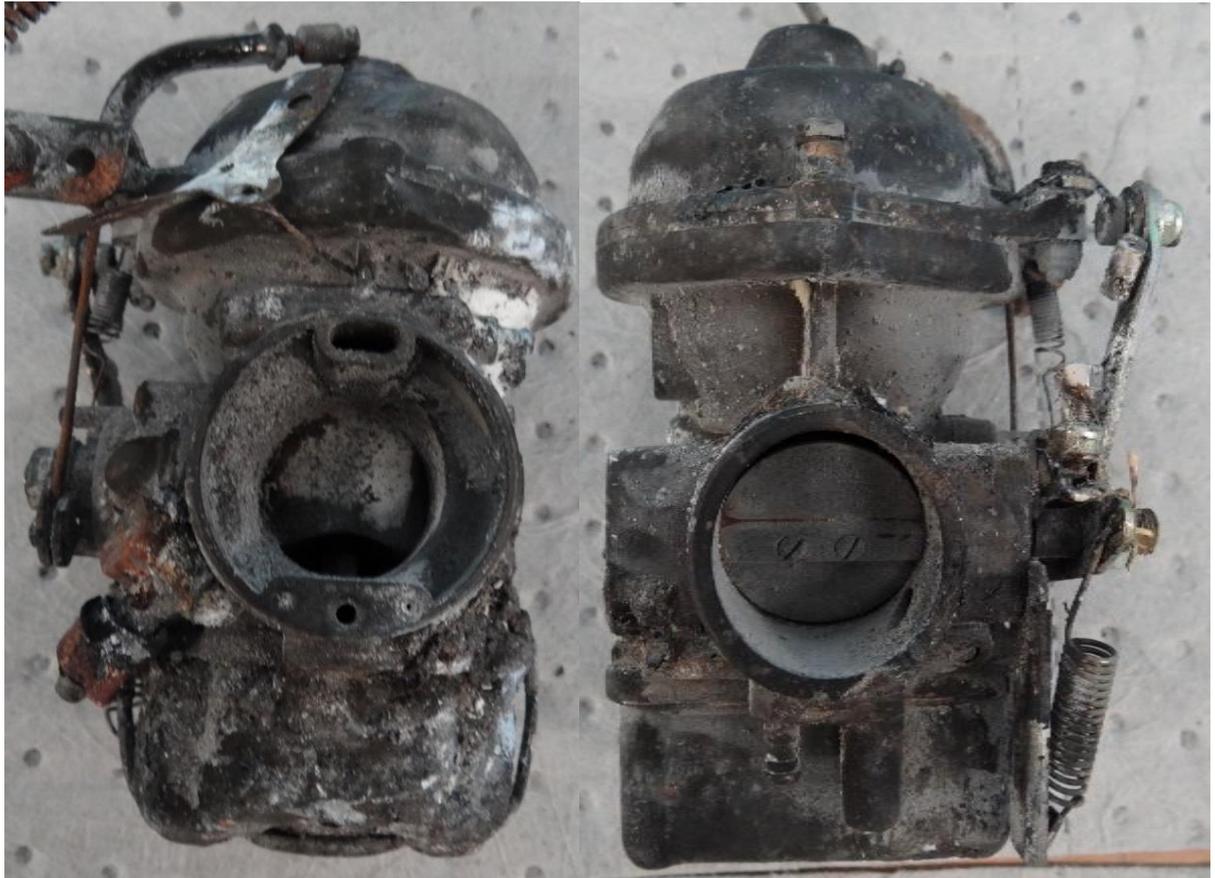
The carburetor was ripped out of the engine and was hanging on one cable from the throttle control. The carburetor showed damage that occurred primarily due to the fire (Fig. 8).

Fig. 8 View of the left carburetor from the throttle and air intake side [source: Institute of Aviation expert opinion].

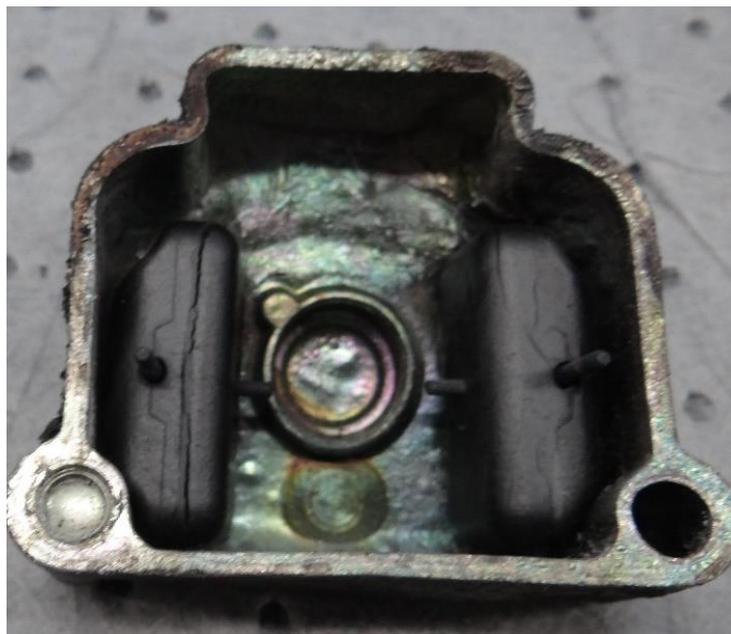
Damage to the floats caused by heat exposure was detected after removing the float bowl cover (Fig. 9). The floats have been weighed; their total weight was 5,750 g (according to MM < 7 g).

Fig. 9 View of the interior of the float chamber with damaged floats [source: Institute of Aviation expert opinion].

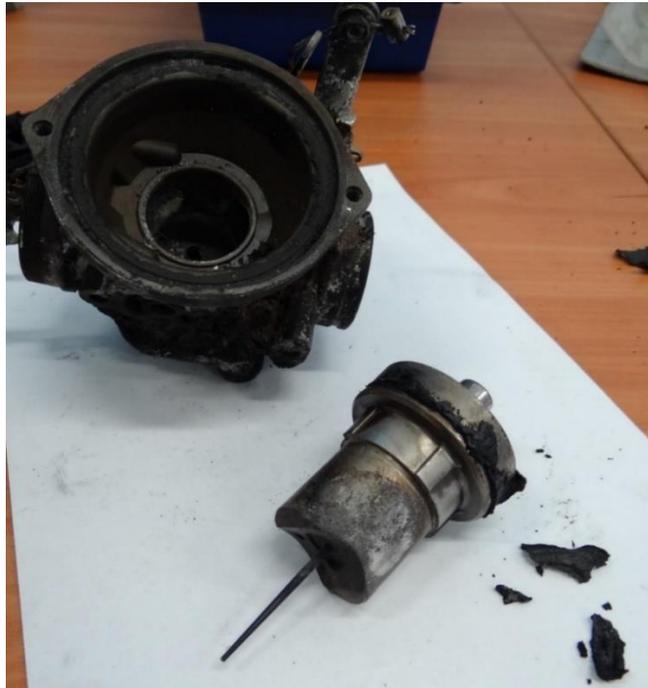
As a result of heat exposure, the control diaphragm of the carburetor piston was burned (Fig. 10); the intake valve control lever was not rotating.

Fig. 10 View of carburetor body and carburetor piston with debris of burnt diaphragm [source: Institute of Aviation expert report].

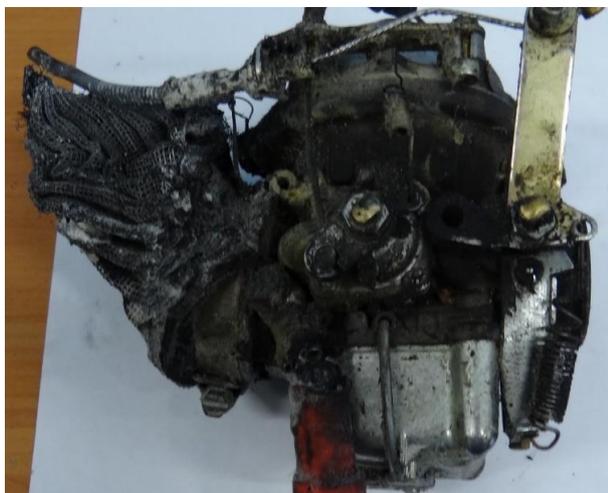
The carburetor had no visible signs of heat exposure. The floats were not damaged and their total weight was 6.2641 g.

All components of that carburetor were functional and their interaction did not raise any reservations (Fig. 11).

Fig. 11 View of the "right" carburetor from the control side [source: Institute of Aviation expert opinion].

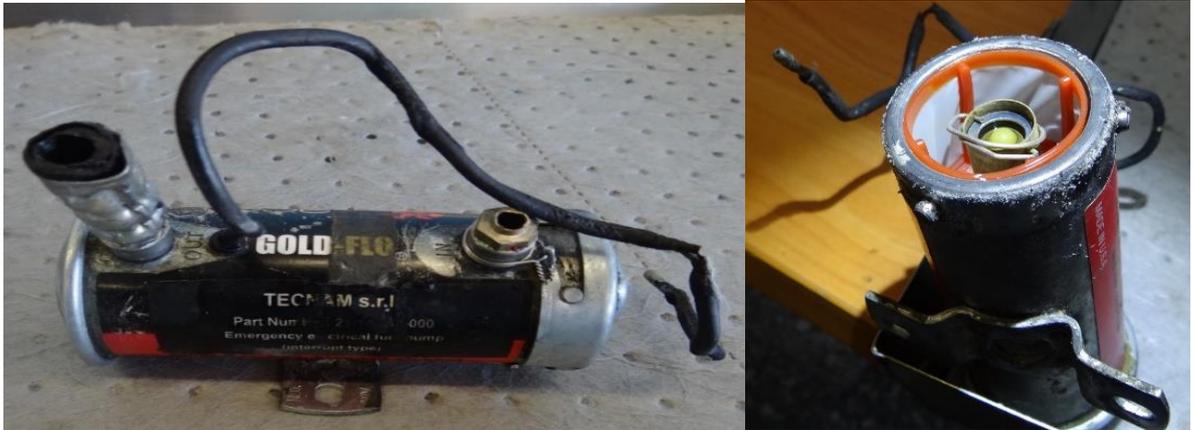
An operation test of the pump was performed (Fig. 12). One end of a hose was submerged in the aviation fuel tank, while the other was connected to the intake spigot. When the pump was powered with 12 V direct current, it started operating and pumping the fuel in a continuous manner.

Fig. 12 View of electric fuel pump [source: Institute of Aviation expert opinion]

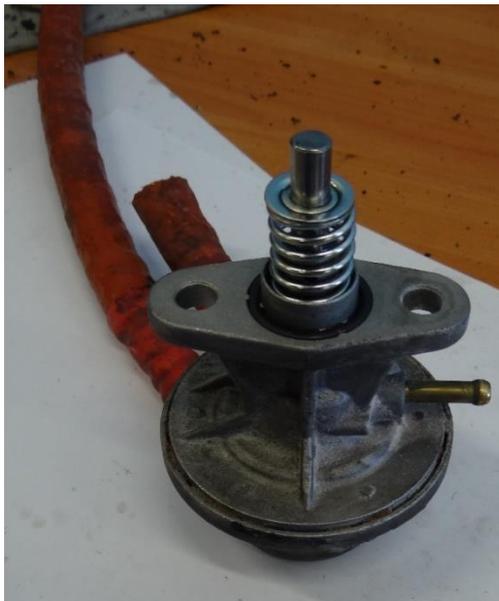
Fig. 13 General view of the mechanical fuel pump [source: Institute of Aviation expert opinion]]

An operation test of the mechanical fuel pump was performed (Fig. 13). When the suction hose was immersed in fuel and the drive pin was pressed, fuel was flowing out through the pressure line without any external leakage

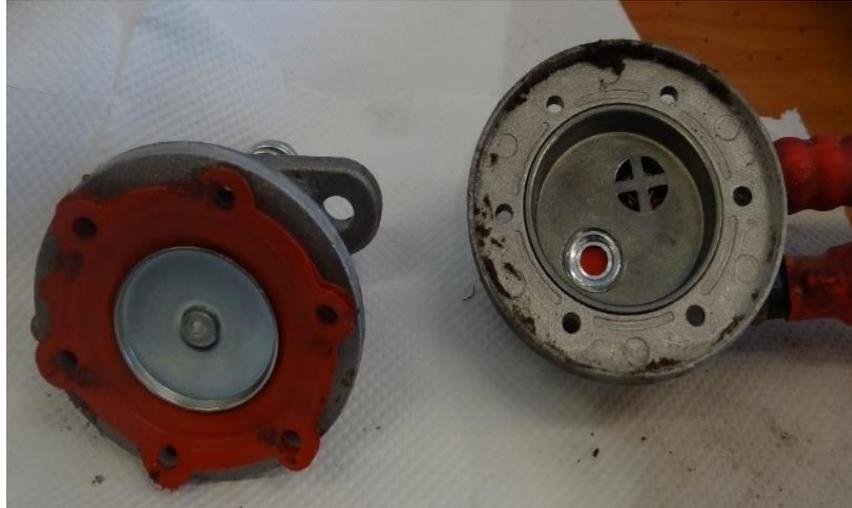
Fig. 14 View of mechanical fuel pump after disassembly [source: Institute of Aviation expert opinion]]
After disassembly, no damage to the diaphragm or valves was found (Fig. 14).

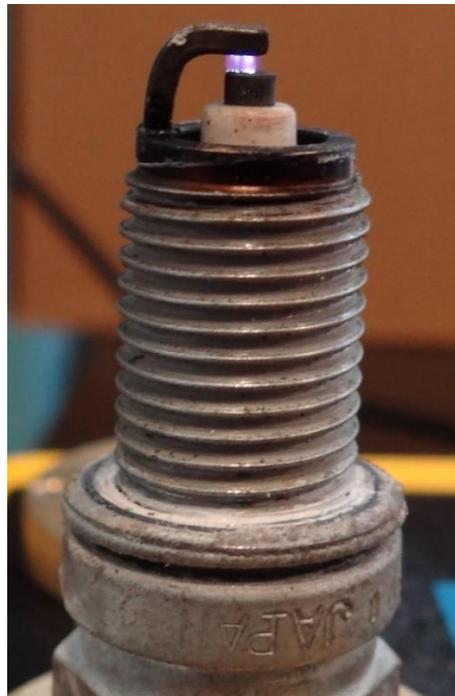
Fig. 15 View of the ignition spark of the lower spark plug in cylinder no. 3 [source: Institute of Aviation expert opinion].

In addition, the plugs were tested with a SPT101 type tester. During the test, a clear electric arc was observed between the electrodes. Fig. 15 shows a plug from cylinder

There was no carbon deposit on the plugs. Only a velvety black residue on the face (visible in the above photo) was found.

Despite the fact that the spark plugs were operative, the velvety-black color of the residue is a typical sign of an engine running on a rich fuel mixture. The combustion rate of this type of mixture is very low which could prolong the time of the combustion that could have lasted even during the exhaust stroke. That could have caused the exhaust backfire and black smoke coming out of the exhaust pipe visible in the footage, as well as a decrease in the engine power during climb.

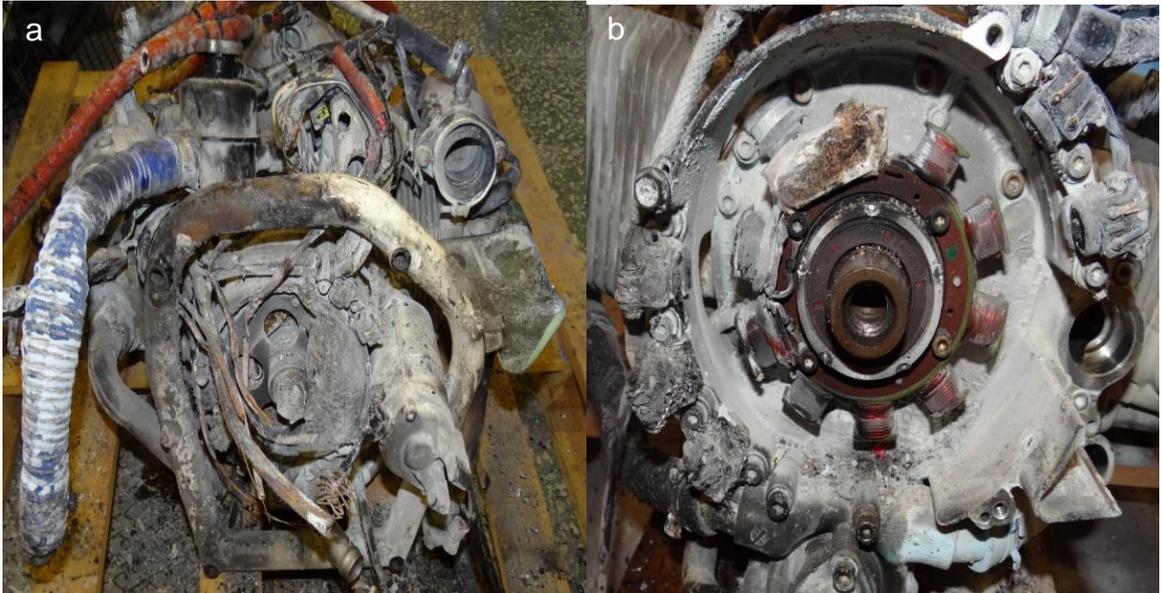
The electrical wires were burned to a considerable extent (Fig. 16 a).

Fig. 16 View of the electrical system (a) and ignition coils (b) [source: Institute of Aviation expert opinion].

The ignition system was damaged to a much lesser extent than the electrical system (Fig. 16 b).

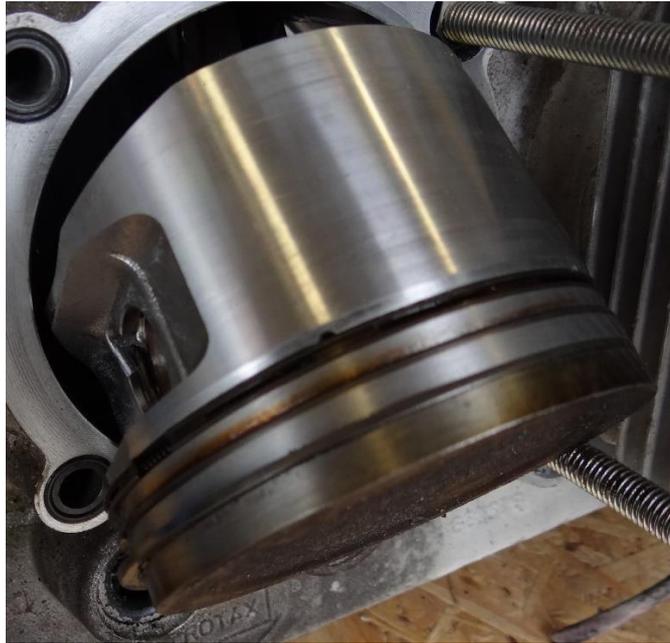
Fig. 17 View of the piston of cylinder no. 2 [source: Institute of Aviation expert opinion].

No damage was found on the piston and piston rings (Fig. 17). Pistons and rings in the other cylinders were found in a similar mechanical condition.

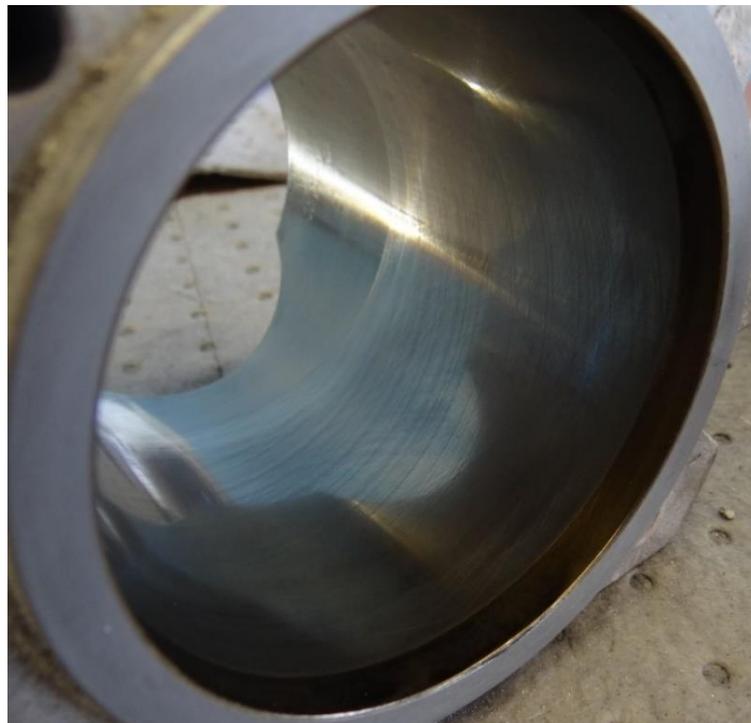
Fig. 18 View of cylinder no. 2 [source: Institute of Aviation expert opinion].

No scratches, signs of overheating or other damage were detected on the inner surface of cylinder no. 2. However, clear traces of internal treatment of the cylinder surface using the honing method were visible. The mechanical condition of the other cylinders was comparable to that shown in Fig. 18.

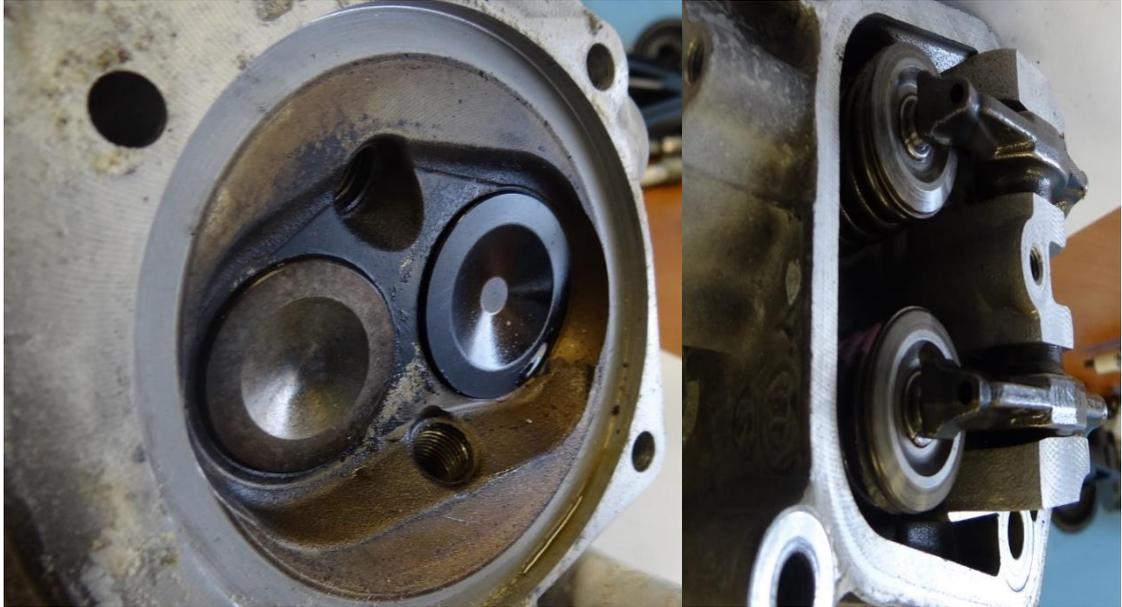
Fig. 19 Cylinder head no. 4 with visible intake and exhaust valves and engine timing gear components [source: Institute of Aviation expert opinion].

The intake and exhaust valves as well as timing gear components of all cylinders were found intact (Fig. 19).

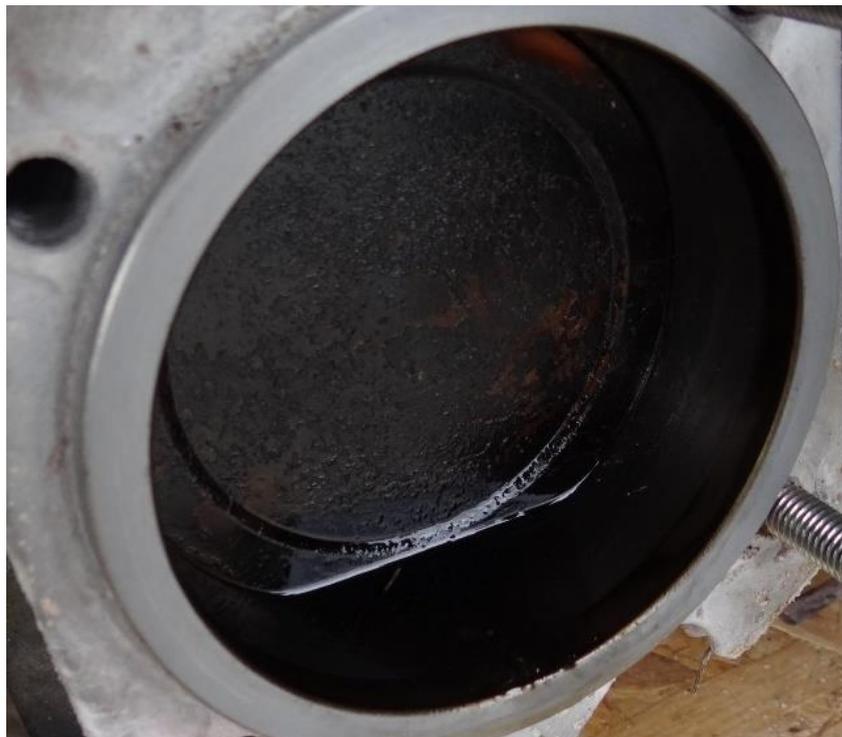
Fig. 20 View of cylinder and piston crown of cylinder no. 2 [source: Institute of Aviation expert opinion].

Large quantity of lubrication oil was visible in cylinder no. 2 (Fig. 20). A similar quantity of oil was also found in cylinder no. 4 located on the same side of the engine. Oil penetrated into those cylinders from the crankcase during transportation and storing the engine for several months after the accident.

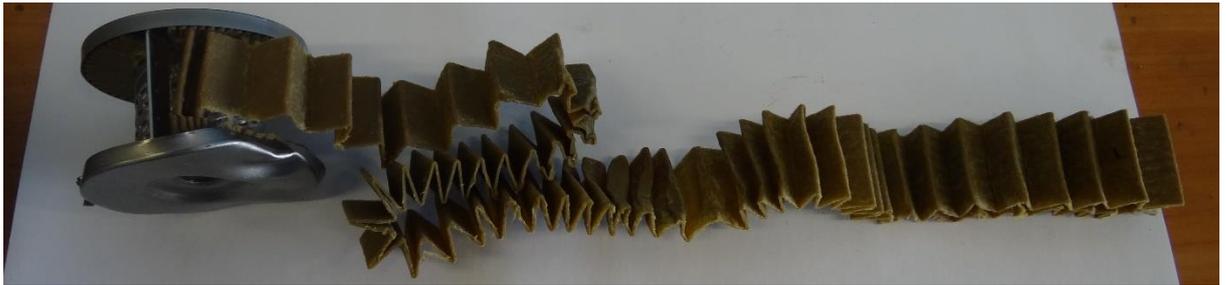
After cutting the filter cartridge out from the oil filter, its condition was inspected; no filings or other pollution was detected (Fig. 21).

Fig. 21 View of the oil filter cartridge [source: Institute of Aviation expert opinion].

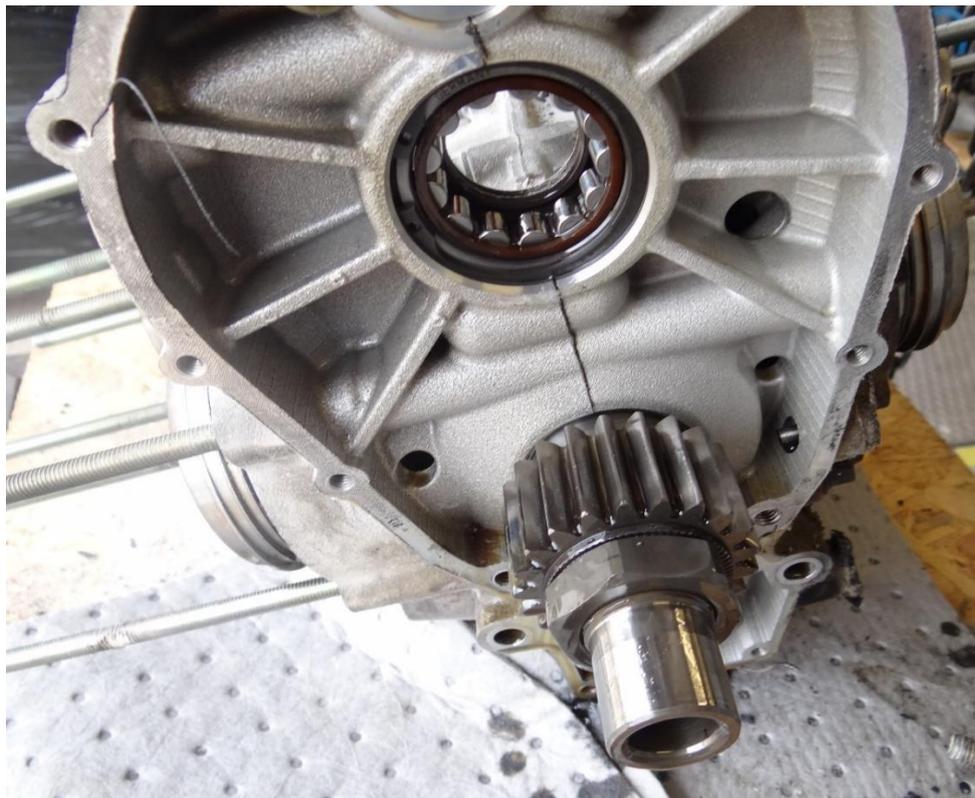
Fig. 22 View of the reduction gear [source: Institute of Aviation expert opinion].

Inspection of the disassembled gear parts revealed no damage to the body, shafts, gears or bearings. (Fig. 22).

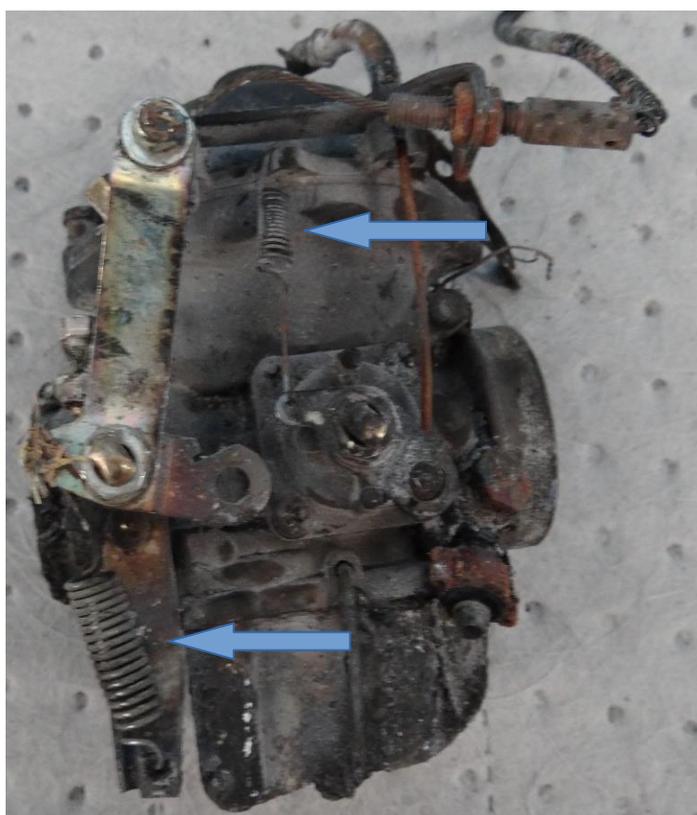
The rich mixture may have been caused by opened choke valve. However, as a result of the destruction of the airplane structure and broken control cables of the choke valve, the springs mounted on the carburetors caused the valve levers to return to the initial (closed) position (Fig. 32). The throttle levers were in different positions (left carburetor - slightly open, right carburetor - more open). The choke valve lever, which should have been located in the cockpit, was not found, it has probably burned down. As a result, it was impossible to determine the reason and the method of enriching the mixture.

Fig. 32 Carburetor view from the choke valve control lever side [source: PKBWL analysis].
