# FINAL REPORT

ACCIDENT 2021/3056

OCCURRENCE NO – 2021/3056

AIRCRAFT – Airplane, Diamond DA 42, SP-TRL

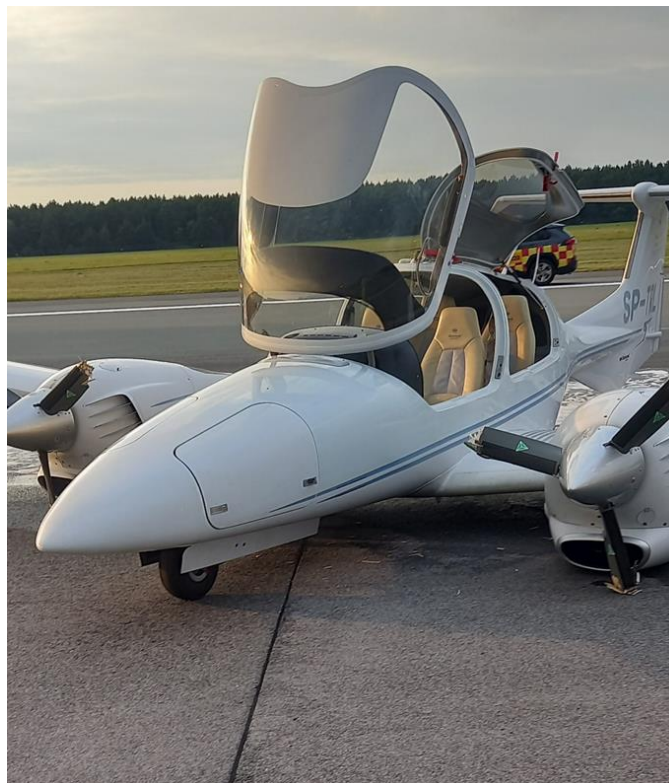
As part of the exercise, 9 take-offs and landings were performed uneventfully. After completing the 9th flight, the crew stopped the plane on the runway and, after a short break, took-off again. During the climb, at an altitude of approximately 500 ft<sup>1</sup>, the pilot-instructor reduced the power of both engines to idle, simulating the powerplant failure. In order to maintain the airspeed, the flight crew started descending with the intention of straight-in landing<sup>2</sup>. The descent was performed with a significant nose down pitch, which caused the plane touchdown with high speed at around 16:05 hrs UTC. As a result the three-wheel landing gear and both three-blade propellers were destroyed and the fuselage was substantially damaged.

Fig.1. SP-TRL airplane at EMPO after hard landing on RWY26 [source: PKBWL]<sup>3</sup>

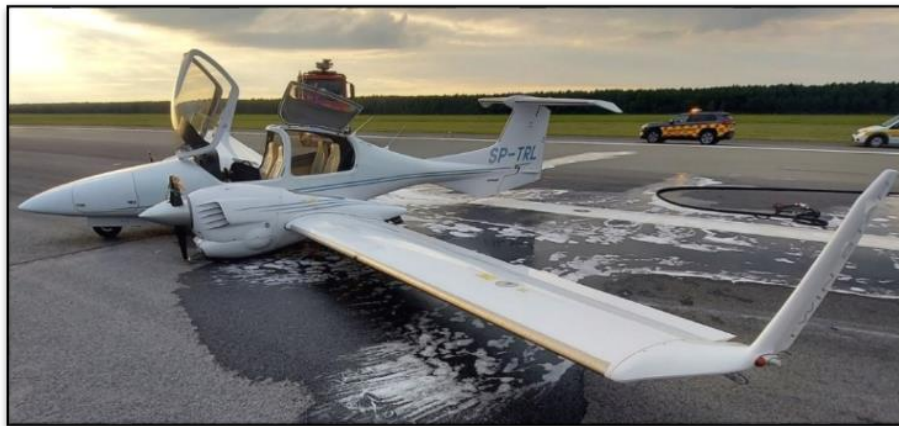
The plane was substantially damaged. The landing gear of the aircraft was damaged, the main landing gear struts were broken and the wheels detached from their construction. The nose landing gear strut and its wheel were pressed into the nose landing gear well.

Fig.2. SP-TRL airplane at EPPO after the accident

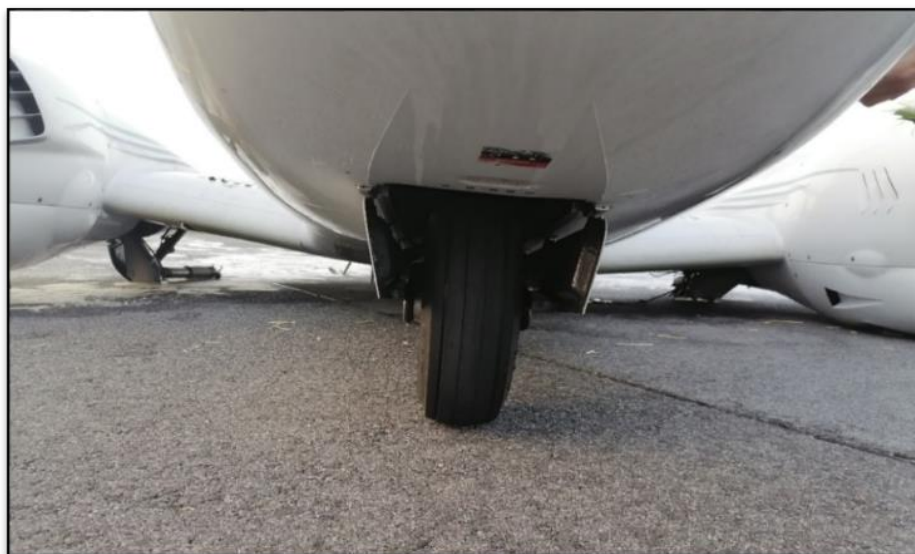
Fig.3. Nose landing gear damaged

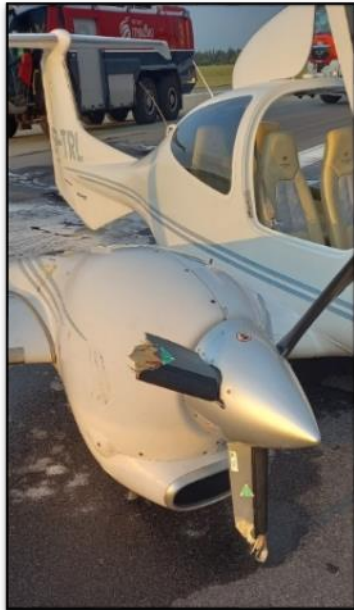
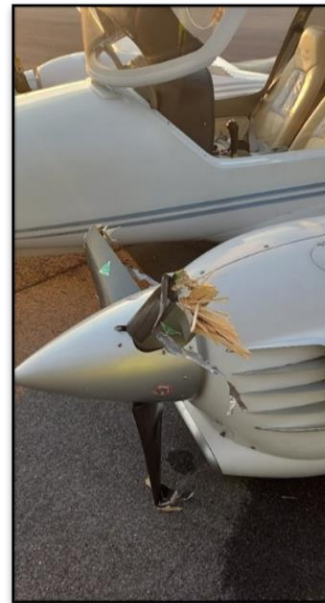
As a result of the destruction of the main landing gear, the plane rested on the lower part of the fuselage, which caused the rotating blades to collide with the runway surface. Their wooden structure was destroyed. The lower part of the fuselage was also damaged.

Fig. 4 and 5. SP-TRL aircraft with destroyed propellers blades of both engines.

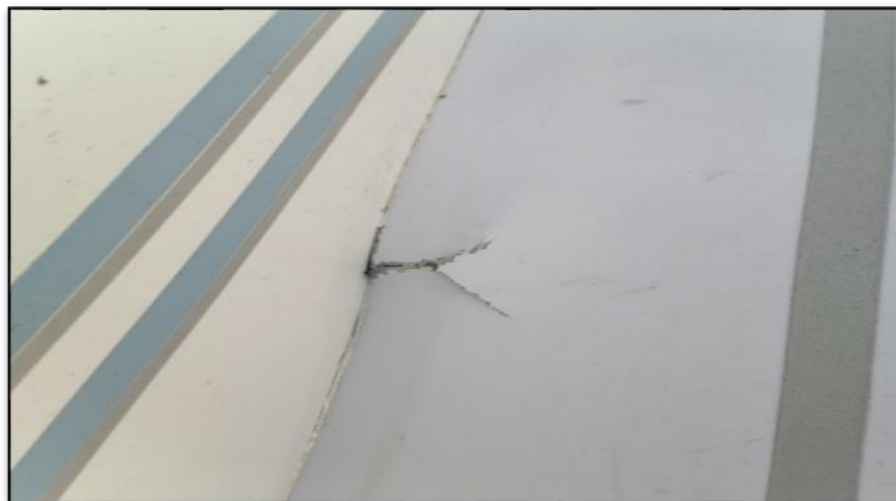
The wings did not detach from the fuselage, but were slightly damaged in many places. Cracks and delamination of the wings structures occurred especially at their roots.

Fig.6. Damaged airframe in the wing connection area.

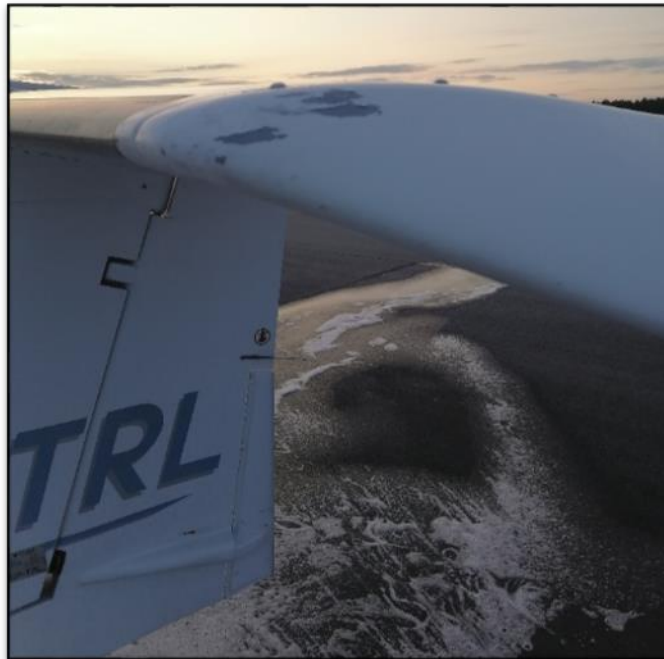
In the empennage area the horizontal stabilizer leading edge was damaged.

Fig.7. Damaged empennage

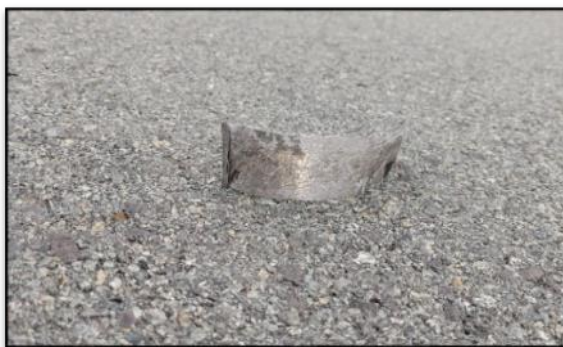
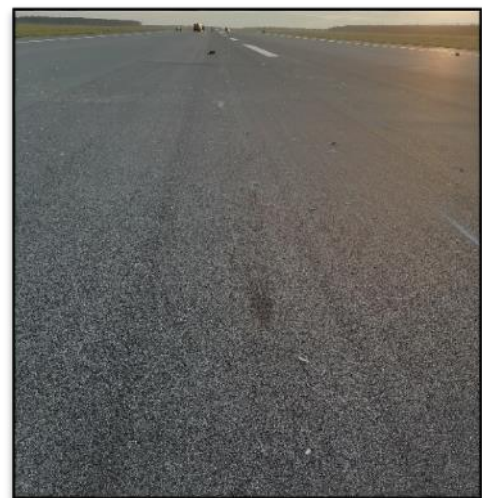
Numerous parts (sleeves, bolts, covering elements), mainly from the damaged nose landing gear and damaged fuselage and wing structures, were found scattered near the wreckage.

Fig.8 and 9. SP-TRL airplane framgents/elements on the runway

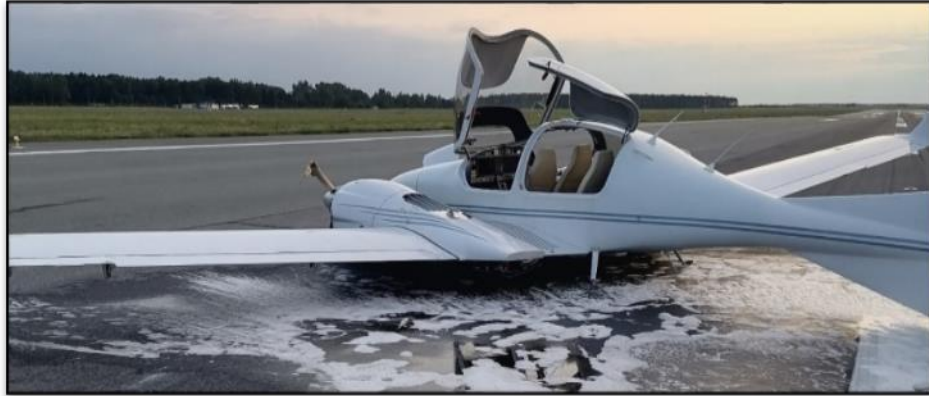
On 19 August 2021, during the accident site inspection, PKBWL found that after the collision with the runway surface, the plane moved to a distance of 268 meters from the touchdown place. The damaged parts of airframe, engine and landing gear were scattered along the length of 336 meters. The plane touched down in the middle of the RWY 26 along its centre line and came to rest with a deviation of about 45° from the runway centre line towards the airport terminal (Fig. 10).

Fig. 10 Accident airplane after it came to rest and was left by the crew [source: PKBWL]

The landing gear, propeller blades and the left engine were destroyed during aircraft movement on the RWY 26 surface.
