INCIDENT 2021/845

OCCURRENCE NO – 2021/845

AIRCRAFT – Airplane, Diamond DA20-C1, SP-NDI

DATE AND PLACE OF OCCURENCE – 21 April 2021, EPDE

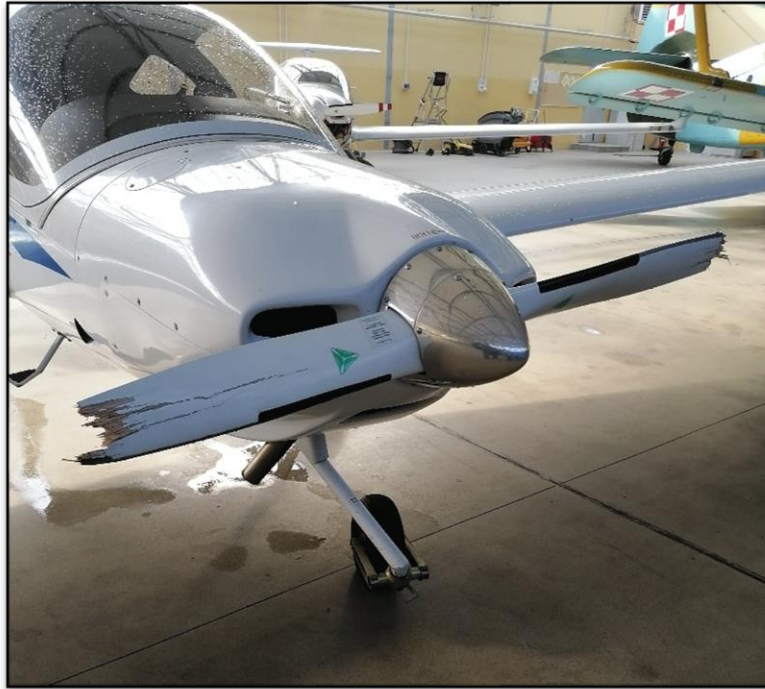
As a result of the occurrence the landing gear strut and damper and the aircraft propeller were damaged.

Fig. 1. Damaged propeller and nose landing gear [source: PKBWL]

a bounce. After the first bounce, the student-pilot reacted by moving the control stick forward, which led to consecutive bounces.

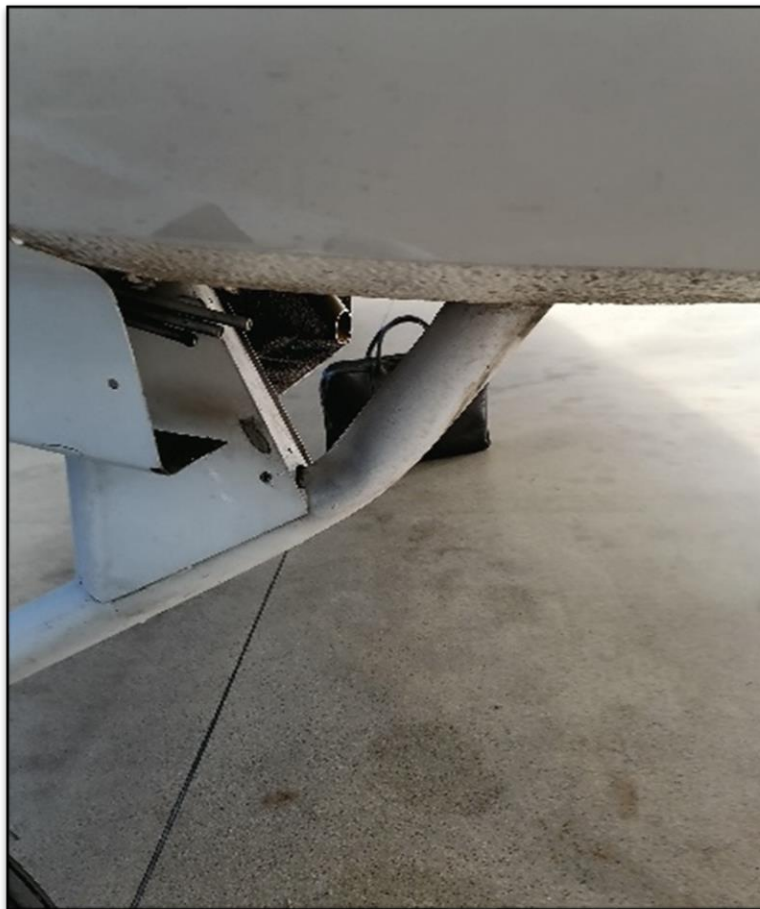
Fig. 2. Damaged nose landing gear [source: PKBWL]
