STATE COMMISSION ON AIRCRAFT ACCIDENT INVESTIGATION

FINAL REPORT

OCCURRENCE NO. – 2022/1027

AIRCRAFT – Fly Penguin 2.0 (FOX), SP-STYL

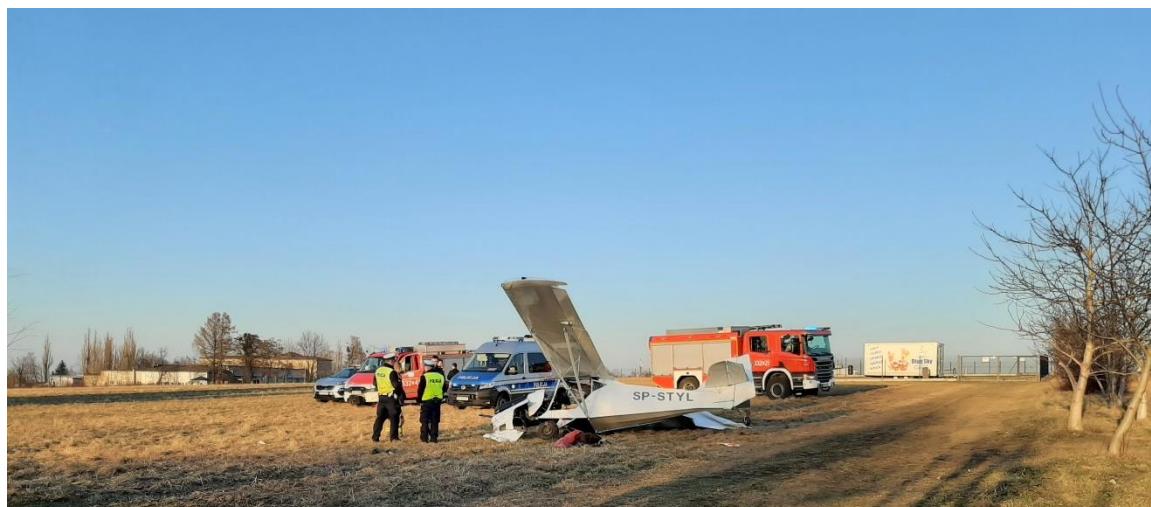
A foreground of the EPBA aerodrome, west side, approx. 90 m from the aerodrome fence (Fig. 1 & Fig. 2).

Fig. 2. Crash scene. In the background the airfield fence to be seen [source: PKBWL]

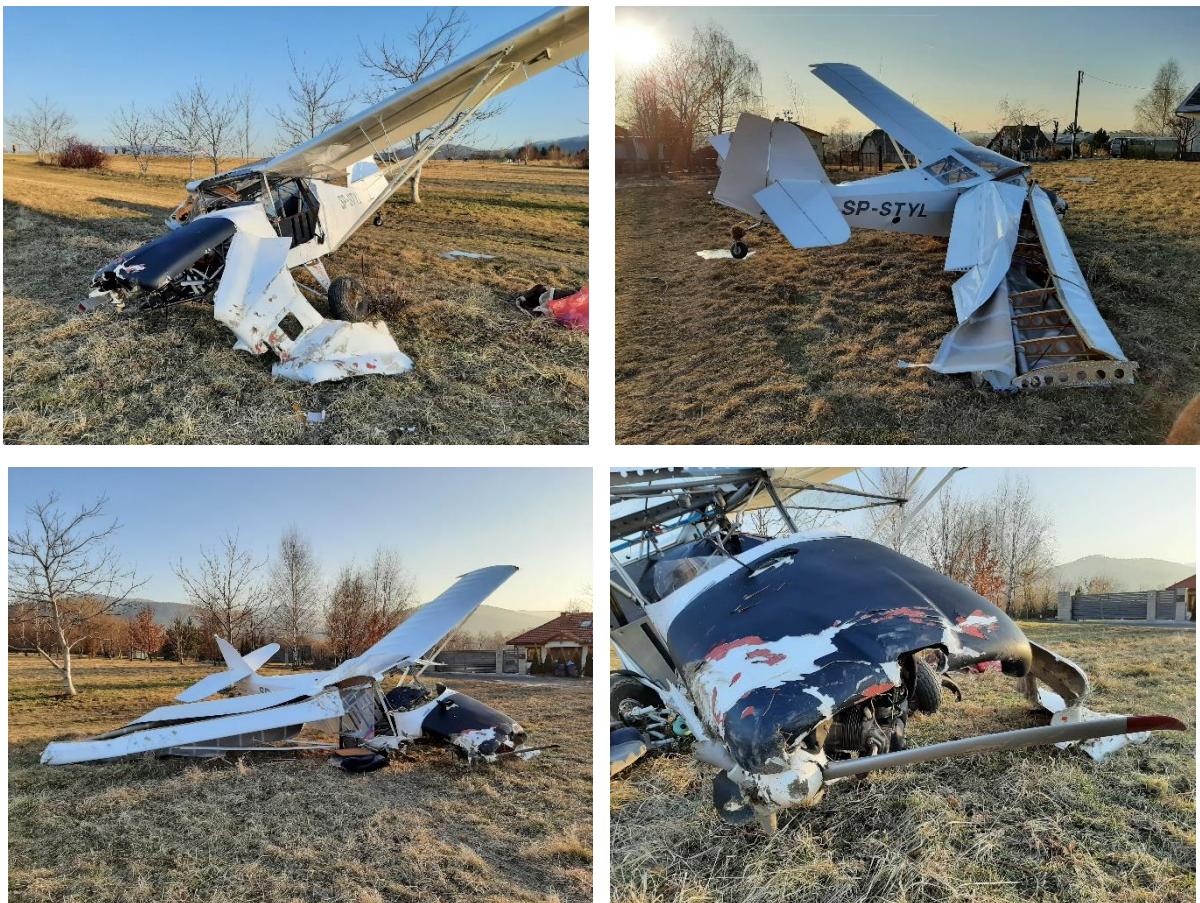
The aircraft was destroyed (Fig. 4). Only the left wing and the part of the fuselage behind the cockpit preserved their structural integrity. The 3-blade propeller, the engine with its mount, the firewall and, partially, the instrument panel with its equipment as well as some controls in the cockpit were destroyed. The kinematic continuity of all controls was not broken, however some plastic deformations on controls supports and the right aileron and flap drives did not allow for their free movement.

Fig. 4. Damage sustained by aircraft [source: SCAA]

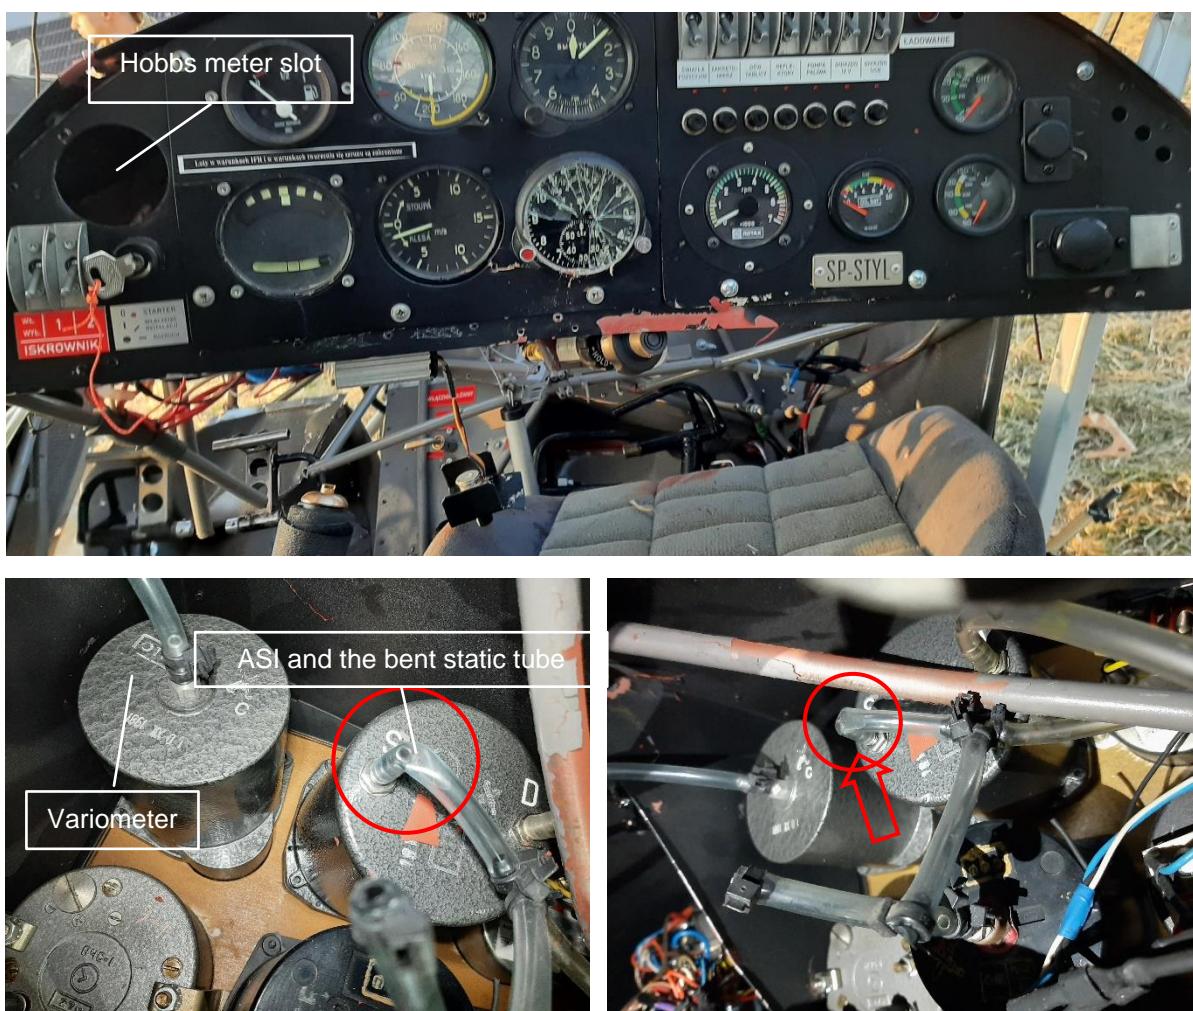
The static pressure tubes were broken in several places and the plastic connectors were also found cracked. It was found that the polypropylene transparent tube connected to the static port („S” of the ASI), was bent of about up to 90 deg. (see Fig. 5), just at the ASI port. The character of this failure (among others, lack of resilience of the affected area and its whitening) shows that the bent had occurred before the accident, probably during instrument panel installation in the cockpit. Pilot „K” assured that neither he nor his colleague checked nor rebuild the static system. The instrument panel has not been reinstalled since aircraft purchase. The bent of the static pressure tube could have had an adverse influence on the quality of the ASI indications. The aircraft with such a malfunction was operated by the previous owner.

Fig. 5. Avionics of SP-STYL a/c and static pressure tube connected to ASI [source: SCAAII]

This was impossible to confirm whether the instrument static pressure system was leakproof inflight. It is irrelevant to the instruments like altimeter or not compensated

The ASI compares the total pressure with the static one, and the mechanical system inside the instrument case acts on the metal diaphragm moving a pointer relative to the ASI scale. The ASI measures the airspeed relative to ambient air and it is a function of dynamic pressure. Bending of any pressure tube disturbs the instrument response and – in consequence – provide improper speed readings.

The ASI readings were higher than the real airspeed and an estimated error could have been even $20\div30$ kph.

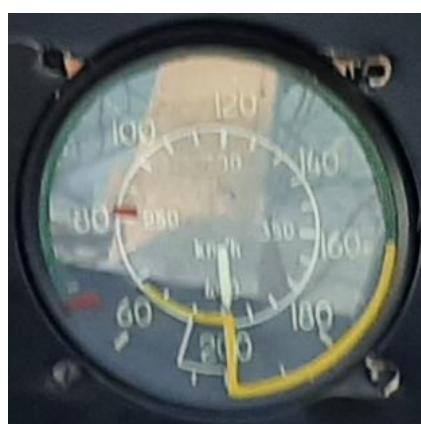
It should be noted, the ASI has not been calibrated for this type of the aircraft. The errors for the ports on the airframe have not been defined and the port positioning were most probably random.

It was found that the ASI markings did not correspond even roughly to the template presented in the Flight Manual with regard to the real operation range (Fig. 6).

Fig. 6. Airspeed indicator (ASI) installed on SP-STYL aircraft (green arc up to $V = 160$ kph., yellow arc up to $V=230$ kph, red line at $V_{NE} \approx 250$ kph.) and the table of ASI marking as per Flight Manual
[source: SCAAI]

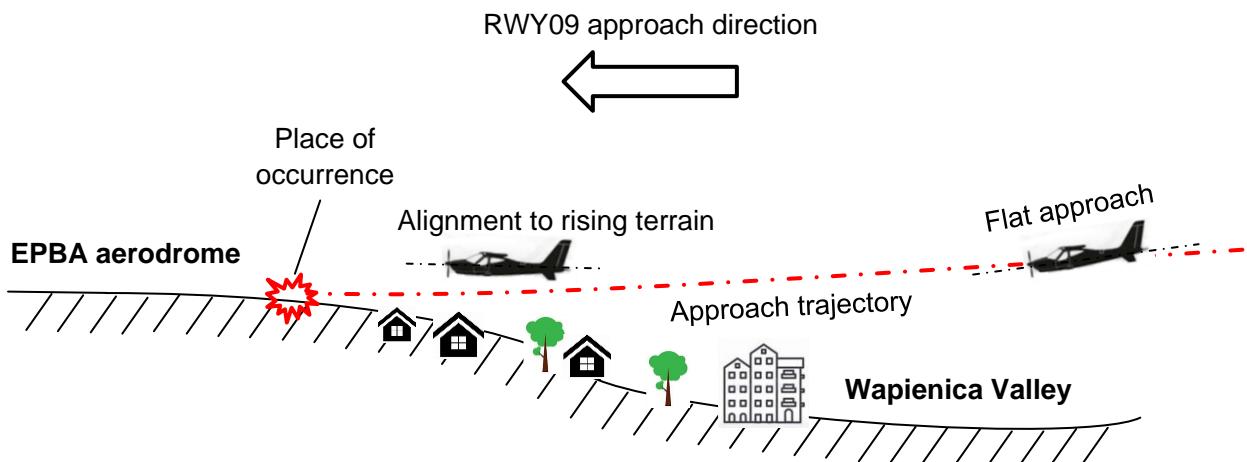
The pilot who was maintaining the approach speed of 90÷100 kph. according to ASI, actually flew much slower and close to the minimum aircraft speed, on the edge of a stall with flaps extended, i.e. v_{s0}. After the accident the flap handle was found on “take-off/landing” setting.

The EPBA aerodrome is located on the plateau, several dozen meters above the Wapienica valley. The aircraft was approaching from the west, over the rising terrain. This was possible that during a flat approach with constant engine power, the pilot intuitively and unwittingly was changing the trajectory, to be parallel to the rising terrain.

In consequence, the airspeed was dropping systematically (Fig. 7). Additionally, the extended flaps were reducing the airspeed.

Fig. 7. Approach of SP-STYL to RWY09 of EPBA aerodrome [source: PKBWL]
