# FINAL REPORT

OCCURRENCE NO. – 2022/1097

AIRCRAFT – Extra NG, SP-HMM

DATE AND PLACE OF OCCURRENCE – 18 March 2022, EPKP

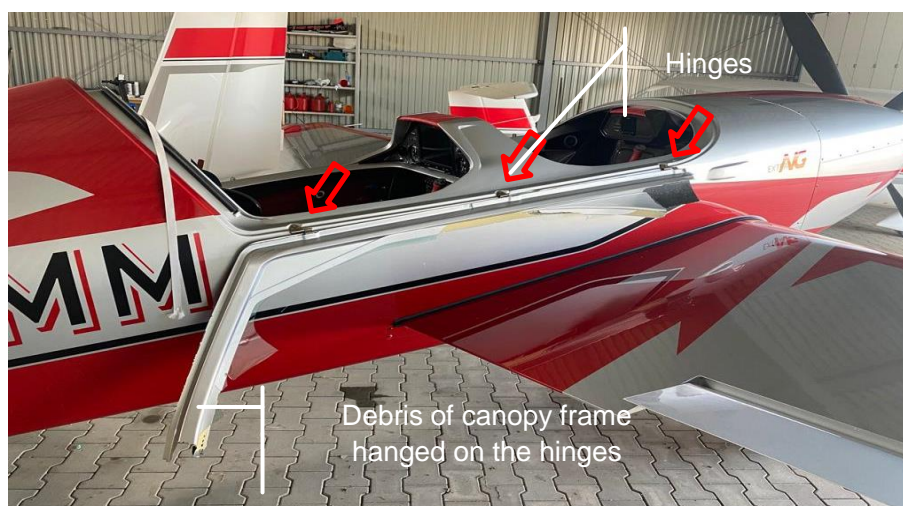
During the flight the canopy released from its locks on the portside of the fuselage, turned on hinges, hit the right upper wing skin and broke. A part of the frame remained on the starboard, some debris detached from the aircraft and fell on the ground. Due to collision with canopy debris, the vertical fin, rudder as well as right side of horizontal stabilizer sustained minor damage (dents, scratches, paint chips).

Fig. 2 Cockpit of the aircraft and a part of the broken canopy frame [source: SCAA]

The aircraft was sent to the manufacturer for repair.

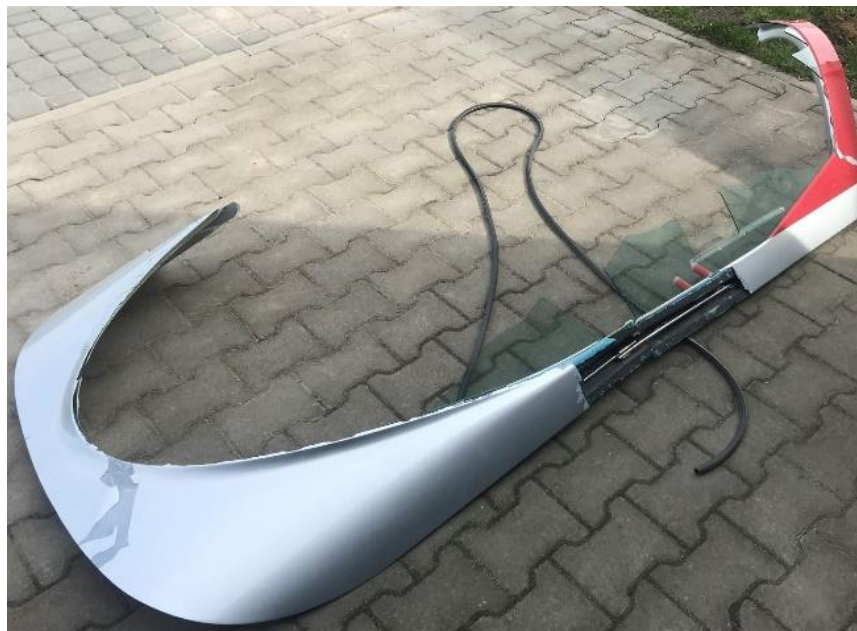
Most canopy parts was found in the airfield area (Fig. 3). They did not cause injuries to third parties or material losses.

Fig. 3 Piece of canopy frame found [source: SCAA]

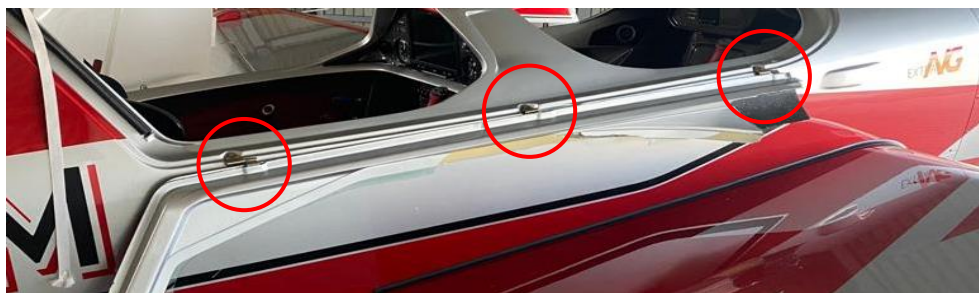
The Extra NG canopy is fixed on the three hinges located on the starboard and is opened in the right direction (Fig. 4).

Fig. 4 Location of canopy hinges on the aircraft starboard [źródło: PKBWL]

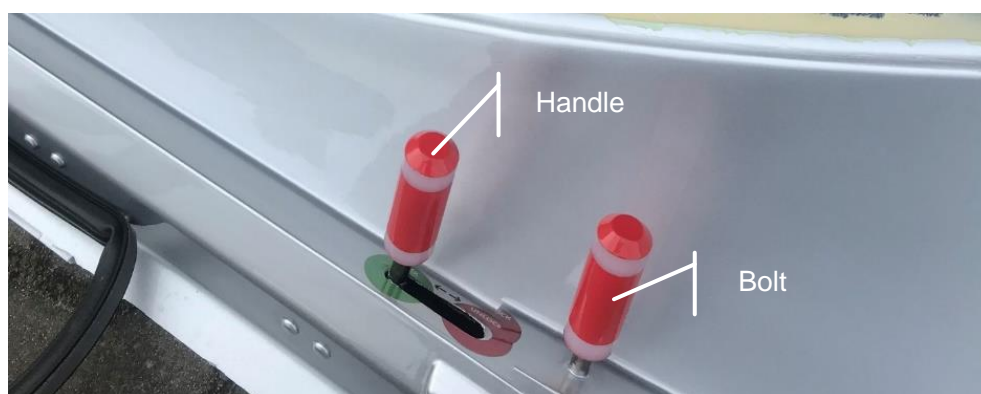
To lock the closed canopy, it is necessary to pull the sliding handle located on the left side of the pilot (Fig. 5). The handle is connected with two pawls getting in contact with appropriate fittings on the cockpit side and creating the locks. The mechanism works in unlocked/locked settings and has been equipped with a notch (dead point) activated after moving the handle to its locked position. Inside the cockpit, on the same pushrod, there are two handles available respectively from the rear and front seat. In flight, in case of unlocking (canopy jettisoning), the canopy moves automatically back on the hinge guides and detaches from an airplane.

Fig. 5 Canopy locking mechanism located at the passenger seat, on the left side (portside). The fixed bolt allows to move the handle in case of high force required [source: SCAA]

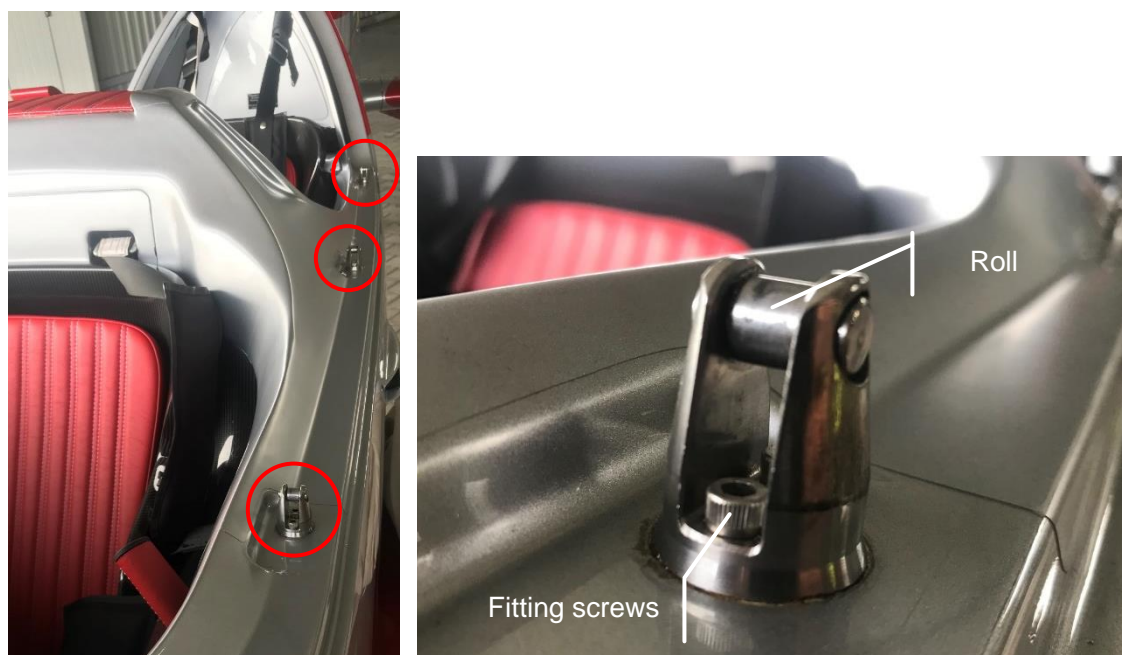
The visual inspection of fittings (Fig. 6) on the portside as well as corresponding pawls located on the same pushrod (Fig. 7) did not reveal their damage. Each fitting was screwed to the fuselage by two screws (Fig. 6). The screws of rear fitting were found loosened, causing that even if the pawl was tightly joined with its fitting, there was a clearance between the fitting and the portside. This clearance could have caused vibrations of the canopy.

Fig. 6 Fittings for pawls on the portside [source: SCAA]

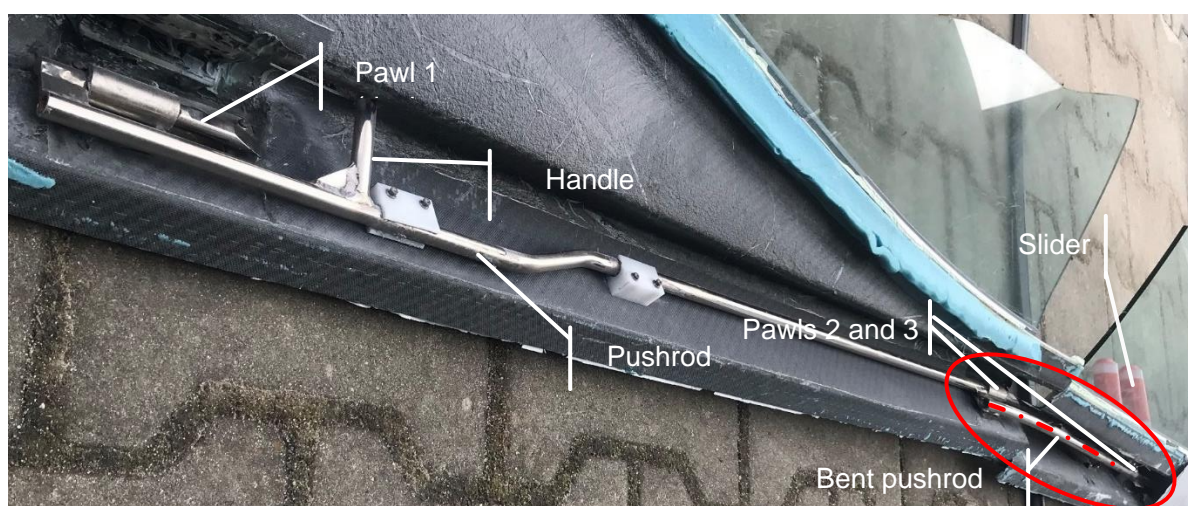
Fig. 7 Pawls on the common pushrod [source: SCAA]

The pushrod with the pawls was found slightly bent, probably due to high stress over the material yield strength, occurred when the canopy was being destroyed – while detaching from the aircraft or/and while hitting the ground. The bent part of the pushrod was marked with the red ellipse (see Fig. 7).

The pawls on the detached part of the canopy were found in their locked settings (Fig. 7). It does not mean that the canopy was detached when the pawls were locked – this would not be possible. The pawls must have been opened prior to the detachment, and after the detachment the pushrod was displaced to the „locked” position of the pawls due to the force exerted by the spring, partially visible in Fig. 8.

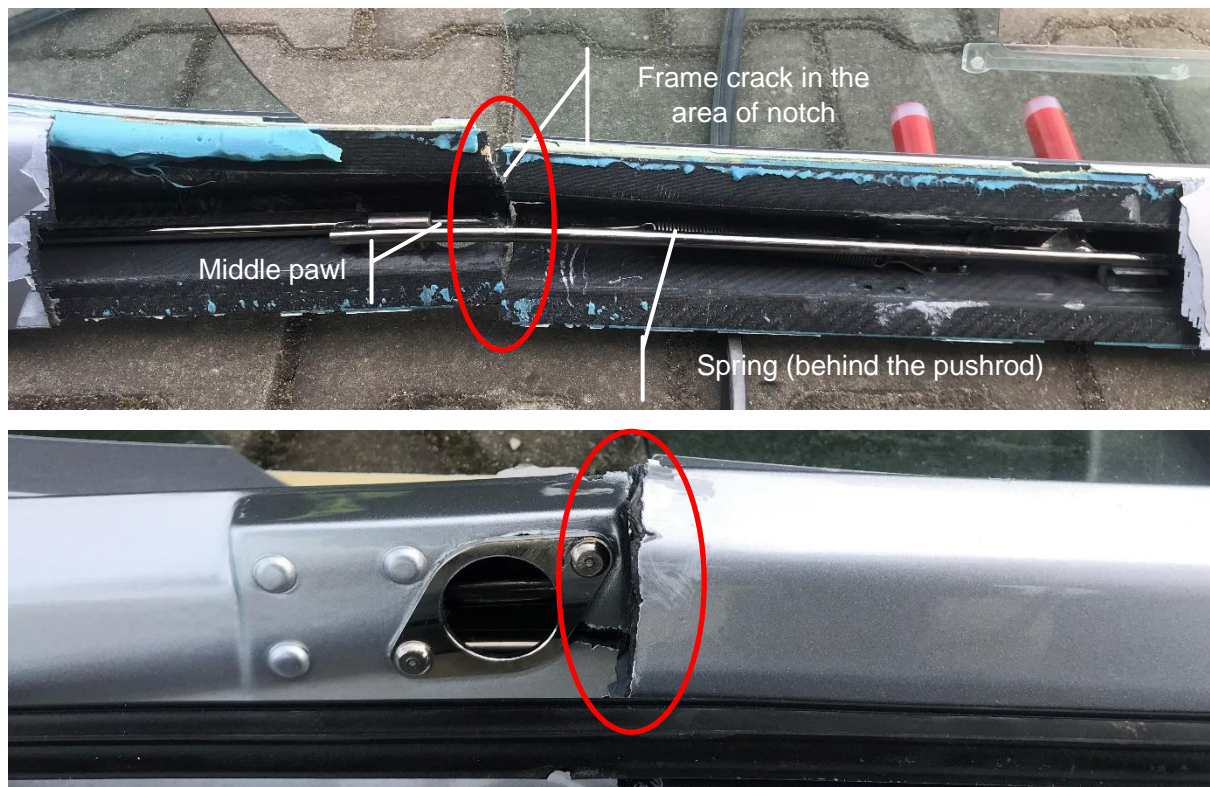
The above leads to the conclusion, the most probable reason of displacement of the pawls from corresponding fittings (if an intended opening is excluded) were vibrations caused by loss of the canopy frame rigidity after its cracking. These vibrations occurred after loosening the rear fitting in the system of pawl locking, when the force pressing the frame to the cabin side decreased. The frame crack started the destruction process. The crack occurred probably in the area of stress concentration (notch), near the middle pawl (Fig. 8).

Fig. 8 Cracked canopy frame in the area of middle pawl location. A notch is present on the edge of fitting slot reinforcement [source: SCAA]
