**State Commission on Aircraft Accidents Investigation**  
**ACCIDENT 2022/1300**  
**RESOLUTION**  
**of 25 August 2022**

<b>Type and model of aircraft:</b>	<b>R44 II Helicopter</b>
<b>Registration marks:</b>	<b>SP-INW</b>
<b>Date of occurrence:</b>	<b>27 March 2022</b>
<b>Place of occurrence:</b>	<b>EPPL</b>

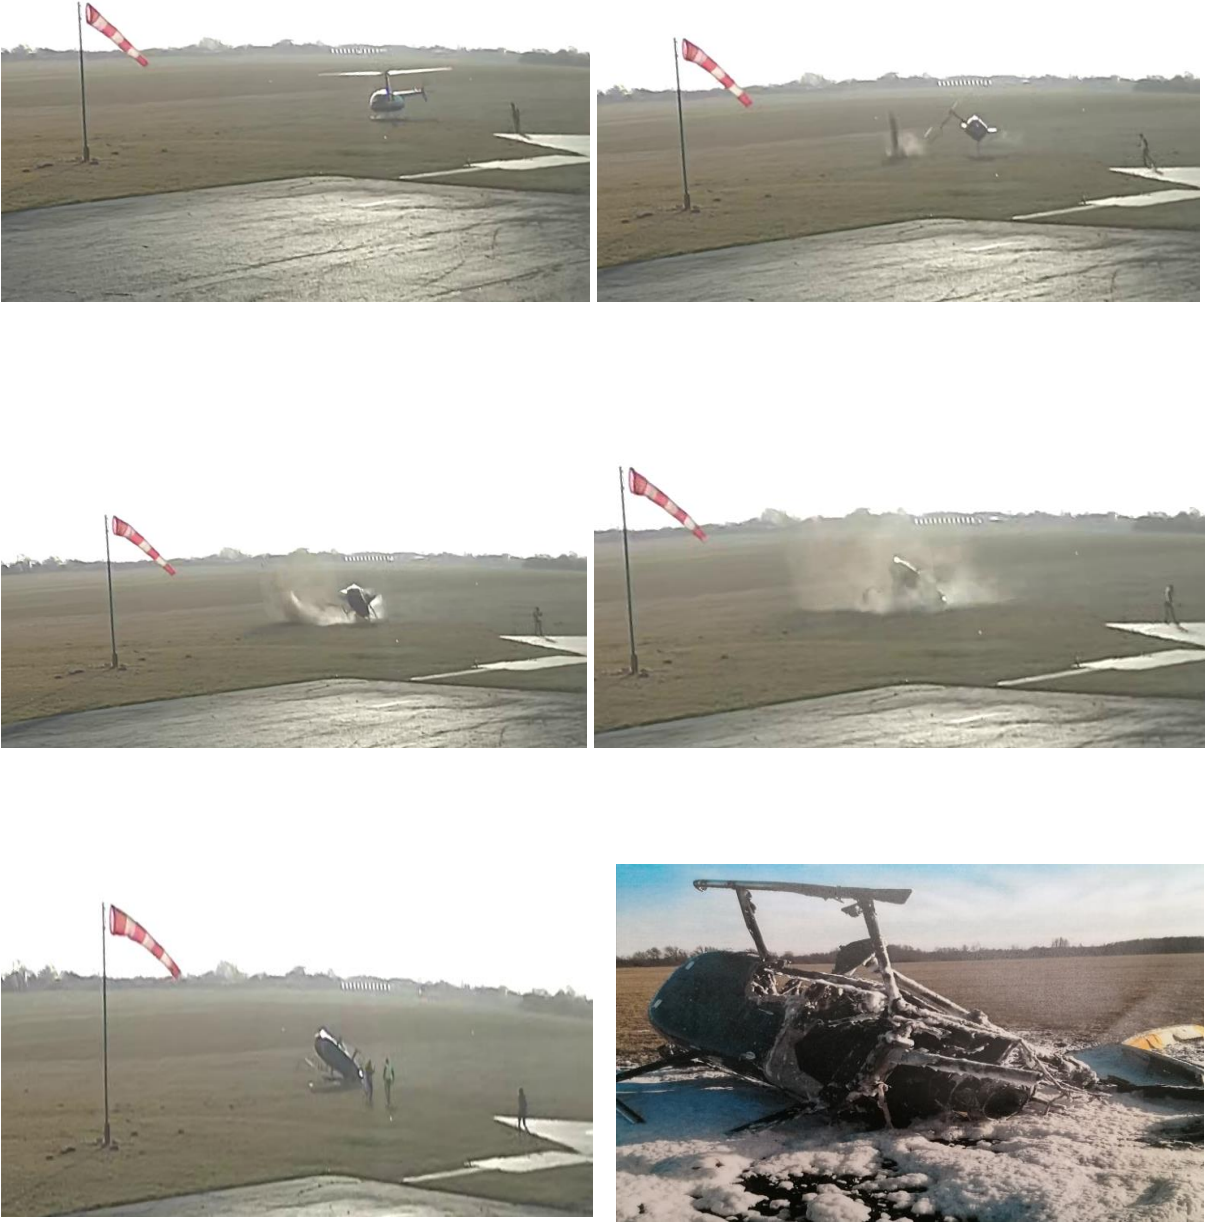
A moment later the main rotor blades hit the ground, and the helicopter dynamically turned over on its right side. The student fell out of the helicopter and walked away unaided to a safe distance, without sustaining any injuries. Shortly after a fire occurred, as a result of which the helicopter was destroyed.

Fig. CCTV images showing the course of the accident [source: Aeroklub Ziemi Mazowieckiej in Płock, PKBWL]

**Delayed reaction of the student in response to helicopter roll to the right side with a simultaneous abrupt movement of the collective upward.**

Training on errors during helicopter take-off and related corrective actions was conducted with personnel involved operator.
