PRELIMINARY REPORT

ACCIDENT

OCCURRENCE NO – 2022/1340

AIRCRAFT – Aeroplane, Aventura II, N27ZX

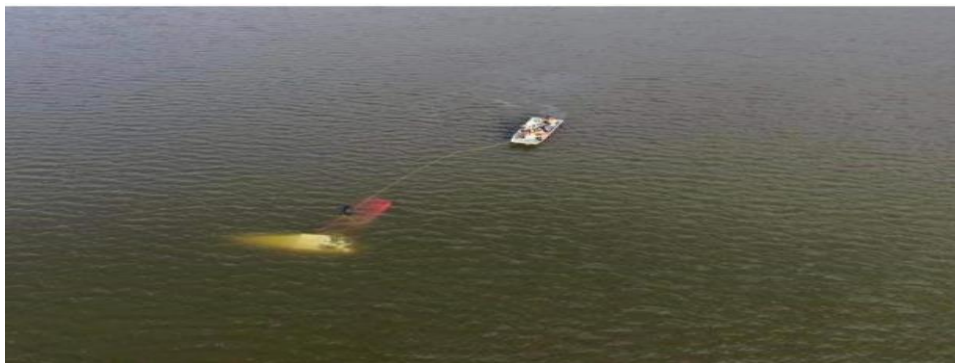
Around 14:20 hrs UTC near Jezioro Kłeckie (lake located in Wielkopolskie Voivodeship), the witnesses noticed a plane that arrived from the south. The plane first made a right turn at a low altitude, then 2-3 small radius turns to the left and around 13:24 hrs, during descent,, it collided with the water surface. The plane overturned and partially submerged (Fig. 1). Several minutes after the collision, the plane sank.

Fig.1. Wreckage of the N27ZX airplane photographed from a drone at the beginning of the rescue operation [source: internet]

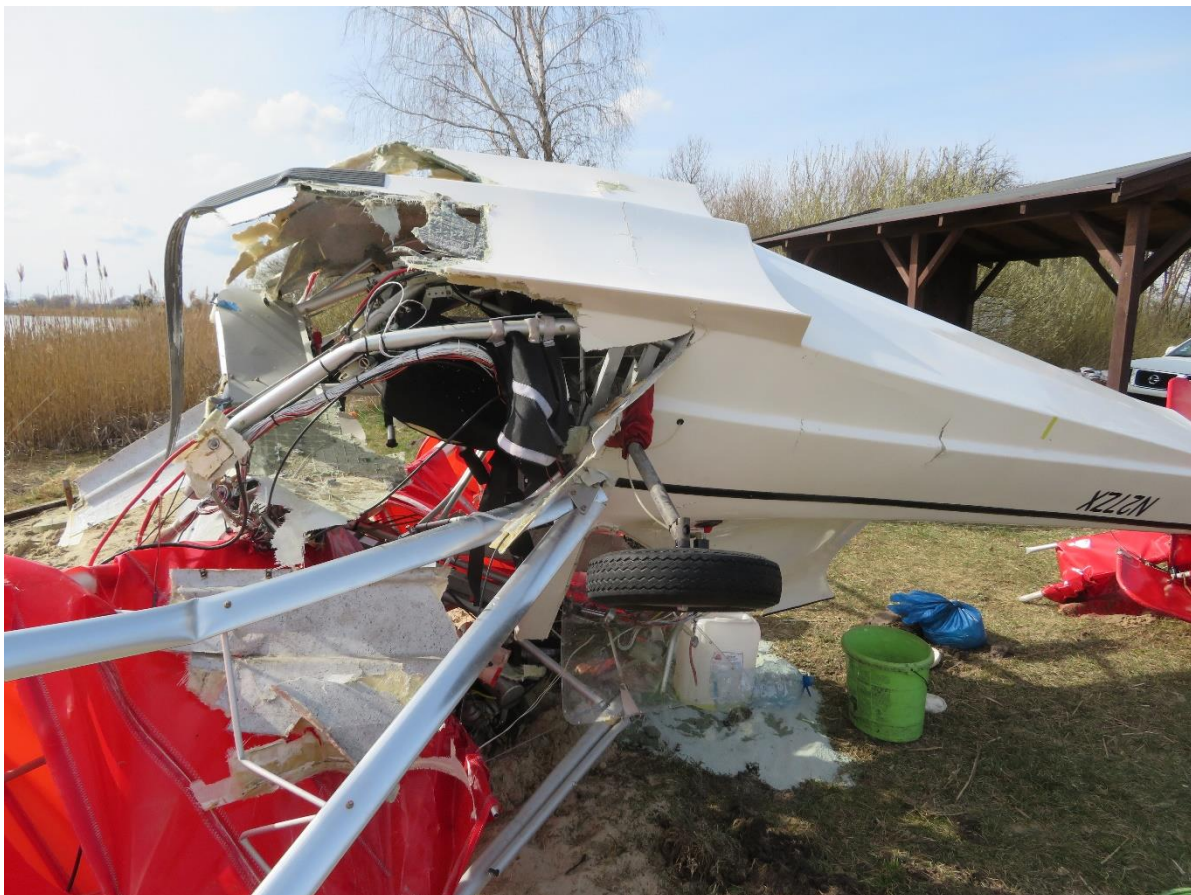
As a result of the collision with water, the plane was substantially damaged, especially the nose part of the fuselage (Fig. 2) which separated from the fuselage (Fig. 3), together with the door and the left float.

Fig.2 Nose part of the fuselage in an inverted position after the occurrence [source: PKBWL]

Preliminary findings show that the nose part of the fuselage and the left wing collided with the water, with a negative pitch angle.

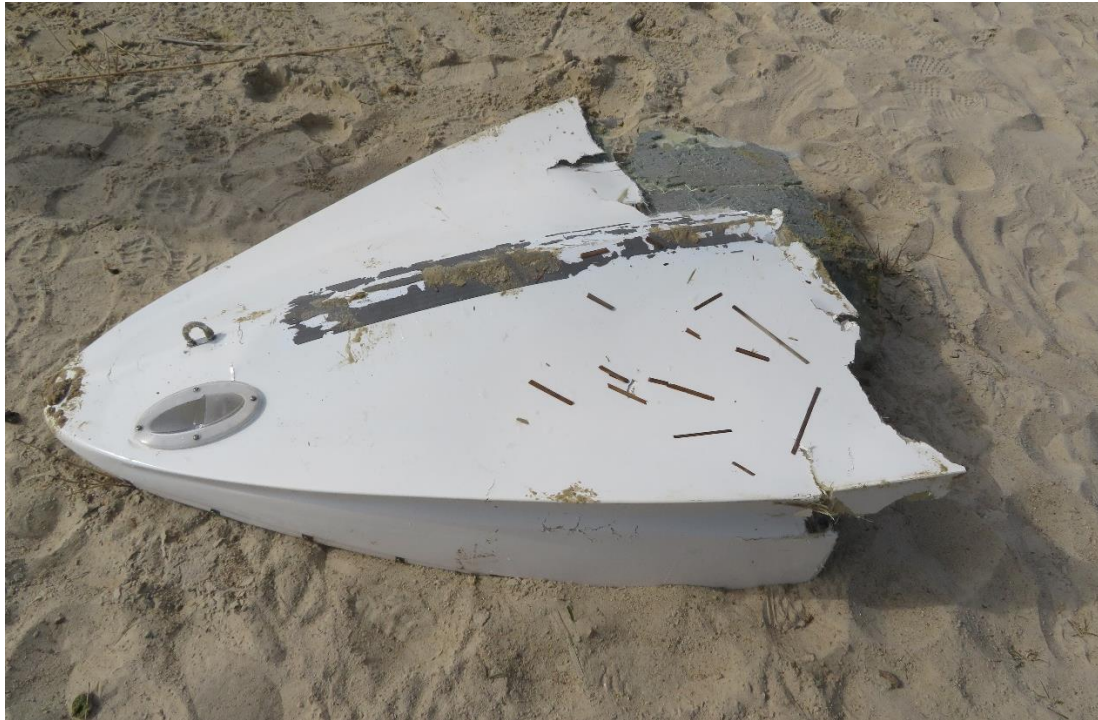
Fig.3 Detached lower part of the fuselage [source: PKBWL]

In addition, the lower laminate fuselage part and the left float were recovered from the water. The right float detached from the wing during the rescue operation.

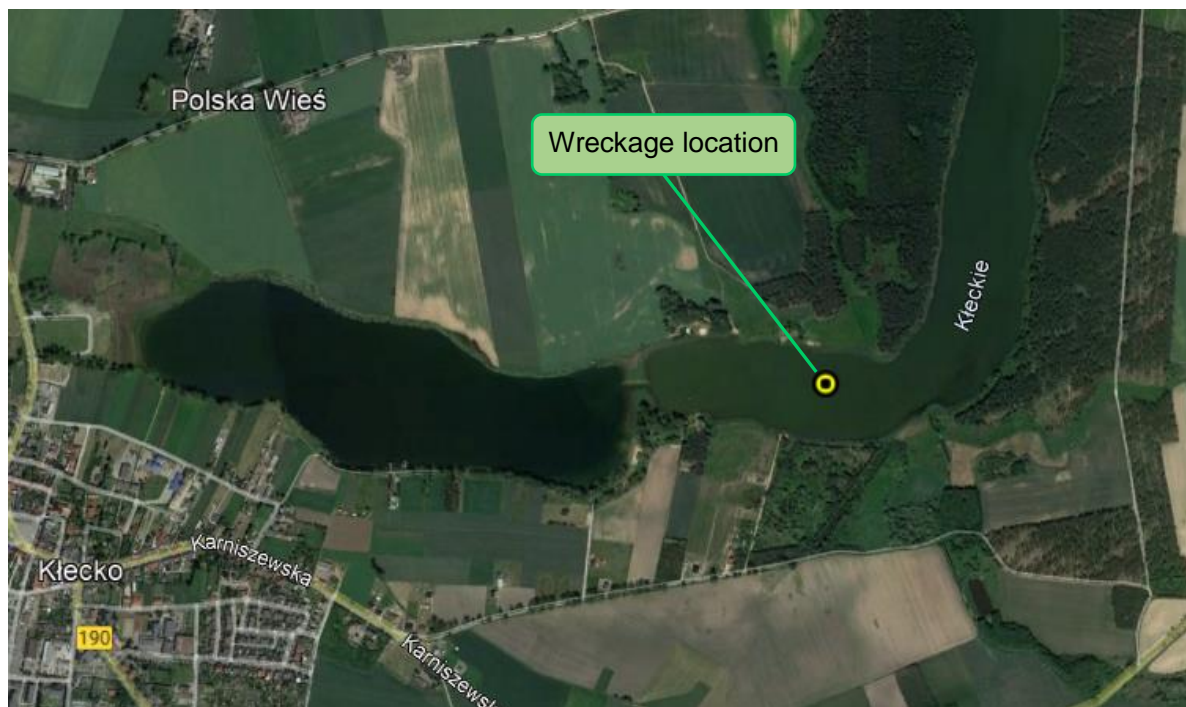
Fig. 4. Place of occurrence [source: internet, PKBWL]

The exact location of the wreck was determined with the use of the Police and State Fire Service sonars. The wreckage was found at the bottom of the lake in an inverted position in the place shown in Fig. 4 (the fuselage was facing south).
