FINAL REPORT

OCCURRENCE NO – 2022/1650

AIRCRAFT – Gyroplane Autogyro Cavalon, SP-XCWA

DATE AND PLACE OF OCCURRENCE – 14 April 2022, Wałczyk Airfield

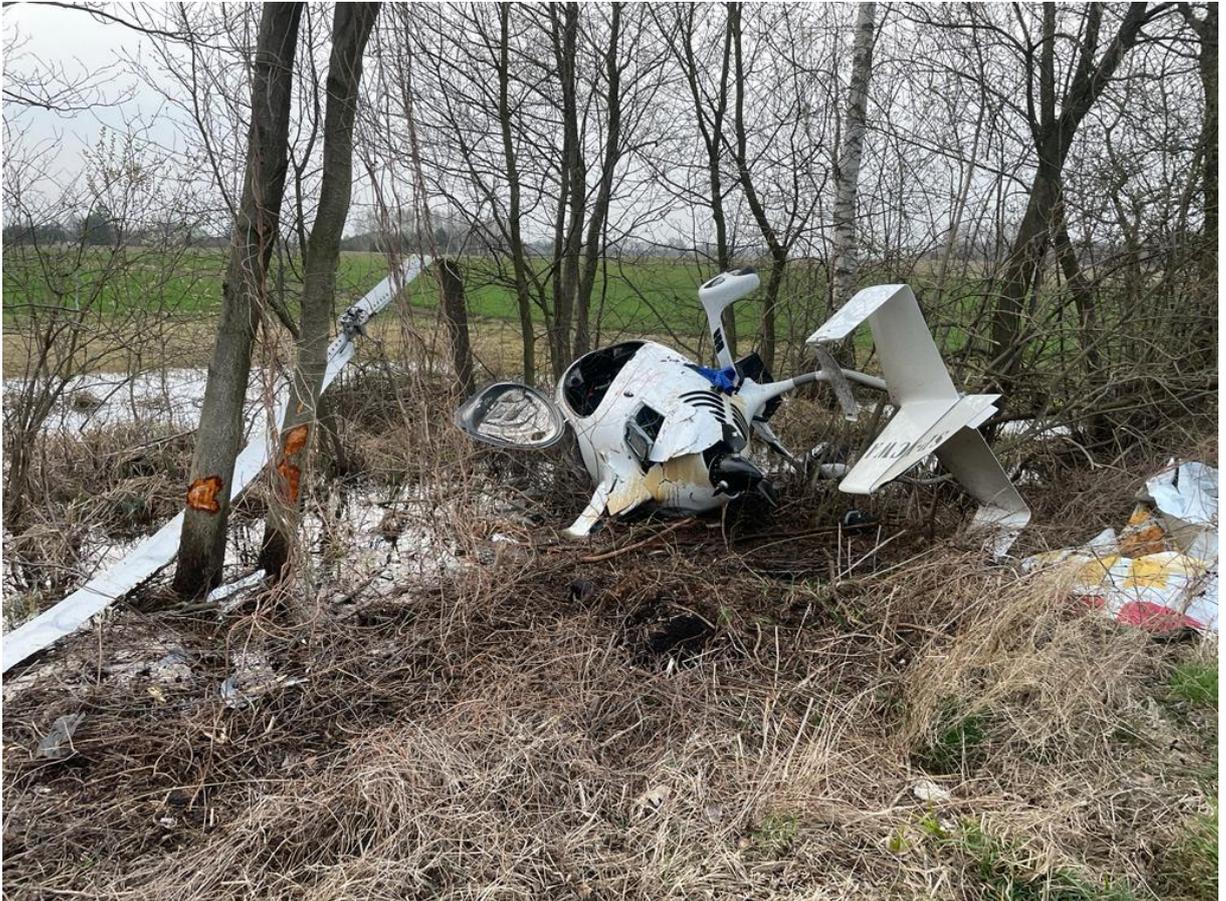
The accident aircraft was destroyed. The nose landing gear strut was detached from the fuselage. As a result of the collision with trees, the two-blade main rotor and the blades of the push propeller were detached and damaged. The composite fuselage of the gyroplane was deformed and cracked. As the wreckage came to rest in a depression of wet terrain, the interior of the fuselage was partially penetrated by water.

Fig. 1. SP-XCWA gyroplane at the accident site [Source: PKBWL]

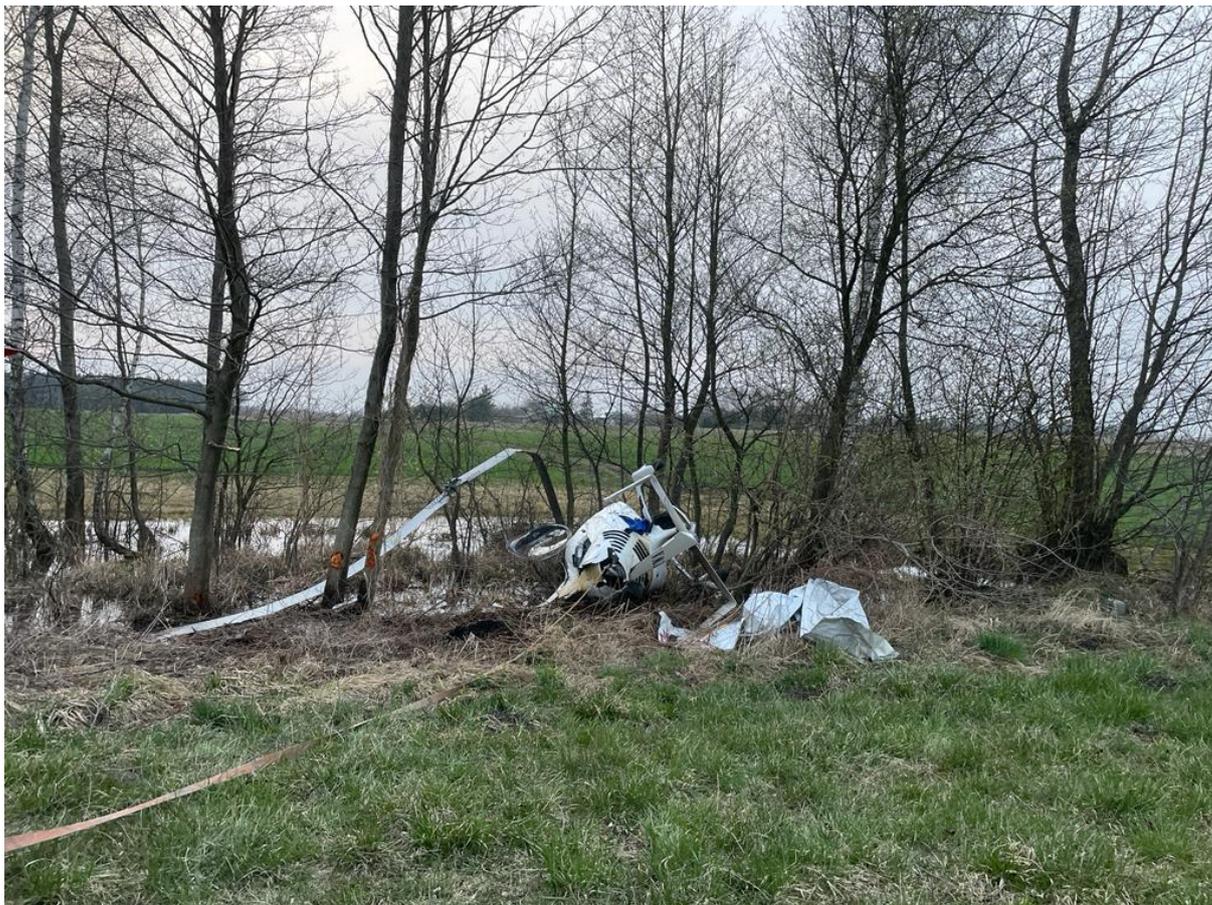
Fig. 2. SP-XCWA gyroplane at the accident site [Source: PKBWL]

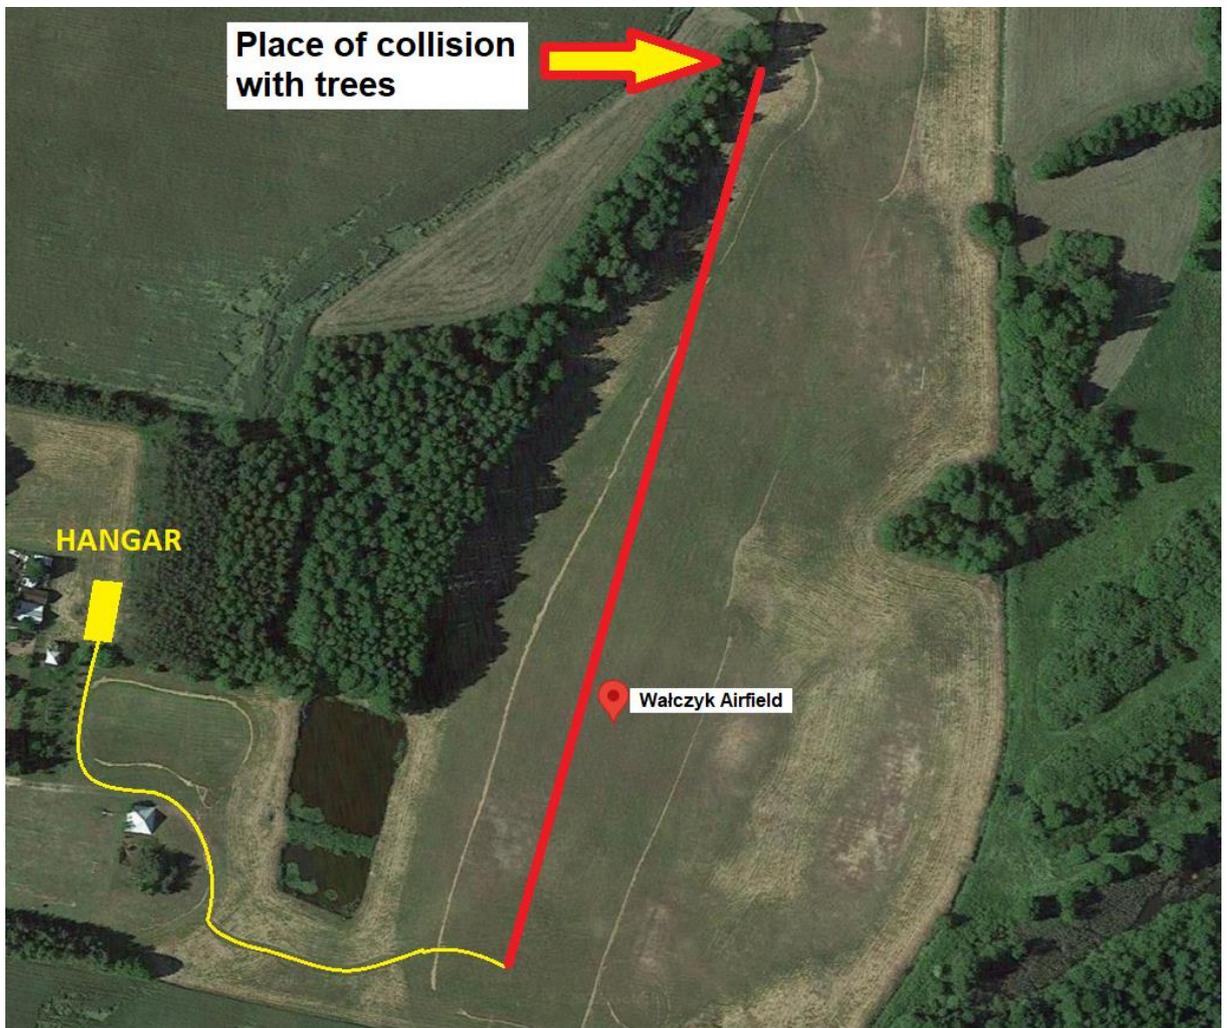
Fig. 3. Wałczyk Aerodrome – the place of the occurrence. The yellow line shows the course of taxiing of the gyroplane from the hangar to the runway. The red line shows the take-off run of the gyroplane which ended in a collision with trees. [Source: google.pl/maps]
