# PRELIMINARY REPORT

ACCIDENT 2022/2454

State Commission on Aircraft Accident Investigation (PKBWL)

AIRCRAFT – Helicopter AS 350 B3e, F-HCHB

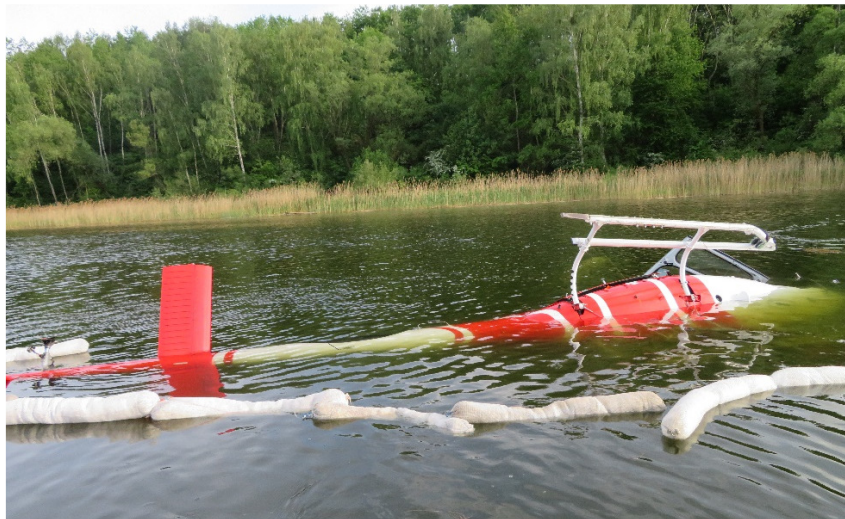
After 8 drops, about 15:00 hrs, while taking water, the helicopter collided with the lake surface and sank (Fig. 1) coming to rest at a depth of about 2,5 m. The pilot managed to leave the cockpit on his own without sustaining any serious injuries. He was waiting for the evacuation sitting on the wreckage.

Fig. 1 Crash scene of AS 350 B3e helicopter [source: SCAA]

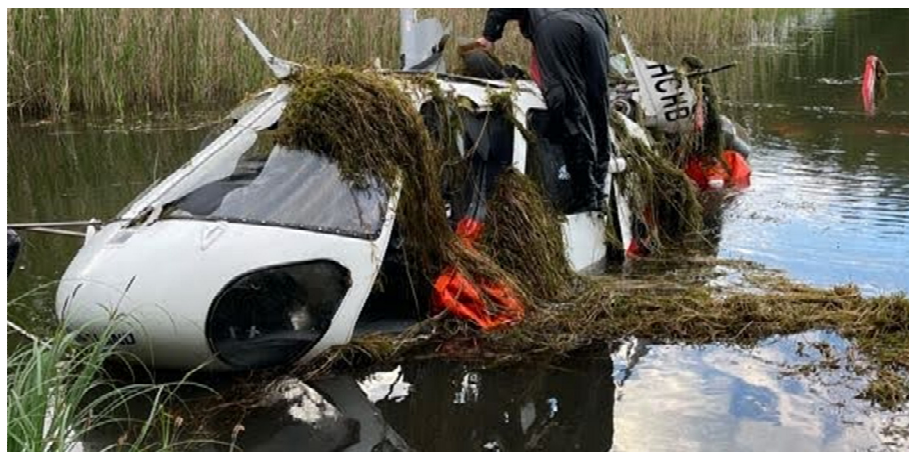
As a result of the collision with water, drowning and recovery action, the helicopter was destroyed (Fig. 2÷3).

During the collision with water the main rotor together with its gearbox detached from the airframe. To lift the wreckage, the divers cut the oil and fuel pipes and electrical harness which were connecting the fuselage with the main gearbox, then the divers dismantled (under water) the main rotor blades from the rotor hub.

Fig. 2 Helicopter wreckage during recovering to the lake shore. The main rotor and its gearbox were recovered separately [source: SCAA]

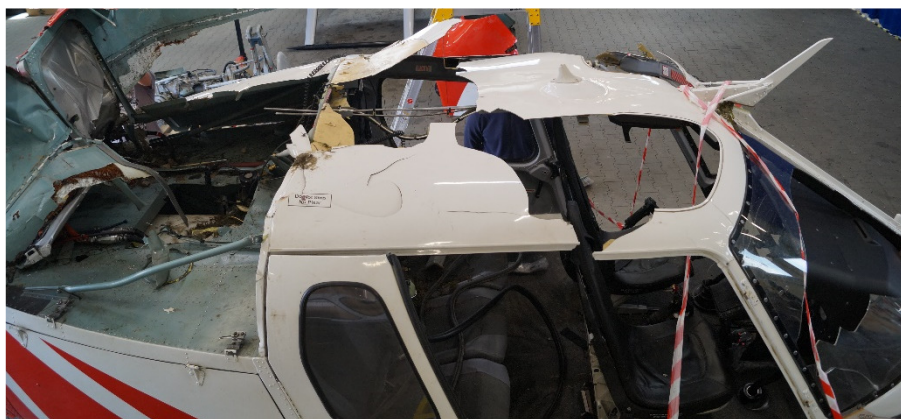
Due to main gearbox detachment, the kinematic connections between the engine and the gearbox were broken, the same happened with the engine and the shaft of the tail rotor. The engine was torn out from its rear fittings.

The tail rotor (detached blades from the hub) and its gearbox (broken fittings on the driving shaft) also sustained substantial damage. The bearings of the tail rotor driving shaft detached from the corresponding nests on the tail beam and the shaft was bent.

As a result of the collision with water the structure of the fuselage was deformed. The composite roof sustained damage, the windshield and its composite central support were destroyed. The left door was damaged due to collision with a main rotor blade.

Fig. 3 The wreck after recovery, during an inspection in the Operator's hangar. Visible the area of gearbox mount, cracked skin of the fuselage and broken windshield [source: SCAA]
