STATE COMMISSION ON AIRCRAFT ACCIDENTS INVESTIGATION

OCCURRENCE NO. – 2022/3434

AIRCRAFT – Aero AT-3 R100, SP-PBC

DATE AND PLACE OF OCCURRENCE – 30 June 2022, Witanowice

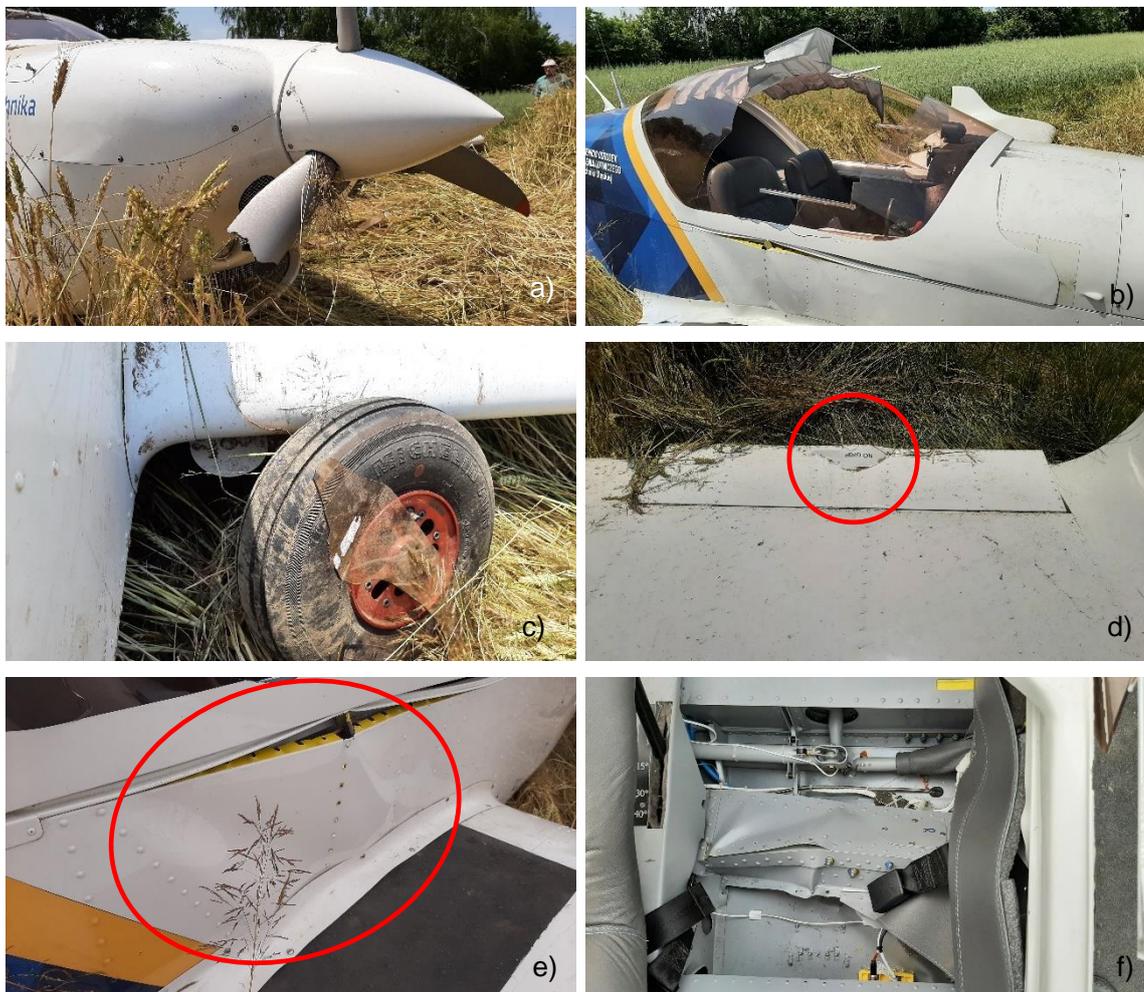
The plane sustained serious damage (Fig. 1). The nose and main landing gears detached from the aircraft as a result of a collision with the local land elevation and uncontrolled ground loop. The fuselage was deformed and one of the propeller blades broke. The windshield was destroyed and its frame was deformed. The left aileron, lower surface of the wings and fuselage were also damaged.

Fig. 1. Damage to the aircraft: a) propeller, b) broken windshield, c) damaged main gear, d) deformed left aileron, e) corrugated structure of the starboard, f) torn fuselage reinforcements for main landing gear [source: SCAAII]

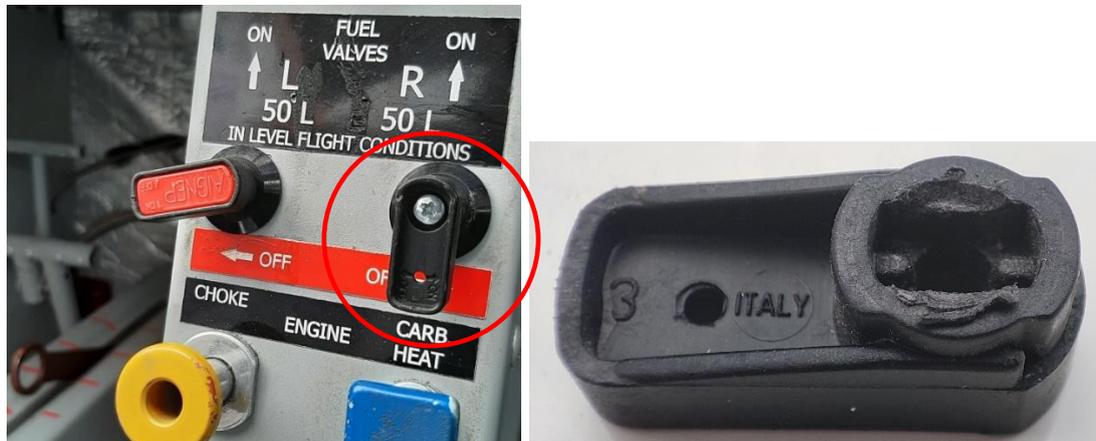
- the engine compartment was clean, without leakage of operating fluids;
- there was no unsealing (leakages) of the fuel system, the system was unobstructed;
- **the fuel tank in the left wing was empty;**
- the carburetor bowls contained traces of fuel, the floats rested in their lower positions (did not float);
- the vent of the right fuel tank was unobstructed;
- **the fuel valve of the right tank, located in the cabin, was closed** – the plastic knob (handle) was damaged, worn and did not ensure proper valve control

(Fig. 2). The knob was rotating freely on the shaft and only its strong pressing allowed to control the valve;

- about 30 l of fuel was drained from the right wing tank (about 3 l remained in the tank). The total quantity of fuel 30+3 l corresponded to the initial quantity prior to the flight (no consumption because the fuel valve of the right tank was closed during the entire flight).

Fig. 2. Damaged knob of the right tank valve. On the right – the enlarged view of the knob (view from the bottom), grooves for the spindle are well visible [source: SCAA]

Therefore, the valve knob was damaged either at the time of its forceful closing after the first flight (by the first student) or during opening prior to the second flight.

The type-certificate holder (which is the aircraft manufacturer) informed SCAA that all users of the aircraft were advised to check the fixing of the fuel valve knobs. None of the users reported any problems related to the valve knob.

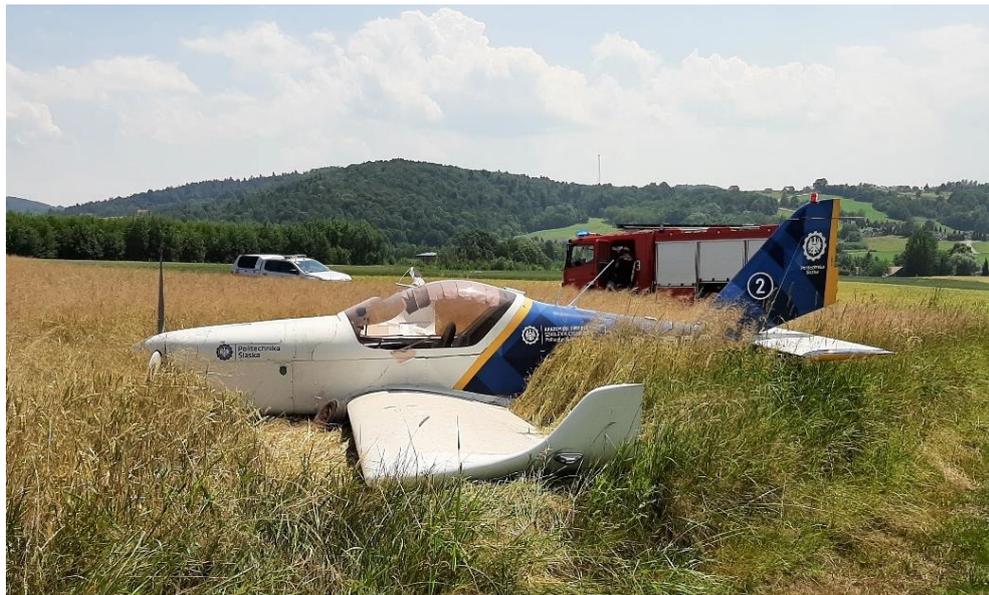
The landing took place in the crop, across the field and downhill (Fig. 5).

Fig. 5. Location of the aircraft in the crop field (view towards S-E) [source: SCAA]

The accident site is shown in Fig. 5. The aircraft preserved its integrity. No part detached from the aircraft inflight. The left wheel along with the part of its fork, a propeller blade and some debris of the windshield, which detached after the impact, were found near the aircraft.

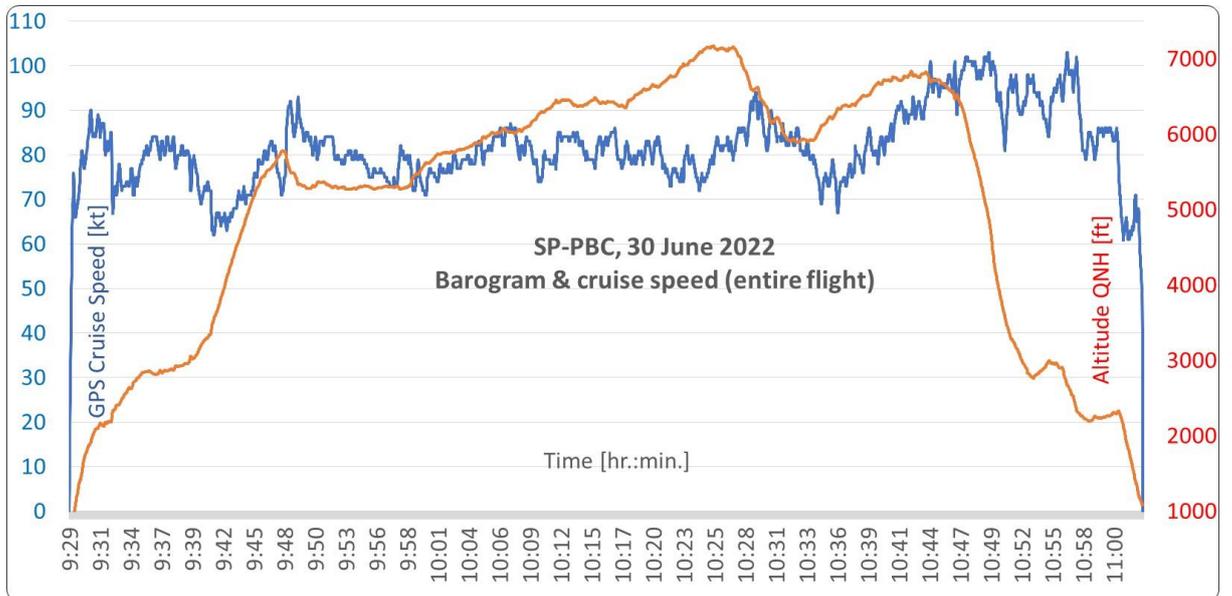
The electronic flight data measurement system (on-board computer) recorded the course of the flight. Fig. 6 shows a barometric altitude and a GPS speed recording from

the entire flight. Attention should be drawn to the a/c descent (from 10:45 hrs) to avoid entering into the EPKK TMA.

Fig. 6. Barometric altitude and ground speed record of the entire flight [source: SCAA]

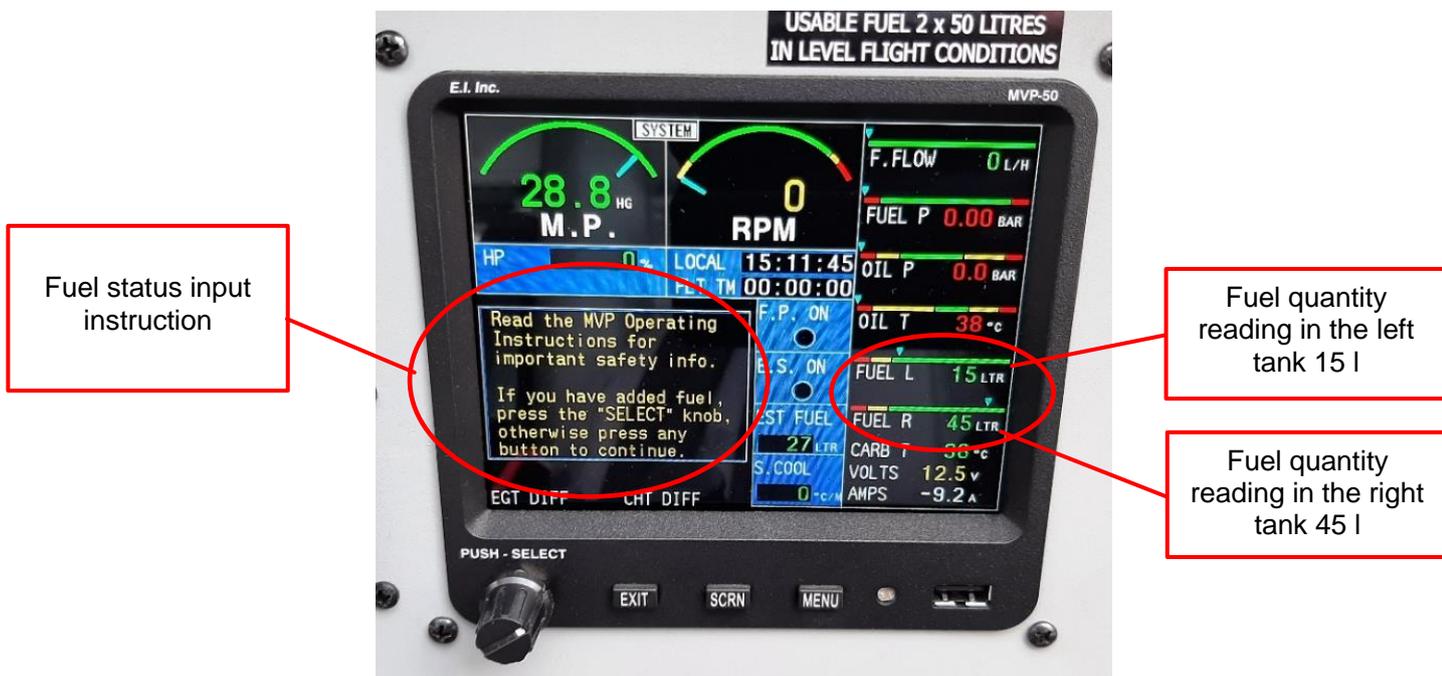
Fig. 7. Graphic illustration of the operating parameters of the powerplant, fuel status according to the MVP-50 after landing [source: SCAA]

The user of the AT-3 raised a concern of incorrect indications of the fuel quantity in a/c tanks. In the investigated case, after the occurrence, the MVP-50 was indicating 15 l of fuel in left tank, but in fact the tank was empty (0 l), while the right tank indicator was indicating 45 l (in fact it was 33 l) – see Fig. 7.

The quantity of fuel read out from the display after the occurrence was 60 l (the sum of the indication values for both tanks, see Fig. 7), which did not correspond to the real fuel consumption during 1 hr. 46 min. flight, which was exactly 31 l. The engine consumed all fuel from the left tank. The fuel from the right tank was not used because its valve was closed during the entire accident flight.

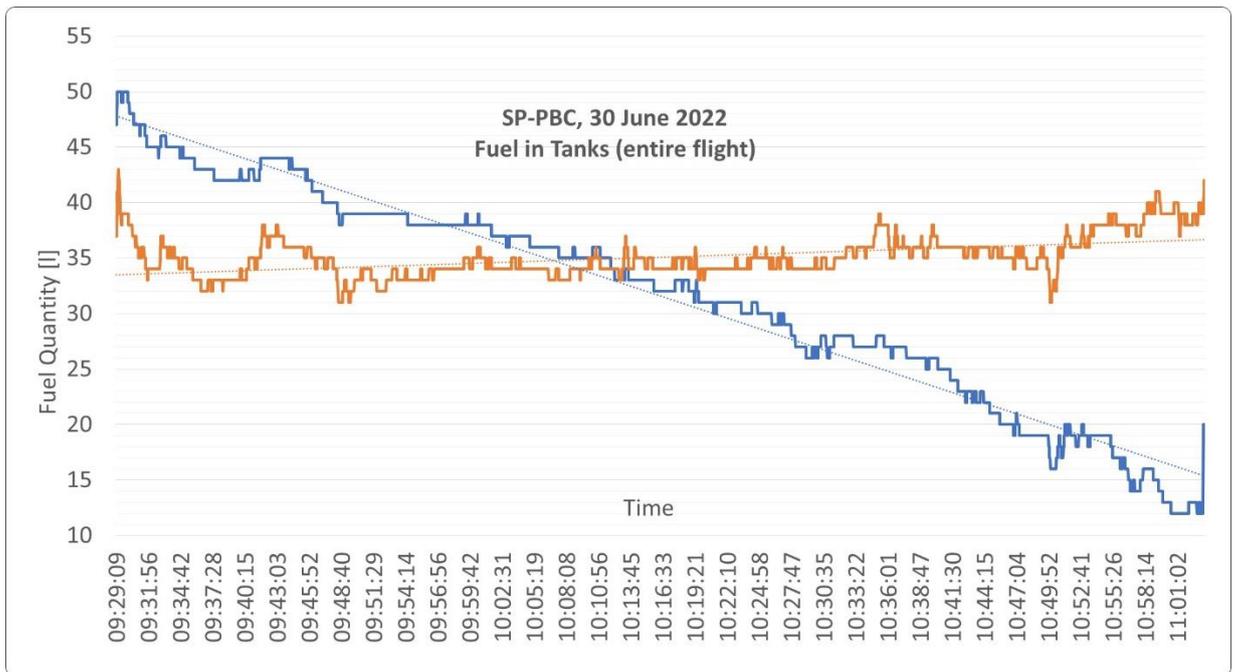
Fig. 8 shows fuel consumption during the entire flight according to data obtained from the electronic engine controller. These data can only be treated qualitatively because neither the initial nor the final fuel quantity was consistent with the measurement by the hand meter during preflight inspection and after the landing.

Fig. 8. Fuel consumption during the entire flight according to the electronic system. Dotted lines show the trend [source: SCAA]

The trend dotted lines show that the system was not consuming fuel from the right tank (orange on the chart) but only from the left, where the fuel quantity is systematically decreasing. It is consistent with the actual course of the flight.

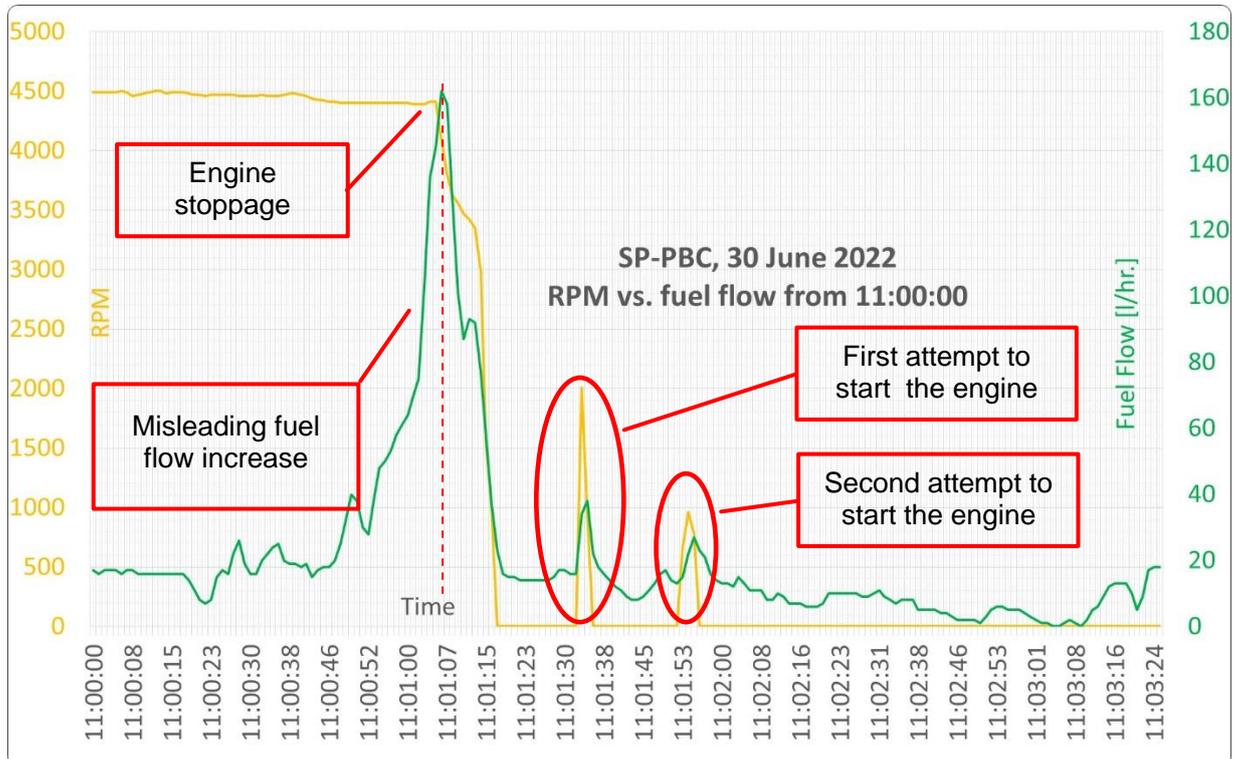
At 11:01:05 hrs, the engine RPM began to drop and 11 seconds later the engine stopped. The pilot made two unsuccessful attempts to start it, what was marked with red ellipses (Fig. 9).

The fuel flow rate, from a value of about 20 l/hr began to increase to 160 l/hr at 11:01:05 hrs. This was an error of the system, which evidently measured the air flow instead of fuel – the air was sucked by the fuel pump from the empty fuel tank.

Fig. 9. Graphical illustration of fuel consumption in the final phase of the flight [source: SCAAII]

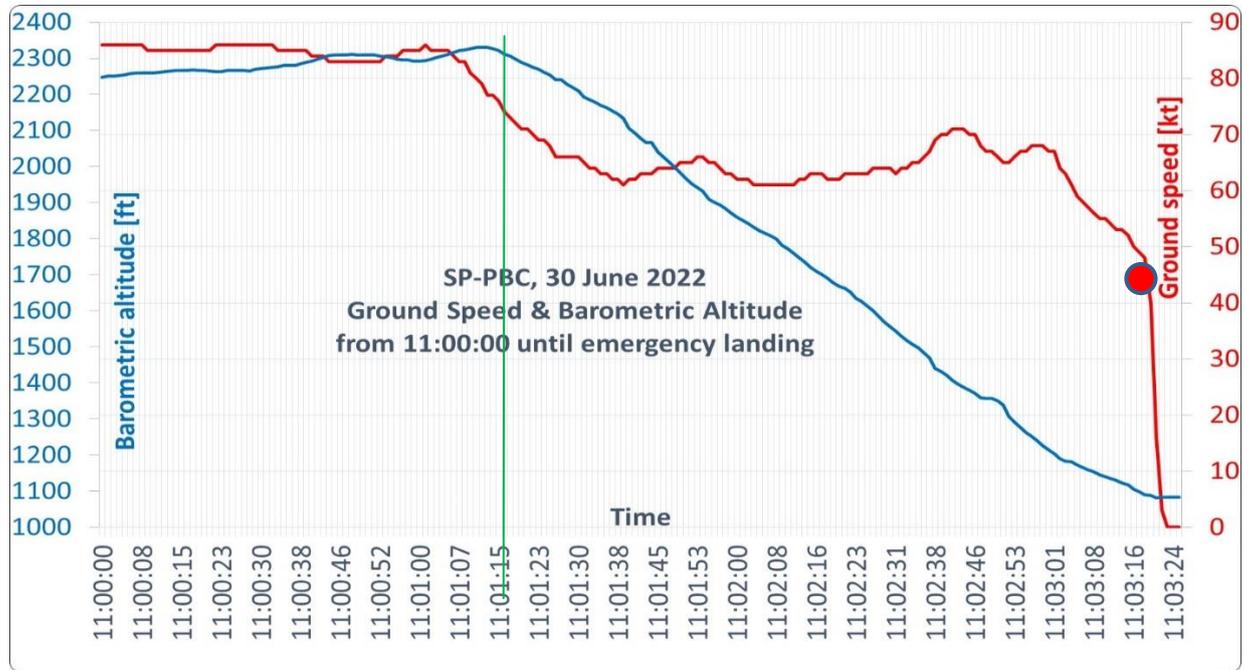
The engine stopped at 11:01:16 hrs. It is marked in Fig. 10 with a green vertical line. The figure shows the ground speed (red curve)⁸ and a barogram (blue curve), starting at 11:00:00 hrs. Place of the collision with the ground (11:03:18 hrs) was marked with a red dot. The aircraft came to rest about 3 seconds after the touchdown which occurred at a ground speed of about 48 kt (89 kph).

Fig. 10. GPS ground speed and barometric altitude records from 11:00:00 (6 seconds before the engine stoppage) until landing [source: SCAA]

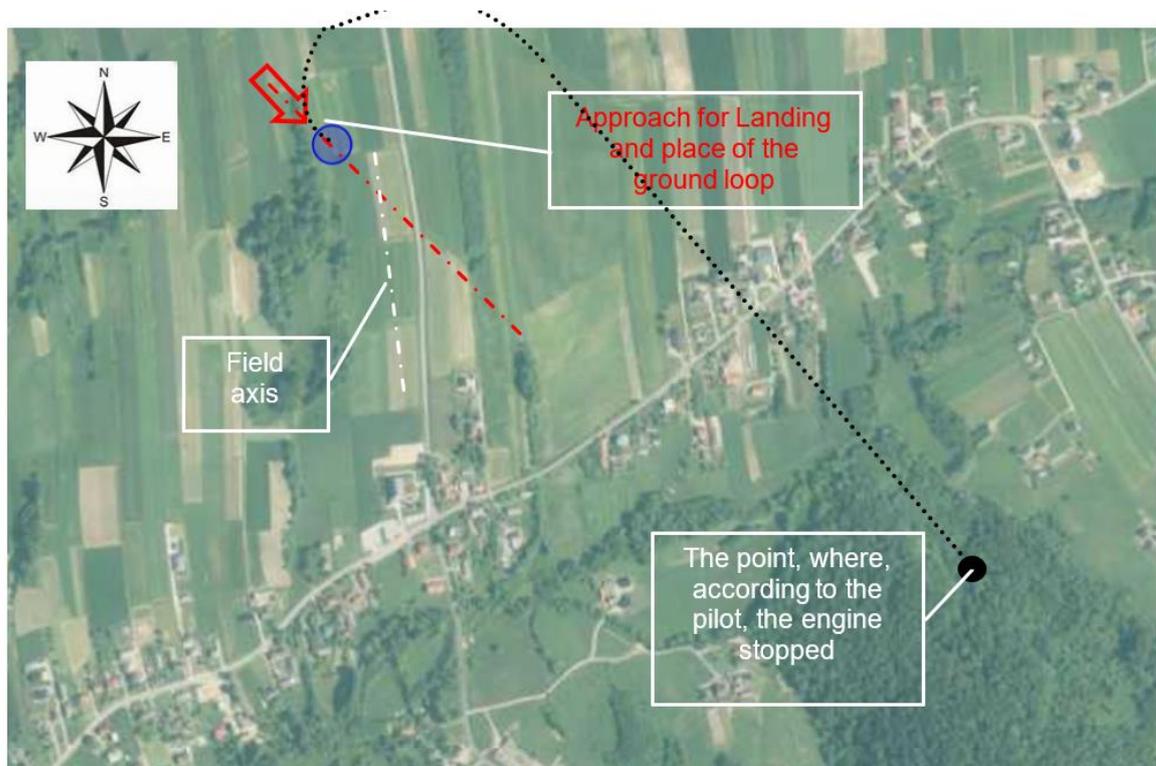
The probable glide path for landing, after the engine stoppage, is shown in Fig. 11.

Fig. 11. Probable glide path prior to landing [source: SCAAI, background: Geoportal]

The aircraft flew across the valley, over a public road. The slope of the terrain is several percent. The difference in elevation between the bottom of the valley and the emergency site was several dozen meters.

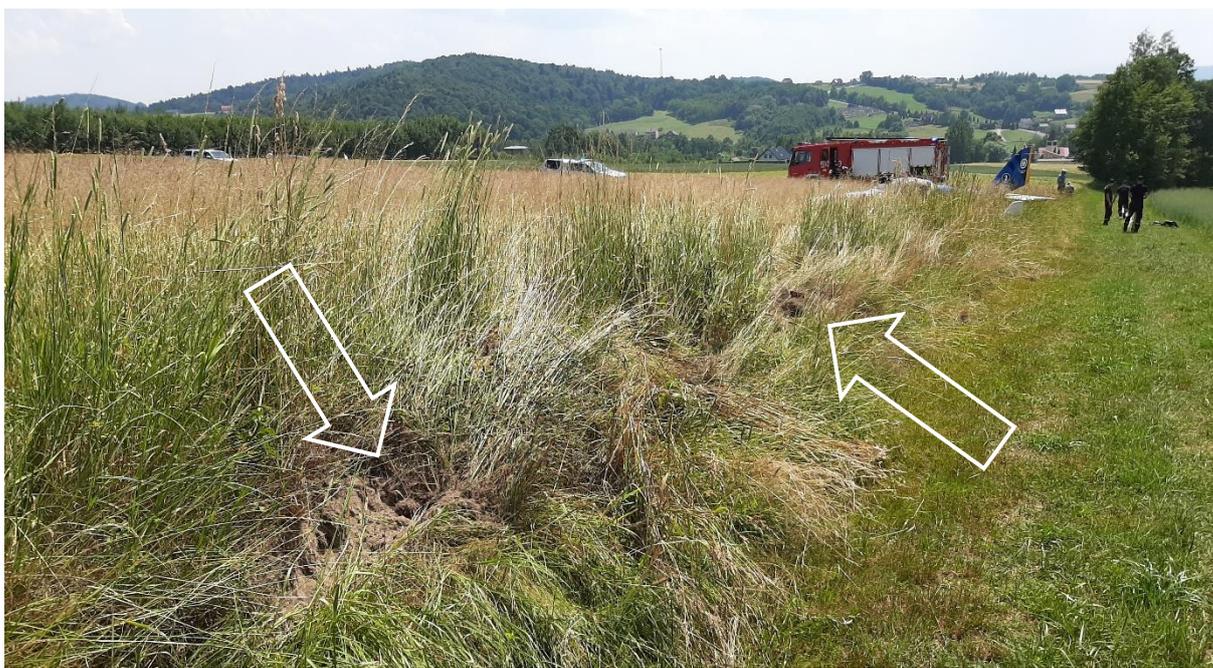
Slowing down, the aircraft "slipped" into a crop, made a ground loop of about 150° and came to rest about 20 m further. The ground loop was due to the moment generated by collision of the landing gear with the land elevation.

Fig. 12. Traces left by the landing gear at the local field elevation [source: SCAAI]

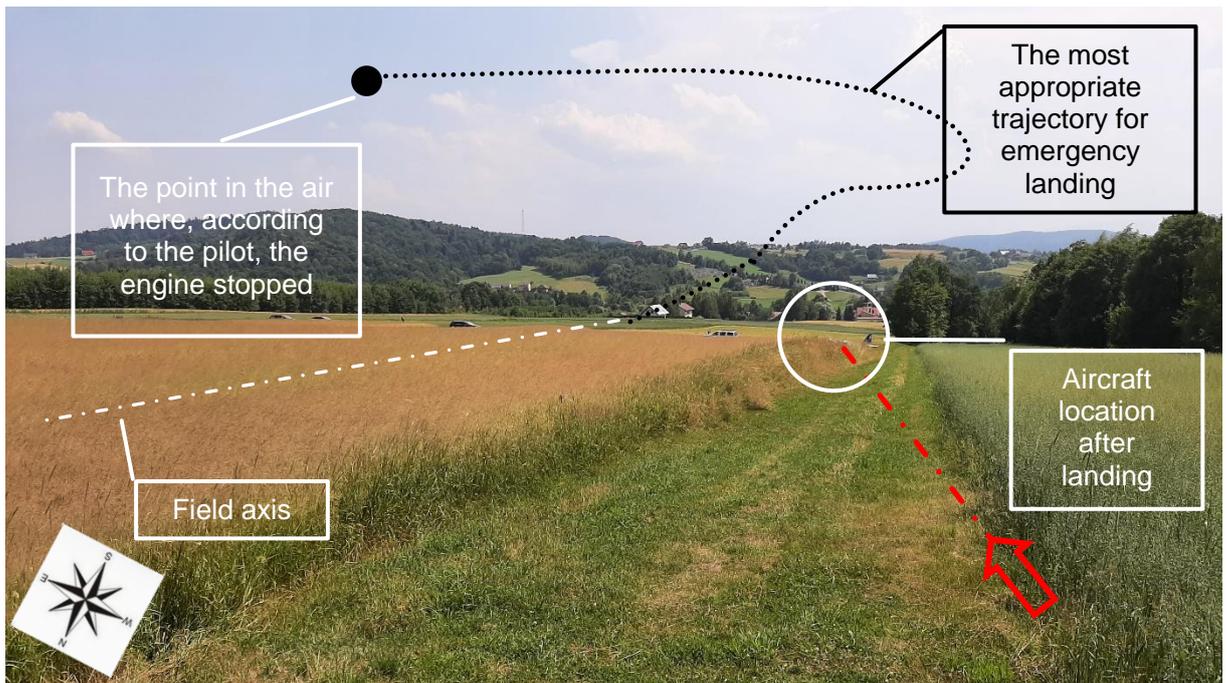
The most important rule for any landing in a hilly terrain is to land up-hill, regardless of the wind conditions. In case of the investigated accident such a possibility existed: to make an approach from above the village, along a large field and against a gentle slope (Fig. 13, black dotted line).

Fig. 13. View from the approach direction (indicated by a red arrow). White circle shows the position of the aircraft in crop [source: SCAA]
