State Commission on Aircraft Accidents Investigation

# FINAL REPORT

**2022/5555**  
OCCURENCE NUMBER

**Private, parachute jumps.  
2 Lightning 193 PS parachutes.  
Longinówka near EPPT,  
23 September 2022**

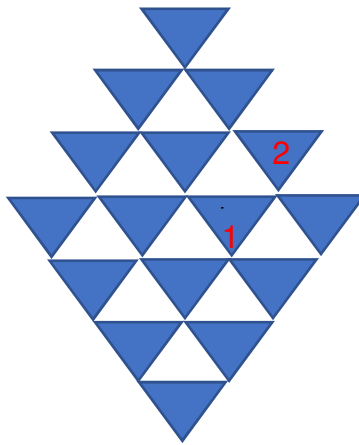
On 23 September 2022, a formation of 16 skydivers and a camera operator performed a jump from a height of approximately 4,000 m maintaining the sequence as planned for the intended formation (Fig. 1). In the initial phase of the formation build-up, there occurred difficulties with stabilising the positions in respective rows. Skydiver no. 1 had been assigned the second position from the right in the fourth row, whereas skydiver no. 2 the extreme right position in the third row.

Fig. 1. A formation of 16 skydivers with marked positions of skydivers no. 1 and 2.  
[Source: PKBWL]

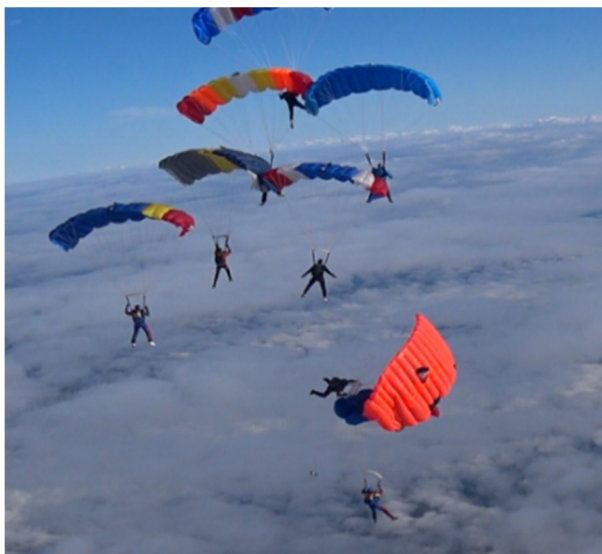
Fig. 2. The moment of the collision of skydivers no. 1 and 2  
[Source: the organiser]

The canopy of skydiver no. 2 flew into the front right lines of the canopy of skydiver no. 1 causing the canopy to dive and the body of skydiver no. 1 to be hoisted up (Fig. 2). The body of skydiver no. 1 was wrapped from head to waist in the canopy of skydiver no. 2 (Fig. 3). The deformed canopy of skydiver no. 1 and the partially working canopy of skydiver no. 2 entered into fast rotation with a significant loss of height. Until the moment of impact to the ground, neither skydiver performed an effective emergency procedure prescribed for such a situation. As a result of impact to the ground at a speed in the range of 70-80 km/h, resulting in serious injuries to skydiver no. 1 and the death of skydiver No. 2 at the scene.

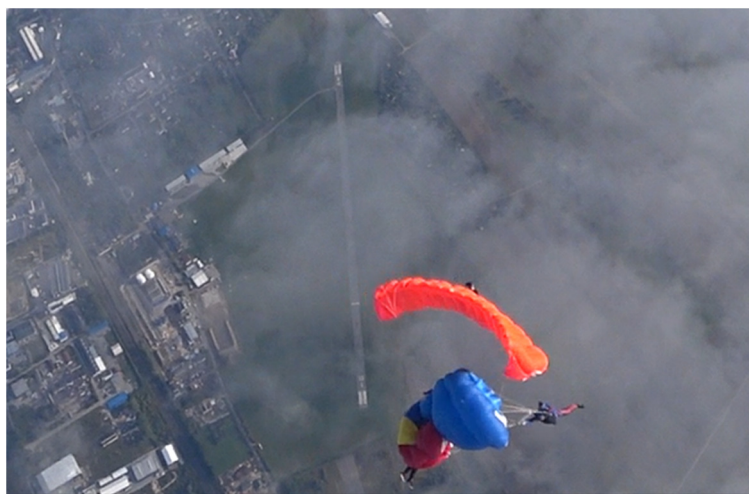
Fig. 3. Entanglement of the parachutes and uncontrolled descent of skydivers no. 1 and 2.  
[Source: the organiser]

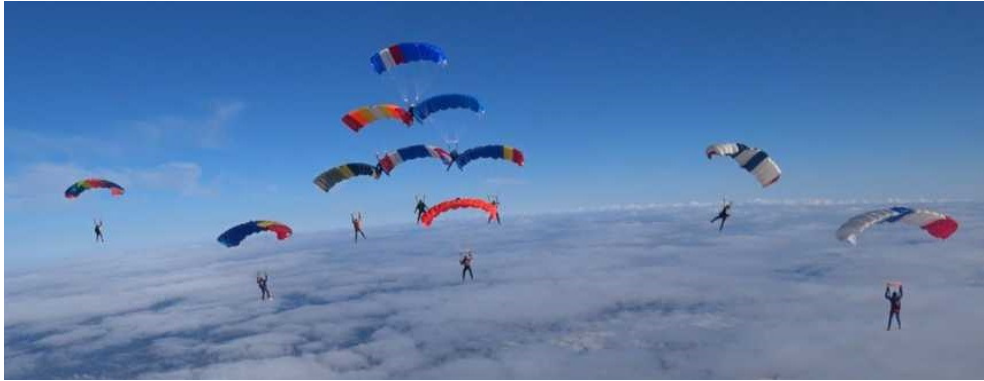
Fig. 5. The skydivers taking their positions in the formation rows.  
[Source: the organiser]

The jumpers and a camera operator exited the aeroplane at approximately 4,000 m in the sequence appropriate for the intended formation. Skydiver no. 1 had been assigned the position in the fourth row, second from the right. Skydiver no. 2 had been assigned the extreme right position in the third row. The task of skydiver no. 2 was to join the formation by "fixing" his canopy to the formation and preventing its turn towards the centre of the formation, in particular until the skydiver from the fourth row (the position assigned to skydiver no. 1) joined to stabilise the setup. Skydiver no. 2 prevented his canopy from turning, but at a moment of stronger work on the canopy the formation waved in such a manner that the canopy cells became closed and the pressure in the canopy dropped. This resulted in a decrease of forward velocity and an increase of vertical velocity, causing the canopy of Skydiver No. 2 to move backward relative to the formation, heading straight towards skydiver no. 1, who was in the right position preparing to join the formation. The unexpected backward direction of flight of the canopy of skydiver no. 2 surprised skydiver no. 1, who was unable to react and avoid the collision. The canopy of skydiver no. 2 collided with the front right lines of the canopy of skydiver no. 1, causing the canopy to dive and the body of skydiver no. 1 to be hoisted up, and eventually wrapping around the body of skydiver no. 1 from head to waist. The deformed canopy of skydiver no. 1 and the partially working canopy of skydiver no. 2 entered into fast rotation generating loads of 3-5 g with a significant loss of height. The descent in entanglement lasted more than 2 minutes, with the rotational speed reaching 39 rotations per minute.
