FINAL REPORT

2023-0008

Blue Sky Balloons, flight with passengers Cameron Balloons, Z-160, SP-BOK Bór, EPNT

Warsaw, 20 March 2024

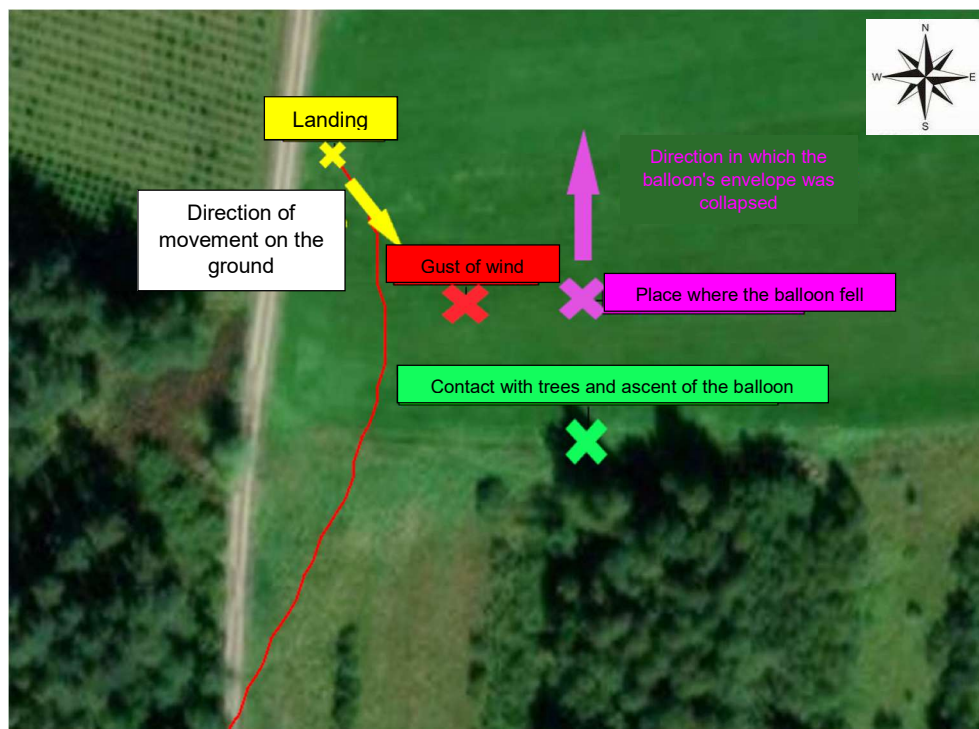
The balloon landed on a meadow close to a hardened field road, at a fenced plot of land, where it became stationary (Fig. 3).

Fig. 3. Place of landing (yellow cross) and fall of the balloon (violet cross), and the position of the balloon after the occurrence [source: a sketch by the pilot/recording of the approach to landing (red line) comes from the flight recorder and represents the balloon's approach to the first landing]

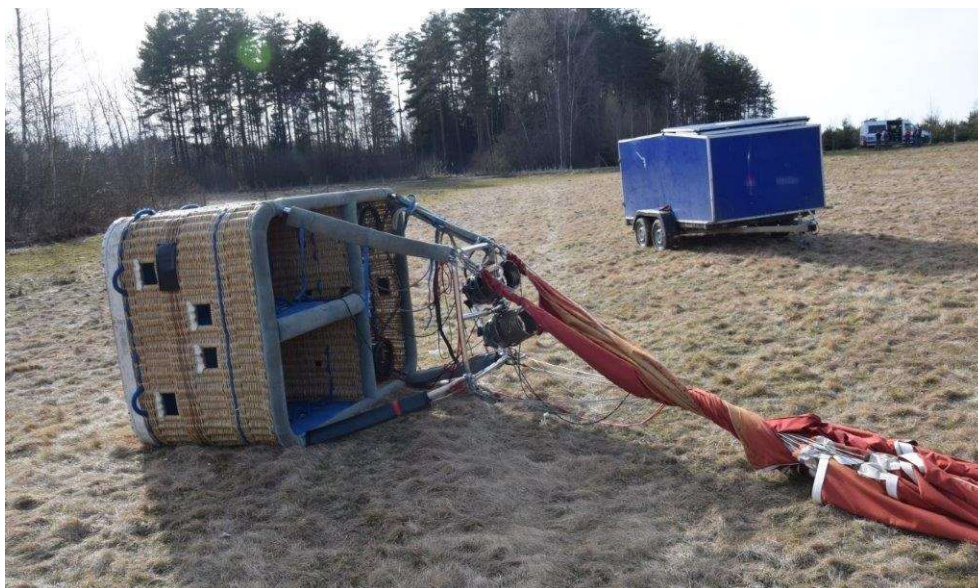
A sudden gust of wind made it impossible for the persons outside the basket to maintain control of the balloon. The pilot considered the situation as dangerous and ordered the men to release (let go) the basket. The lightened balloon, with four persons in the basket, moved suddenly towards a group of trees, came into contact with them and ascended above the tree tops. The pilot reacted by activating the rapid deflation system (RDS), while at the same time instructing the female passengers to "brace for landing and hold on tight". At 13:57 hrs, the balloon collided with the ground at a high rate of descent. The basket and envelope fell in the northerly (N) direction (Fig. 4).

Fig. 4. The balloon after hard landing on the meadow – the overturned basket and a fragment of the envelope can be seen [source: Police]

The pilot stated that after the occurrence, when disassembling the balloon for transport, he had not identified any damage to any of the balloon's elements. As a result of the collision with the ground (hard landing), at a low forward speed, the basket of the balloon and the partially deflated envelope overturned.

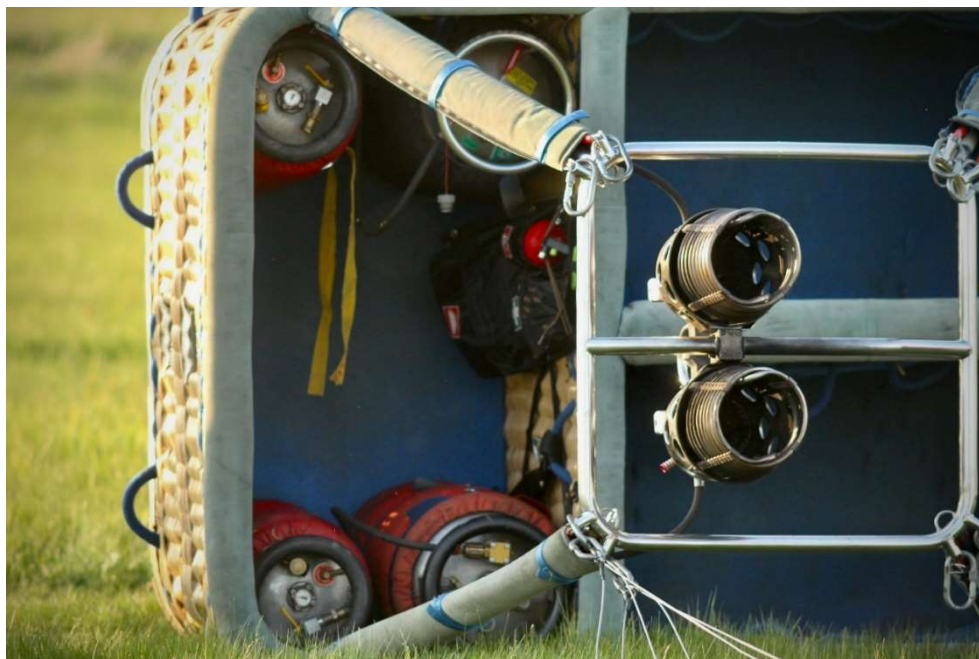
Fig. 7. Configuration of the balloon's basket – partially visible are the passenger compartments and components: burners and 3 gas cylinders [source: materials obtained from the pilot].

The basket turned over on impact against the ground due to the forward movement of the balloon caused by the effect of the wind. During the hard landing, the female passengers and the pilot were subjected to strong G-force and inertial force directed downwards and in the direction of the balloon's movement.

The impact took place with the burners on and gas valves on the gas cylinders open. In one of the compartments, there were three metal cylinders. The reserve of gas was around 60 l. These circumstances posed a real hazard of burns to the persons in the basket, and of a fire of the balloon.

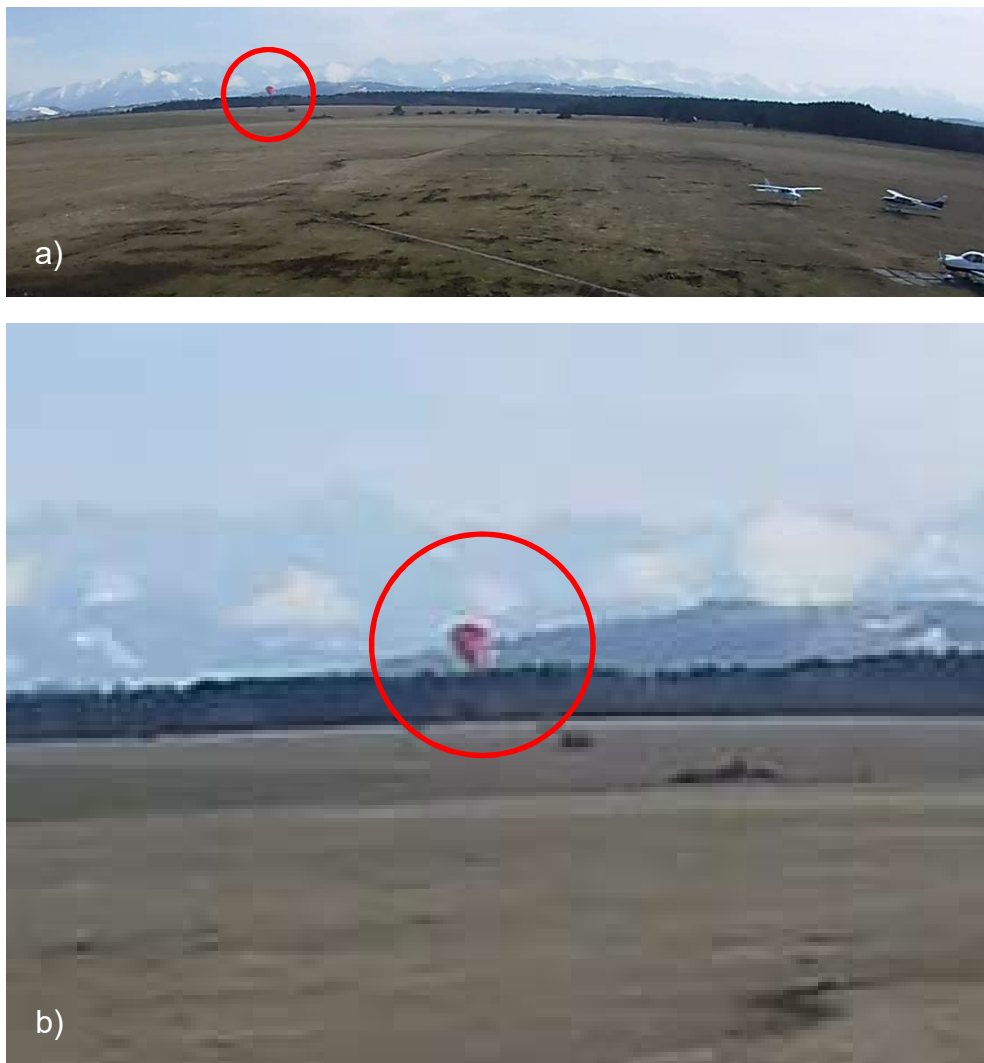
When the balloon was lifted, the pilot, fearing that the men outside the basket, who were holding the balloon, could be crushed under the basket, instructed them to let go of the aerostate. However, one of the men was lifted by the basket and fell to the ground, but he sustained no injuries. The balloon ascended to the tree top height. The situation was recorded by a CCTV camera at the EPNT aerodrome (Fig. 8).

Based on that recording, it was established that the time that passed between the first landing (touchdown) and lifting of the balloon was only around 2 minutes 50 seconds. Over that time, the men got out of the basket and moved it on the meadow for several metres.

Fig. 8. Recording from a CCTV camera at the EPNT aerodrome – a view to S: (a) the balloon after being lifted into the air, just before the accident (the highest point), (b) an enlarged fragment of (a) [source: Aeroklub Nowy Targ]

The height of the balloon, from the base of the basket to the highest point on the envelope, is around 25 m. Based on the photograph (Fig. 8), it can be estimated that the aerostate ascended to the height close to its size, i.e. around 20÷25 m AGL. At the moment the balloon was lifted, the pilot activated the rapid deflation system to prevent the balloon from being lifted to a greater height.

The passengers together with the pilot should stay in the basket and wait for the assistant. The pilot could maintain the balloon in the vertical position (with the envelope over the basket) in order to avoid its possible collapse onto ground obstacles. It was fully possible, as there was a sufficient reserve of gas and, as the pilot stated, "After landing, the balloon was in the vertical position and the wind conditions did not indicate there could be any wind gusts". Therefore, the pilot did not need to hurry to deflate the envelope and risk its emergency collapse onto obstacles.

The balloon should be cooled to the condition in which it could be lifted, and then – after the arrival of the assistant – try to take further actions related to letting the passengers out of the basket, collapsing the envelope and disassembling the set.

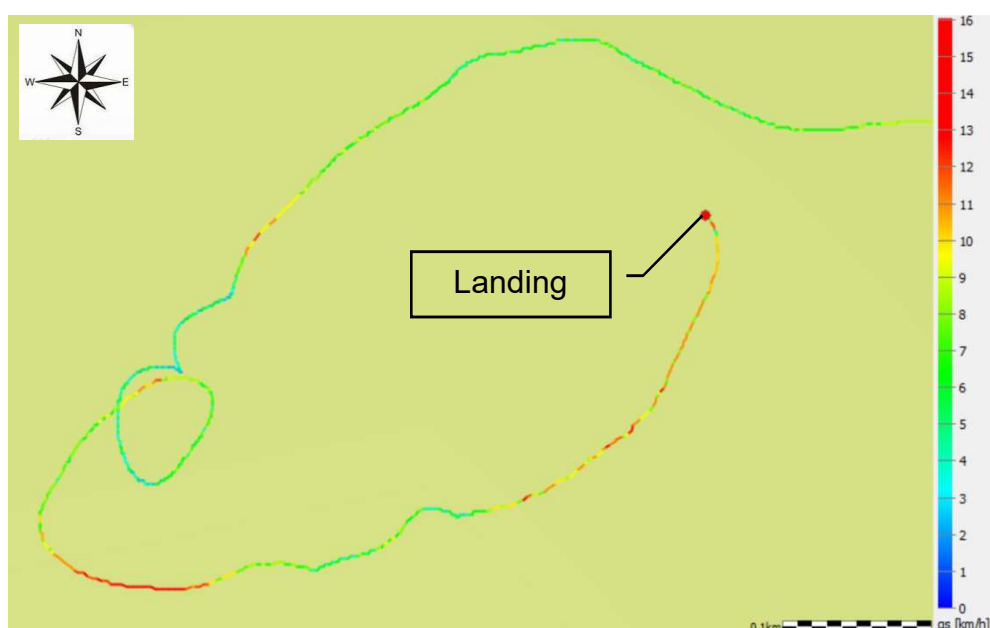
The wind gust which took place caused the balloon to move on the ground. The weather conditions prior to landing indicated that the air in the ground layer is not ideally calm – the wind direction and speed had been changing as illustrated by Fig. 9, which shows the flight path in the final 15 minutes before landing, from the height of around 200 m AGL and below. The coloured line corresponds with the colour scale on the right side of the figure (the so-called ground speed). However, it must be assumed that the speed was equal to the wind speed, as the aerostate gives in completely to the effect of the air, moving with it. Recordings show the balloon touchdown took place at the speed of around 10 km/h.

Fig. 9. The path and ground speed of the balloon in the final 15 minutes. The distribution of wind speeds and directions prior to landing [source: SeeYou]
