State Commission on Aircraft Accidents Investigation
ACCIDENT 2023-0030
RESOLUTION
of 18th August 2023

Type and model of aircraft:	Aeroplane, Cessna C-182L Skylane
A/C registration marks:	D-EDYP
Date of occurrence:	25th June 2023
Place of occurrence:	EPJG (Jelenia Góra)

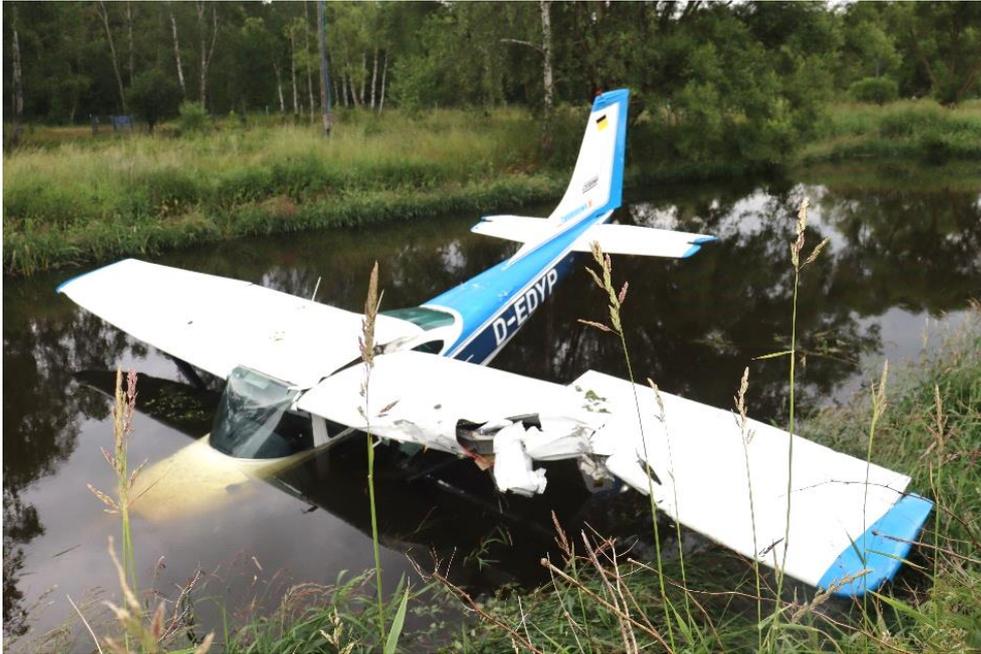
On 25th June 2023, individual and tandem parachute jumps were performed from a Cessna C-182L aeroplane operating from the Jelenia Góra aerodrome (EPJG). In the third flight, the jumpers left the aircraft at 3000 m AGL¹ over Góra Szybowcowa in Jeżów Sudecki. The aeroplane pilot performed a descent to the north of the EPJG, entering the right circuit to RWY 28, following which he commenced a long and low approach. While configuring the aeroplane for landing, the pilot realised that the engine had stalled and did not respond to throttle movements. In order to extend his range in a gliding flight, the pilot retracted the flaps and continued the flight towards the aerodrome. At ca. 700 m before the runway threshold, the aeroplane caught on a tree with its left wing. It lost its forward speed and, making an uncontrolled $\frac{3}{4}$ horizontal turn, hit an earthen embankment flat and vertically at 13:15 hrs LMT². After that, it fell into a water reservoir, which was ca. 1 m deep, located within a water intake for the City of Jelenia Góra. The aeroplane's wings and tail protruded above the water surface, whereas the cabin was flooded and the engine was completely submerged (Fig. 1).

Fig. 1 The Cessna C-182L Skylane after the collision with the tree, embankment and water surface of the reservoir [source: the Police]

The aeroplane was destroyed due to the collision with obstacles.

Prior to the PKBWL arrival, at the request of the commander of the law enforcement services on site, due to fears of possible contamination of the water intake with the aeroplane's operating fluids, the IIC⁵ permitted urgent recovery of the wreckage from the reservoir. The on-site inspection demonstrated that the fuel tank in the aeroplane's right wing was empty and without any fuel residues, while the fuel tank in the left wing contained a residual, hardly noticeable quantity of fuel. The fuel distributor switch in the cabin (the main valve) was set to the intake of fuel from the right-wing tank. The damage to the propeller indicated that the engine was not running during the occurrence.

The immediate cause of the engine stall was fuel starvation.
