Państwowa Komisja Badania Wypadków Lotniczych

# FINAL RAPORT

2023-0005

### **Robinson, R22 Beta, OK-MAZ.**

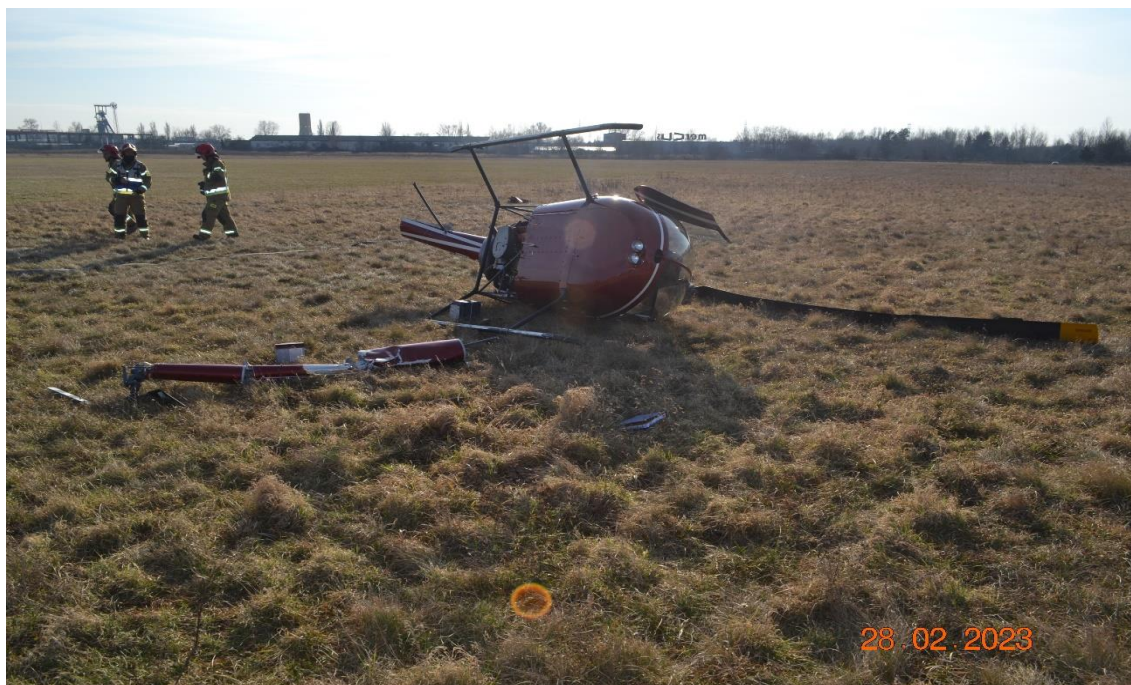
The helicopter was substantially damaged. All the damages to the helicopter were the result of its collision with the ground. The results of the collision with the ground include:

- damaged main rotor blades;
- damaged main rotor hub;
- damaged covering of the left side of the fuselage;

- separation of the tail beam from the fuselage along with the tail gear and tail rotor blades.

Figure 1 Robinson R44, OK-MAZ – at the place of occurrence.

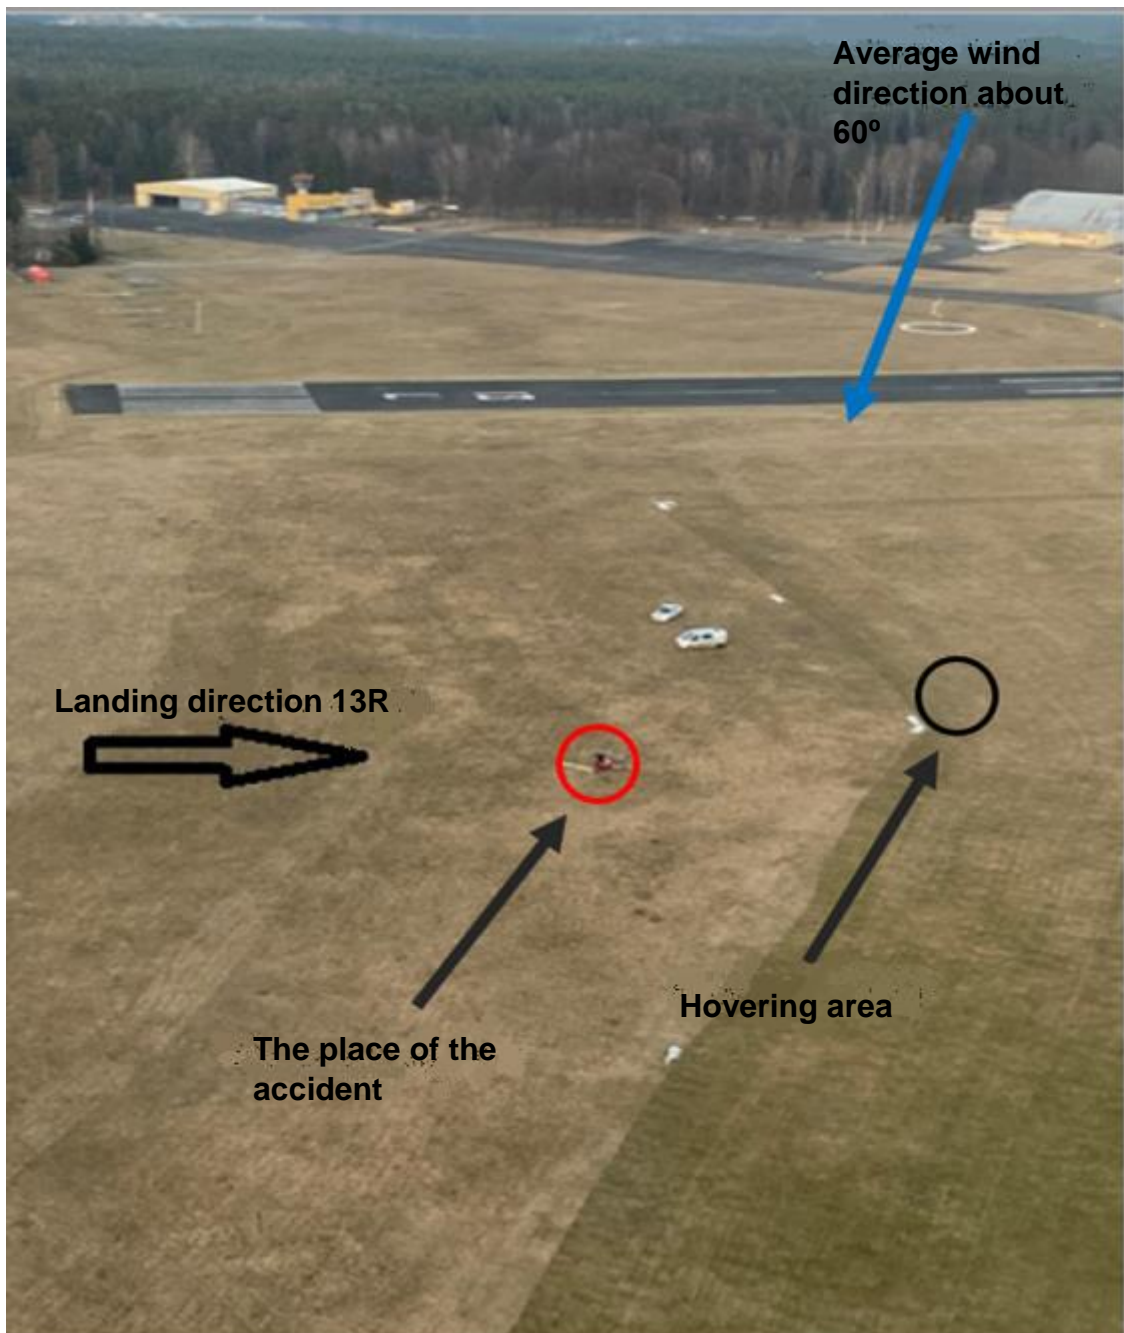
According to witness statements, the helicopter made about two rotations to the right along the vertical axis, during which it moved about 15 m in a westerly direction (Figure 4).

Figure 4 The blue arrow indicates the average wind direction, the black circle marks the hovering area, the red circle marks the accident site.

All the debris of the helicopter was found on an area of about 30 m<sup>2</sup>, on the grassy, operational part of the airport.

While hovering (at an altitude of about 2 m), the helicopter rotated to the right around the vertical axis, and then the helicopter moved in an uncontrolled manner about 15 m in a westerly direction. While in tilt to the left side, one of the of the main rotor blades hit the ground. As a result of the destruction of the main rotor blades, the helicopter collided with the ground on the grassy part of the airport and then rolled over onto its left side.
