State Commission on Aircraft Accidents Investigation

FINAL REPORT

2023-0024

CH 601, OK-KUA15 .

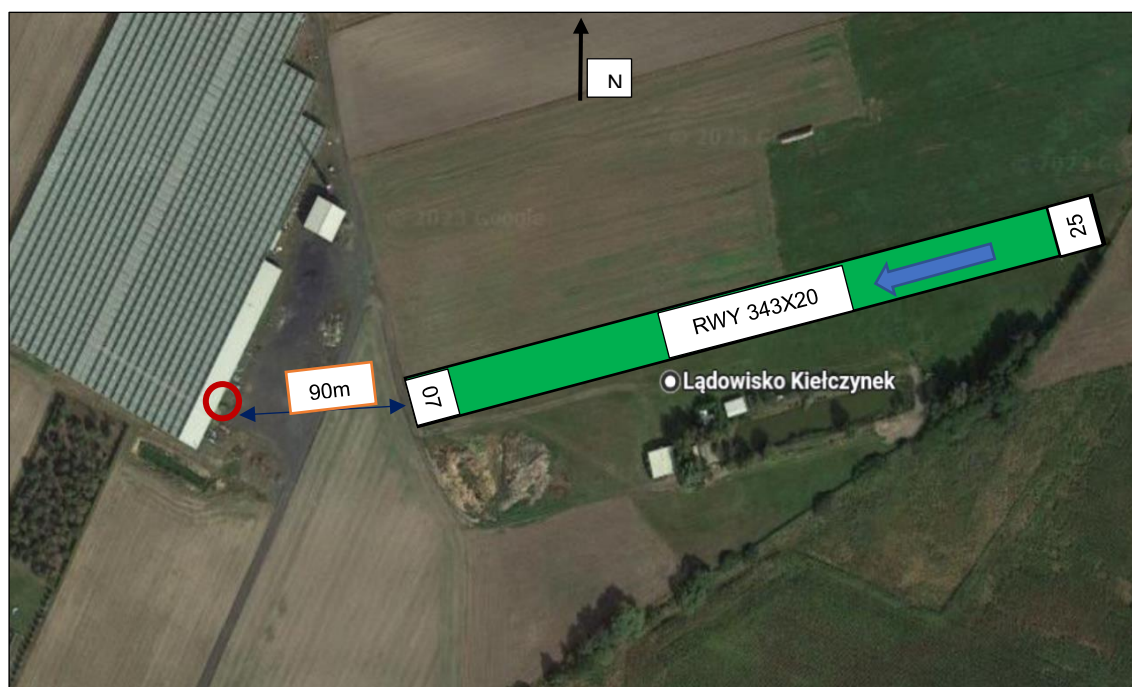
Figure 1. The accident area – the blue arrow indicates the direction of the flight, while the red circle shows the place where the aeroplane collided with the building.

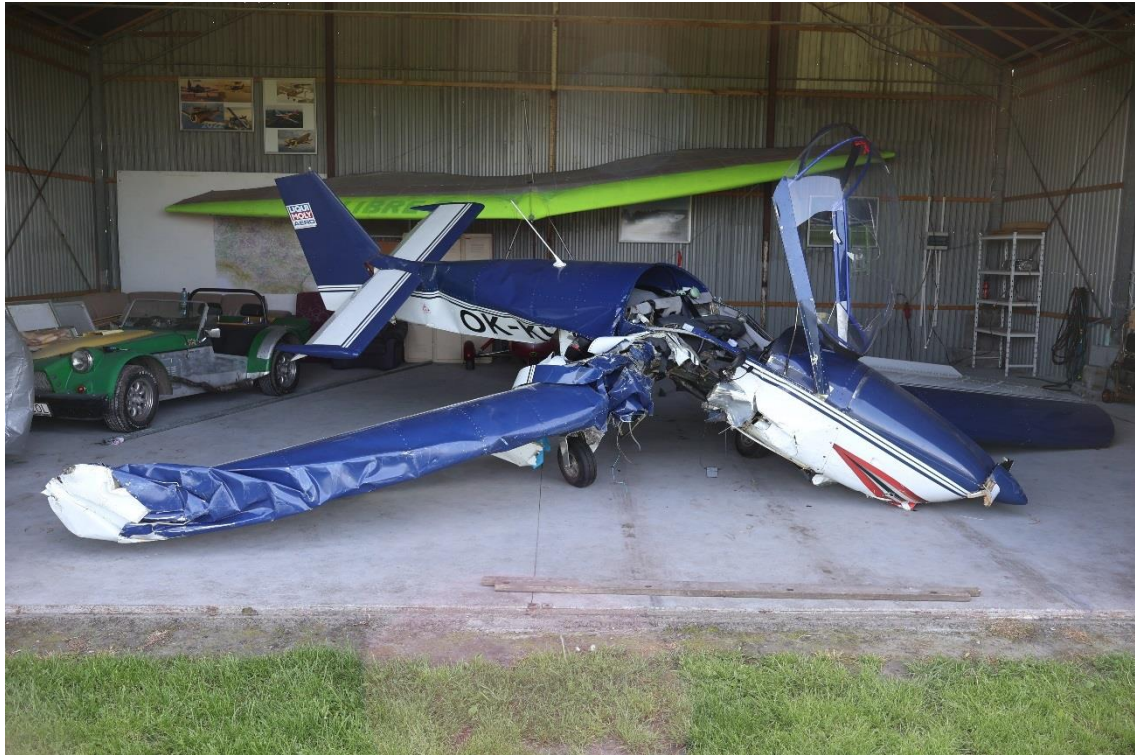
The aeroplane was destroyed as a result of the accident. All damage to the aeroplane was caused by the collision with the outbuilding. The wreckage is shown in Fig. 2.

Figure 2. The wreckage after being moved to the hangar.

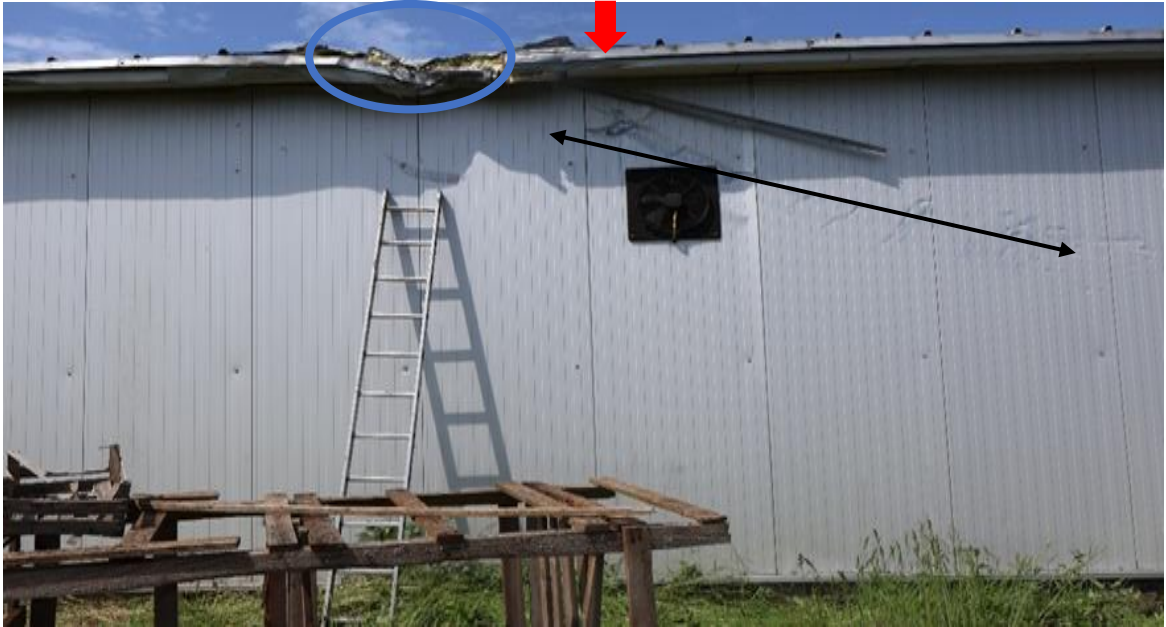
After take-off, on passing the runway threshold, the aeroplane collided with an outbuilding located on the runway's axis at 90 m from its threshold (Fig. 3). When hitting the building at 3.75 m over the runway, the aeroplane was banked 20° to the right, as a result of which the front section of the fuselage hit the roof surface, the right wing hit the building's wall, and the main impact of the lower fuselage was on the edge of the roof. The left wing, which was above the surface of the roof at the moment of impact, sustained the least damage (Fig. 4).

Figure 3. The place of the aeroplane's impact on the building: the main impact on the edge of the roof (blue circle), the impact of the right wing (black line), the impact of the front fuselage (red arrow).

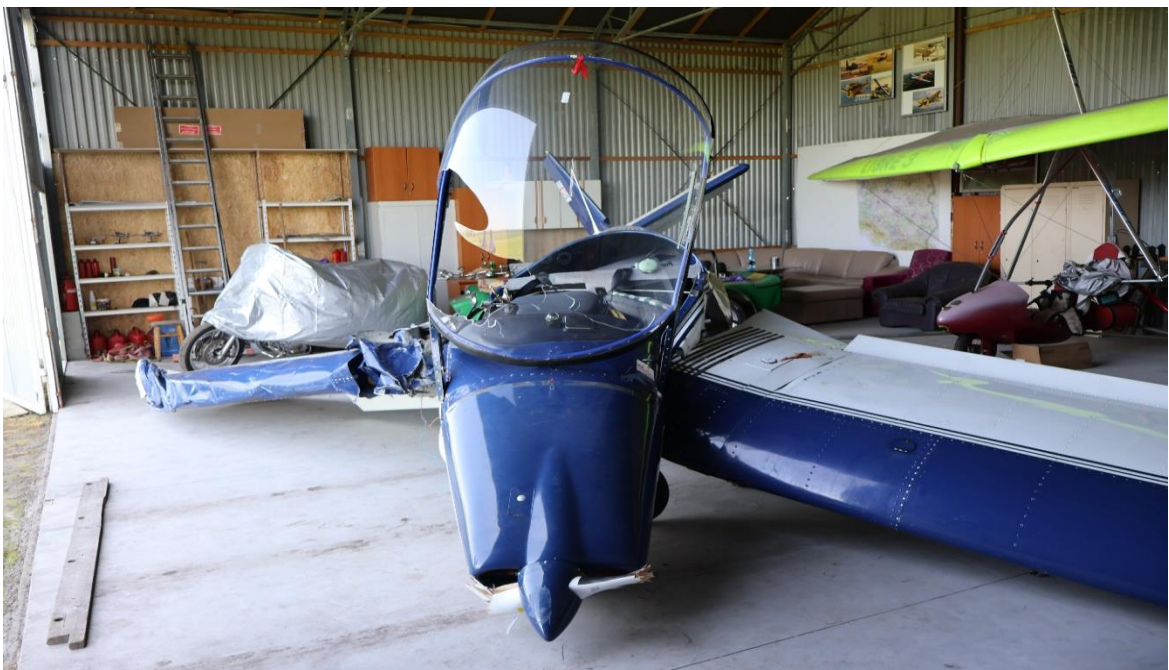
Figure 4. The view of the damage to the propeller and left wing of the aeroplane.

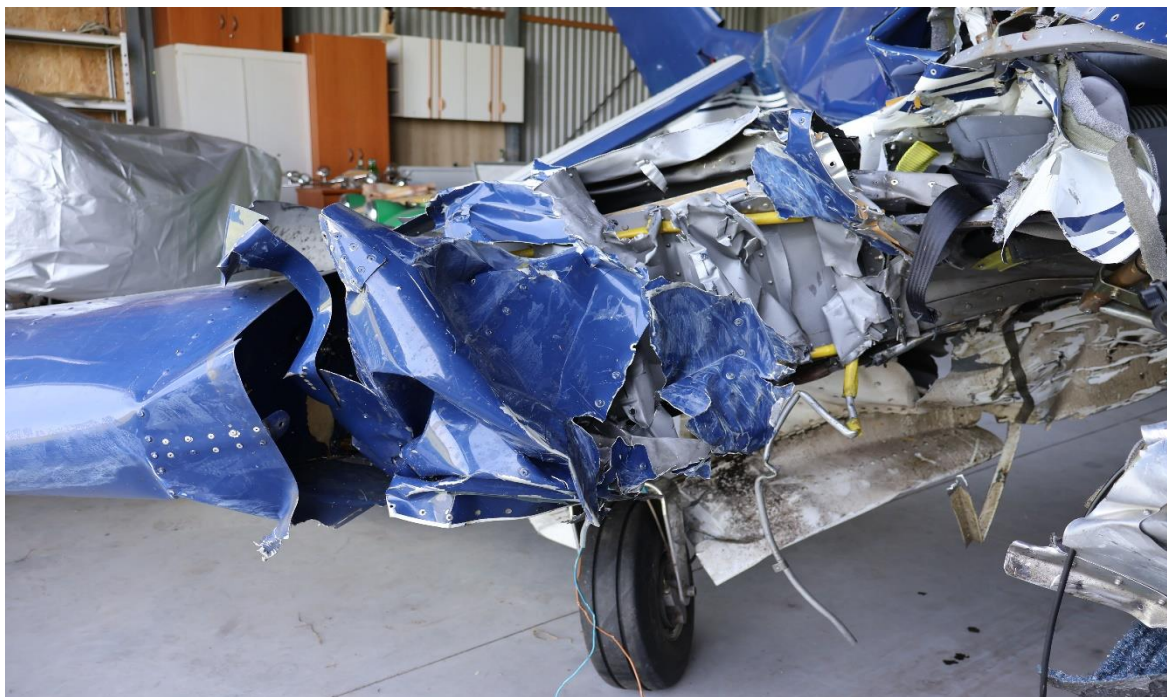
The edge of the outbuilding's roof was damaged.

Figure 5. The damage caused by the aeroplane's impact on the edge of the roof.

An inspection of damage to the wreckage and building shows that the edge of the roof made of metal sandwich panels cushioned the force of the impact.

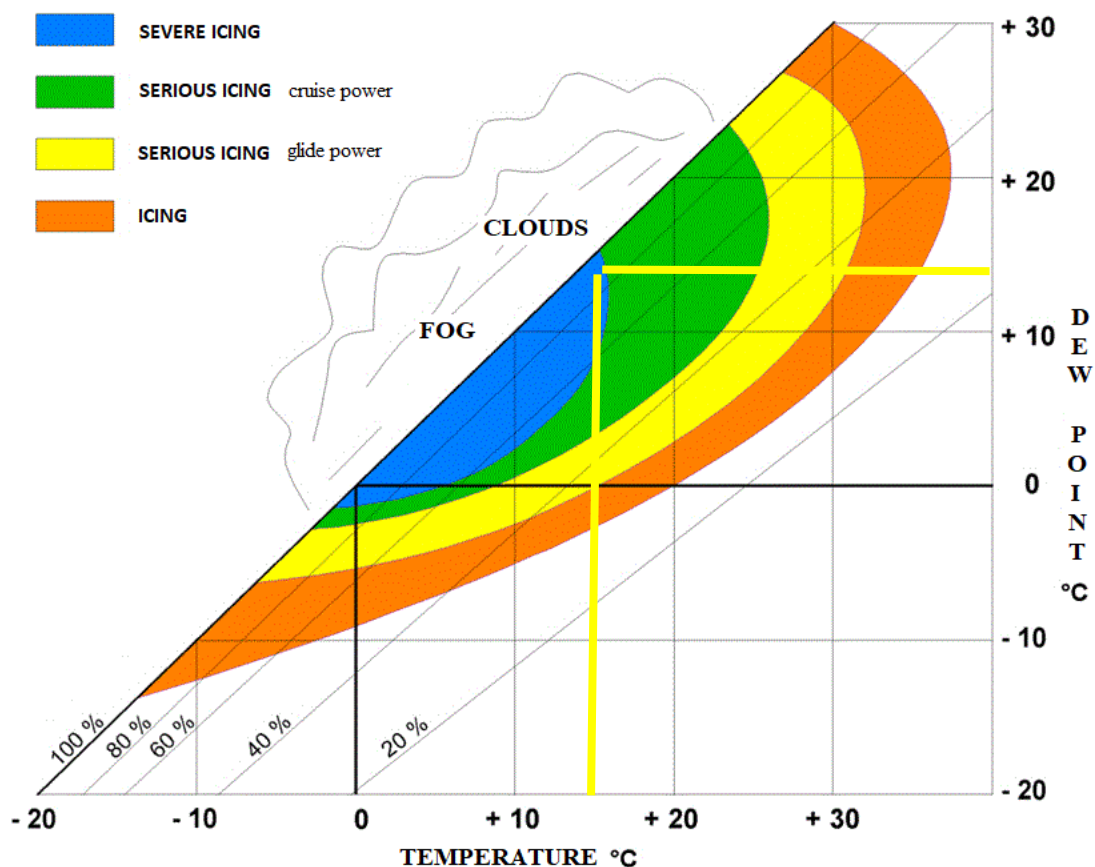
The above meteorological data was plotted on a chart (Fig. 6) showing the likelihood of ice formation on aircraft piston engines (yellow lines).

Figure 6. A chart showing the carburettor icing probability [source: the Internet] Internet]

The chart shows clearly that intensive carburettor icing was likely during the occurrence at any stage of the flight.

It is likely that the meteorological conditions had caused carburettor icing, thus causing a decrease in the engine power and lower thrust generated by the propeller, leading to a longer take-off run.
