# FINAL RAPORT

## 2024-0009

Reims Aviation Cessna, Cessna F150F, D-EKIQ

Warsaw, 1 March 2024

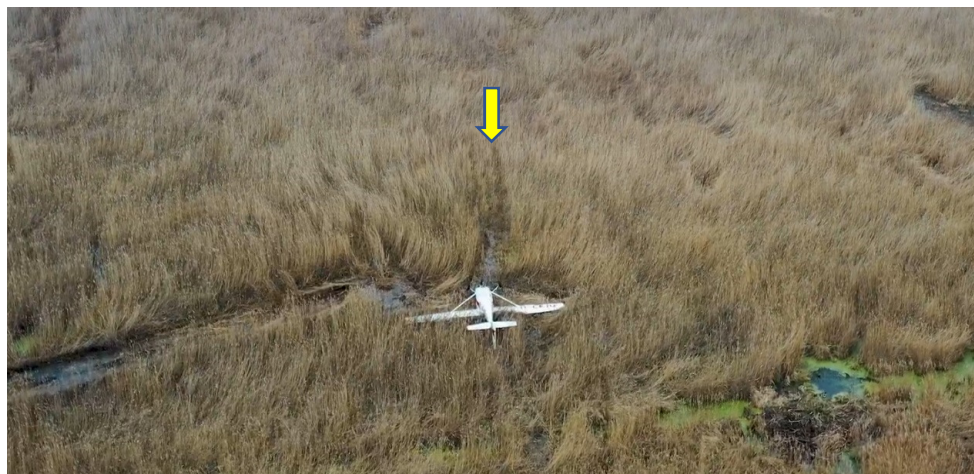
Fig. 2. The position of the airplane after overturn, with the touchdown point marked by a yellow arrow

The airplane sustained minor damage, mainly to the nose section of the fuselage. All damage to the airplane was caused by the collision with the ground and overturning on a very waterlogged ground that generated a strong resistance. No other visible damage that could have been caused earlier was found. The locations and character of the damage to the airplane are shown in Fig. 6. The very small damage to the airplane shows that the pilot performed a correct landing.

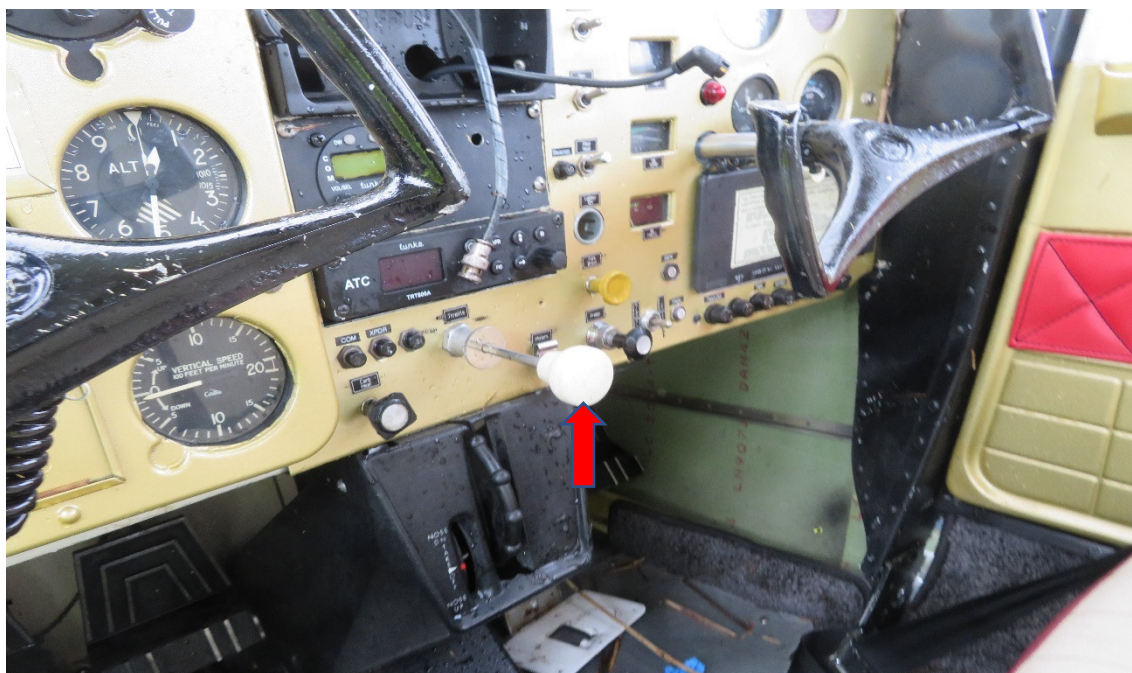
The pilot considered at that moment that the engine speed drops could be caused by a malfunction of the throttle control mechanism and he ruled out carburettor icing, which is why he did not turn on carburettor heating any more until the end of the flight. It was found during the inspection of the cabin at the site of the occurrence that the carburettor heating lever had been in the closed position and the throttle lever had been in the opened position (Fig. 3).

Fig. 3 A view of the pulled out throttle control lever.

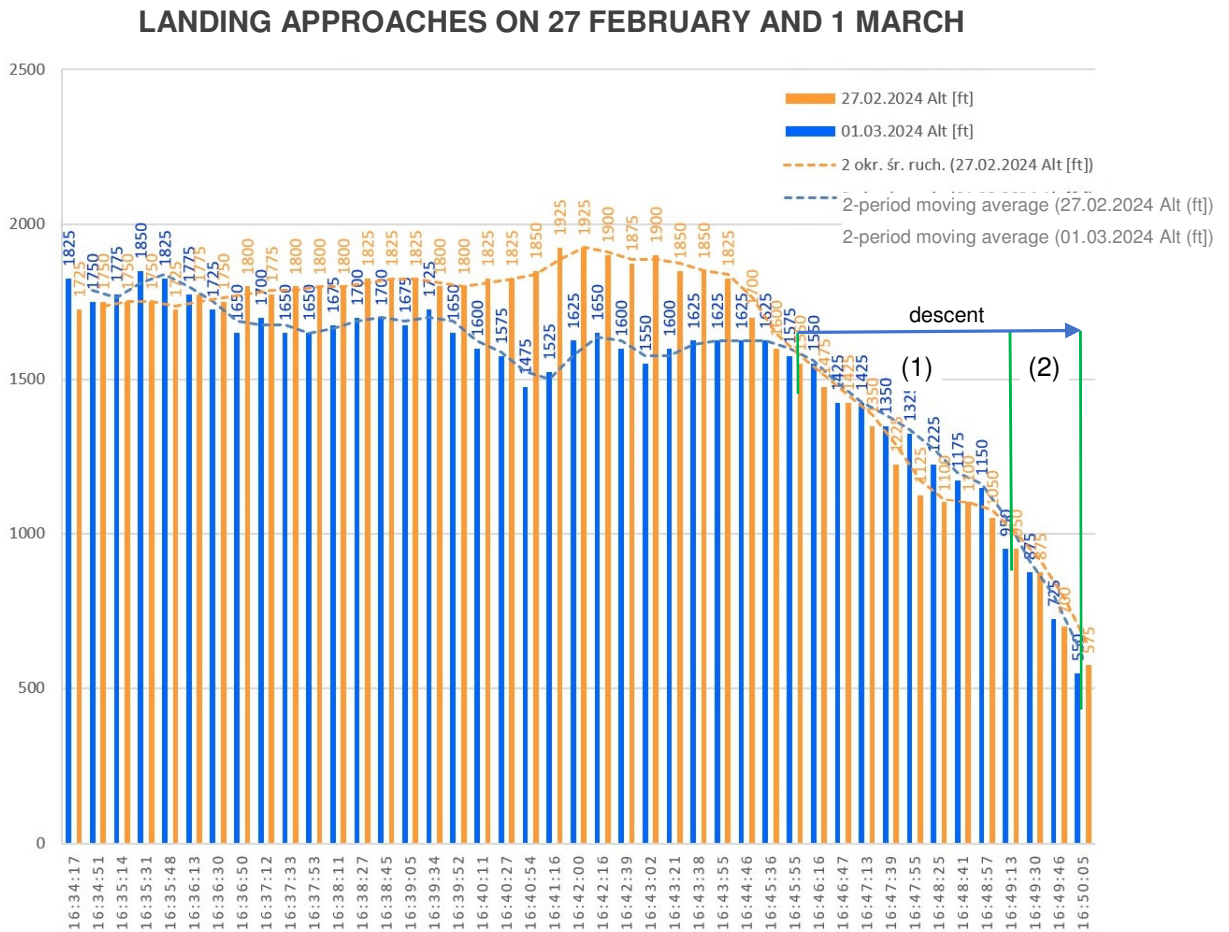
Fig. 4. A chart of the Cessna's flight altitudes during approaches on 27 February and 1 March and 2024.

- the flight path during descent was at similar altitudes in both flights;
- in the first phase in Fig. 4 (1), the descent during the flight on 1 March 2024 proceeded at an altitude higher by approximately 100 ft;
- in the second phase in Fig.4 (2), the descent proceeded at a slightly different altitude, with the difference below 25 ft.

The similar characteristics of the two flights, notably almost identical flight paths during descent, confirm that it was possible to continue the flight to the aerodrome.

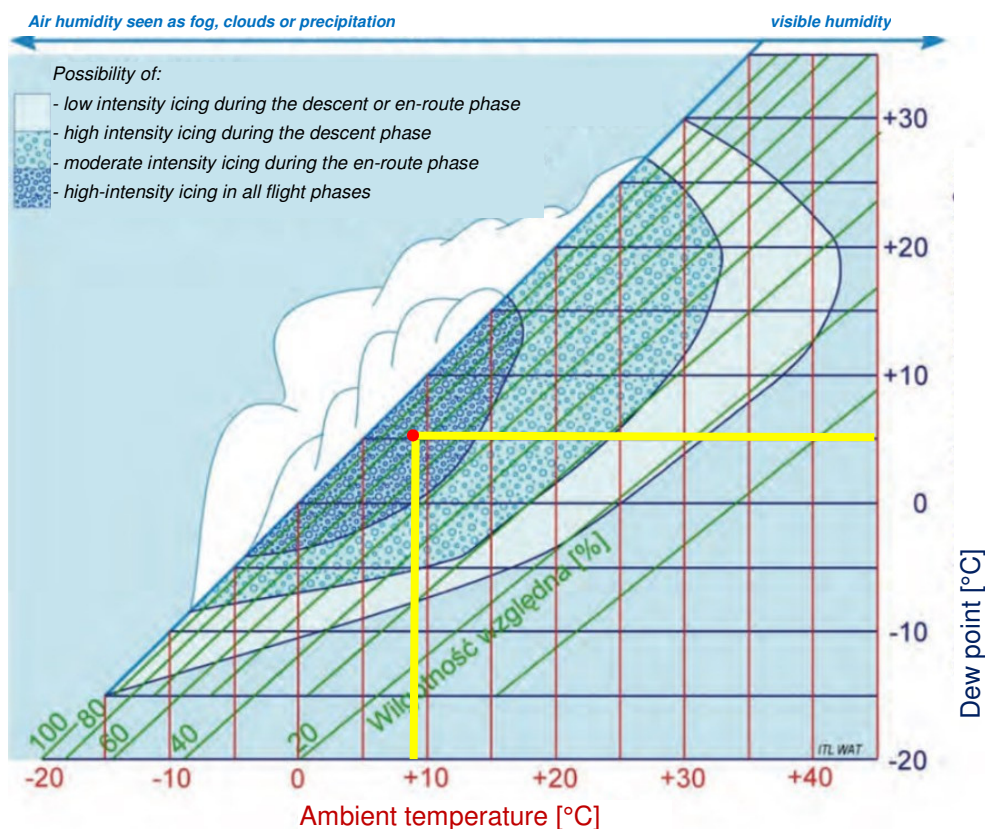
Fig. 5. A graph for determining the possibility of carburettor icing [source: the Internet]

**The graph shows clearly that at the time of the occurrence carburettor icing was likely at each phase of the flight.**

- high air humidity: 76.03%;
- car fuel - due to its higher volatility and water content;
- strong susceptibility to icing in the fuel feed system of the Continental O-200A engine;
- partial opening of the carburettor heating lever during the flight;
- decision not to turn on carburettor heating prior to the start of the descent to land;

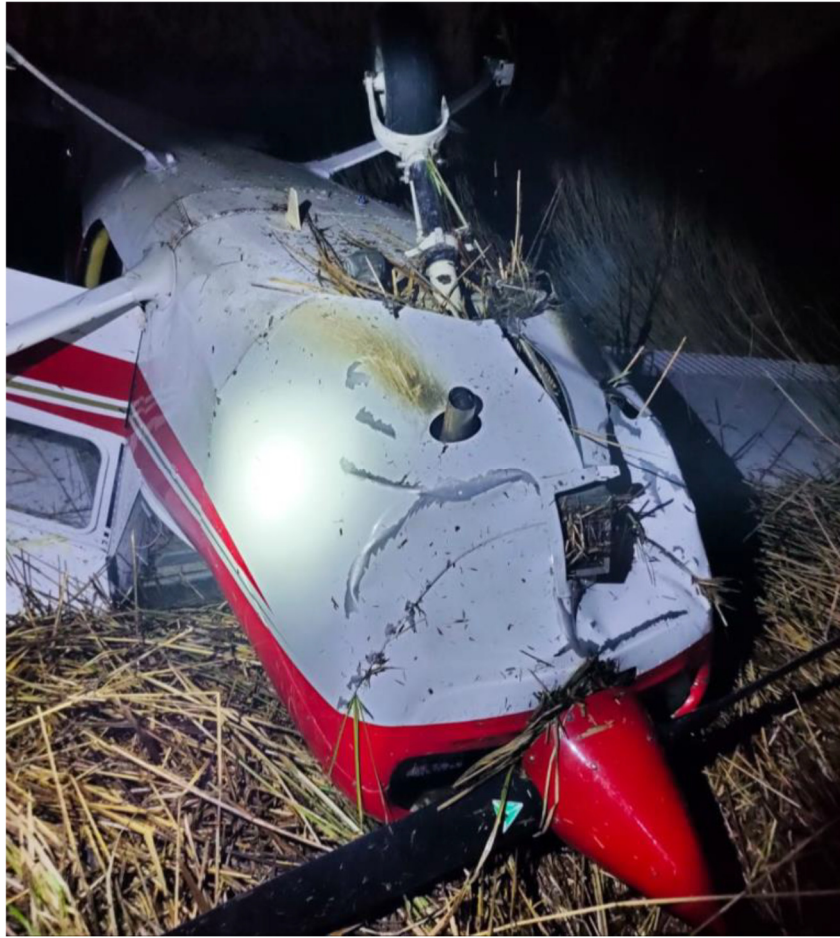
Fig. 6. A view of the damage to the nose section of the fuselage.

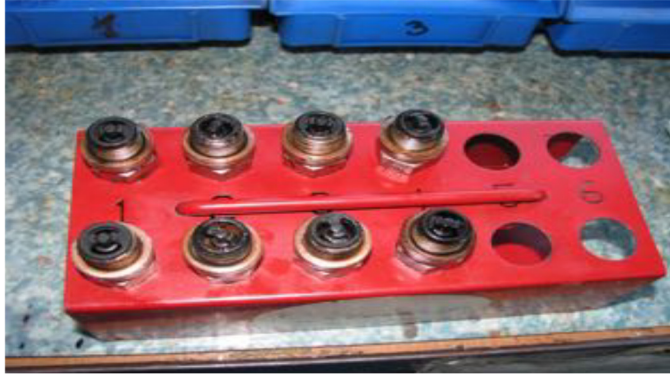
The spark plugs were checked on an SPCT100 test bed and found to be in working order. The colour of the carbon deposit on the spark plugs indicated a normal engine performance, appropriate composition of the fuel mixture and proper performance of the ignition system (Fig. 7).

Fig. 7. The spark plugs before cleaning.

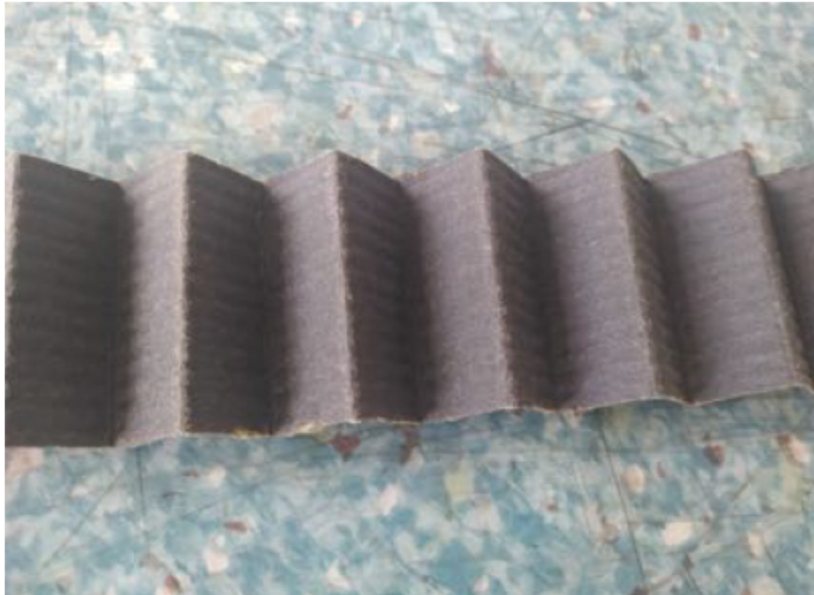
The absence of soiling and metal filings in the oil filter insert indicated proper performance of the engine's crank and piston system (Fig. 8).

Fig. 8. A view of the oil filter insert

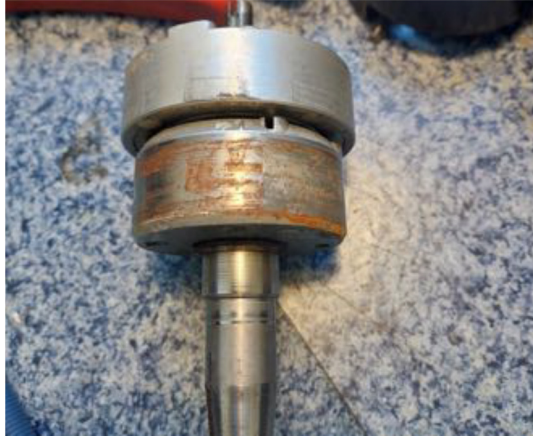
The magnetos were checked on a test bed. The performance of the right magneto was appropriate. On dismantling, components of the left magneto were found to be corroded due to long-term exposure to water. After cleaning, it was confirmed to work properly (Fig. 9).

Fig. 9. Corrosion visible on the magneto's stator.

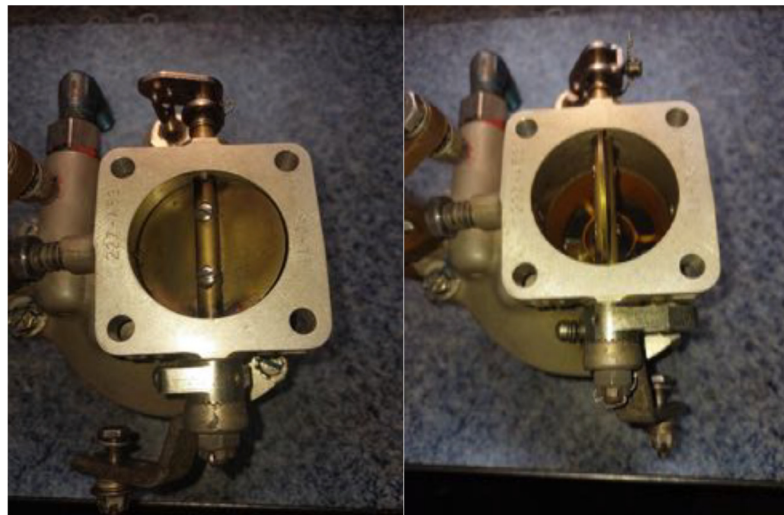
The throttle lever was found to move within the full range of travel (Fig. 10). The floater chamber was soiled with dirty water due to prolonged exposure of the engine to waterlogged terrain. The fuel level setting in the floater chamber was compliant with the standard.

The examination and check on a test bed confirmed its proper performance at the moment of the occurrence. The absence of soiling and traces of water in the initial fuel filter and fuel lines that feed fuel to the carburettor confirmed that the feeding system worked property at the moment of the occurrence.

Fig. 10. The throttle in the opened and closed position.

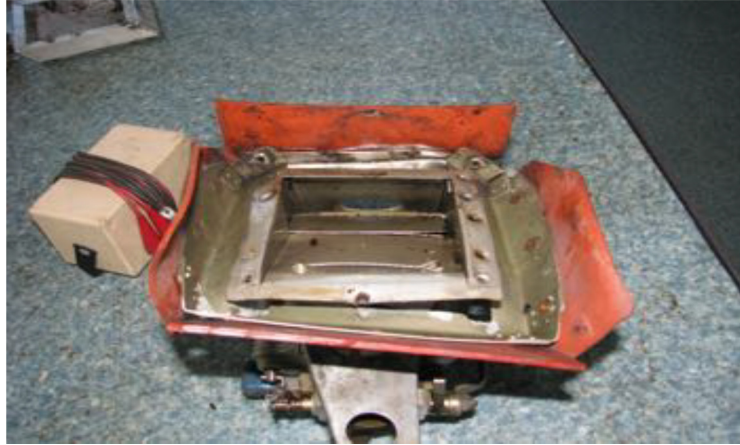
The throttle control system was found to operate properly. The lever moved within the full range of travel and tightly closed the hot air throttle.

Damage was found (deformed air inlet housing) due to the collision with the ground (Fig. 11). It was the only engine element that was damaged.

Fig. 11. A view of the hot air throttle with a deformed air intake housing.

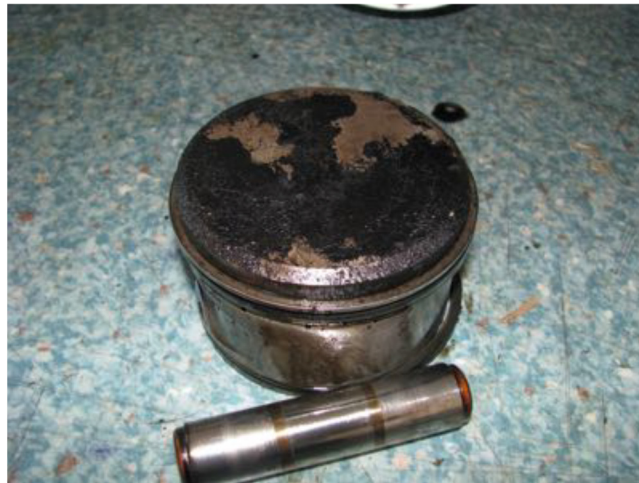
No traces of seizures, overheating or other damage were found on the cylinders, pistons and rings. The dark deposit found on the pistons was due to normal operation (Fig. 12).

Measurements of the piston/cylinder diameters and clearance confirmed proper operation of the pistons in the cylinders. Normal wear and tear was found.

Fig. 12. A dark carbon deposit visible on a piston.

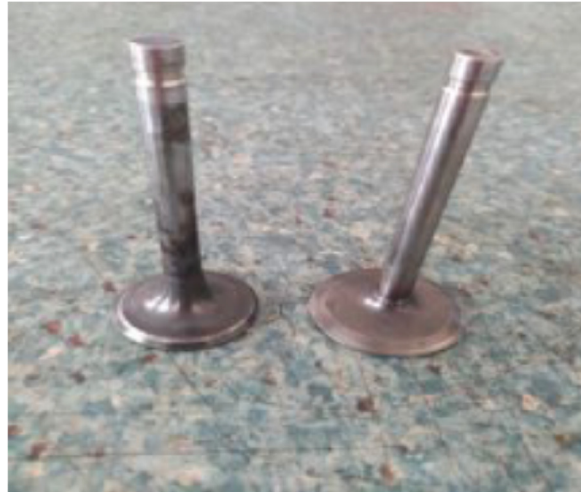
The condition of the valve face surface confirmed proper performance of the suction and exhaust valves that ensured tightness of the cylinders (Fig. 13).

Fig. 13 A view of the exhaust and suction valve faces.

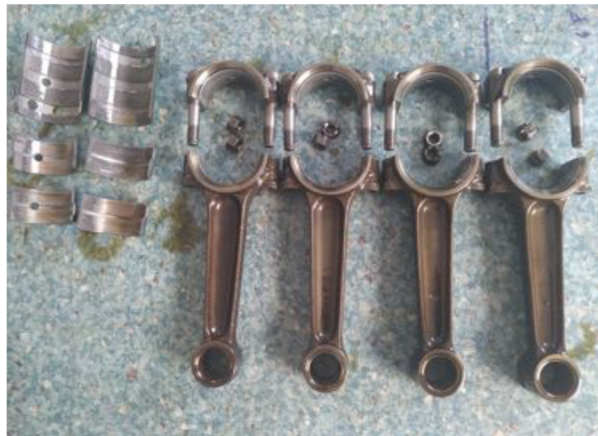
No signs of seizures or overheating were found on the surface of the con rods and bushings (Fig. 14). The bushings were properly mounted, and the presence of oil on the cooperating surfaces indicated that the lubrication system operated properly. The measured bushing and con rod slacks were within the values set by the manufacturer.

Fig. 14. A view of con rods and bushings
