State Commission on Aircraft Accidents Investigation

# PRELIMINARY REPORT

2024-0025

**Bell Textron Inc., Bell 505**

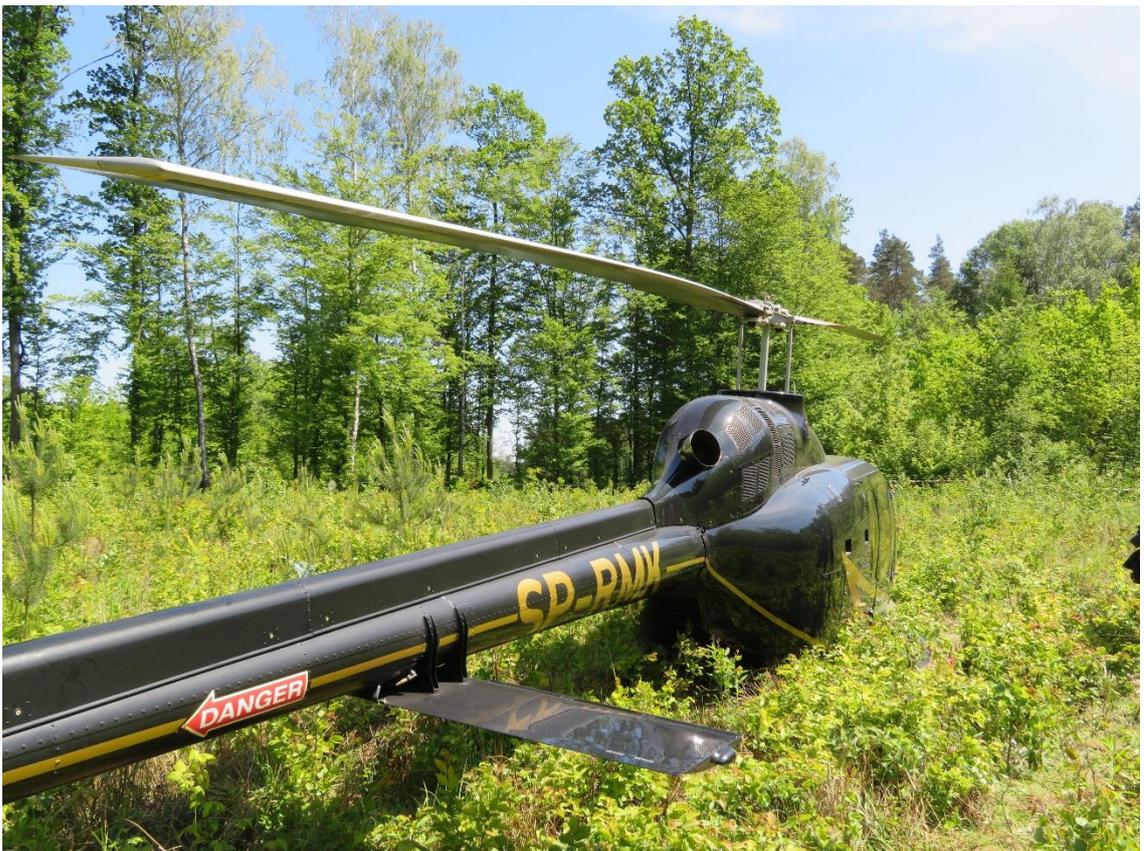
Figure 2. The helicopter at the site of the emergency landing.

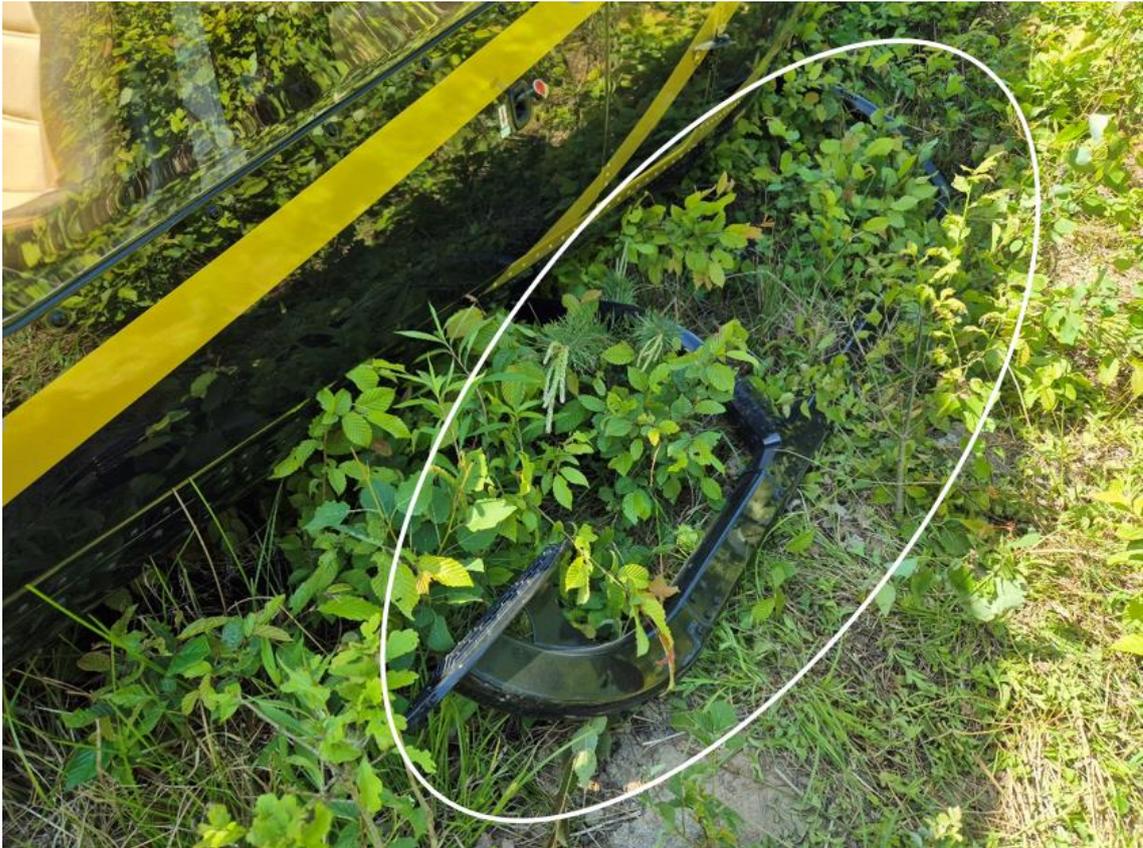
Figure 3. Damage to the left landing skid of the helicopter.

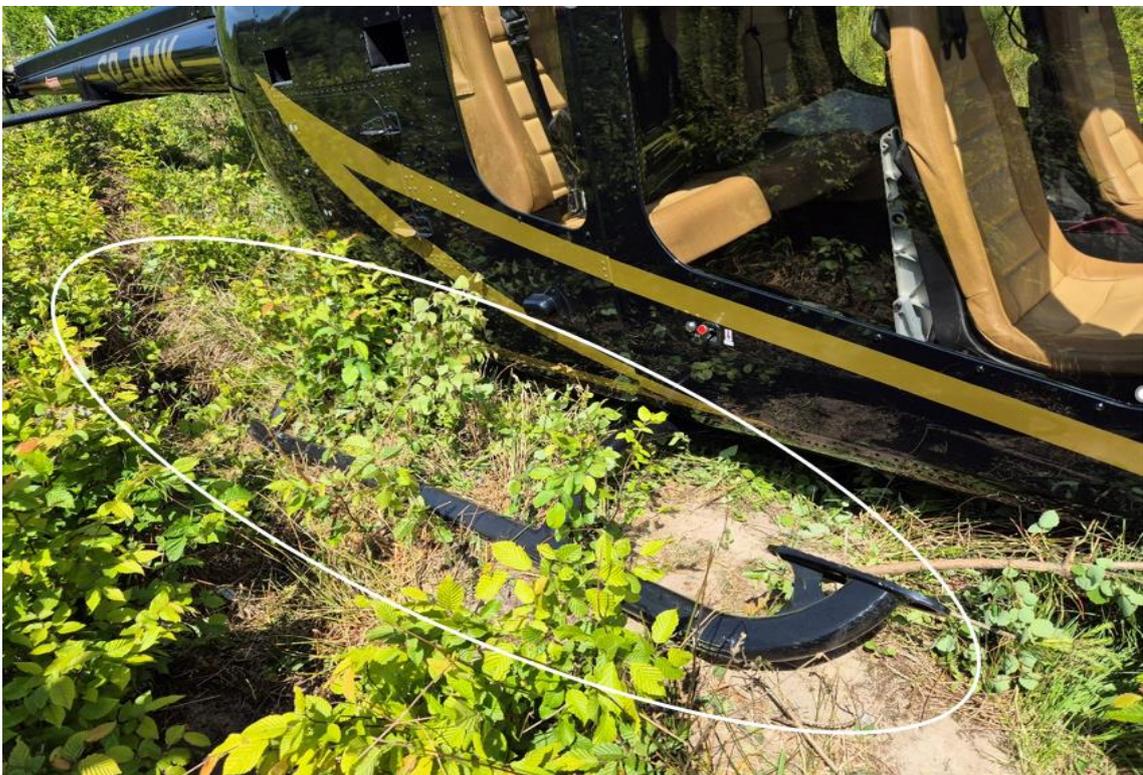
Figure 4. Damage to the right landing skid of the helicopter.

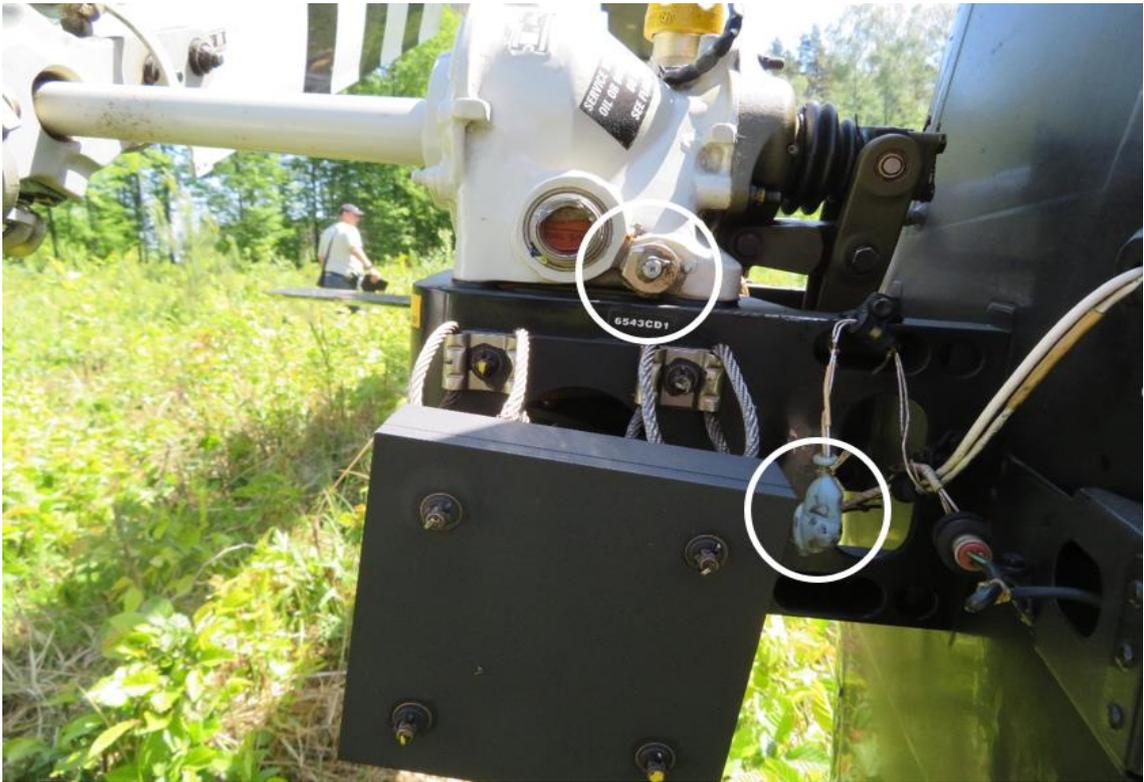
Figure 5. Damaged oil sight glass, torn off control cable chip detector in the angled gearbox.

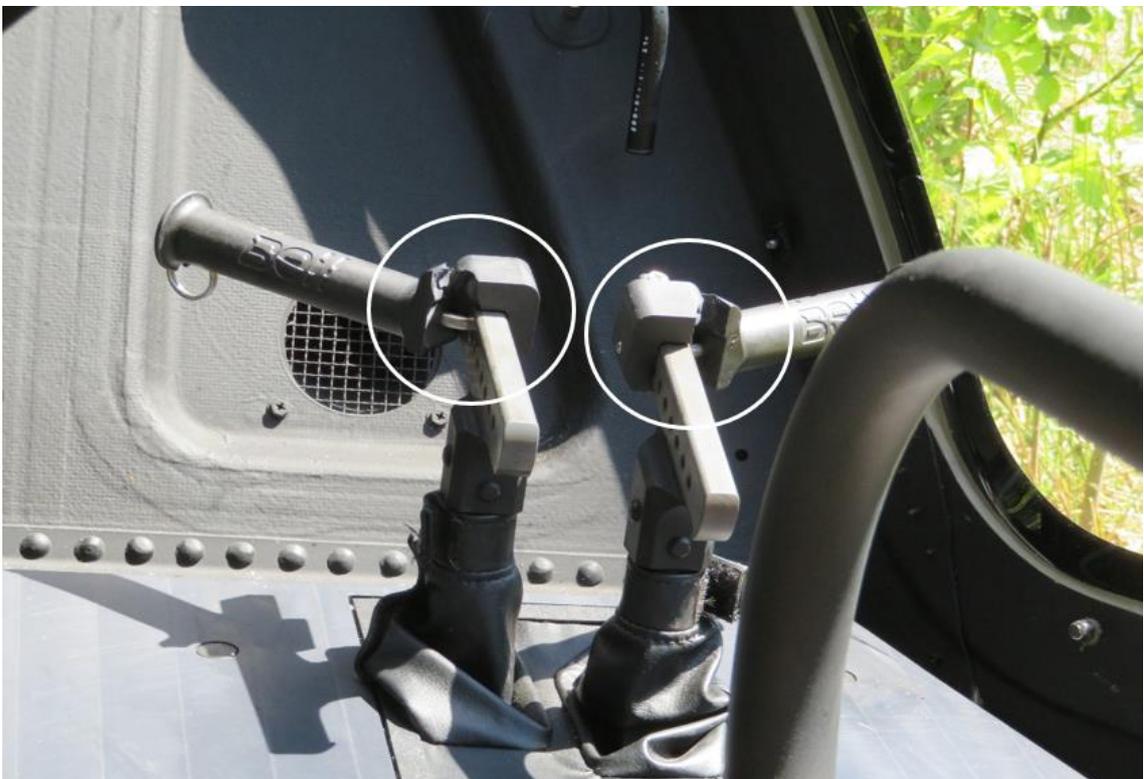
Figure 6. Damaged pedals on the side of the pilot flying.

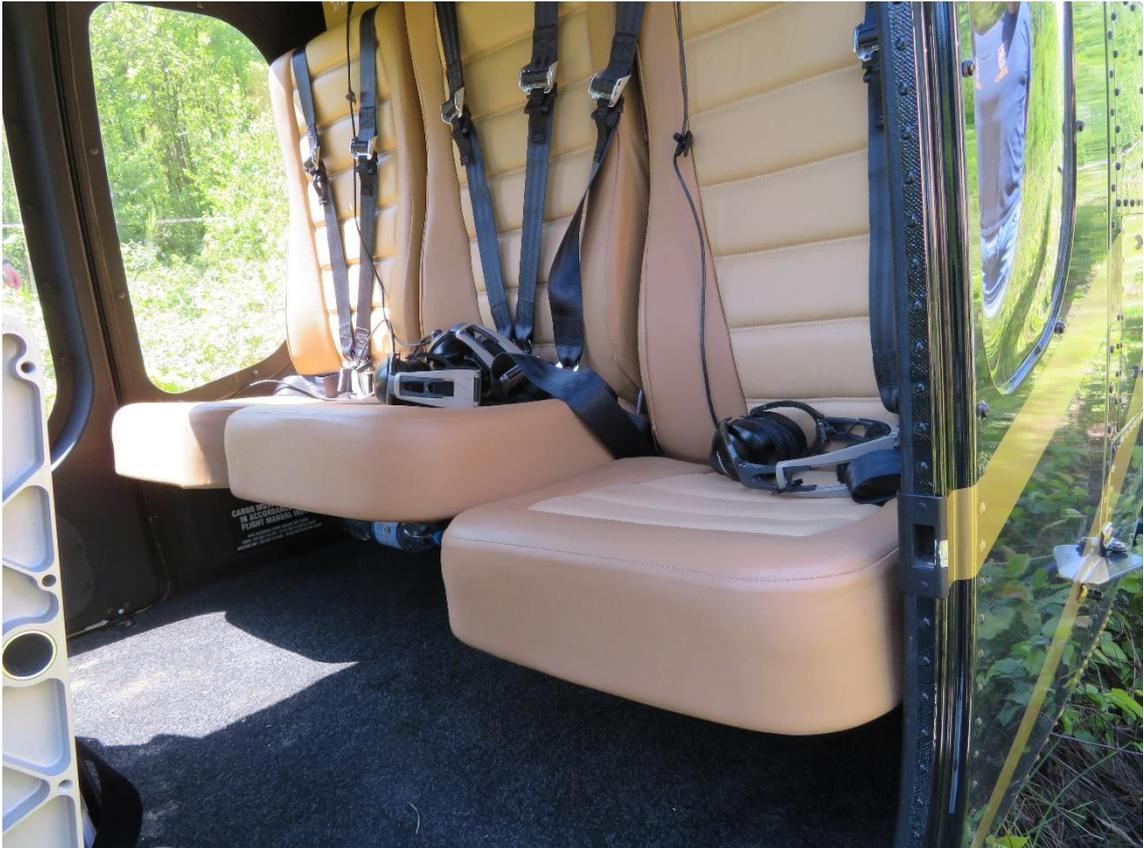
Figure 7. Rear passenger seat after operation of the energy absorption system

The seat occupied by the pilot and passengers sustained damage and deformation. The brackets mounting the cabin seats to the floor were partially deformed. This shows that the seat structure absorbed some energy of the helicopter ground impact.

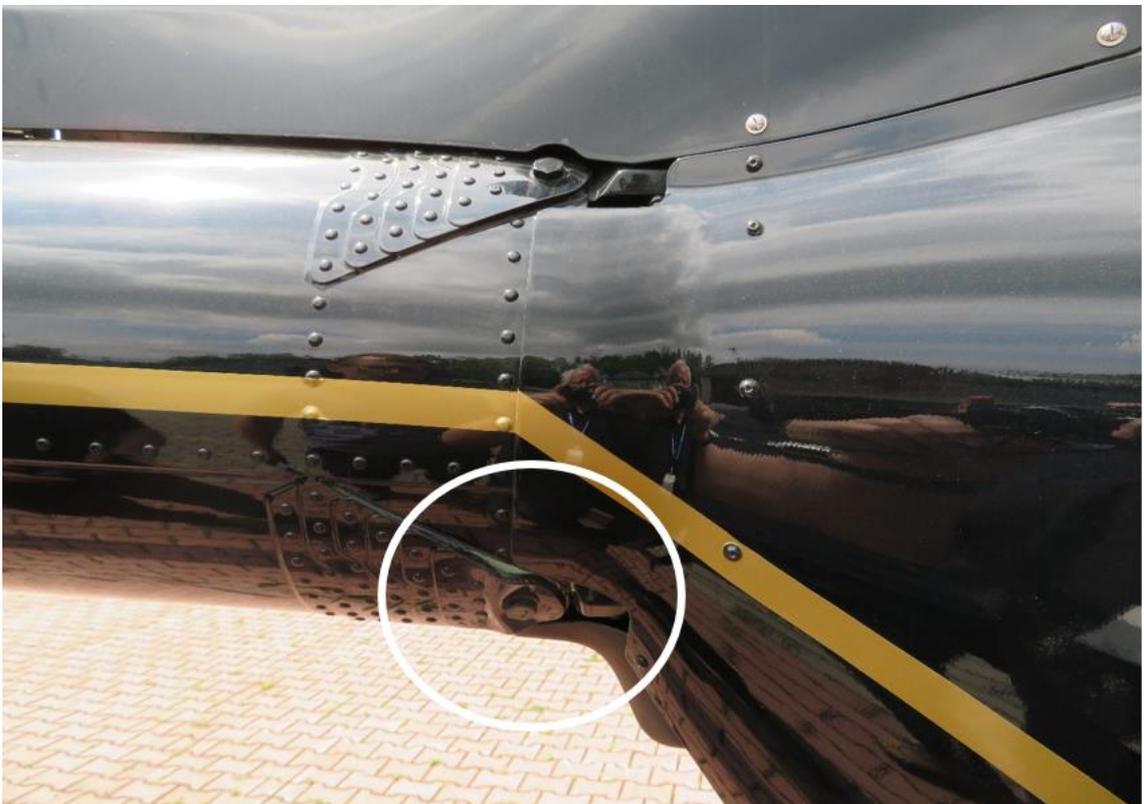
Figure 8. Damage to the lower attachment of the tail beam to the helicopter fuselage.
