# FINAL RAPORT

of the State Commission on Aircraft Accidents  
Investigation

## 2024-0083

Cessna Aircraft Company, Cessna 172 P, SP-RBI

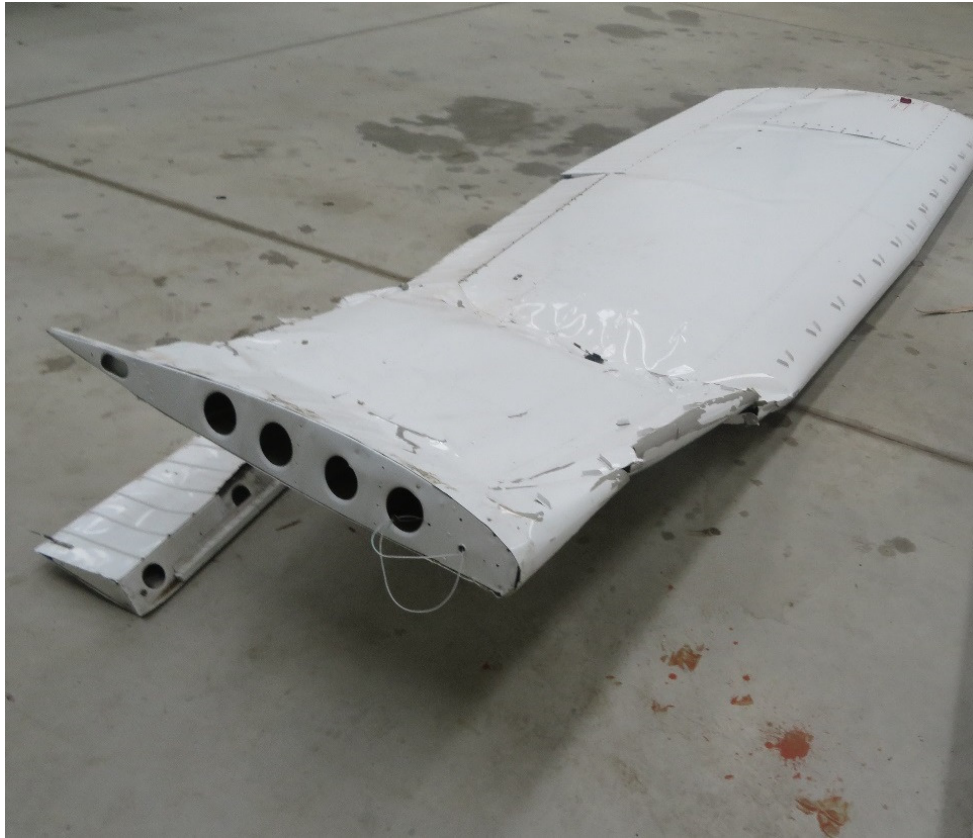
- 1) Right wing (Fig. 1);
- 2) Float struts (Fig. 2);
- 3) Fuselage skin at the cockpit's rear window (cracks)
- 4) Lower engine cowling (Fig. 3);
- 5) Left door (Fig. 4);
- 6) Float mounting elements (Fig. 5).

Fig.1. Destroyed right wing with the broken-off aileron

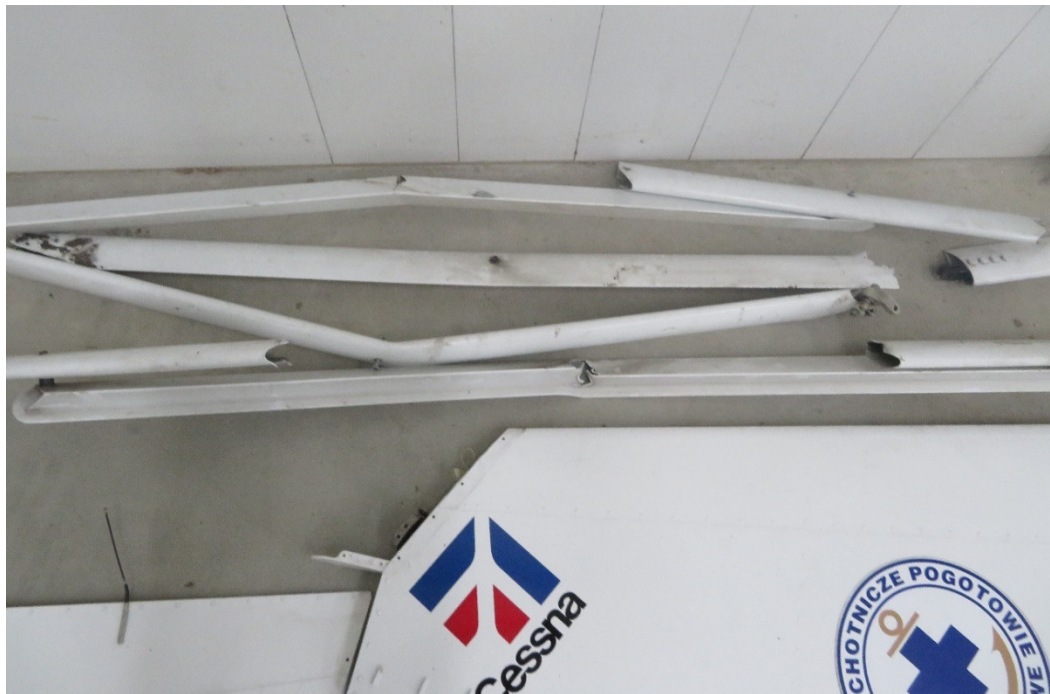
Fig. 2. Broken and bent float struts

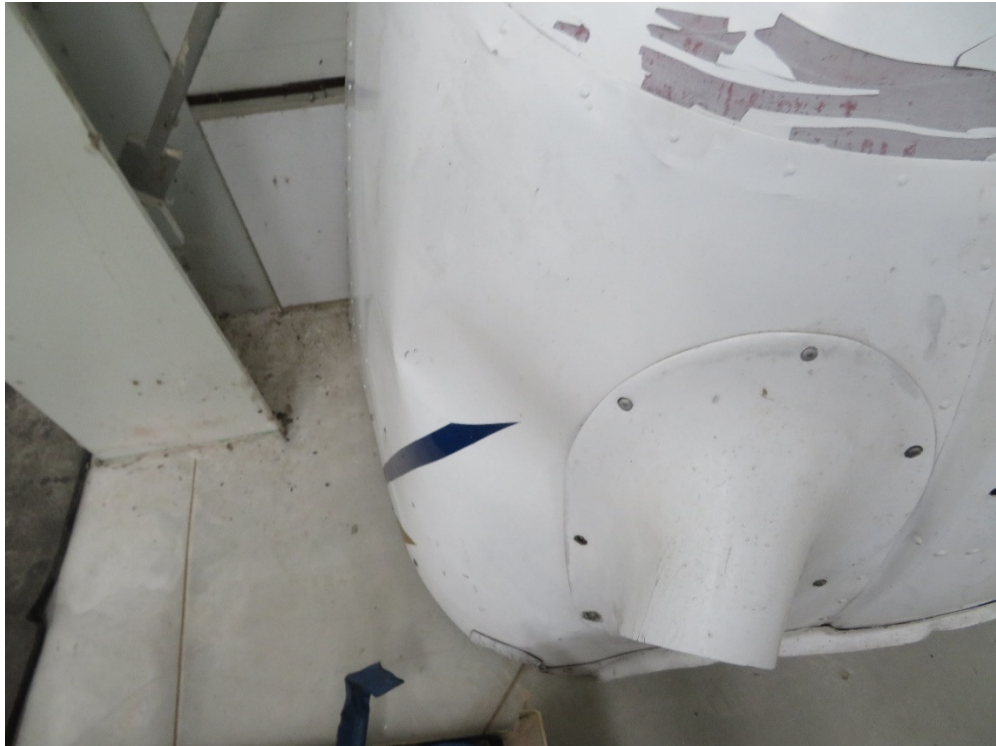
Fig. 3. Dents in the lower engine cowling

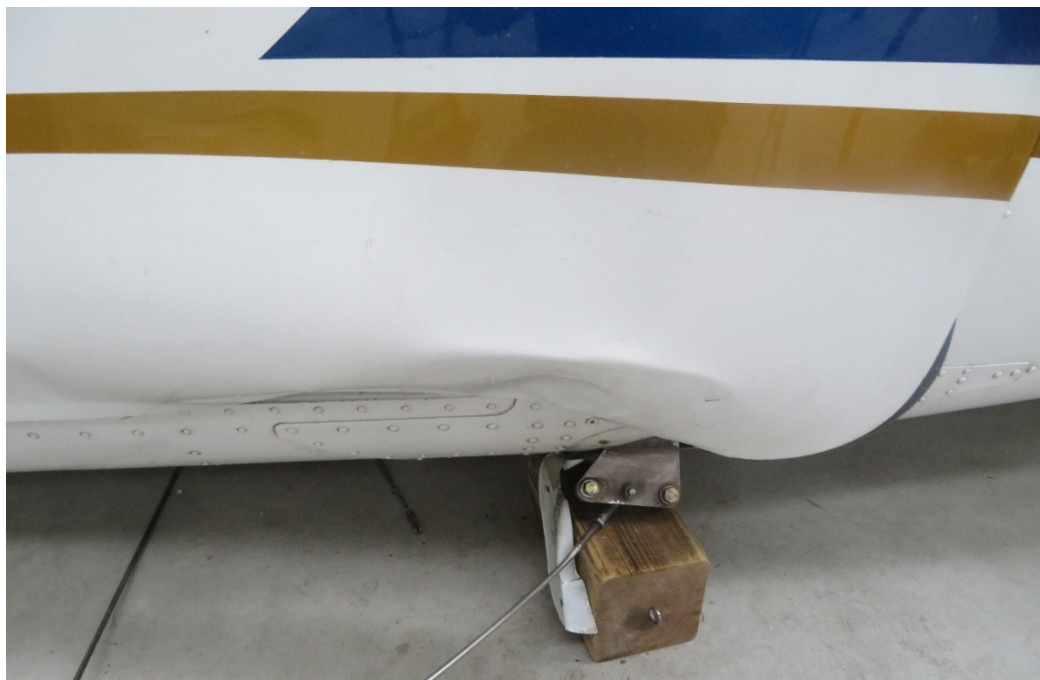
Fig. 4. Dents in the left door skin

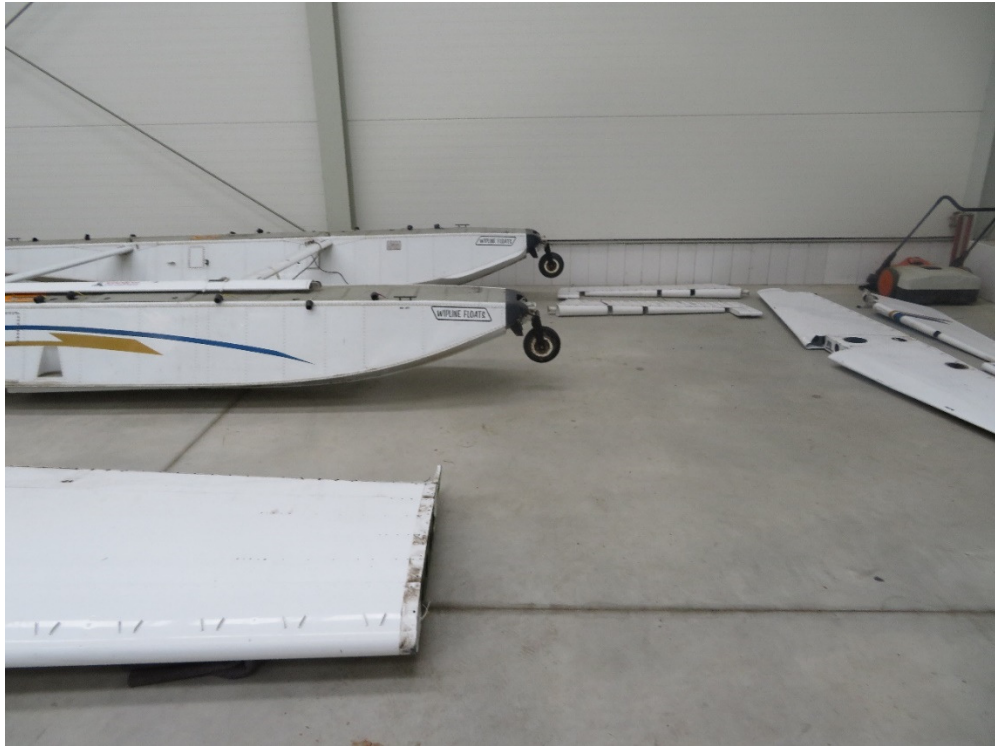
Fig. 5. Deformed and dislocated float mounting elements

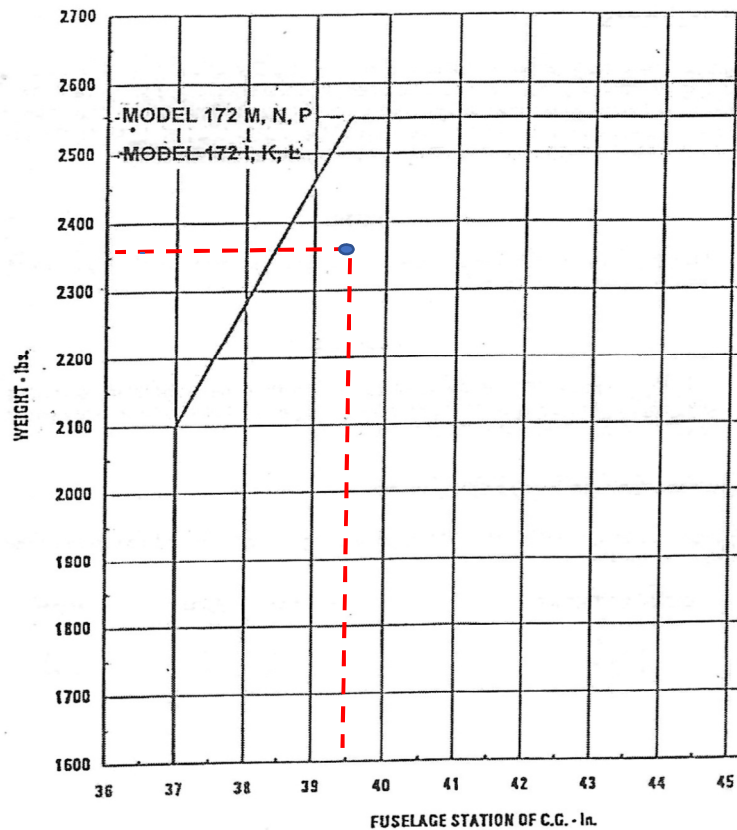
The mass and the CG position<sup>10</sup> are within the envelope of the Cessna 172 P diagram (Fig. 6).

Fig. 6. The CG envelope of the Cessna 172 P

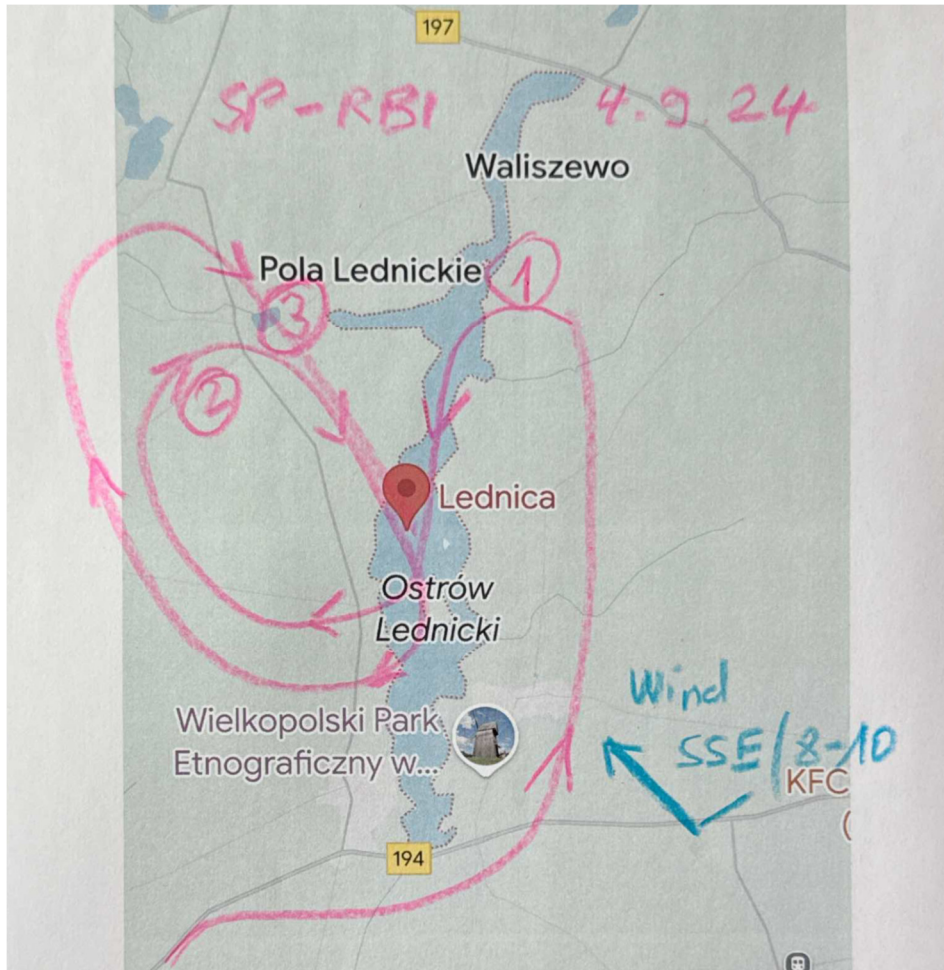
According to the pilot's statement, the third circle was more elongated (Fig. 7), but he aimed for the same point on the water during the landing approach. The aeroplane was rolling sideways slightly during the approach, which was not a problem for the pilot. However, shortly before the landing, there was a sudden and strong wind gust from the starboard side. The pilot did not manage to compensate for the gust, as a result of which the right wing rose significantly, thus causing the aeroplane to roll to the left wing.

Fig. 7. A sketch of the flights performed over Lake Lednica [source: the pilot]

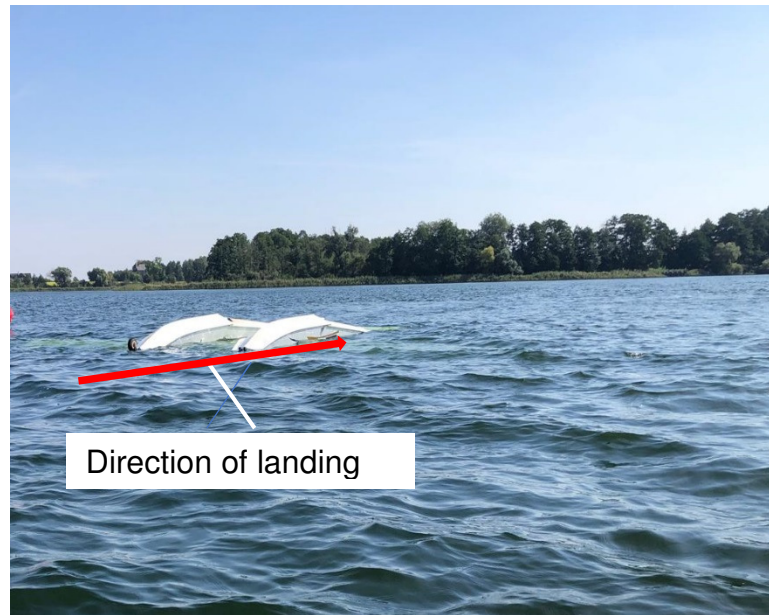
While overturning, the aeroplane moved to the left relative to the flight direction, which is confirmed by its roll to the left wing at the moment of the collision with water (Fig. 8.)

Fig. 8. The aeroplane after overturning, with the deviation to the left visible.

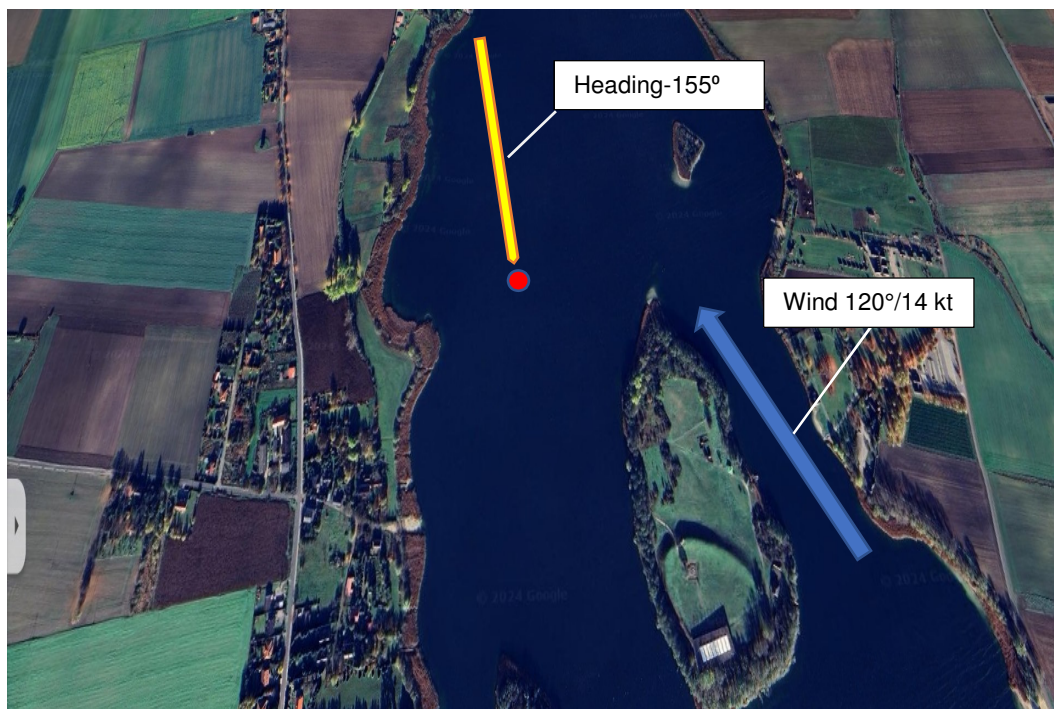
Based on an analysis of photographs from the occurrence site, it was established that during the third flight the pilot had approach to landing at the heading of around 155° and wind blowing from 120° (Fig. 9), and float landed around 50 m offshore (the town of Rybitwy).

Fig. 9. The landing approach in the third flight (the place where the aeroplane collided with water is marked in red)
