FINAL REPORT

of the State Commission on Aircraft
Accidents Investigation

2024-0113

Daher Aerospace TB 9 , SP-FNL

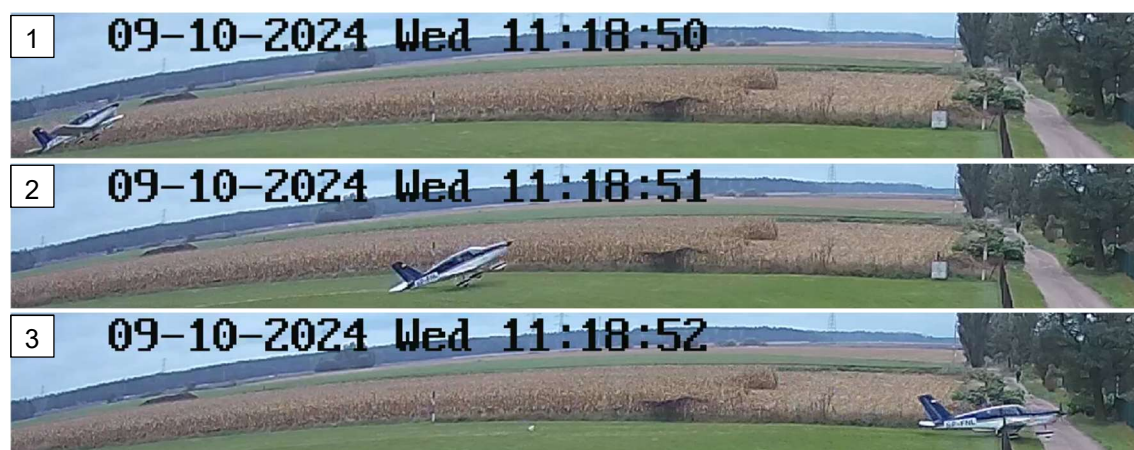
Having taxied to the threshold of RWY 28, the pilot shifted the throttle lever to maximum and, after the engine speed reached maximum, he released the brakes and commenced take-off on a wet grassy surface. The aeroplane was accelerating very slowly and reached 60 kt after passing 650 m. The pilot pulled the control column back but the aeroplane climbed only to 2÷3 m. At that moment, the pilot assessed that he would not fly over a house ahead, and he commenced a 5° left turn. At the same time, intending to fly over the fence, he pulled the control column still further back, causing a sudden increase in the angle of attack and a dynamic stall of the aeroplane (Fig. 1).

Fig. 1 A time-lapse view of the final phase of the flight: 1 - an attempt to fly with a supercritical angle of attack; 2 - the tail hits the ground; 3 - the collision with the first fence and a concrete post; 4 - the collision with the second fence [source: a CCTV camera of the airfield manager]

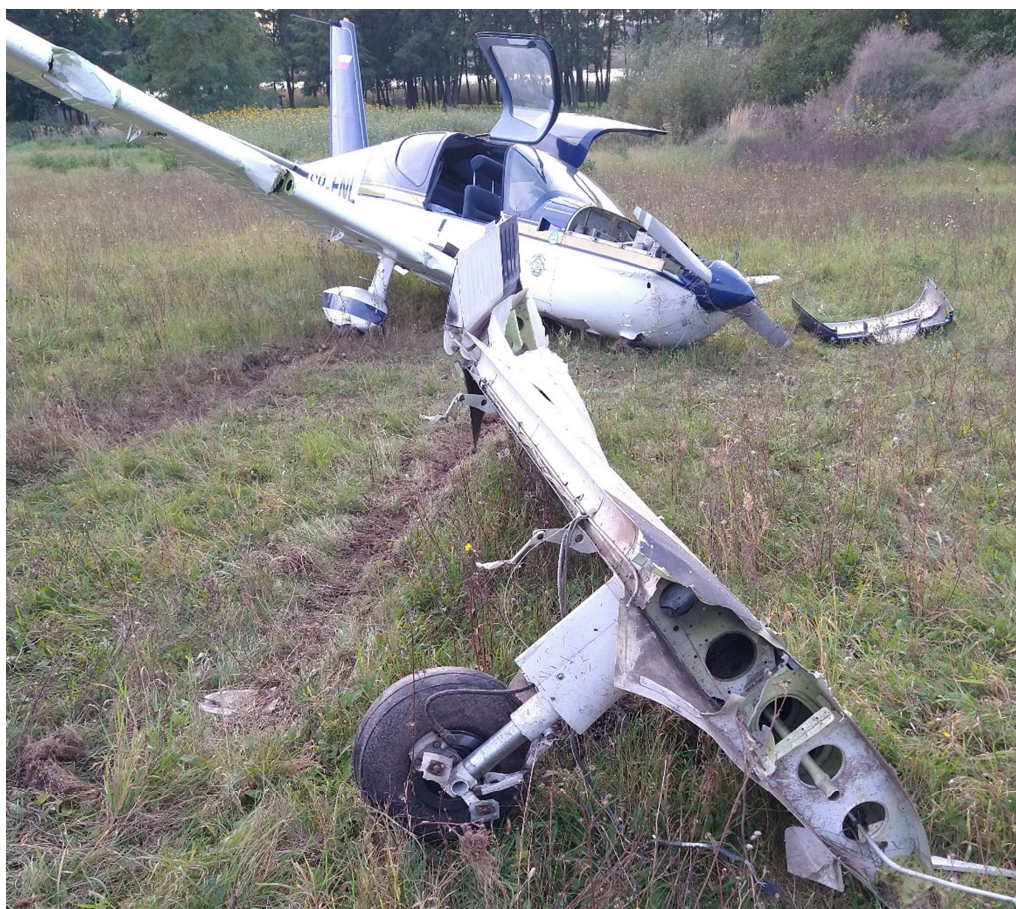
When just above the ground, the aeroplane hit its tail on the RWY surface, rolled to the right wing and rammed two fences in that configuration, coming to a stop on a clearing some 40 m past the airfield's boundary (Fig. 2).

Fig.2 The aeroplane after it stopped, turned 180°.

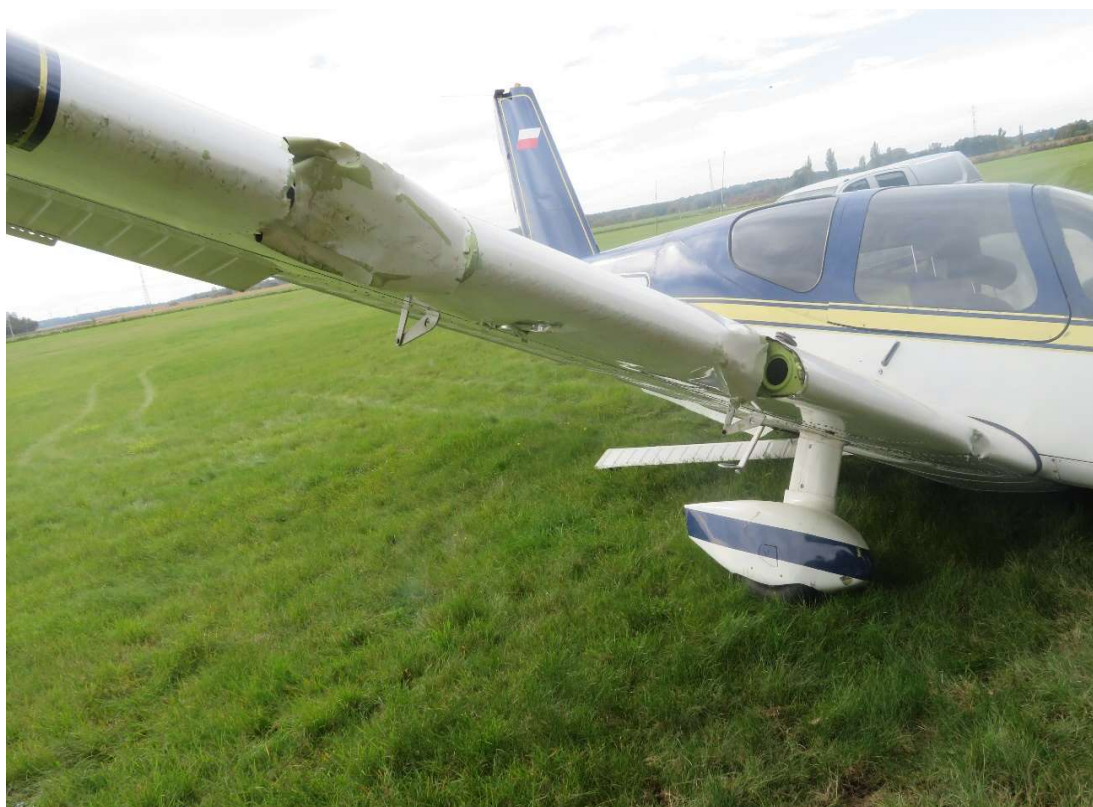
Fig. 3 Damage to the leading edge of the right wing.

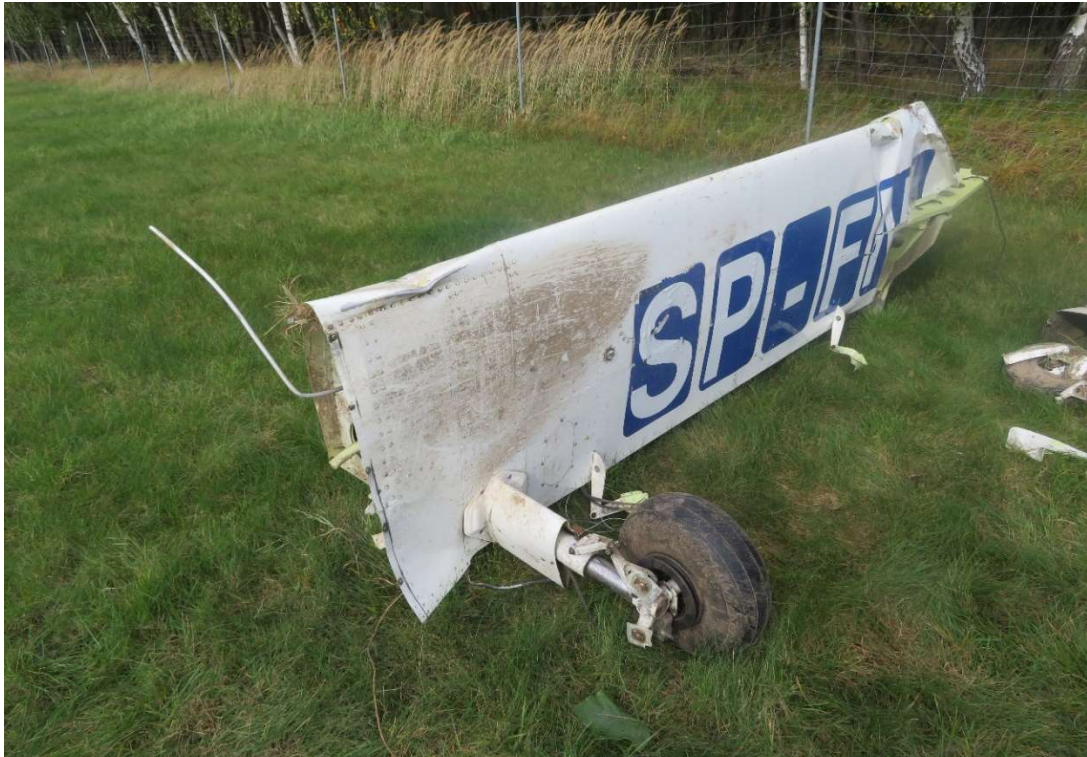
Fig. 4 The separated left wing.

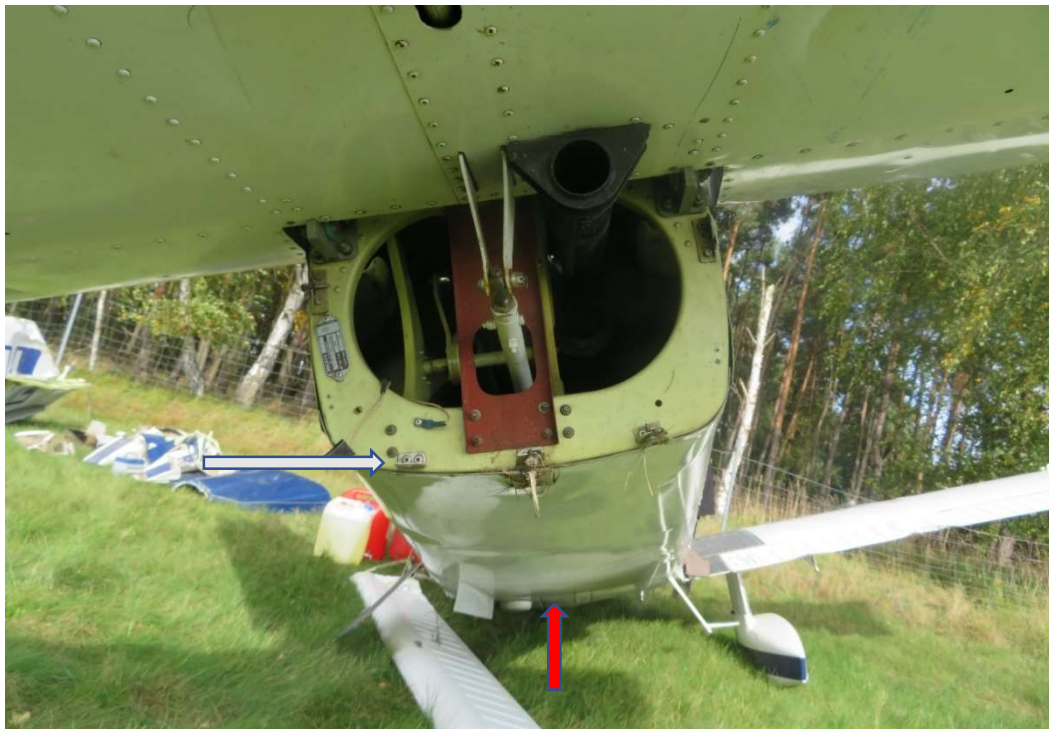
Fig. 5 Damage to the tail section of the fuselage (the fairing missing and dents in the lower fuselage) [source: PKBWL]

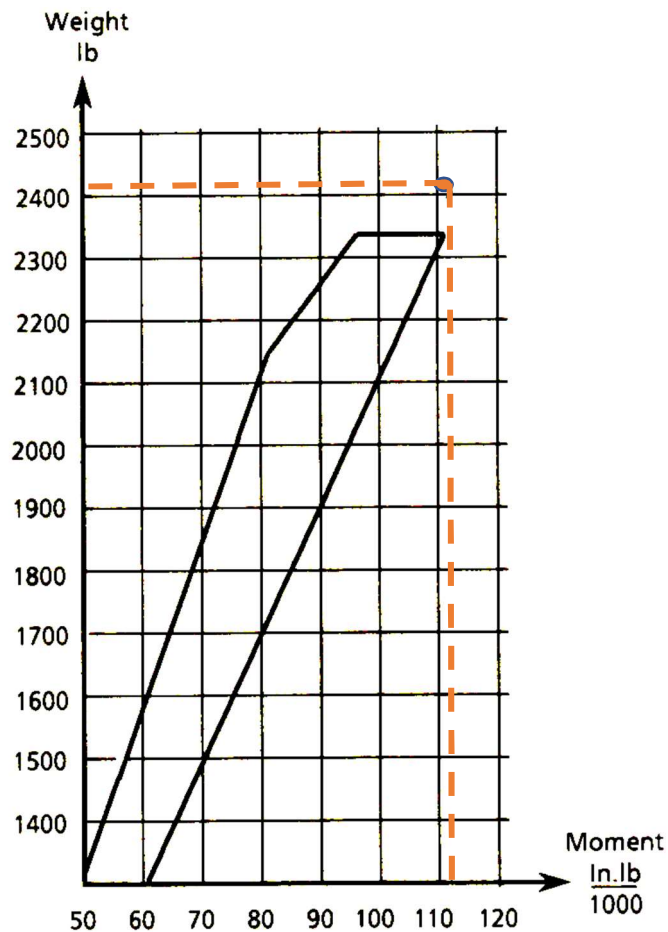
Fig. 6 The aeroplane's mass and total moment envelope (limitations) chart [source: the Socata TB-9 Flight Manual]

The aeroplane's loading in the take-off configuration was unacceptable because the intersection of the mass and moment values was beyond the established envelope. The aeroplane's MTOM of 1,060 was exceeded by 34 kg.

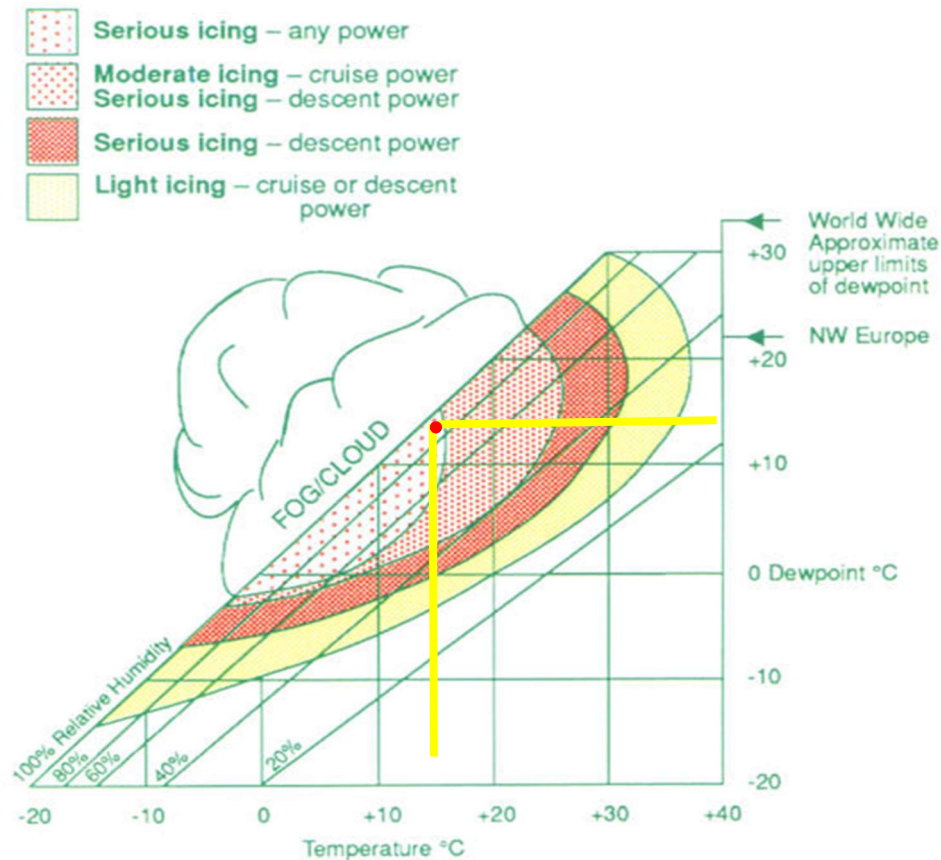
Fig. 7 A chart for determining the possibility of carburettor icing [source: Internet]

The chart shows clearly that at the time of the occurrence carburettor icing was likely at each phase of the flight.

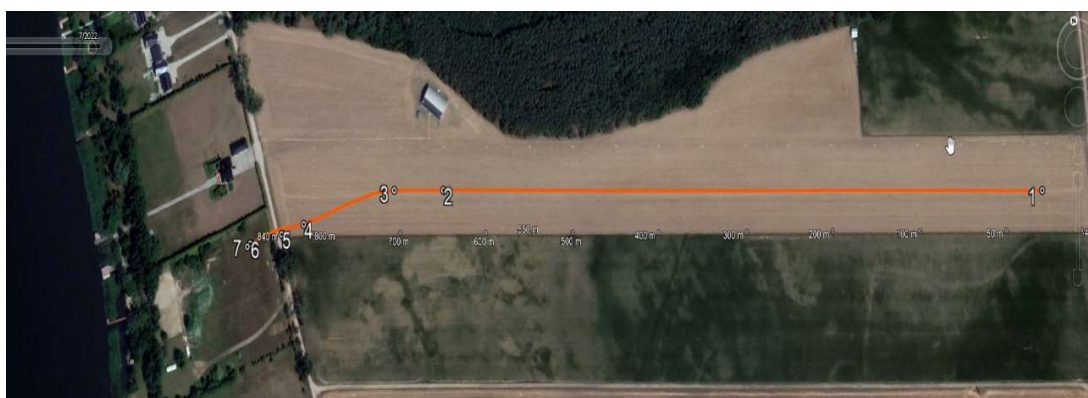
Fig. 8 The aeroplane's take-off route: 1 - the start of the take-off run; 2 - lift-off and flight with critical angles of attack (650 m); 3 - turn to the left; 4 - the tail hits the ground; 5 - the collision with the fence; 6 - the place where the left wing came off; 7 - the place where the aeroplane came to a stop [source: PKBWL]

The pilot said that prior to the take-off he had set a possible aborted take-off point. The point was "in line" with the hangar (around 650 m). In fact, the pilot should have aborted the take-off after around 460 m, i.e. almost 200 m earlier. After assessing that the aeroplane might collide with the obstacles ahead, the pilot decided to make a left turn. He stalled the aeroplane by pulling the control column back on himself.
