Reg. No.: SKA2011011

FINAL REPORT

on investigation of air accident
of aircraft type **CESSNA 150 L**
registration No. **SP-KDN**

Date: 20.08.2011

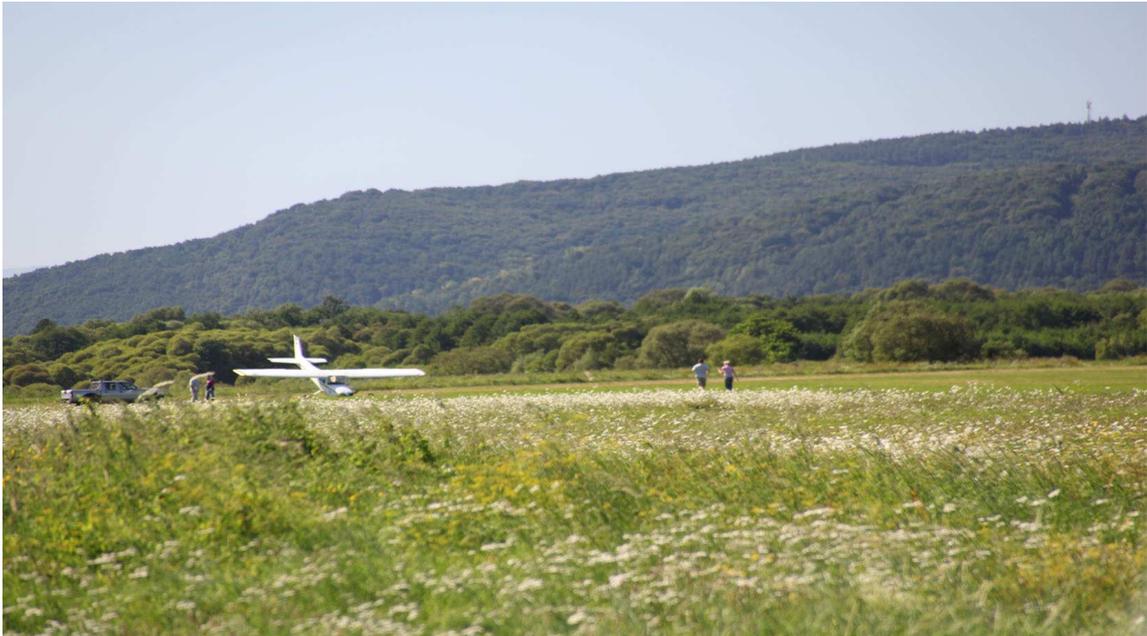
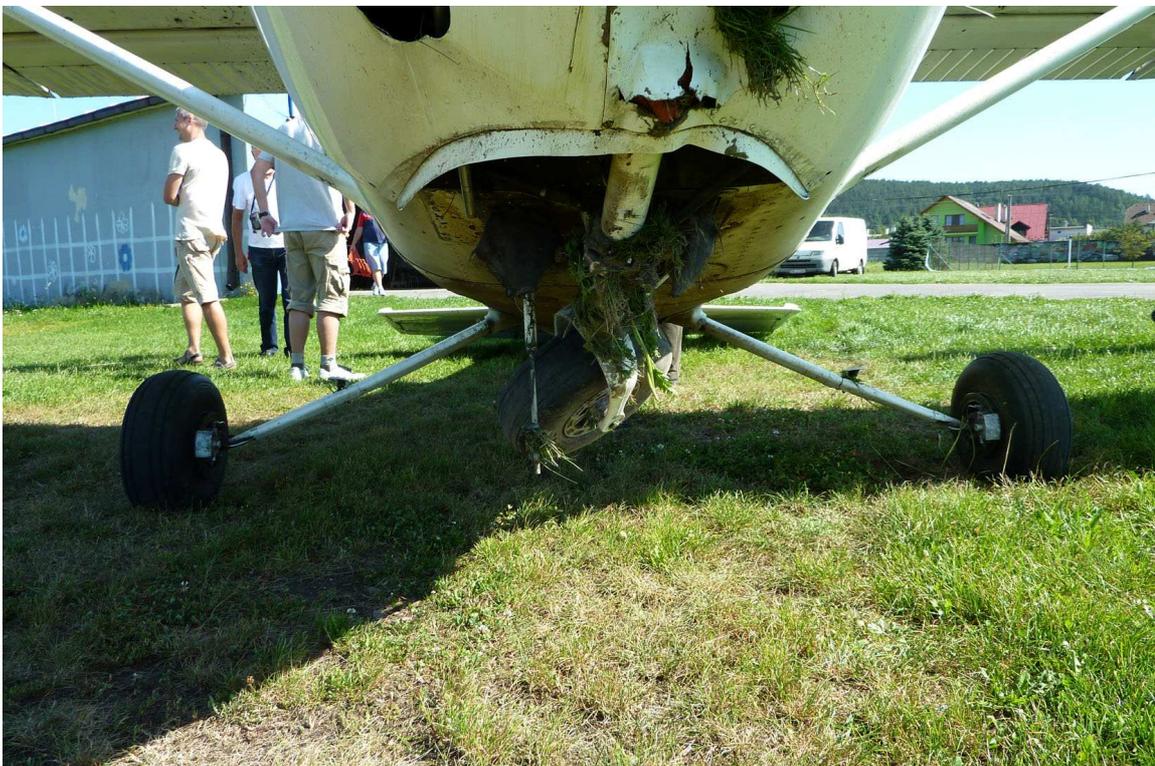
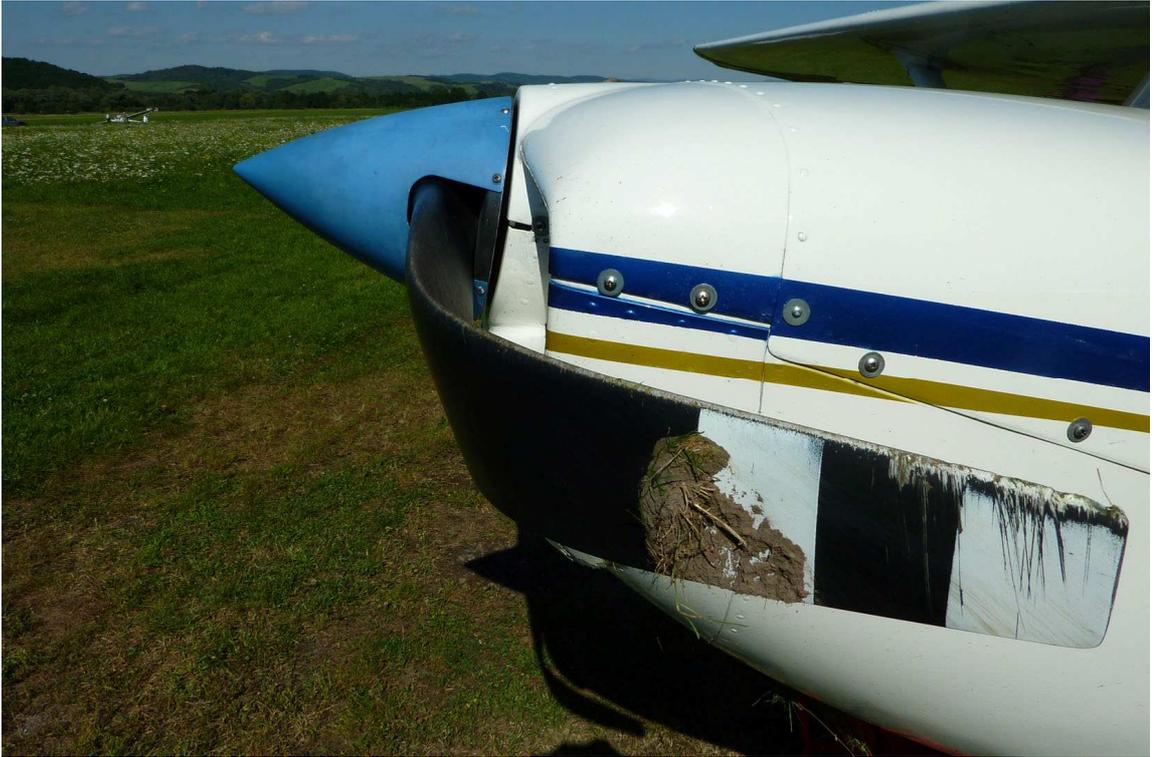
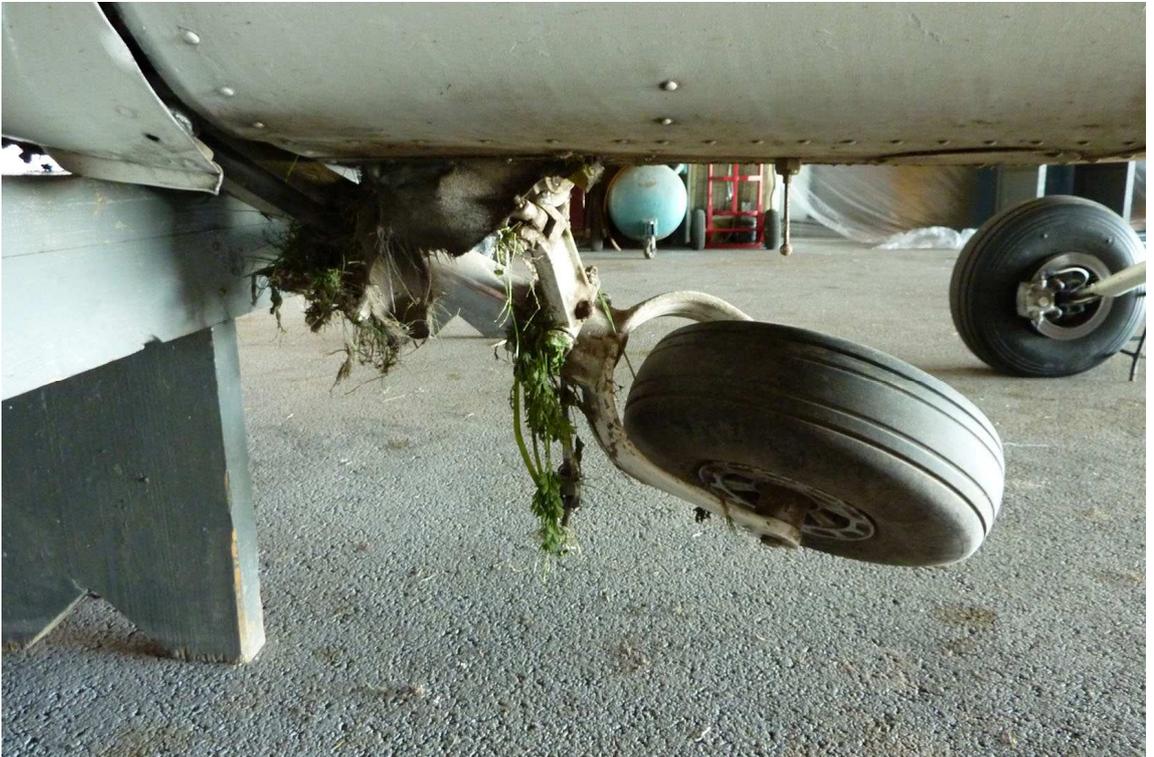
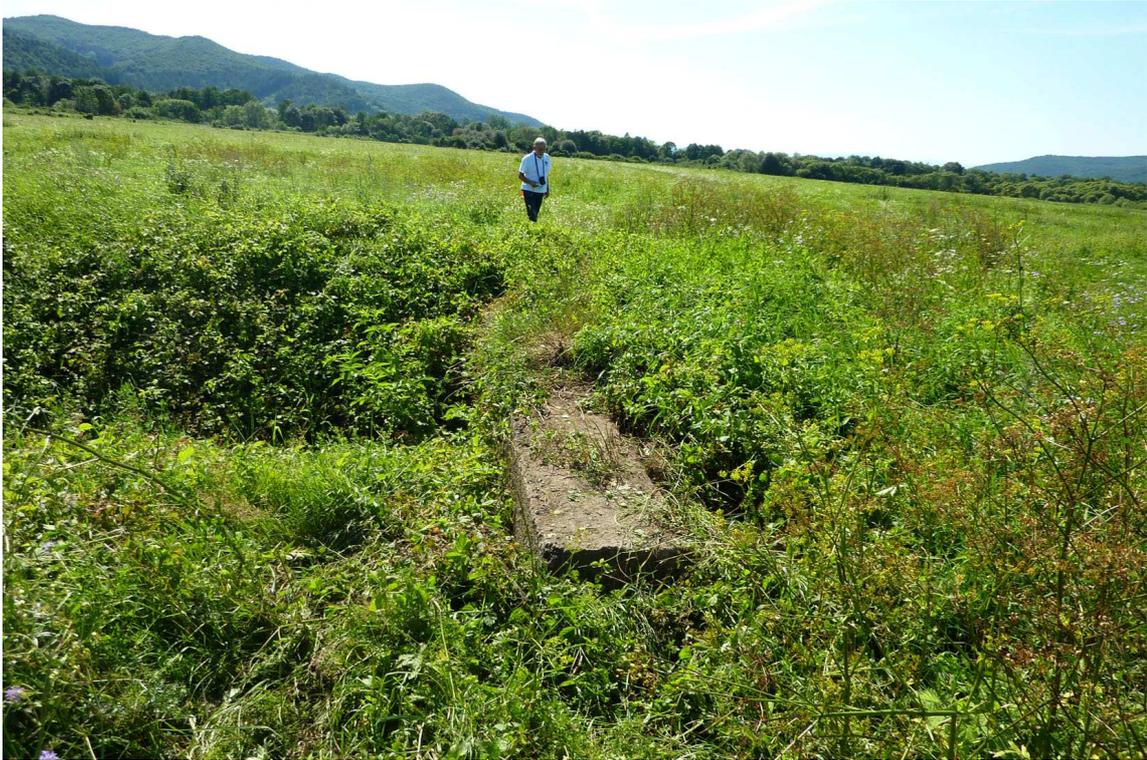
Immediately after the contact with the ground the aircraft slid along the concrete bridge over the reclamation canal in the clearway and under the influence of inertial forces continued the forward motion on the ground, until it stopped on RWY about 40 m away from its threshold. Before stopping the aircraft bent to the left side, rebounded from the left wing and stopped in the position, leaned on the engine in the landing direction.

front landing-gear leg, both legs of main landing gear, attachment of main landing gear in aircraft body, lower body section in suspension of the attachment of main landing gear on the right and left sides, deformation of skin in the lower body section near the attachments of main landing gear, left wingtip arc, propeller, forced engine cut-off, engine hood in upper and lower sections, engine air.

The aircraft stopped on RWY leaned on the engine in the landing direction, in one piece.
