# **ALBUM OF ILLUSTRATIONS**

**Accident to  
McDonnell-Douglas MD-500E helicopter  
(Hughes Model 369E)  
N60EP  
7 April 2016, Suwalki**

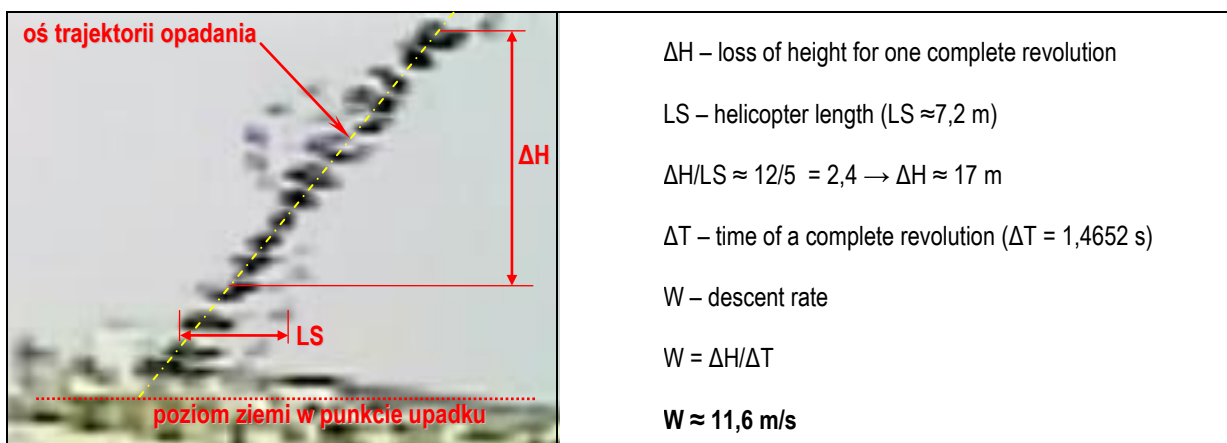
3 – Images of the successive phases of the helicopter's movement during the descent (based on analysis of the recording from "A" camera).

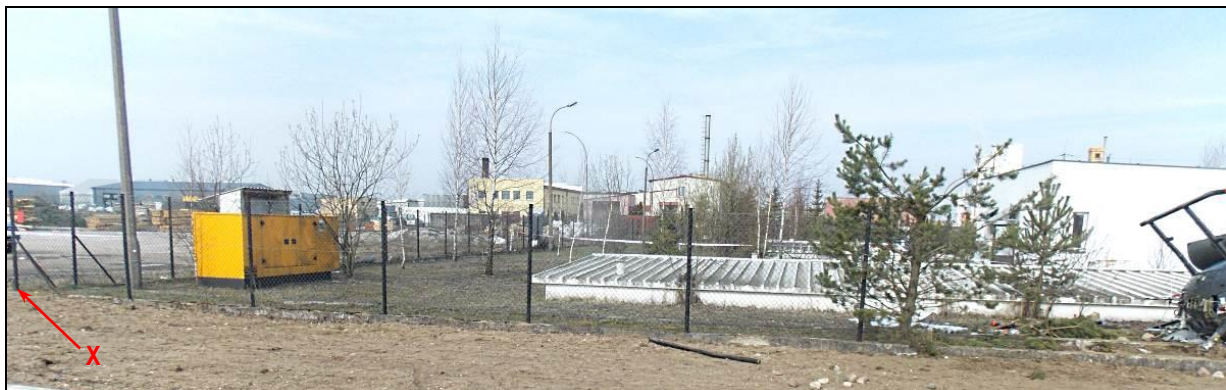
7 - Immediate vicinity of the accident site along Turkusowa Street, reference point X is marked with the red arrow.

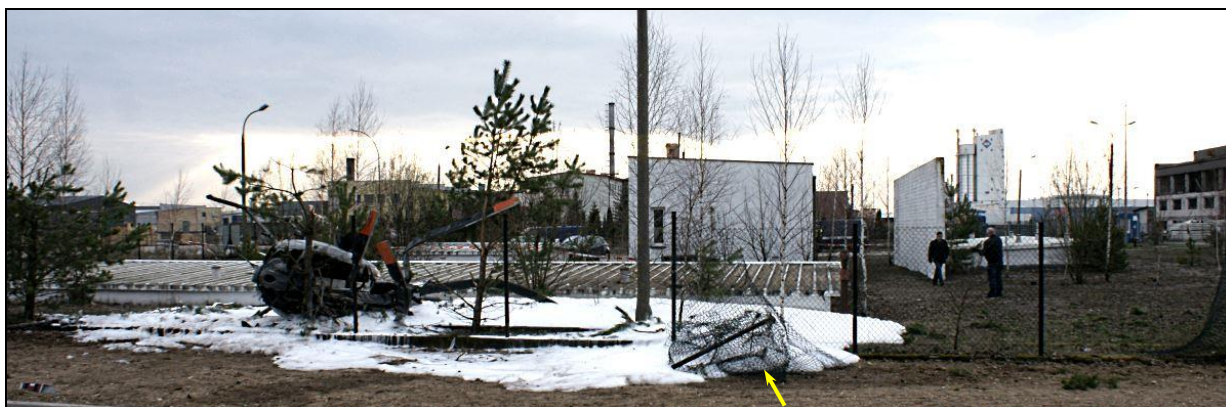
8 - Immediate vicinity of the accident site along Turkusowa Street, continued to the north. The arrow shows a collapsed, damaged portion of the fence [photo KMP Suwałki].

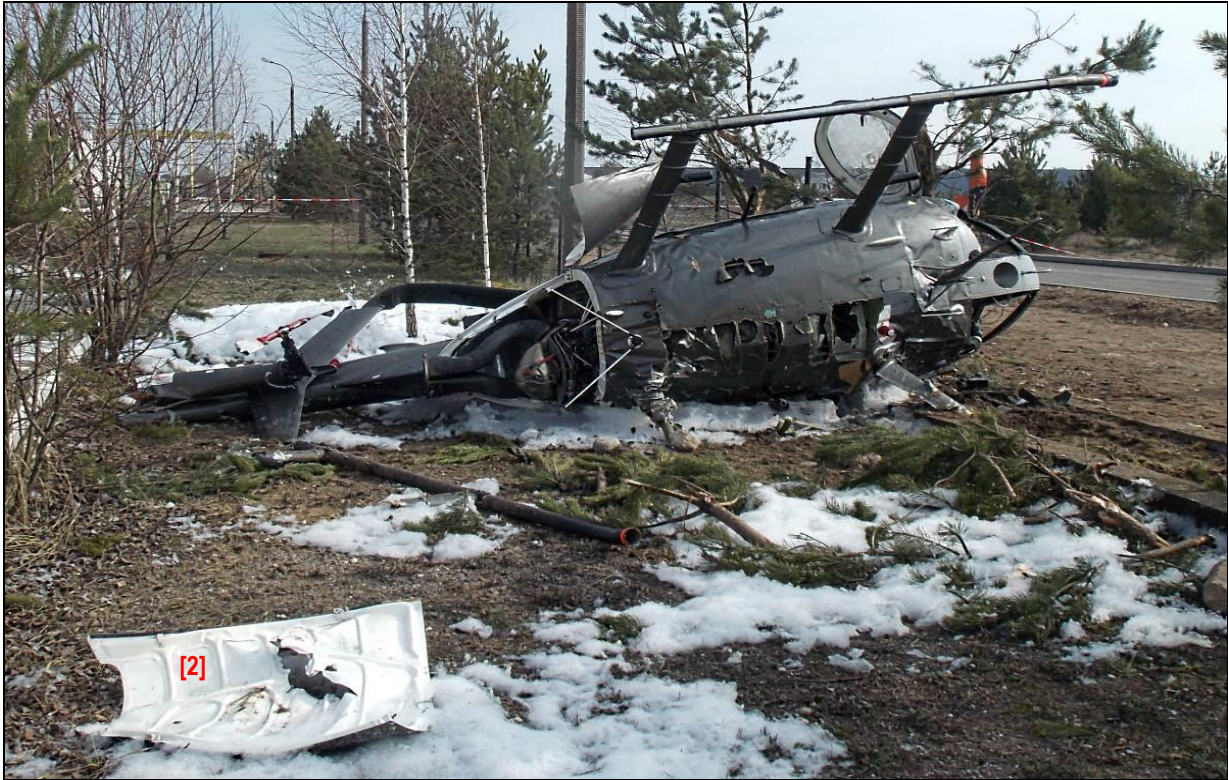
9 – Crashed helicopter, bottom view. In the foreground, the engine cover [2], moved after the accident to the place shown in the photo.

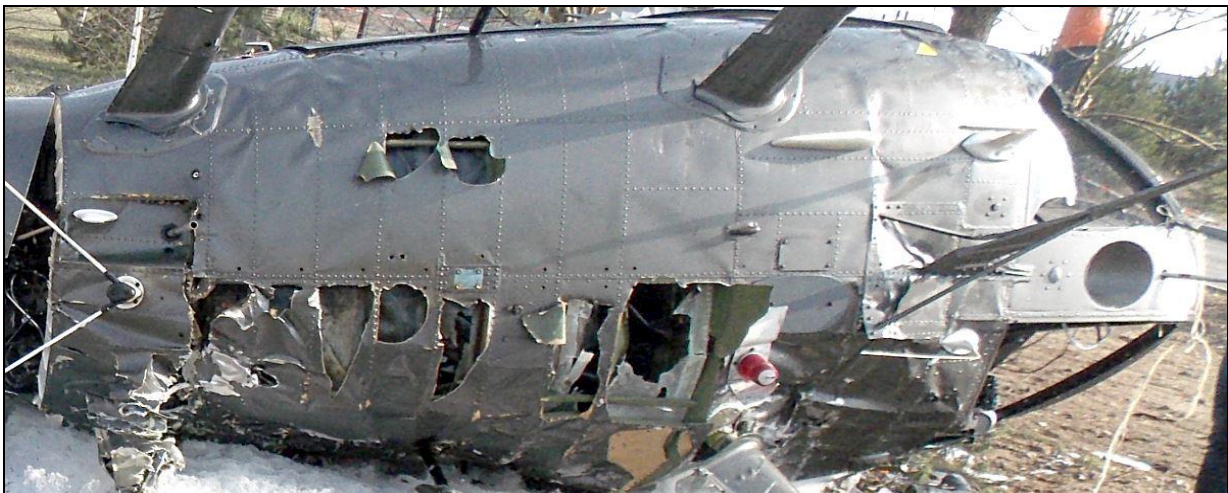
10 – Damage to the lower skin of the fuselage.

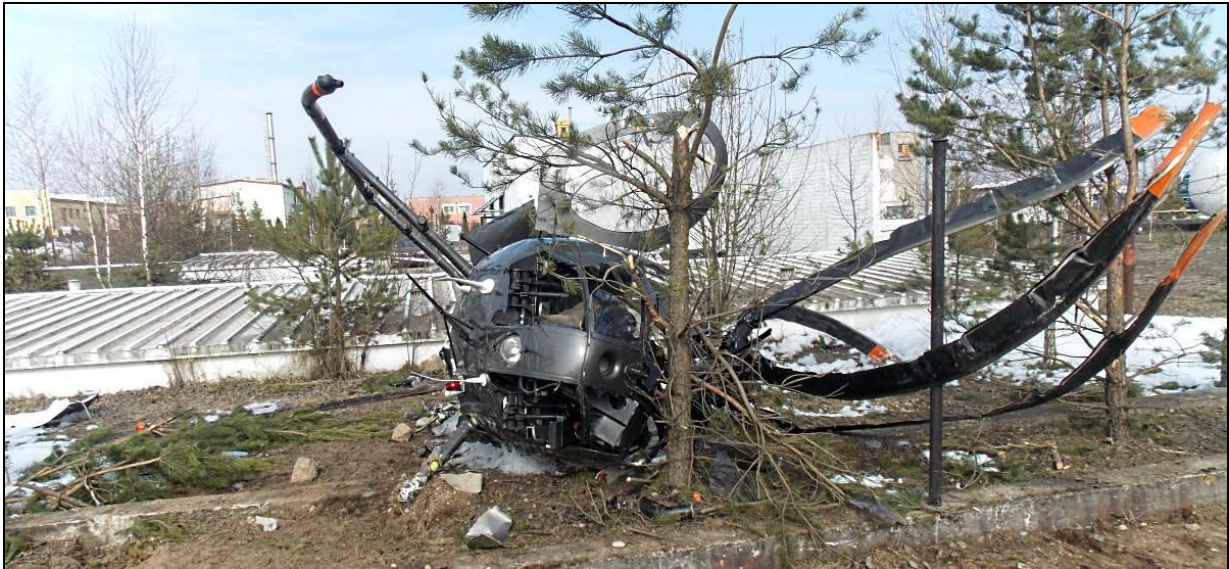
**11 – The crashed helicopter, front view. Characteristic damage to the main rotor blades.**

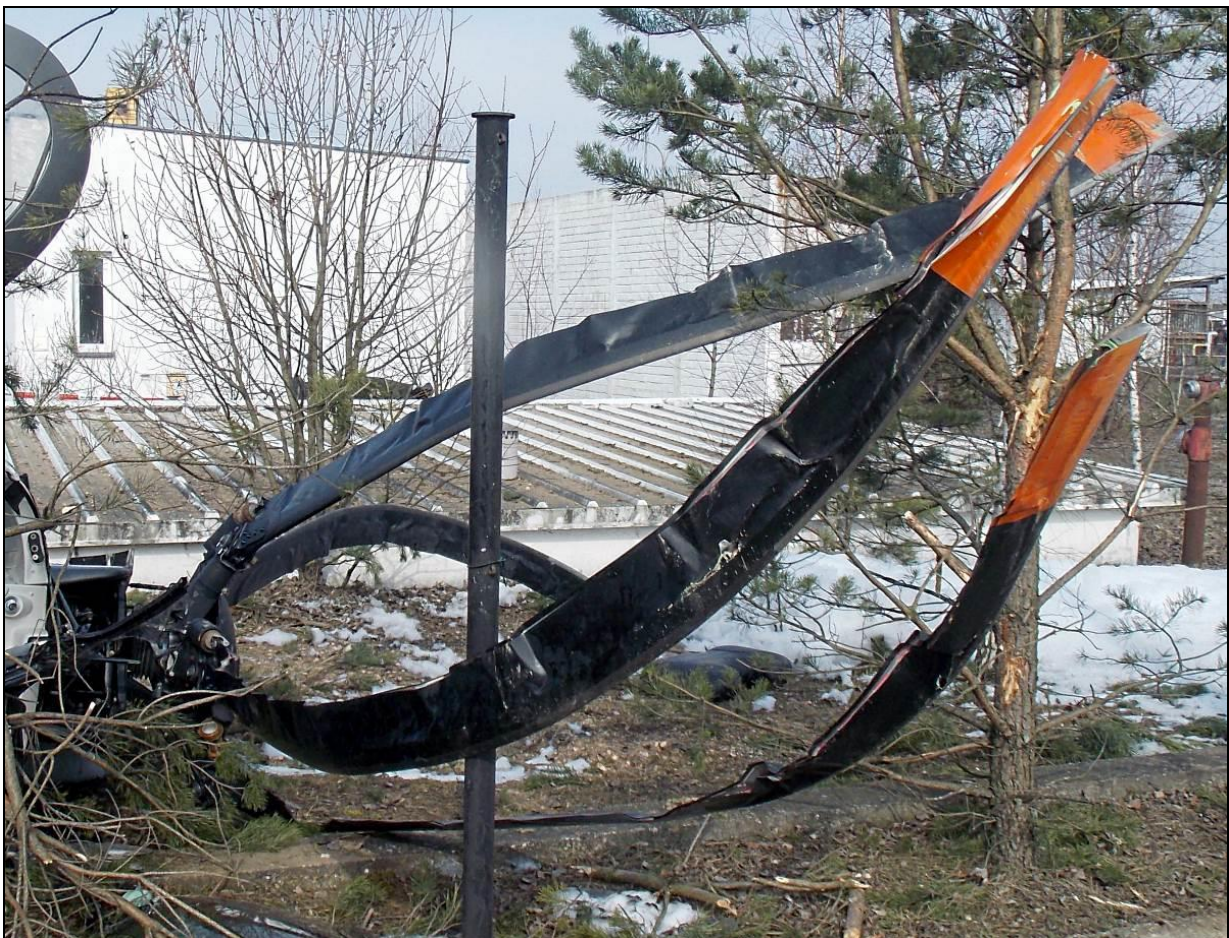
**12 - Damaged main rotor blades, characteristically bent into a “tulip” shape.**

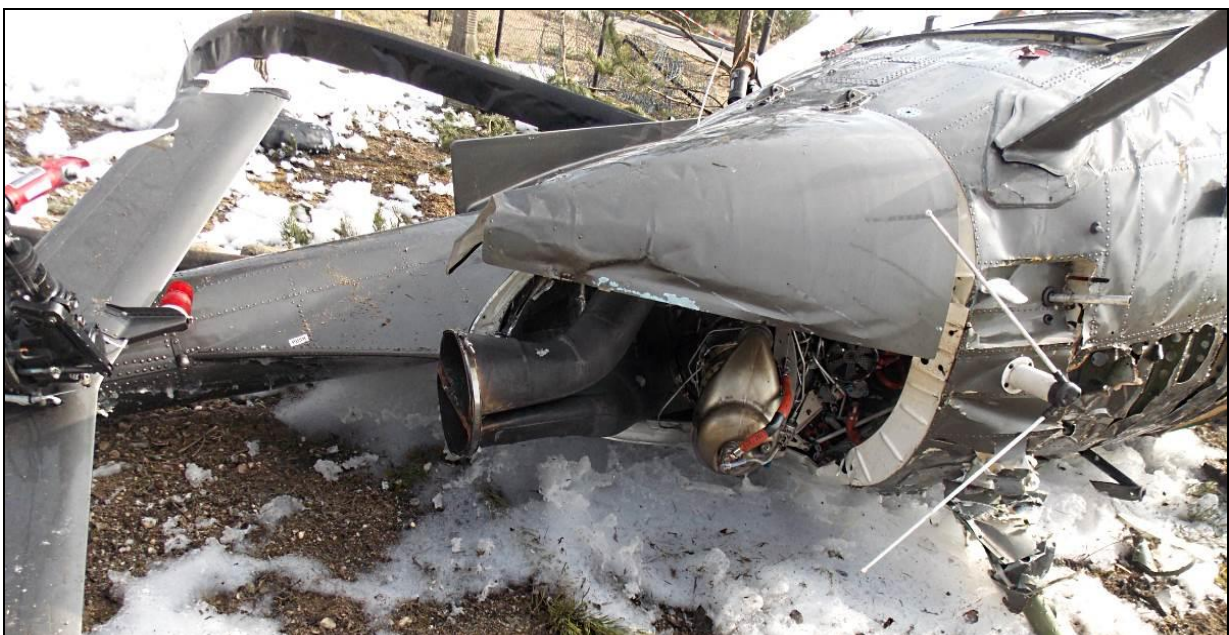
19 - Engine exhaust pipes. Significant soot deposit visible.

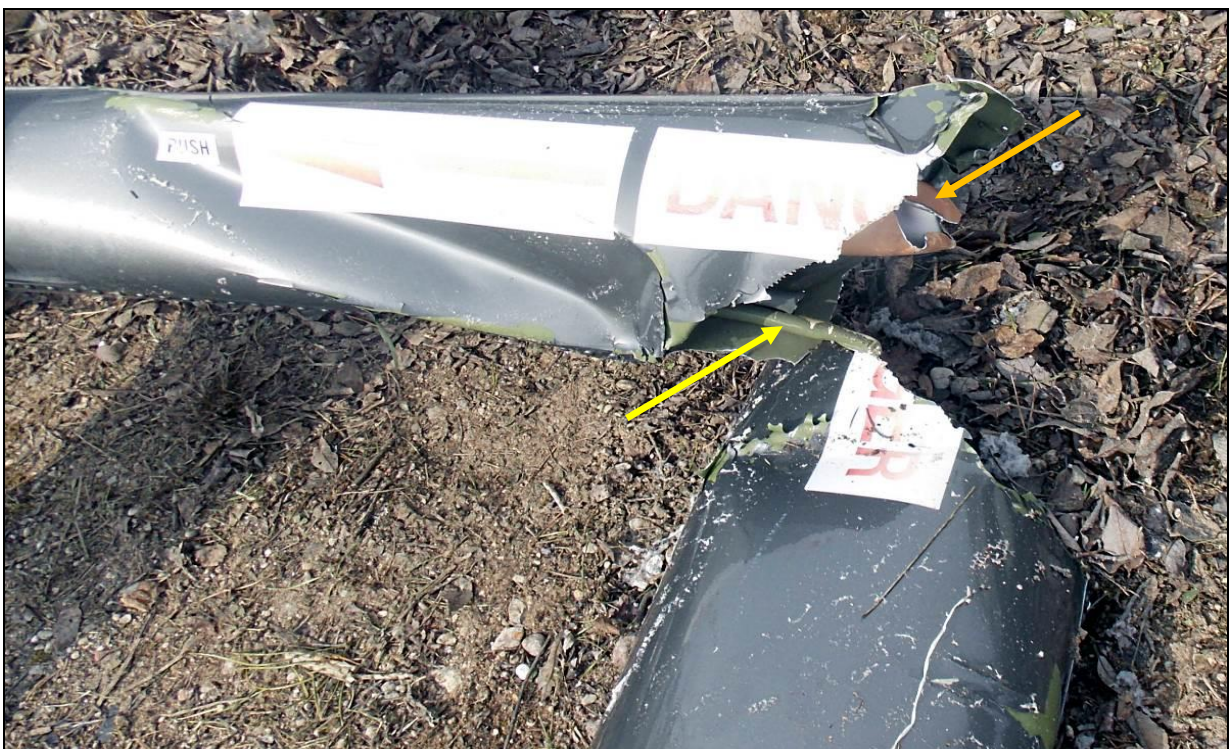
21 – Portion of the tailboom with vertical tail and tail rotor with blades broken off.

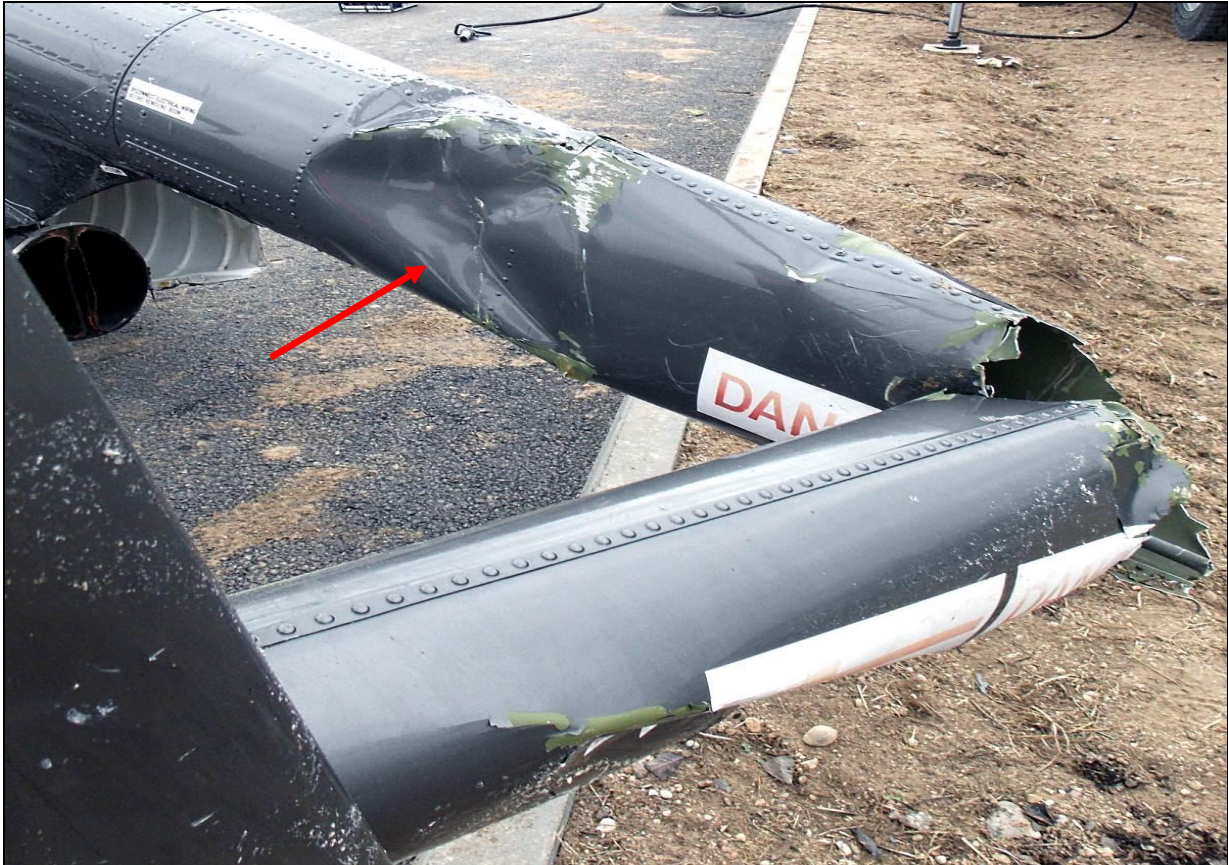
22 - Tailboom breakthrough. The yellow arrow marks the bent tail rotor control pusher, the orange arrow – the broken shaft of the tail rotor.

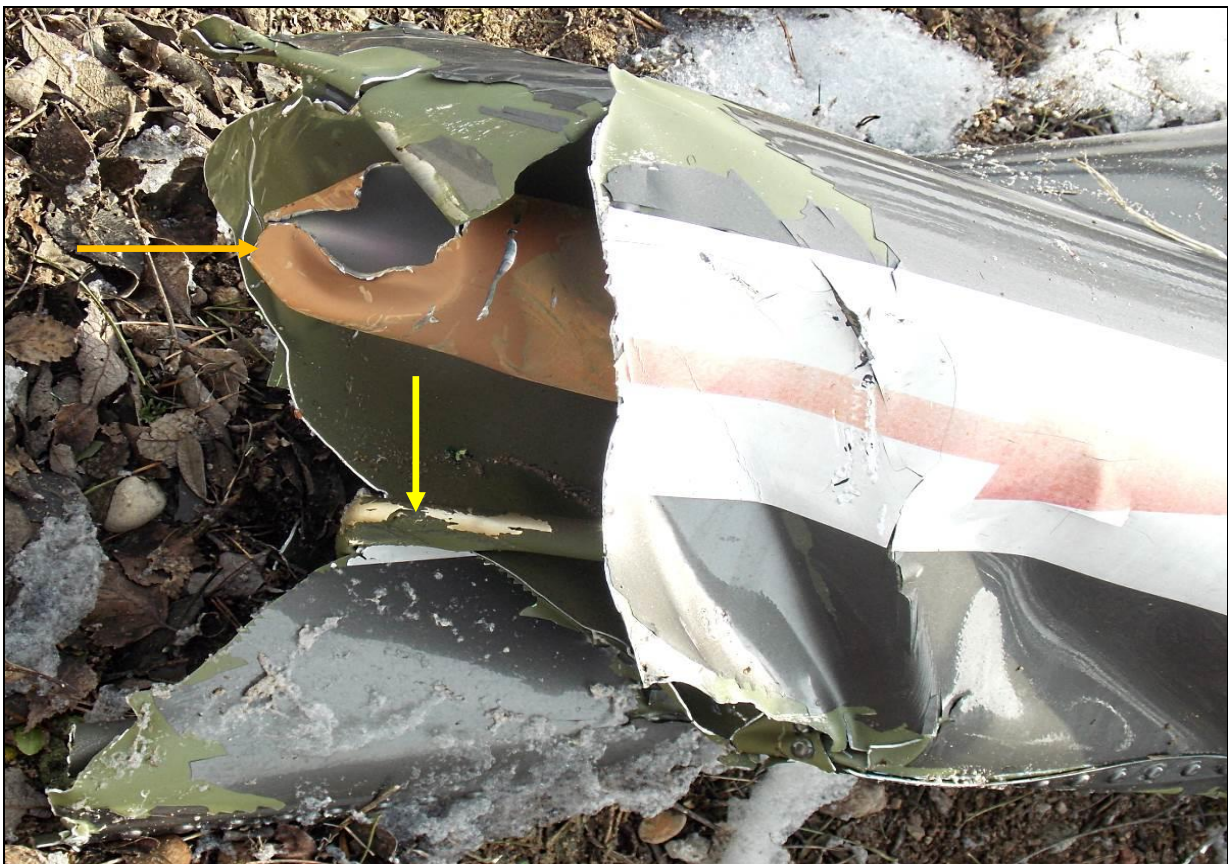
23 - Tailboom breakthrough. Red arrow shows dents caused by impact of the main rotor blade.

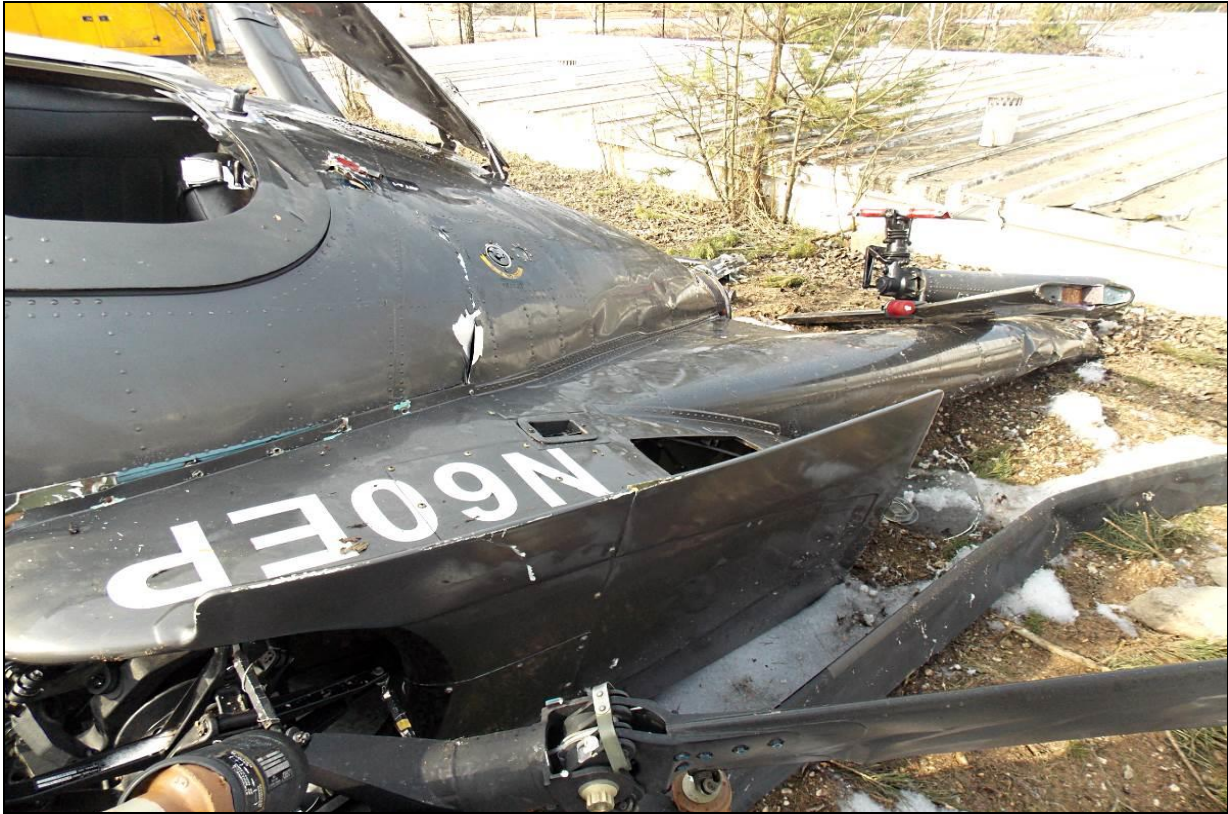
24 - Tail boom breakthrough close-up. The yellow arrow marks the bent and broken tail rotor control pusher, the orange arrow - the broken shaft of the tail rotor.

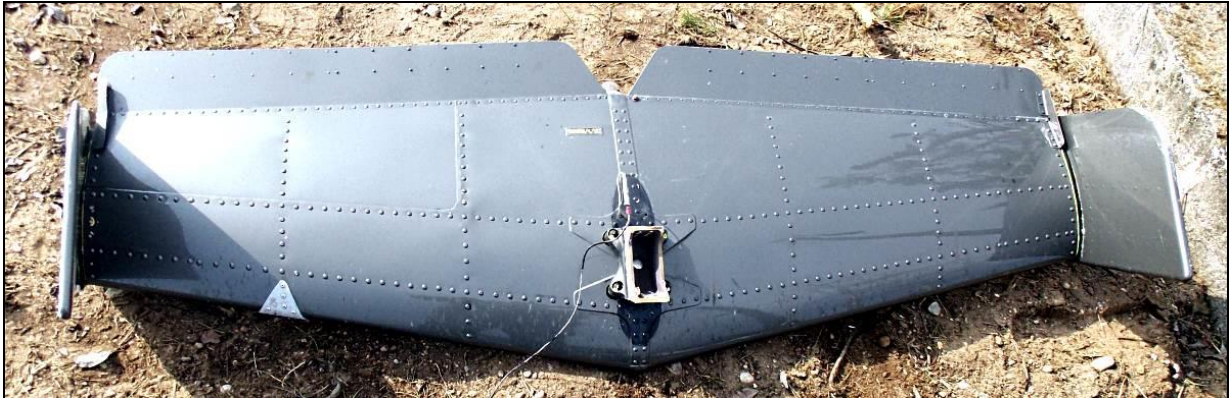
**33 - Horizontal stabilizer - top view. A visible patch on the left part of the leading edge.**

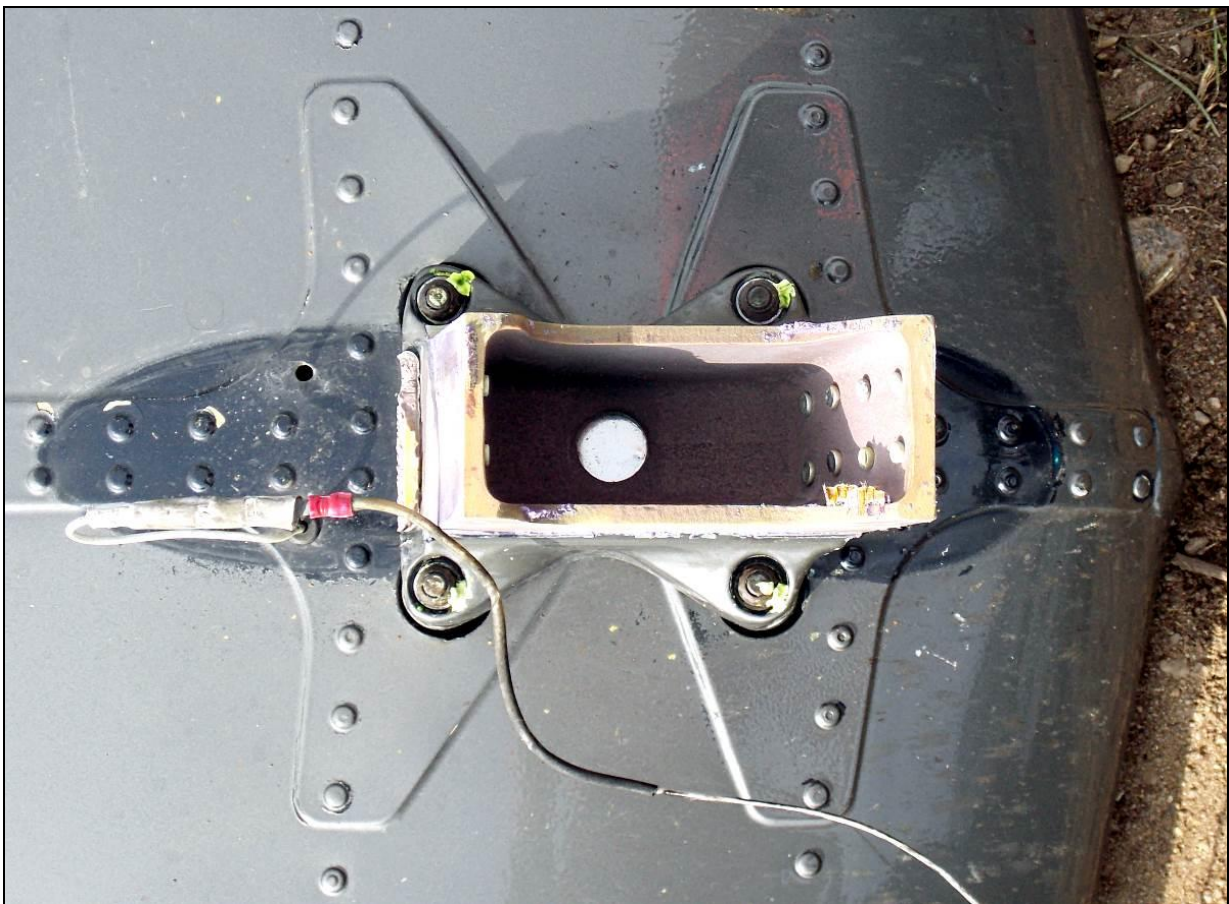
34 - Horizontal stabilizer - bottom view. A visible patch on the left part of the leading edge.

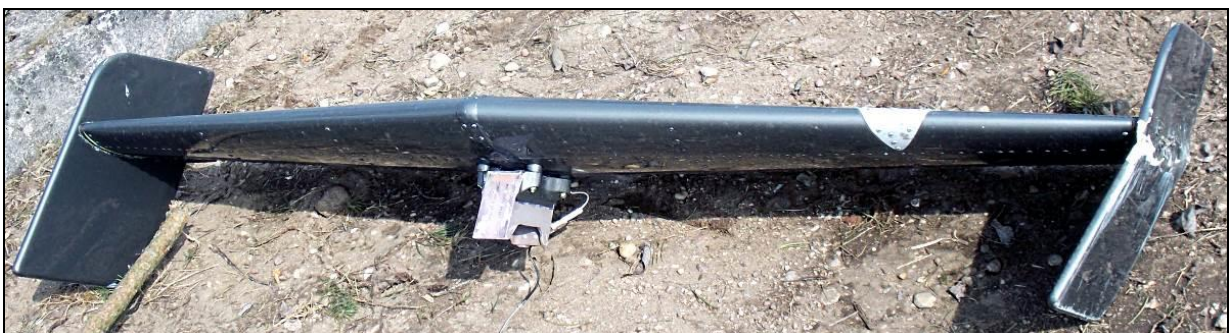
35 - Horizontal stabilizer - close-up on the damaged fitting for the vertical stabilizer.

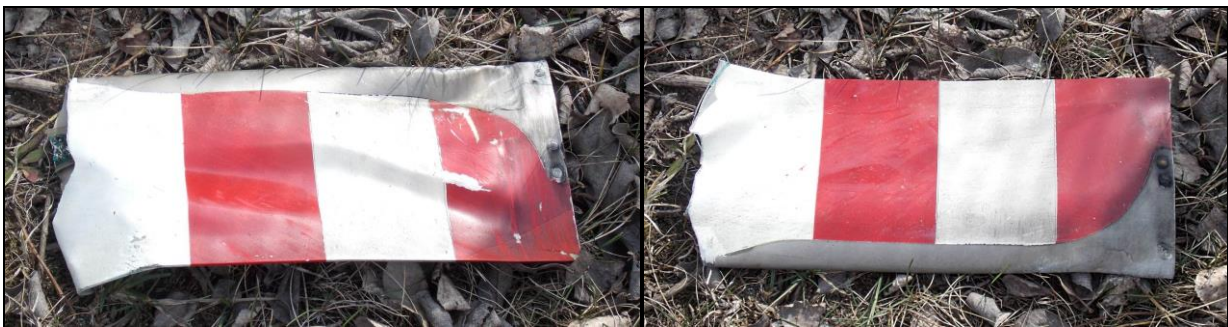
39, 40 - Broken tail rotor blade shown from both sides.

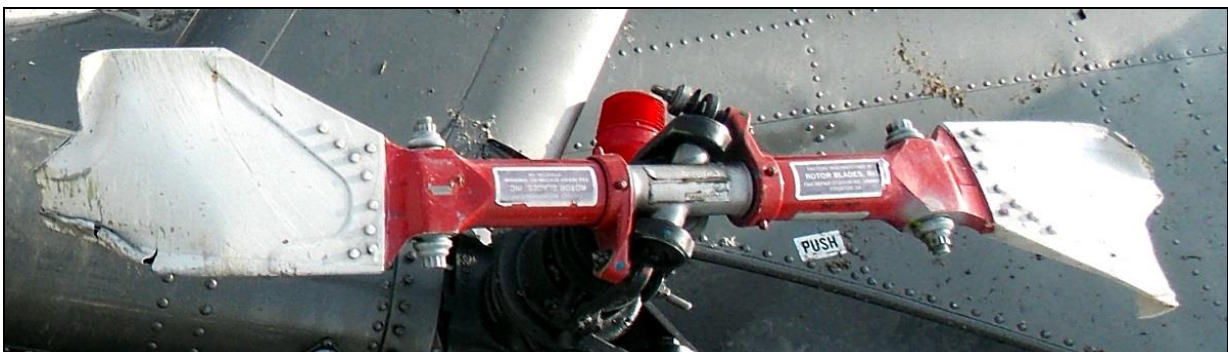
41, 42 - Broken tail rotor blade shown from both sides.

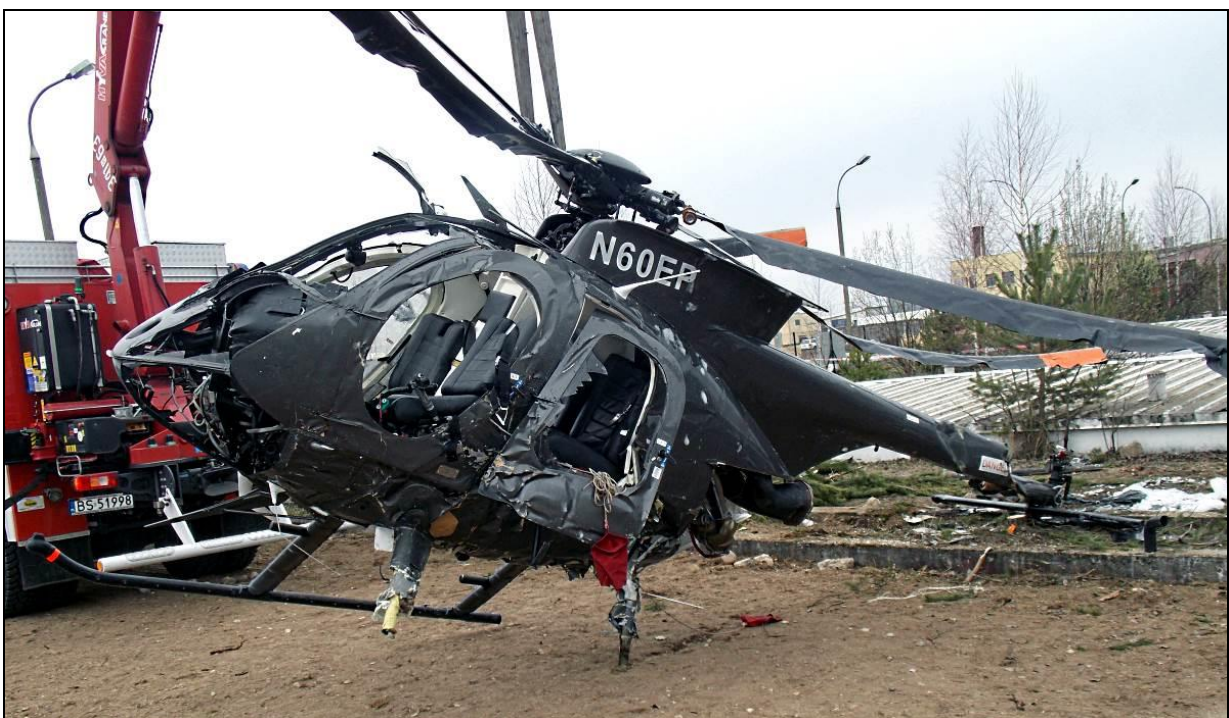
52 – Helicopter wreck lifted by a crane, visible damage to the left side of the fuselage.

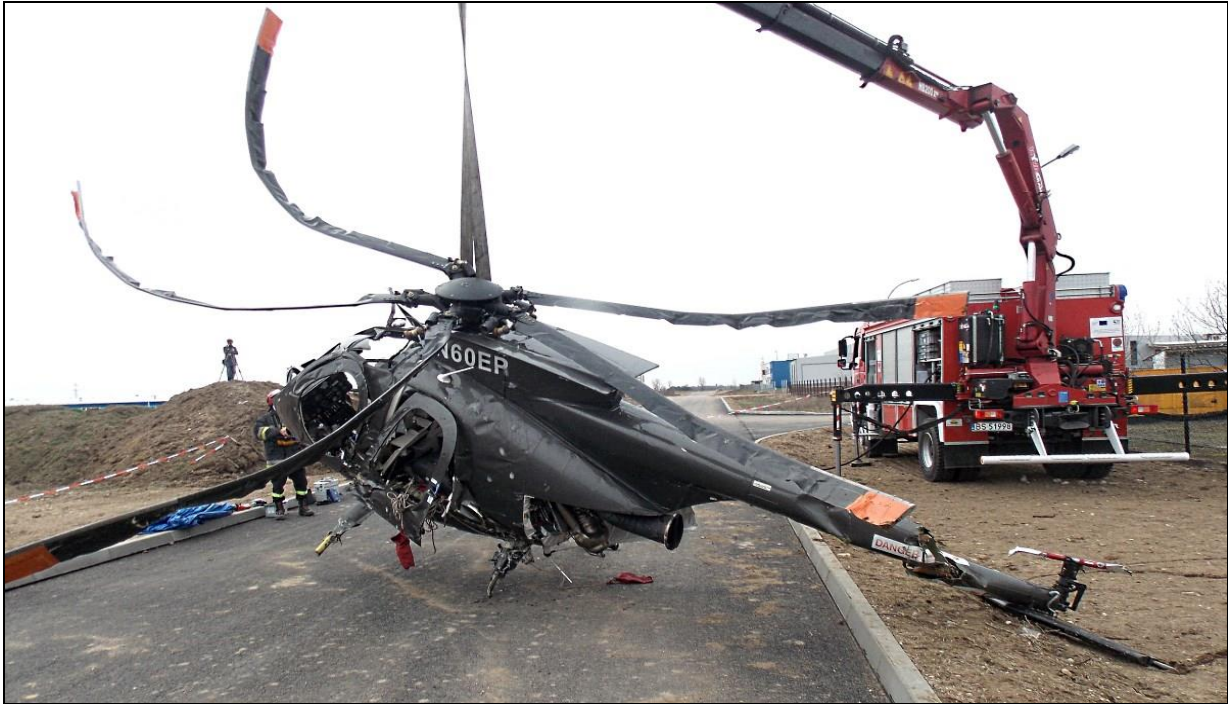
53 – Helicopter wreck lifted by a crane, visible damage to the left side of the fuselage.

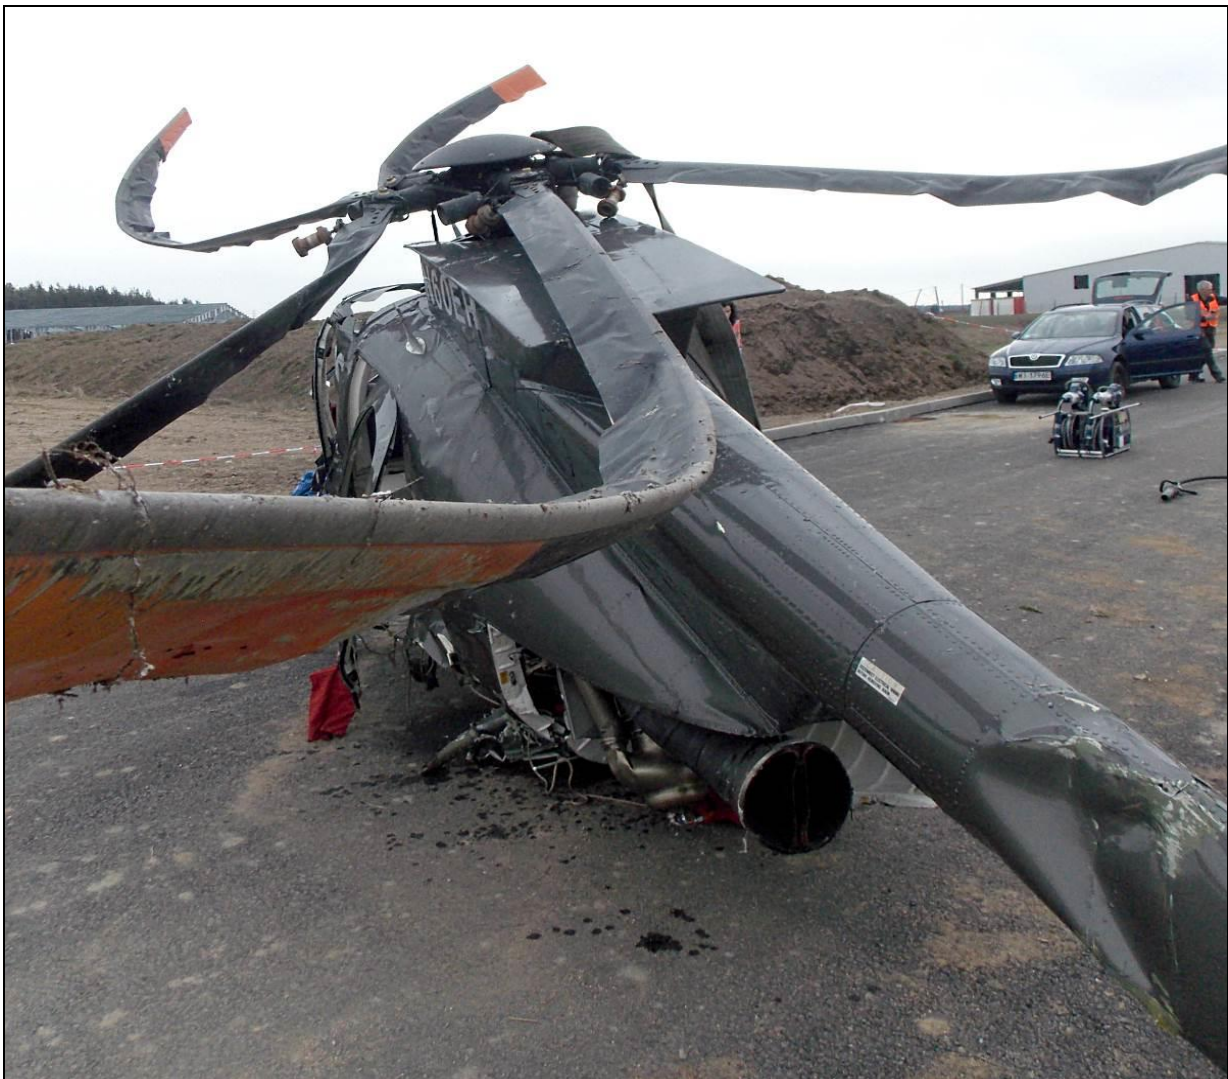
54 – Helicopter wreck lifted by a crane, visible damage to the left side of the fuselage and the main rotor.

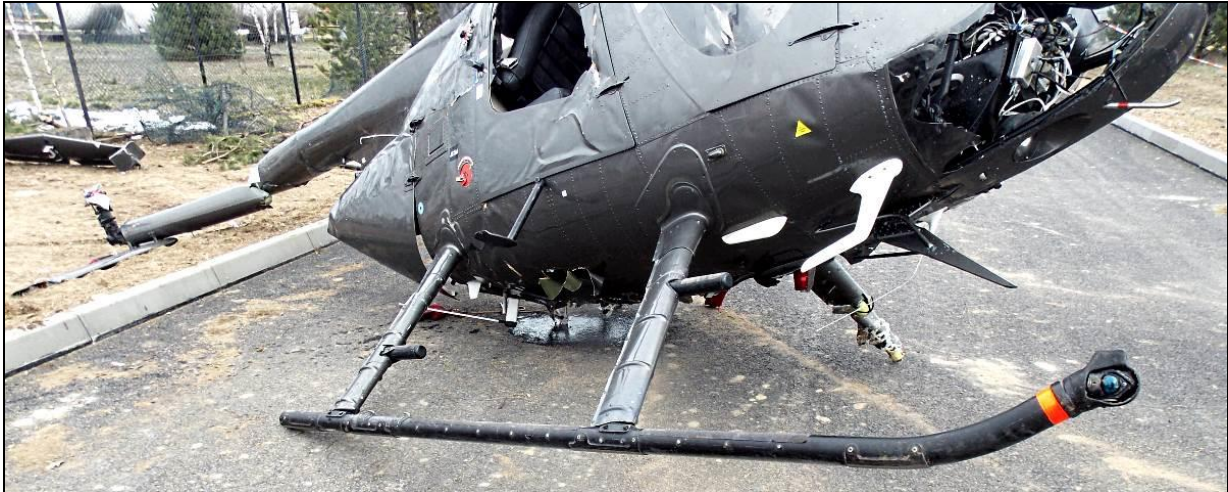
55 – Helicopter wreck lifted by a crane, visible damage to the left side of the fuselage and the main rotor.

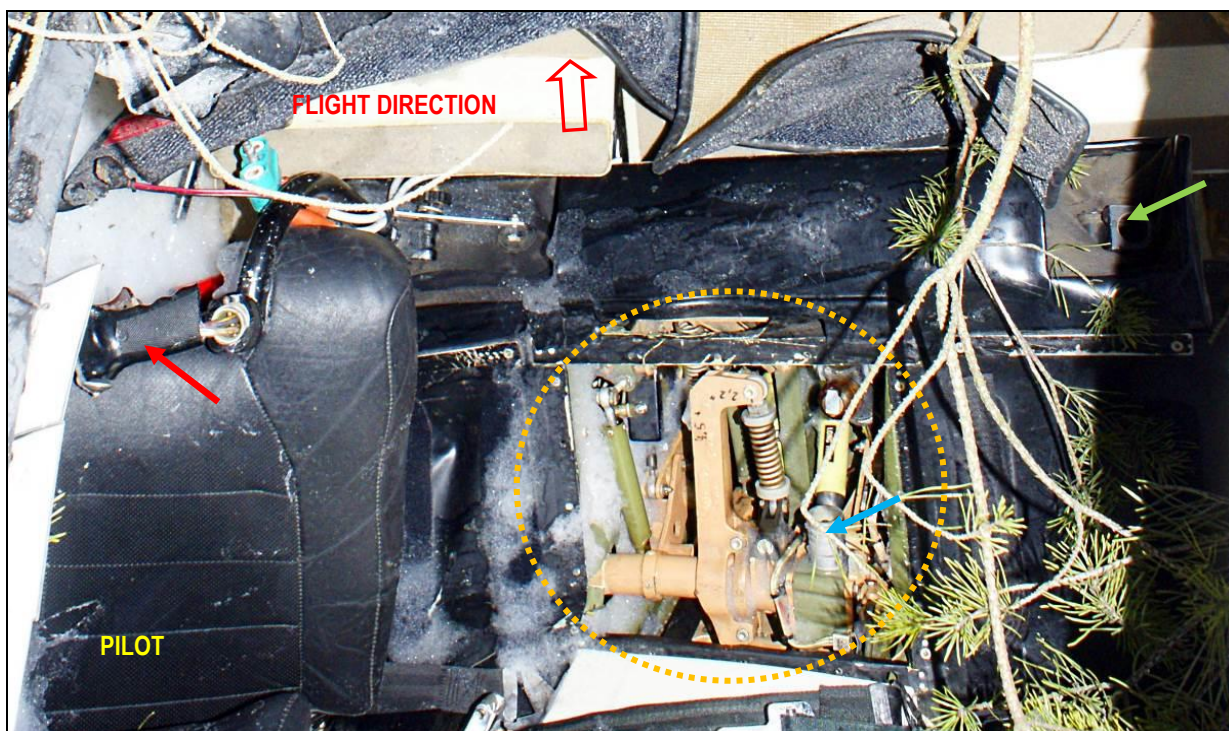
63 - Pilot's and passenger's seats. The red arrow shows the broken cyclic on the left side. The green arrow shows the mount of removed cyclic. The blue arrow shows the mount of removed collective. A portion of the flight control system in the cabin is visible because an unsecured center seat cushion has fallen off.
