FINAL REPORT

State Commission on Aircraft Accidents Investigation (PKBWL)

OCCURRENCE NO – 2020/2397

AIRCRAFT – Airplane, Bristell NG-5, SP-SLES

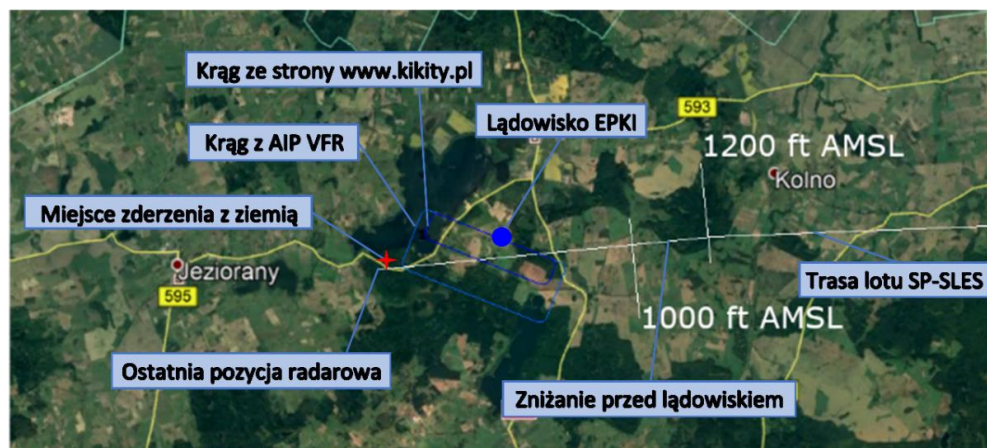
Fig. 1 Final portion of the flight path based on a radar screenshot [source: PKBWL¹]

The analysis of the last minutes of the flight, shows that probably the pilot, after reaching the aerodrome, started descending to the recommended circuit height (1000ft) and started a turn in the area of the third turn to runway 11. From the analysis of the radar screenshot as well as the statements of witnesses, it is assumed that the pilot was flying with a little descent and probably in this configuration collided with tall trees and later with the ground.

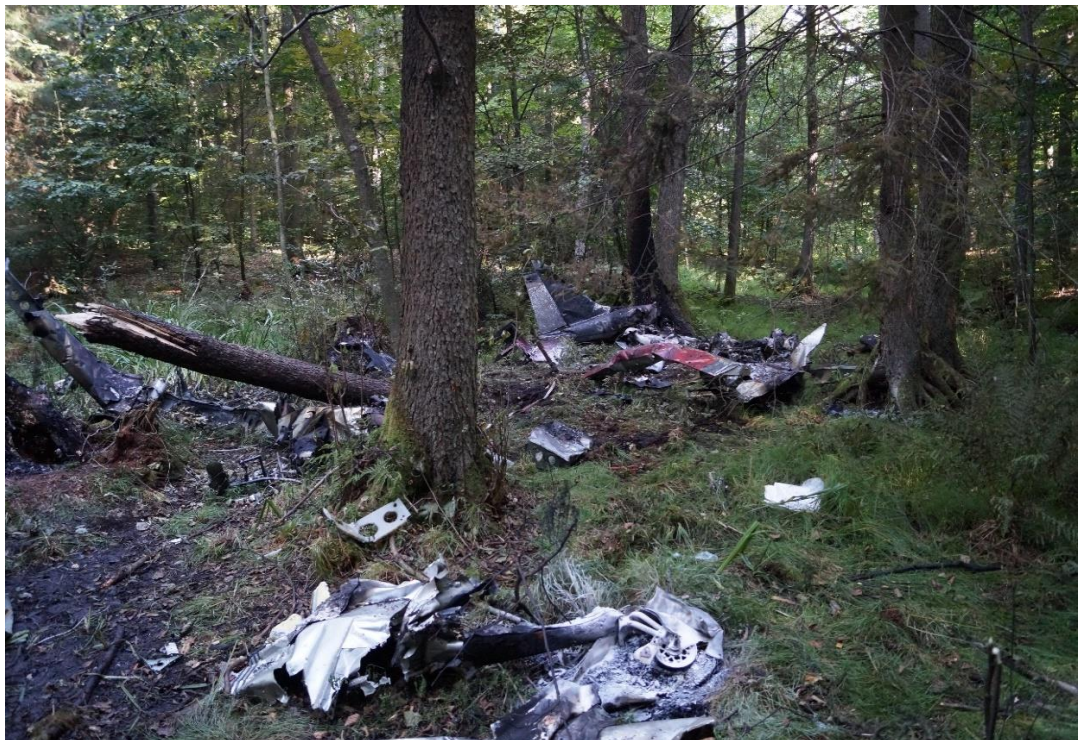
After colliding with the ground, the plane broke into many parts, and the spilled fuel was ignited, causing a fire at the scene of the accident. For this reason, it was not possible to determine the type and amount of fuel on board the aircraft, however, when assessing the area covered by the fire, it may be assumed that at the time of the accident the quantity of fuel in the aircraft tanks was sufficient to continue the flight towards the aerodrome and land. The elements of the plane were scattered over a large area, some were hung on nearby trees, which may indicate that the destruction of the plane began at the moment of its contact with trees. When the plane crashed into the ground, a fire occurred, but went out by itself, because the plane fell in a swampy area with high humidity (Fig. 2).

Fig. 2 Accident site and wreckage

During the examination of the wreckage, PKBWL did not find any evidence of the accident aircraft failure, however, due to its destruction, it was not possible to completely rule out the possibility of such a case.

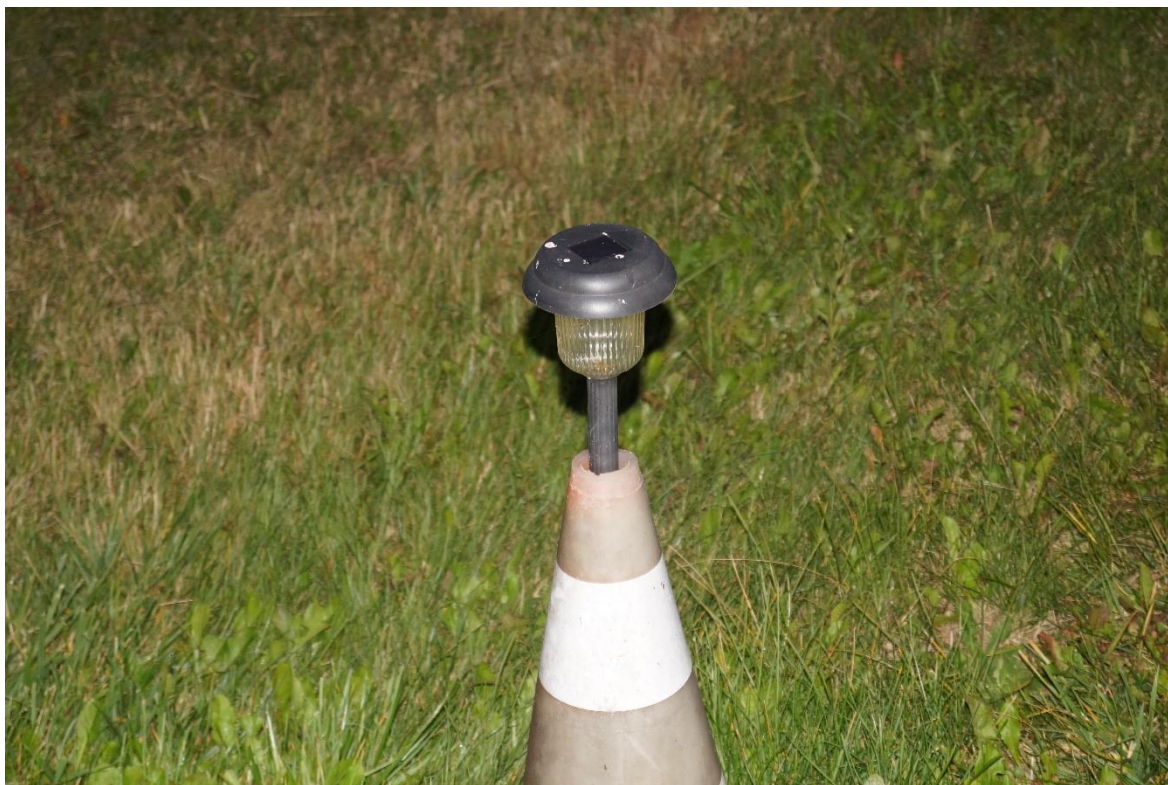
The runway is illuminated by solar lamps placed on rubber bollards spaced every several dozen meters on both sides of the runway (Fig. 6) and solar lamps at the end of the runway, which are directed towards the landing approach (Fig. 7). The regulations do not specify the requirements for lighting the landing field for night flights. The decision as to whether to perform night flights at the landing field is made by the pilot on his own responsibility.

Fig. 6 Solar lamps on the runway edges

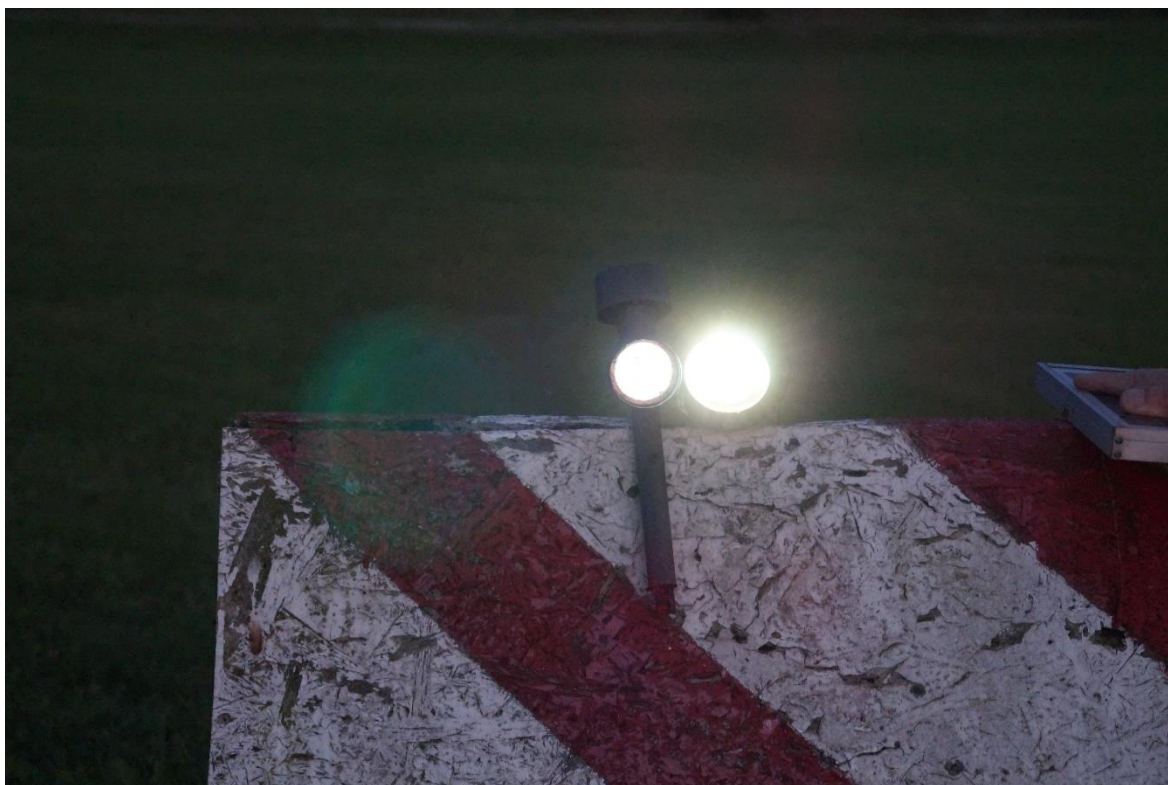
Fig. 7 Solar lamps at the end of runway

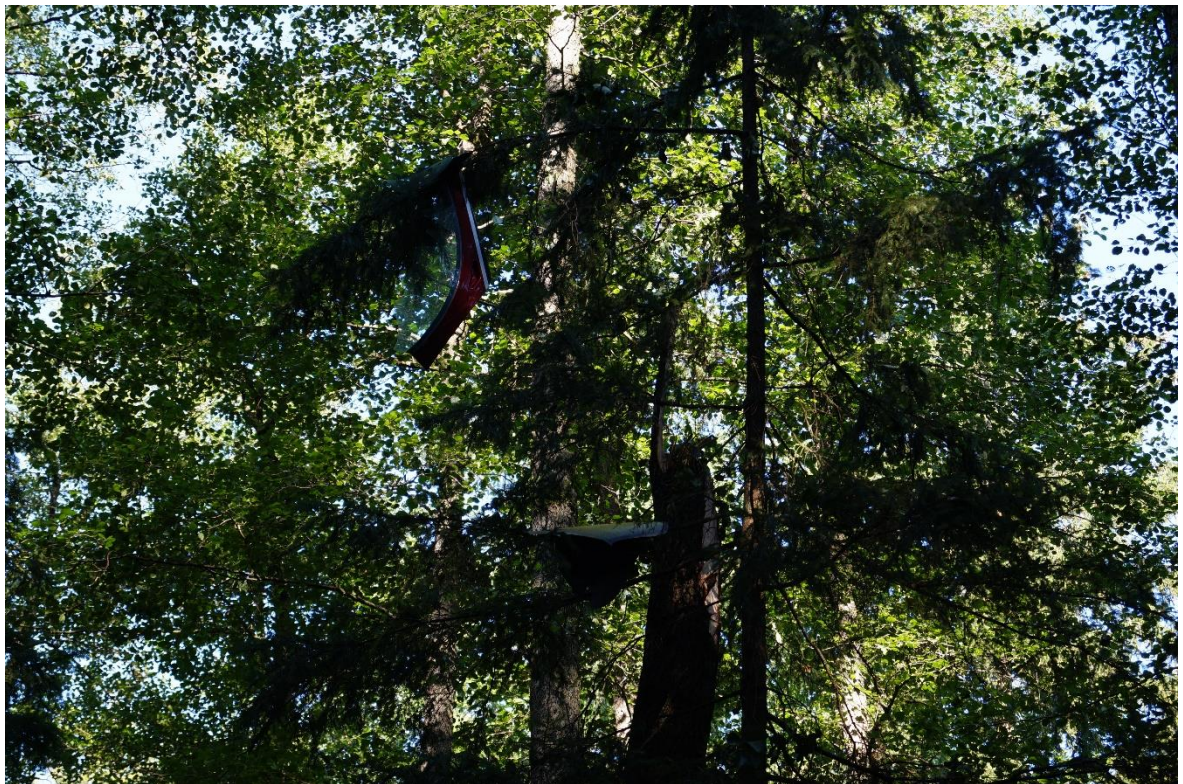
The occurrence site was located approximately 2,400 meters from the threshold near the third turn to RWY 11. On the basis of the inspection of the accident site, PKBWL established that the plane entered a tall forest at a little angle of descent. When the plane collided with trees, several tree tops were cut at a height of about 15 meters and the destruction of the plane began. Some elements of the plane remained in the trees (Fig. 8 and 9). Then the partially destroyed plane collided with the ground, the fuel ignited and a fire broke out. The wreckage of the plane was scattered over a fairly large area.

Fig. 8 Detached aircraft elements that remained on trees after the accident

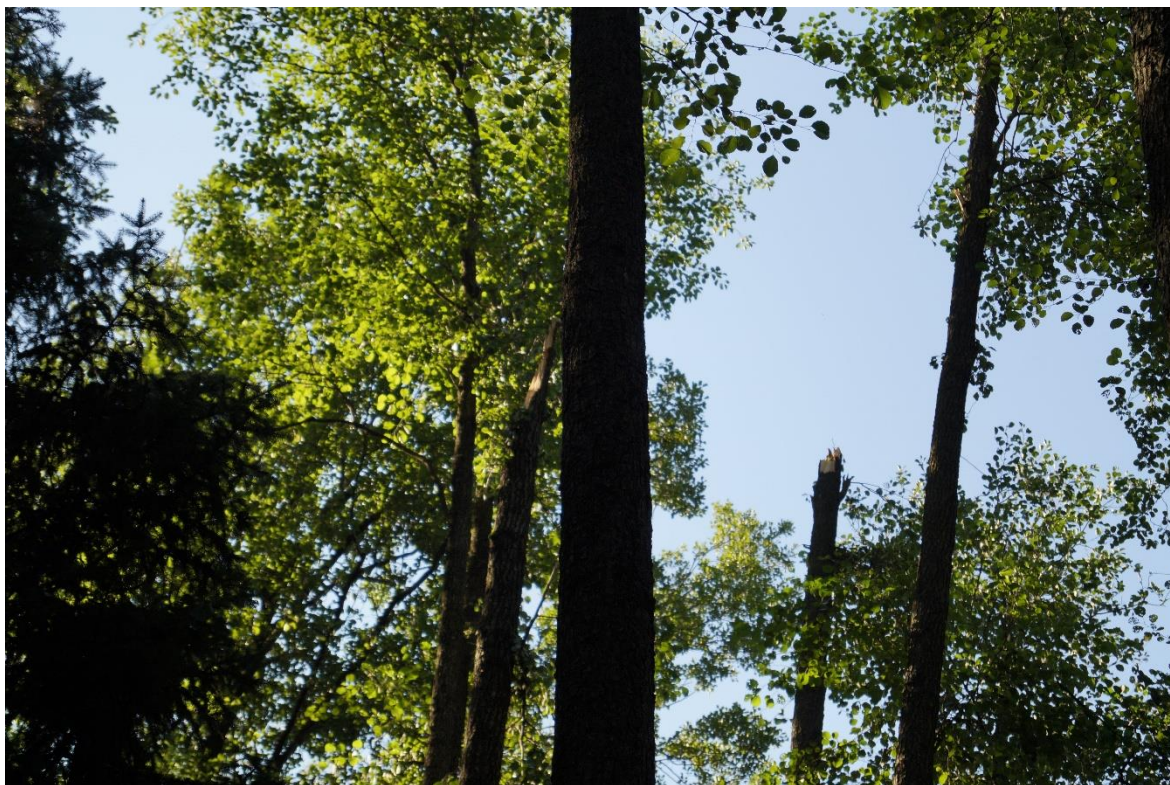
Fig. 9 The area of the occurrence site - treetops cut by the airplane during the collision

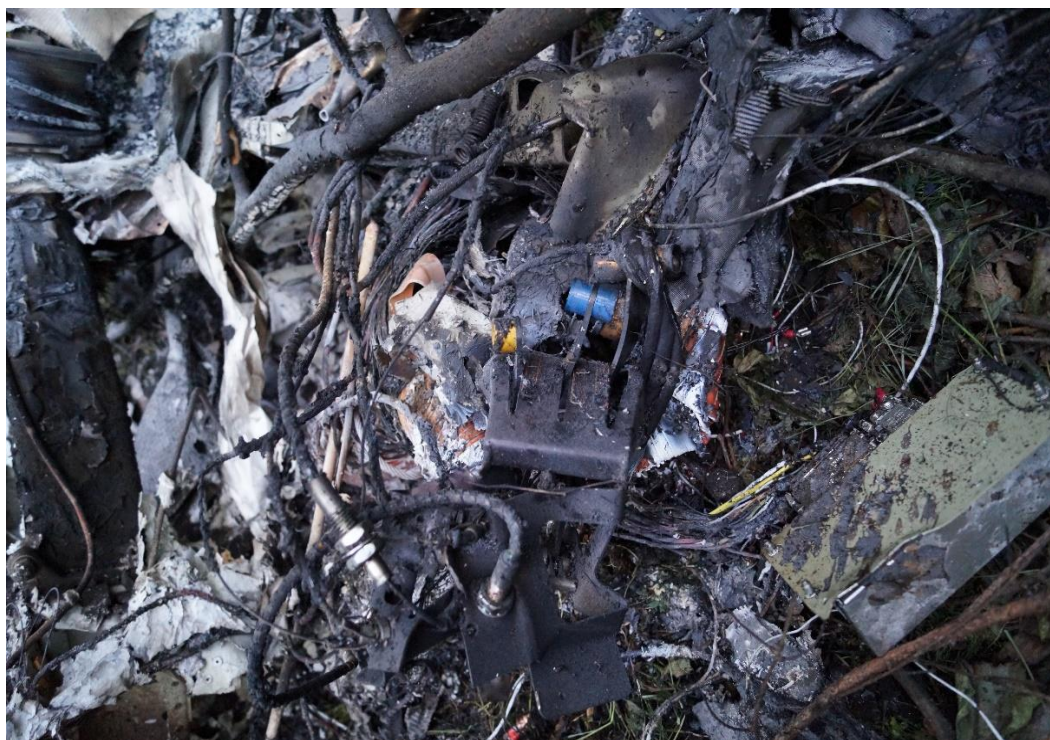
During the examination of the wreckage, PKBWL did not find any signs of the aircraft malfunction prior to the accident. However, due to the destruction of the wreckage, it was not possible to completely exclude such a case.

Fig. 10 Engine control system elements found at the occurrence site
