FINAL REPORT

ACCIDENT 580/16

AIRCRAFT – McDonnell-Douglas MD-500E helicopter, N60EP

DATE AND PLACE OF OCCURRENCE – 7 April 2016, Suwałki, Poland

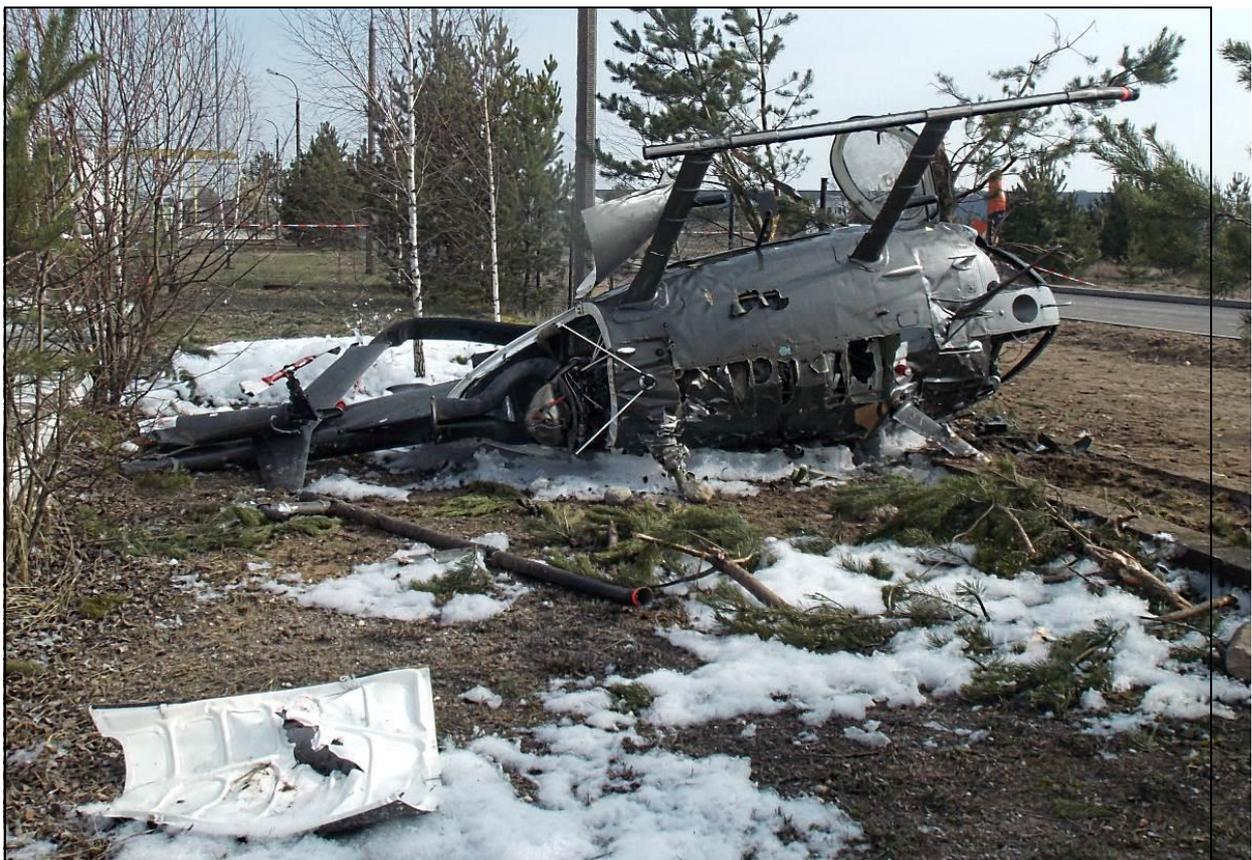
1 – Helicopter at the accident site, bottom view [photo: PKBWL].

- main rotor blades - destroyed;
- left landing gear - destroyed (broken struts, partly detached from the fuselage);
- structure of the cabin part of the fuselage - substantially damaged (substantial damage to the lower skin during firefighting operation, dents and tears of the skin);
- windshield and glass parts of the roof and doors - broken;
- powerplant cowlings – separated and locally dented;
- tailboom - destroyed ((its rear part broken off together with the tail rotor shaft and its angular gear and vertical stabilizer, the pusher of the tail rotor blade pitch control system - bent);
- horizontal stabilizer - detached;
- tail rotor – destroyed (broken blades);
- the structures of the pilot and passenger seats – deformed;
- local displacements of the cabin inside equipment;
- puncture of the fuel tank under the cabin floor and fuel leakage.

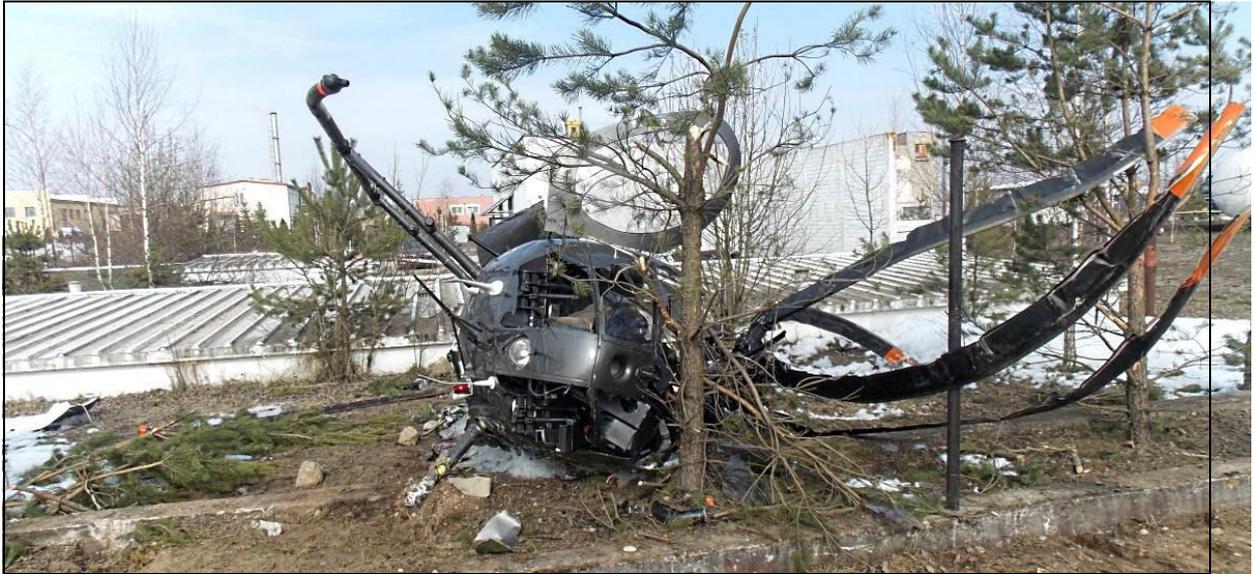
2 – Helicopter at the accident site, front view [photo: PKBWL].

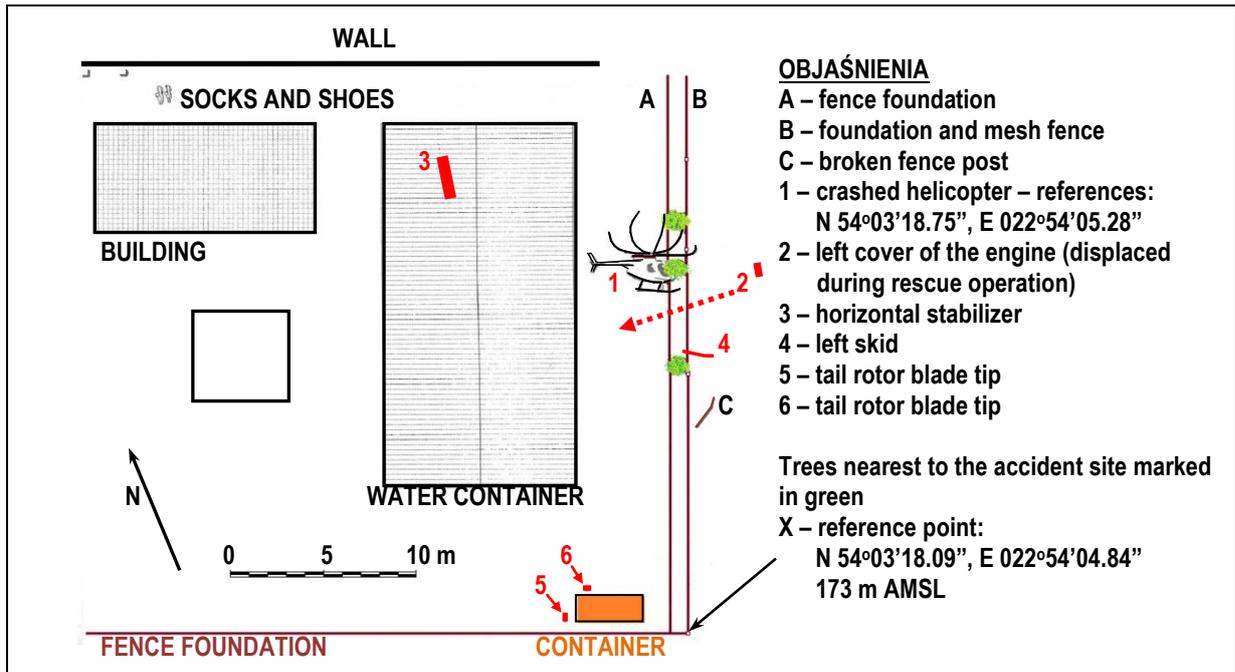
When the pilot lost control over the helicopter, it entered the right yaw with the left bank angle. The left skid was the first to come into contact with the ground (and young trees growing at the site), and then the main rotor blades (due to their deformation "into a tulip").

This sequence of collision with the ground and then breaking off the left skid and the left struts contributed to the absorption of part of impact energy. During the collision with the ground, the tail beam was also broken and the tail rotor blades were cut off by the main rotor blades, which dropped elastically after the helicopter hit the ground, and then returned to the state of deformation "in a tulip". No part of the helicopter was found to have fallen off the helicopter prior to impact with the ground.

4 – Sketch of the accident site [based on materials from Suwałki police station].

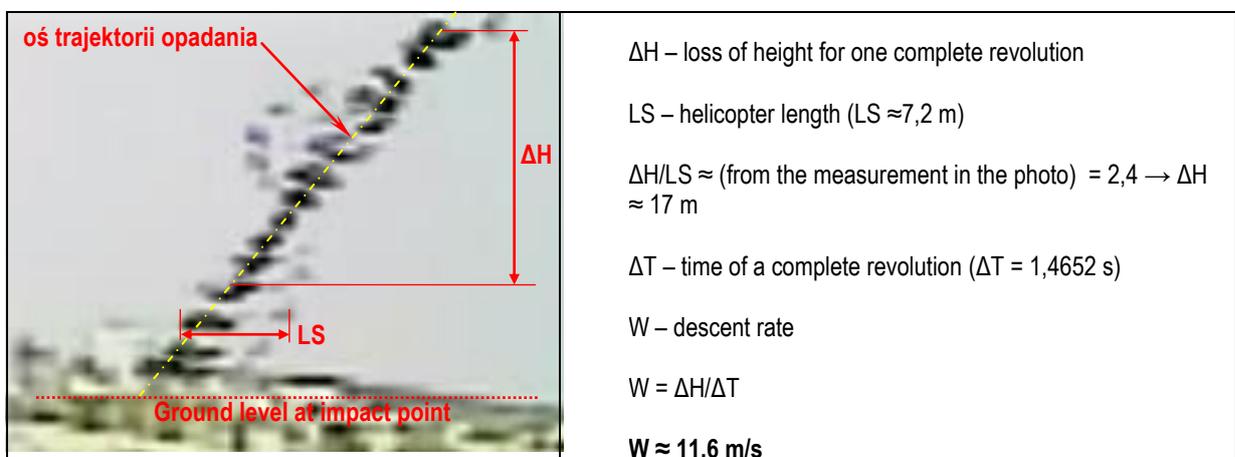
Based on the analysis of the video recording obtained from the "A" CCTV camera (camera position – see Fig. [3] above), the vertical component of the speed during the descent was estimated to be approx. 11,6 m/s (see figure [8]).

5 - Successive phases of the helicopter's movement during the descent (based on analysis of the recording from "A" camera and the calculation of the vertical component of the descent rate. Noticeable decrease in the angular speed of the helicopter's rotation around the vertical axis in the last portion of the descent phase.

After review of the recording and interviewing the pilot and witnesses, PKBWL concluded that the cause of the accident was the stall of the helicopter main rotor. The phenomenon of rotor stall can happen very often, among others, in hovering and in the low speed range. In principle, helicopters are constructed in such a way that the blades operate in the area of subcritical angles of attack.

The change in load on the main rotor blades as a result of stalling caused their characteristic "tulip" deformation.

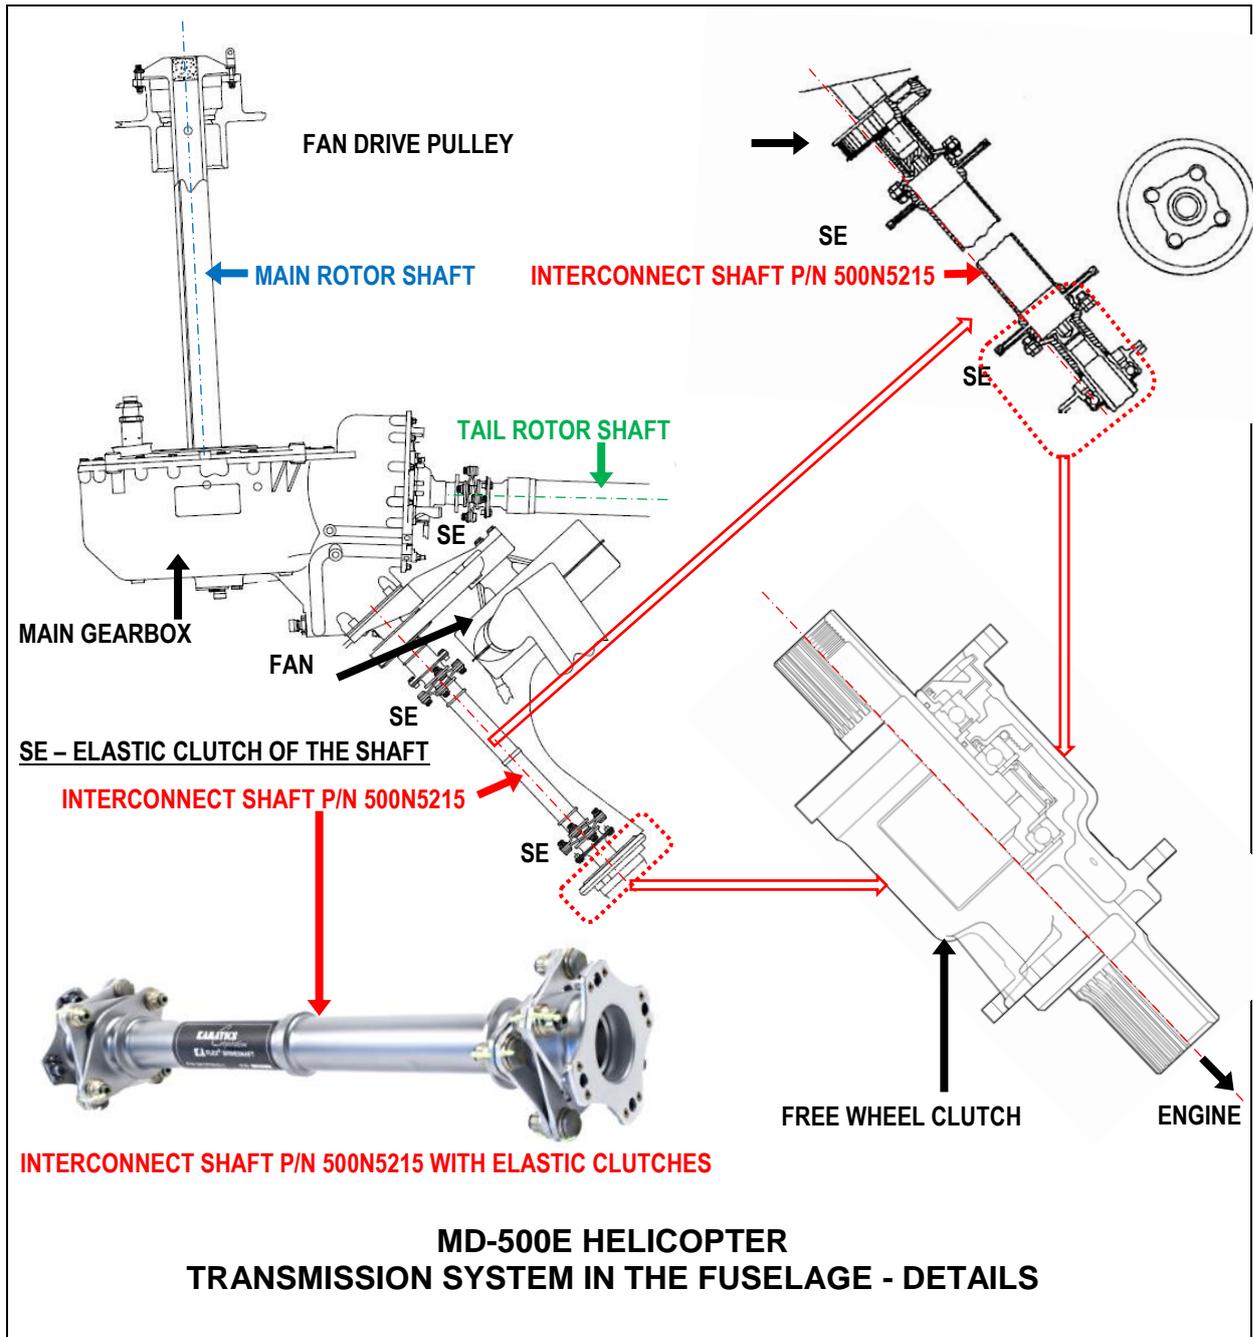
During an additional inspection of the helicopter wreckage, the Investigation Team conducted a detailed inspection of the interconnect shaft (P/N 50N5215) and its clutches (upper and lower). It was done at the request of the pilot, who expressed his assumption that the replacement of the shaft might have been effected in an improper way (it was the subject of maintenance works in the period immediately preceding the accident and was the only activity that might have had a technical impact on the occurrence).

No irregularities related to the interconnect shaft P/N 50N5215 were found.

The replacement of the interconnect shaft P/N 50N5215 effected in the scope of 100H inspection on 10-12 November 2015, was the implementation of the Mandatory Service Bulletin of the helicopter manufacturer of 22 December 2010, covering its six versions. Numbering of this bulletin for each version of the helicopter was: SB369H-250, SB369D-208, SB369E-103, SB369F-088, SB500N-044 and SB600N-052.

8 – Transmission system of the MD-500E helicopter – details. Interconnect shaft P/N 500N5215 marked in red.
