Inflight loss of window, AgustaWestland AW139, G-SNSI

Den Helder Airport, 7 October 2022

Ground loop during winch launch, PZL-Bielsko SZD-51-1 "Junior", PH-934

Lemelerveld glider airfield, 19 April 2023

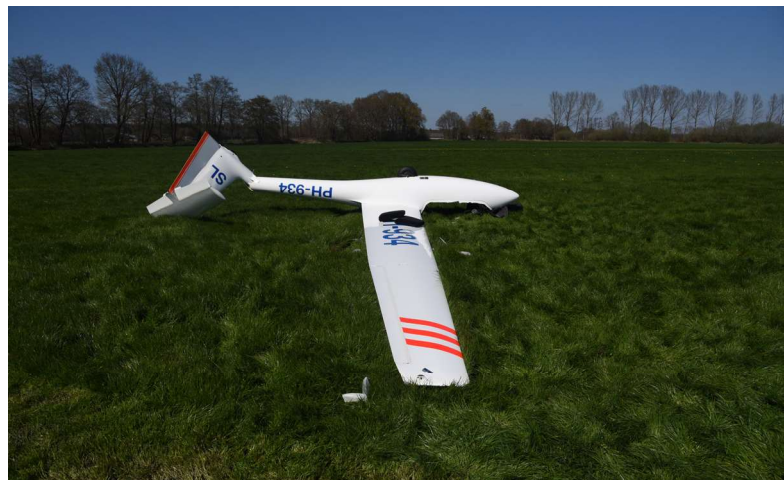
▲ The glider after the ground loop. (Source: Dutch Aviation Police)

As sole occupant of the Junior, the pilot was ready for a winch launch from Runway 09 at Lemelerveld glider airfield. The wind was blowing in an east-north-easterly direction, at a speed of approximately 10 knots. After the glider had started its takeoff and the wing walker had let go of the wing tip, the wings were horizontal. After approximately 10 metres, the left-hand wing tilted downwards. The wing tip then became caught in the grass causing the aircraft to make a ground loop whereupon it came to rest upside down. The pilot reported not having noticed that the tip had touched the ground; he had released the winch cable when he saw the right-hand wing tip rising. The pilot suffered minor injuries. The aircraft suffered severe damage.
