State Commission on Aircraft Accidents Investigation

# FINAL REPORT

2022/5134

**Skyvan Service Piotr Wojciech Jafernik Spółka  
Komandytowa  
Short Brothers PLC, SC-7 Skyvan series 3  
VARIANT 100, SP-HIP  
Głina k. Piotrkowa Trybunalskiego, 3 września  
2022 r.**

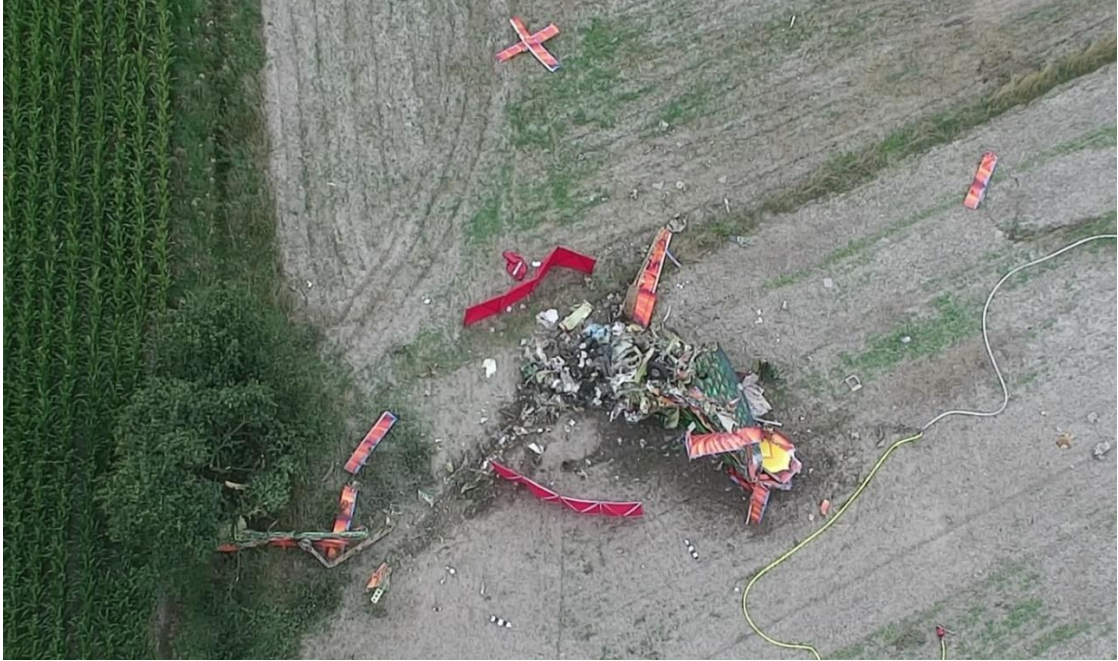
As a result of the collision with the ground, the aircraft was completely destroyed (Fig. 2).

Fig. 2. View of the aircraft wreckage [source: Police]

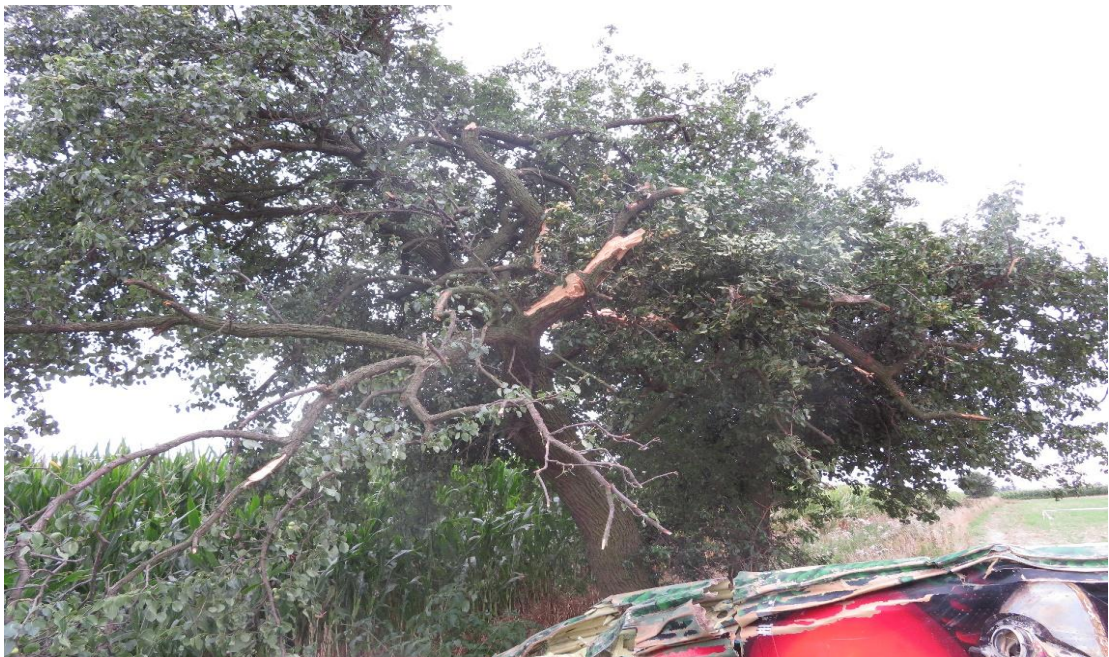
As a result of the occurrence, a tree branch was broken off (Fig. 3).

Fig. 3. The damaged tree.

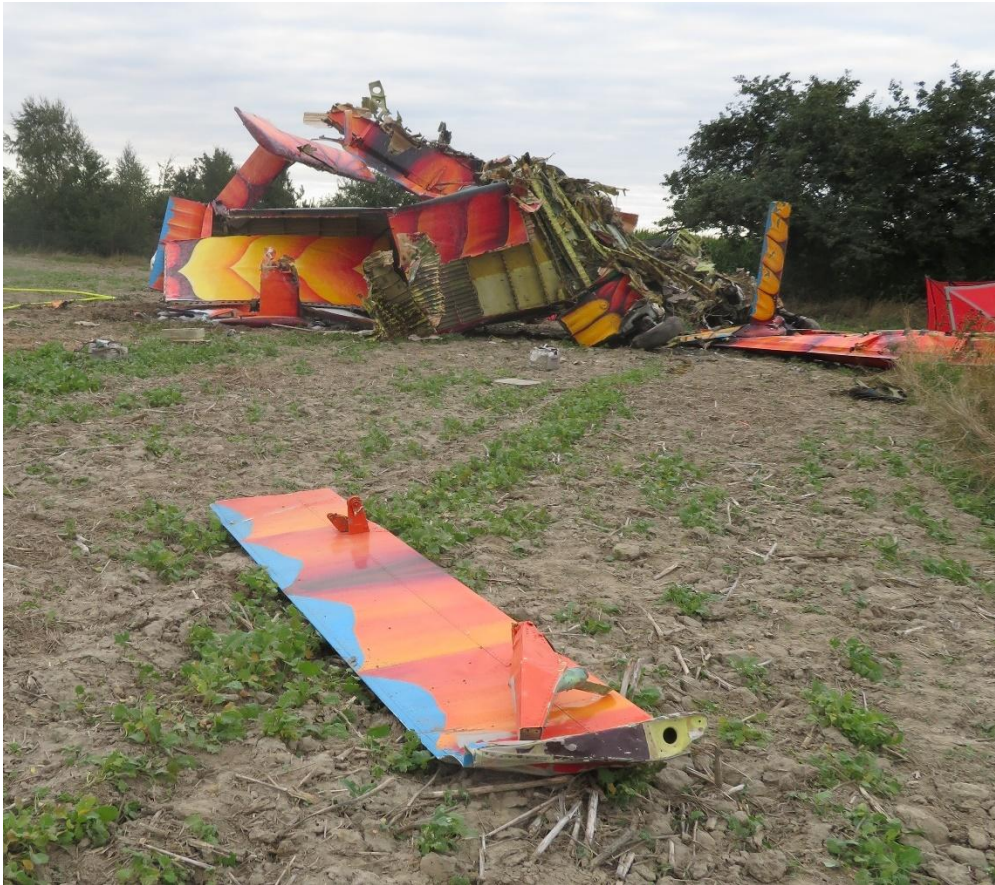
The aircraft wreckage was scattered over a small area. The aircraft was lying on its left side. All the elements of the control system (elevator, rudder, ailerons, flaps) were located within the wreckage and in its immediate vicinity. The right wing had been torn off, together with the strut, at a point approximately 1 m from the engine. During the impact, the right engine separated from the wing and was found next to the wreckage of the forward part of the fuselage. The inboard section of the left wing, together with the engine, was located beneath the fuselage. The remaining part of the wing, together with the strut, was located beside the fuselage. During the impact, the fuel system lost its integrity and fuel leaked out. The fire brigade, which arrived at the site of the occurrence, protected the aircraft wreckage against fire using foam.

Fig. 5. The aircraft wreckage at the site of the occurrence.

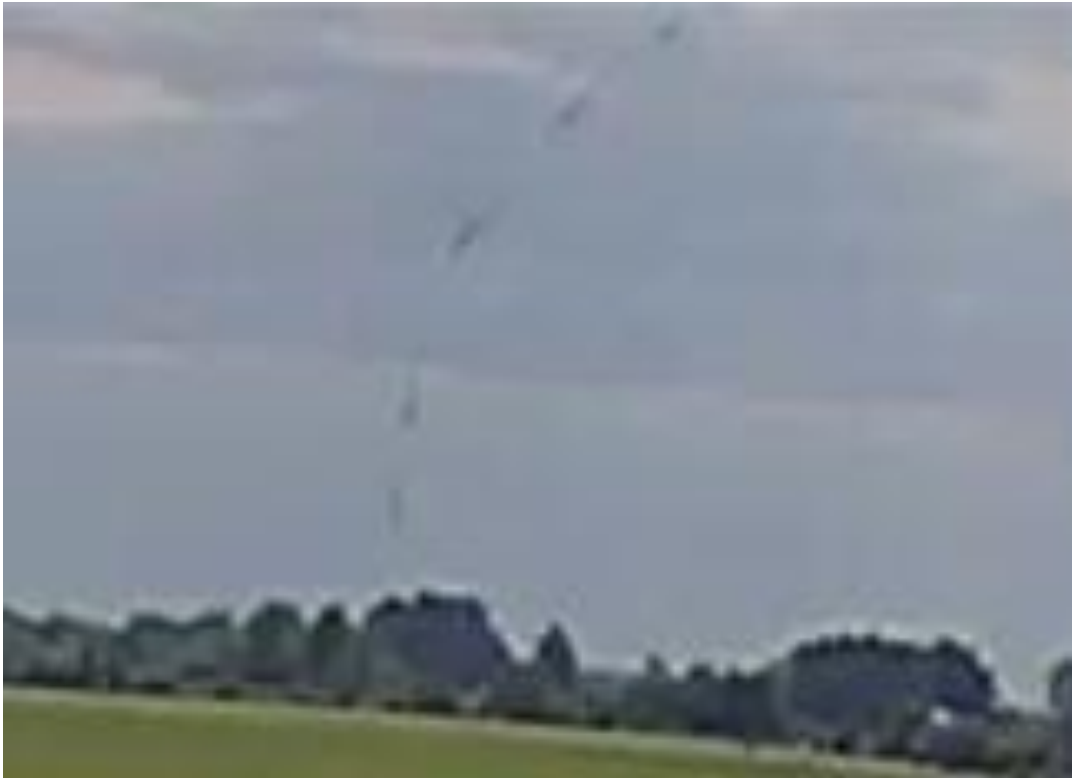
On 3 September 2022, combined aeroplane and glider flights and parachute-dropping flights were taking place at Piotrków Trybunalski aerodrome. That day, the Skyvan have 11 flights to drop parachutists; all these operations were performed by one pilot. After the 11th flight, there was a break to refuel the aircraft. Once refuelling had been completed, the pilot was changed. Having taken over the aircraft, the new pilot took his seat in the cockpit and additionally took on board a passenger with whom he intended to make the parachute-dropping flight. After the parachutists had boarded the aircraft, it took off and climbed to the drop altitude of approximately 4,000 m. On reaching the required altitude, the pilot contacted the flight operations supervisor and advised that the parachutists would be dropped in 1 minute. The flight operations supervisor acknowledged that information, after which the pilot reported that the parachutists had left the aircraft and that he was descending. The descent was made to an altitude of approximately 600 m. The pilot reported that he would be flying “the right base for runway 03” (quotation) and was cleared by the flight operations supervisor to land as number 1. A moment later, the right base for runway 03 was also reported by the instructor of the Tecnam, who was carrying out a familiarisation flight. He was cleared to make the approach as number 2, which he acknowledged. The instructor pilot of the Tecnam stated that he had been watching the Skyvan, which was making its approach ahead of him, and that he was building up an appropriate separation between the aircraft. The Skyvan turned onto final approach for runway 03 and reported its position. The flight operations supervisor issued a landing clearance. This was the last transmission from the pilot of the Skyvan. The pilot of the Tecnam reported that, after turning onto final approach to land, the Skyvan had climbed while simultaneously banking to the right and turning right; after turning through approximately 90°, the aircraft lowered its nose and, continuing the turn, entered a dive; after a few seconds in a steep dive it collided with the ground approximately two kilometres from the threshold of runway 03L (Figs 6 and 7), on a heading opposite to the landing direction. On the basis of an analysis of the available material, including recordings from the aerodrome and private-property cameras, it may be assumed that the aircraft was stalled at the moment it performed the pull-up. The pilot reacted correctly and stopped the aircraft's rotation about its longitudinal axis; however, because of the low altitude he was unable to recover the aircraft from the dive and it collided with the ground at a steep angle.

Fig. 6. Frame-by-frame stills of the final phase of the flight, footage from the aerodrome CCTV camera.

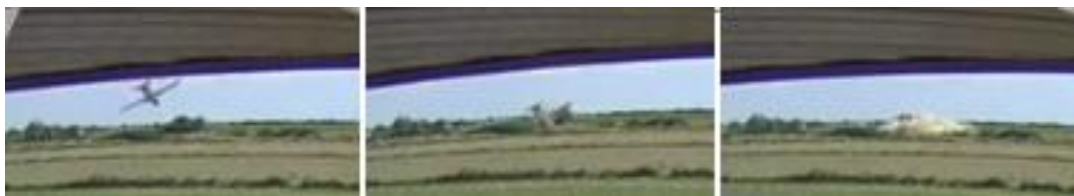
Fig. 7. Frame-by-frame stills of the aircraft before the impact and of the impact itself (source: CCTV camera on private property)
