ACCIDENT 2020/1574

# FINAL REPORT

# ACCIDENT

OCCURRENCE NO – 2020/1574 AIRCRAFT – Airplane Piper PA-46-500TP, SP-EVA DATE AND PLACE OF OCCURRENCE – 1 July 2020, EPBC

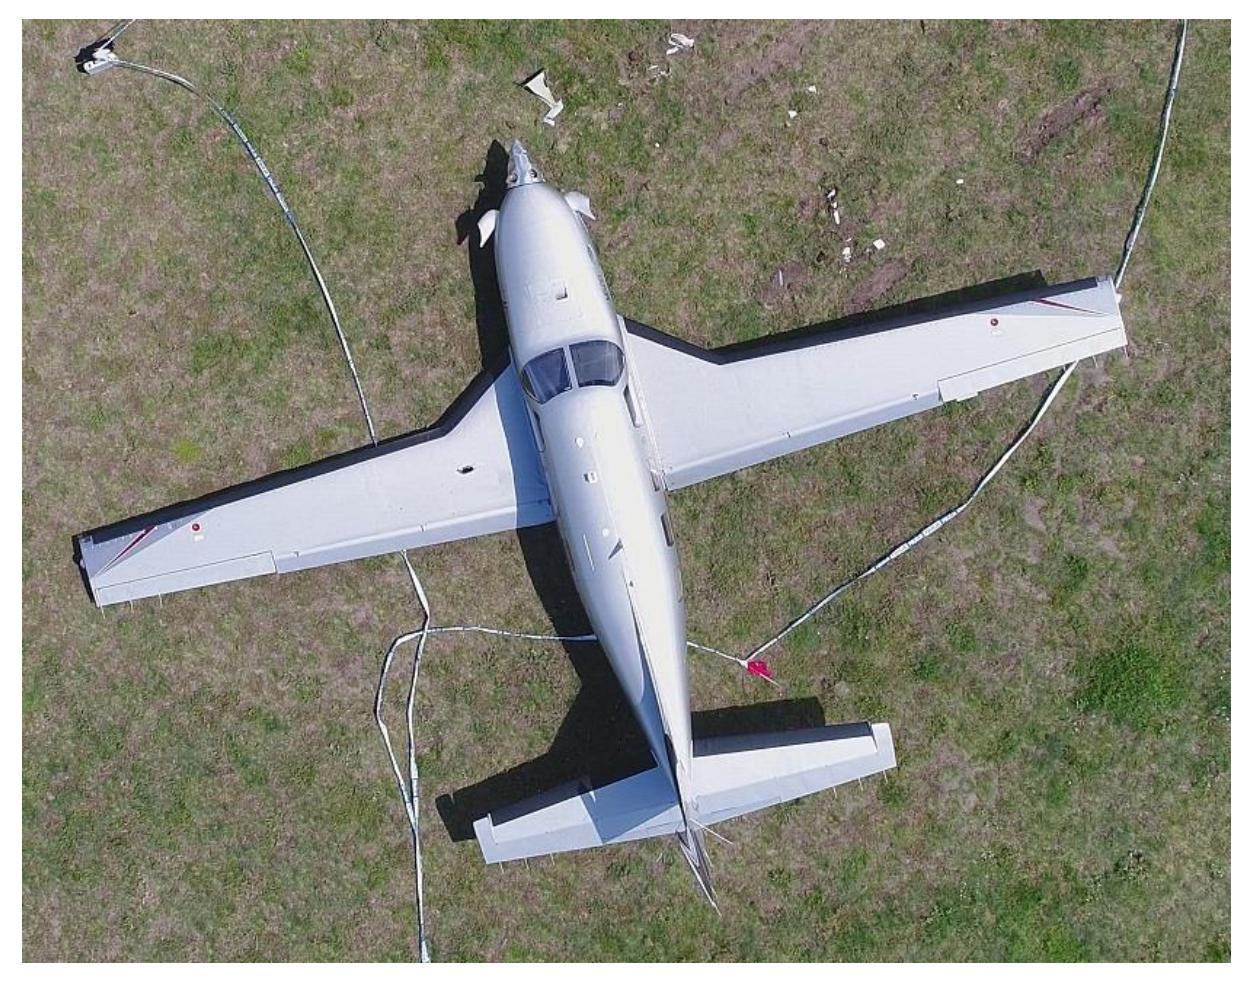
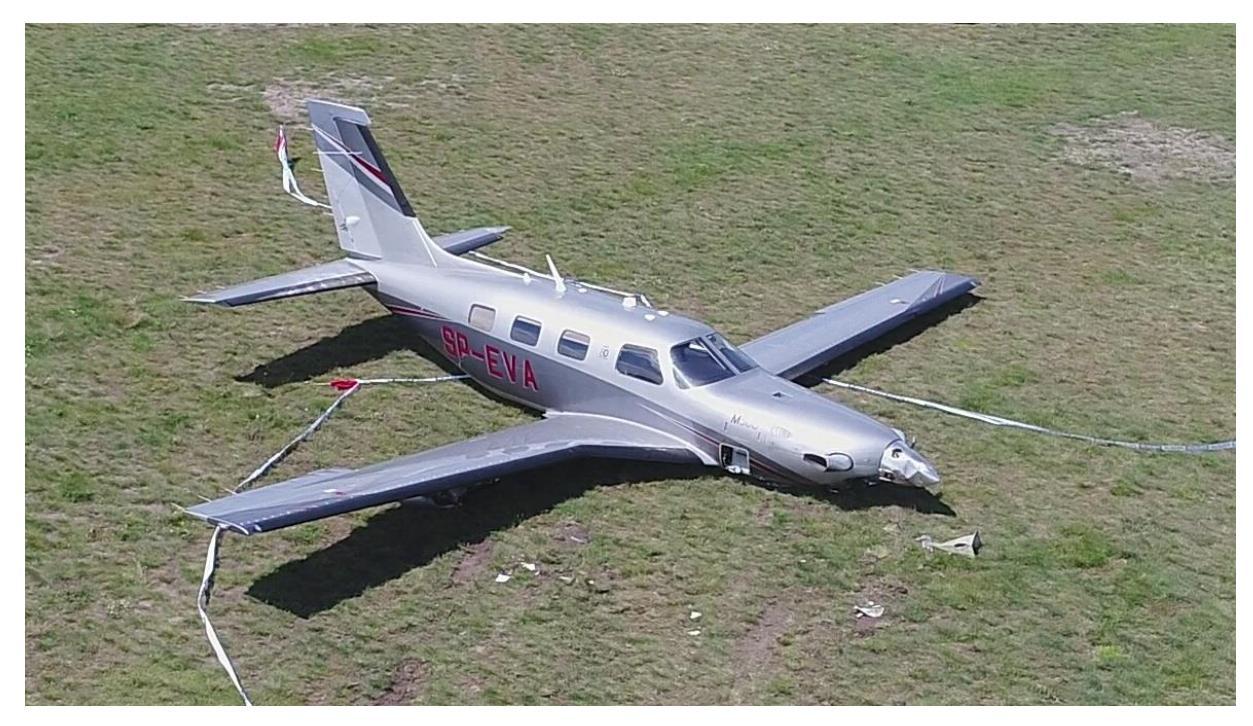
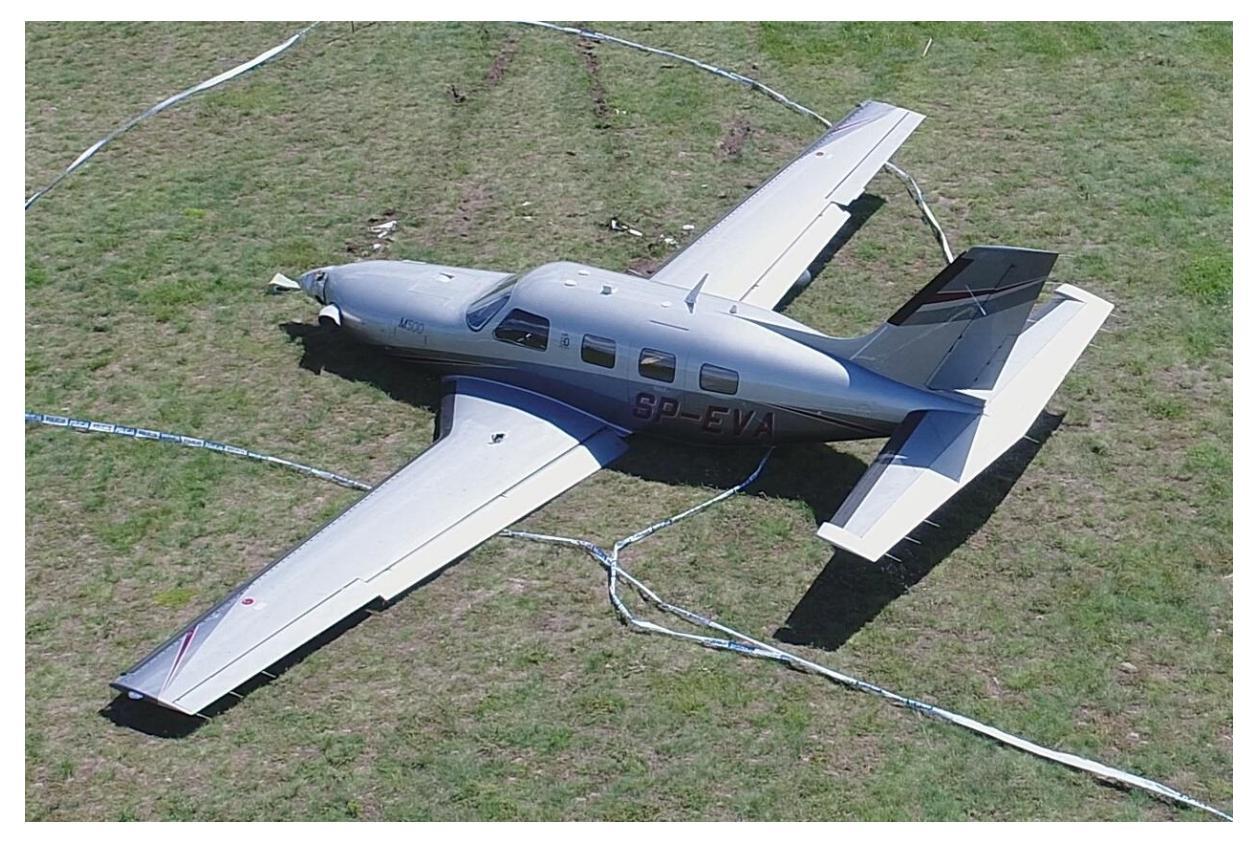
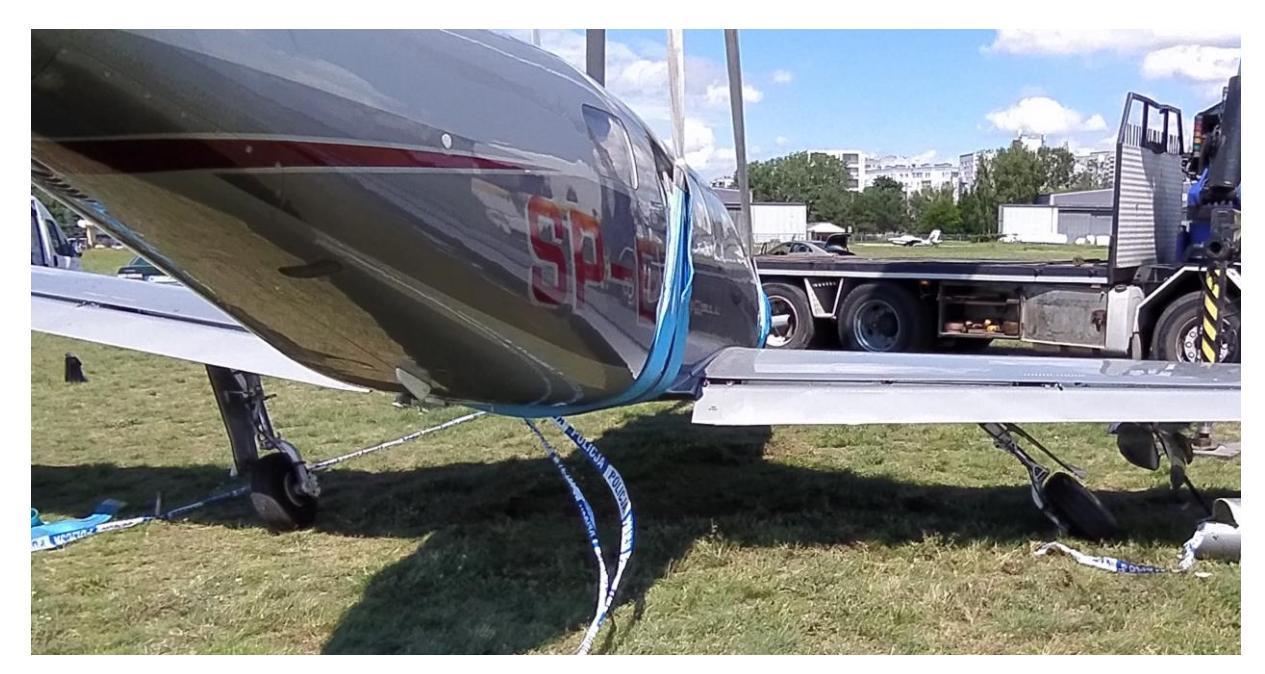
The accident aircraft was substantially damaged. The nose landing gear strut broke off and together with the wheel and the retraction actuator detached from the airplane. The main landing gear struts folded to the right, i.e. in the case of the left strut in the direction of its retraction, and in the case of the right strut, opposite to the direction of its retraction. As a result of the airframe contact with the runway surface, the fivebladed propeller and the lower fairings of the engine and nose landing gear were damaged. The lower fuselage below the cabin was damaged to a lesser extent. Local deformations and cracks in the wings skin were observed, including the upper skin of the left wing being punctured by the broken fitting of the main landing gear left strut.

Fig. 1. PA-46, SP-EVA, at the accident site [Source: PKBWL]

Fig. 2. PA-46, SP-EVA, at the accident site [Source: PKBWL]

Fig. 3. PA-46, SP-EVA, at the accident site [Source: PKBWL]

Fig. 7. PA-46, SP-EVA, at the accident site [Source: PKBWL]

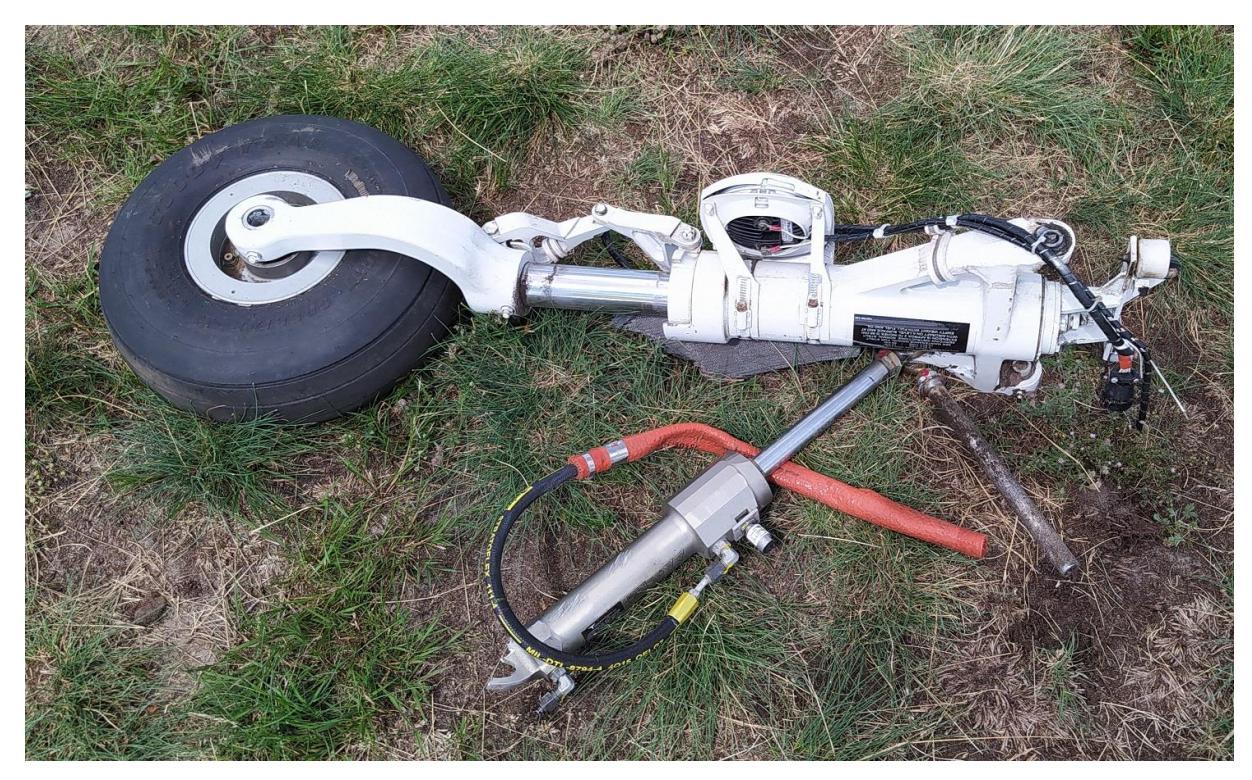
Fig. 5. SP-EVA broken nose landing gear strut [Source: PKBWL]

- 1) Take-off operation performed from the grass runway;
- 2) Different quality of the grass runway surface;
- 3) Take-off run performed close to the right edge of the runway;
- 4) Too dynamic pilot's reaction to counteract the loss of direction during take-off run, which at the speed of 55 kt resulted in creating a great force acting on the deflected wheel of the nose landing gear. As a result, the nose landing gear strut was detached from the aircraft.

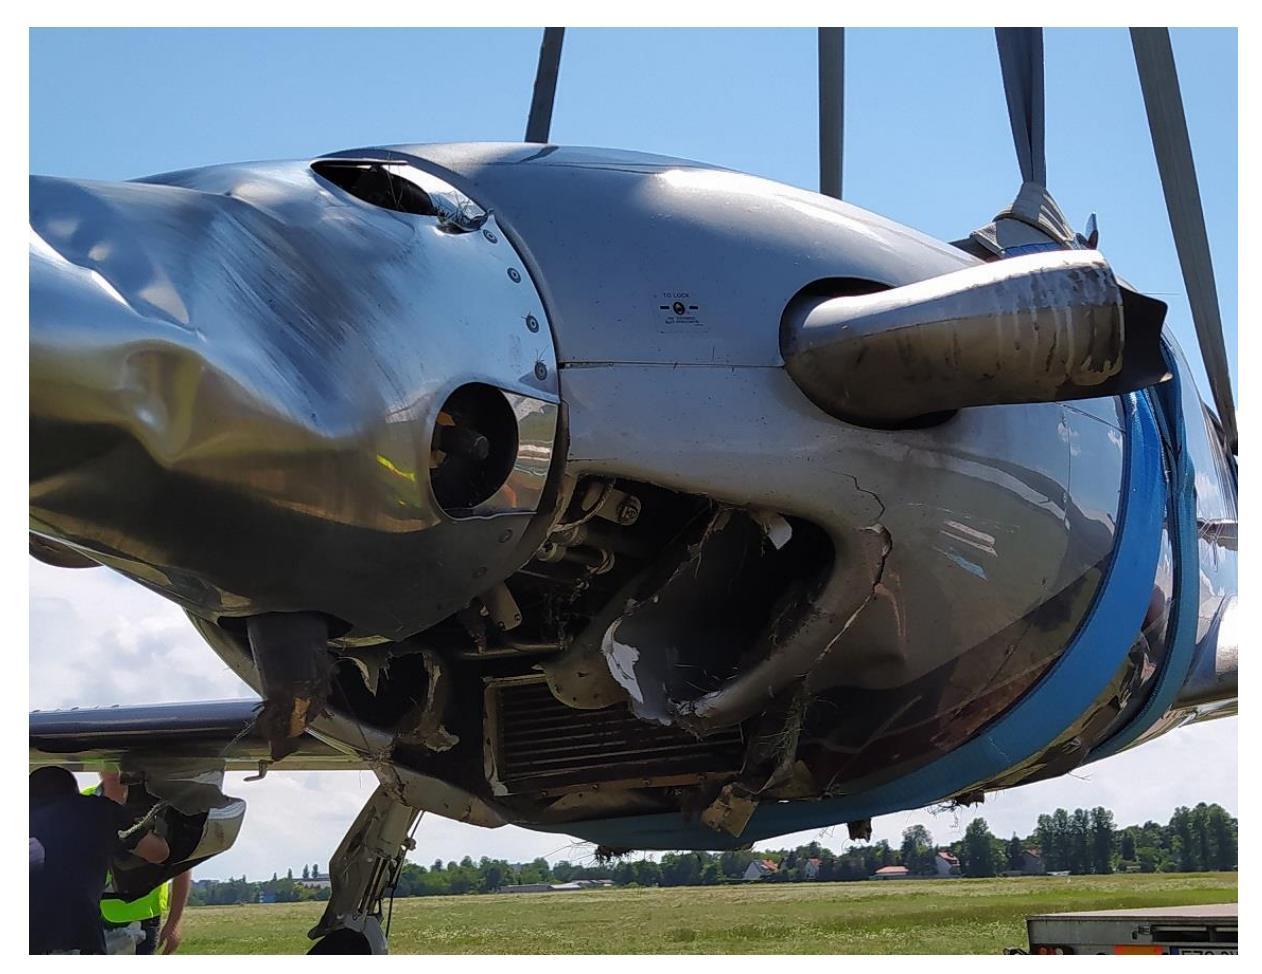
Fig. 6. Damage in the area of the propeller, lower fairing of the engine and nose landing gear of SP-EVA [Source: PKBWL]

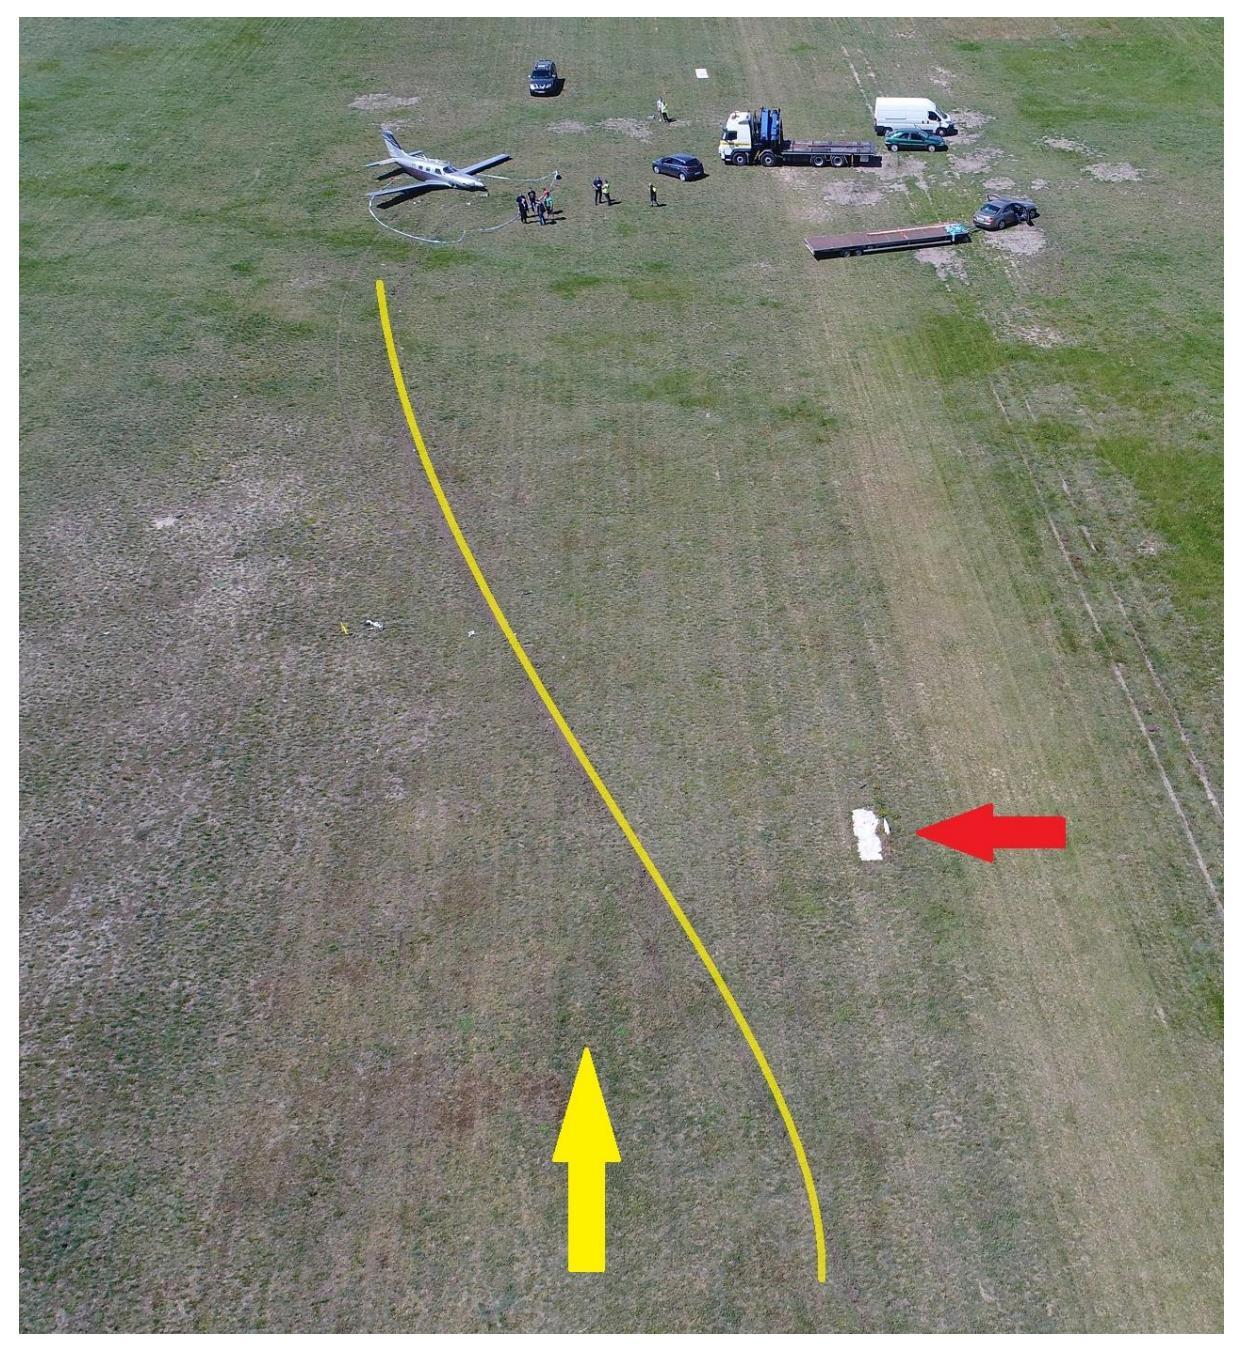
Fig. 8. The occurrence site – grass runway 28 of EPBC. The red arrow indicates the marker of the right edge of the runway, the yellow arrow indicates the take-off run direction, the yellow line indicates the path of the plane moving on the grass after the collapse of the landing gear. [Source: PKBWL]

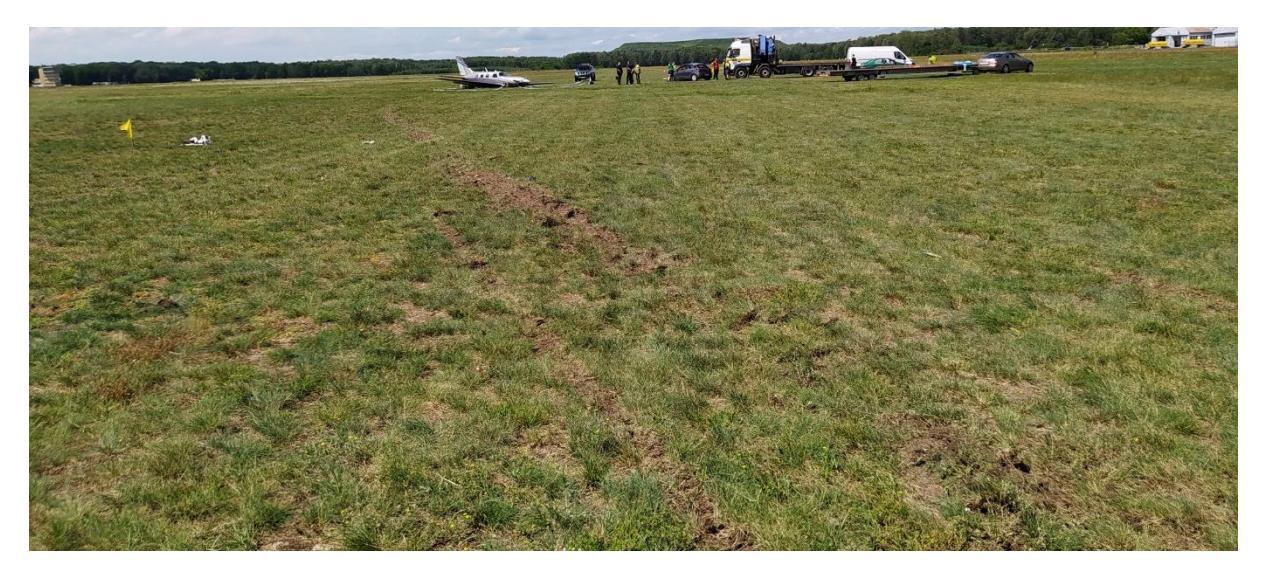
Fig. 9. The surface of the grass runway at the accident site. Visible marks left by main landing gear struts that folded under the weight of the aircraft [Source: PKBWL]
