STATE COMMISSION ON AIRCRAFT ACCIDENTS INVESTIGATION

Final Report

Serious incident

**Simultaneous beginning of take off by the crews of Boeing
737 (OM-NGF) and Boeing 767 (SP-LOA) aircraft on
crossing runways.**

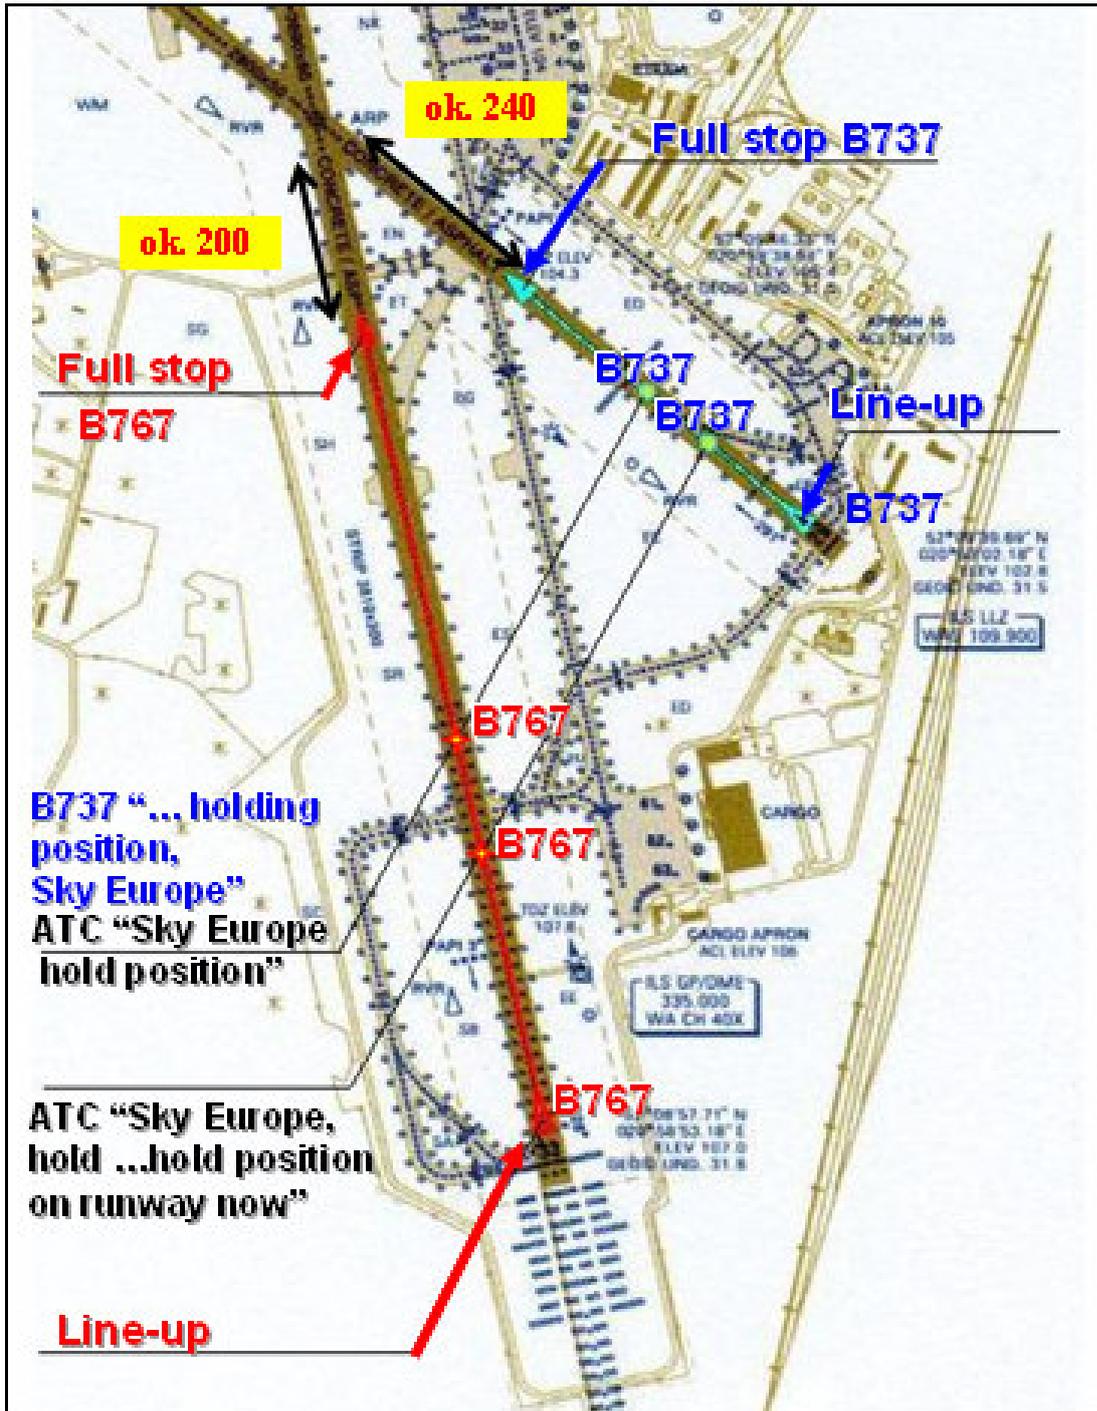
On 13 August 2007, departures of aircrafts Boeing 767-200ER with registration marks SP-LOA (call sign LOT15), flying to KEWR aerodrome and Boeing 737 with registration marks OM-NGF (call sign Relax 8HS) flying to LFPO aerodrome were planned from EPWA aerodrome. At 16:07:31, the crew of the Boeing 737 was granted clearance to line-up at RWY 29 and was given an order to wait. The record of the correspondence: „**Relax 8HS, line up and wait runway 29**”, which was confirmed by: „**Line up and wait runway 29, Relax 8 HS**”. At 16:07:53, the crew of Boeing 767 was given clearance from the controller to line up at RWY 33 after the landing of an Embraer 170 aircraft. At 16:09:46, upon arrival on RWY 33, the crew of Boeing 767 received information on wind direction and speed as well as clearance for takeoff. During the call-back repetition of the clearance for takeoff by the crew

of Boeing 767, another transmission was overlapped. Both aircraft began takeoff run almost simultaneously. When the Boeing 737 was passing the “N” taxiing path, i.e. about 12 seconds after beginning the take-off run, the controller twice definitely ordered the Boeing 737 crew to reject takeoff. The aircraft was stopped about 240 meters from the runway crossing. The crew of Boeing 767 rejected take-off on its own initiative and began abrupt hard braking, stopping the plane about 200 meters from the runway crossing. As a result of the braking, an overheat of the breaks of Boeing 767 aircraft occurred the crew had to taxi to an apron in order to cool and examine them. After a one hour stopover, Boeing 767 flew to the destination aerodrome. Boeing 737 aircraft, after stopping and returning to the beginning of RWY 29, took off to fly to the destination aerodrome.
