Aircraft Incident Ref. No.

**129/06**

## **FINAL REPORT ON AIRCRAFT INCIDENT INVESTIGATION**

Beach King Air 350

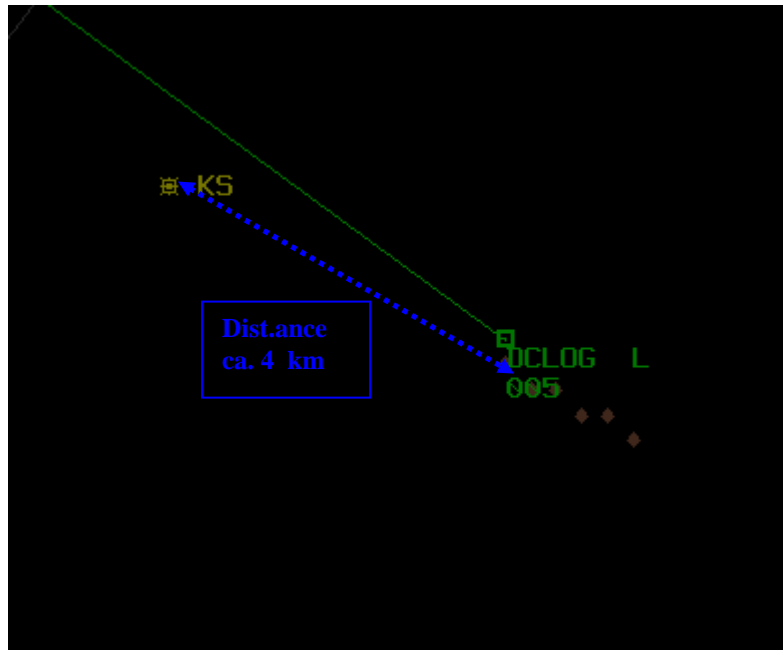
The pilot affirmed the approval and continued descending on NE to 2,500 ft. At 18:35:45 UTC the pilot of D-CLOG reported aerodrome in sight and requested approval for a visual approach to RWY 29. The TWR EPPO controller approved visual approach with a left-hand traffic circuit, and at the same time gave clearance to continue descending to 2,500 ft AMSL, and then further descend on the path of approach to landing. The pilot affirmed approval and continued the flight. At 18:39:28 UTC the pilot reported “short final” and was cleared to land by the TWR EPPO controller.

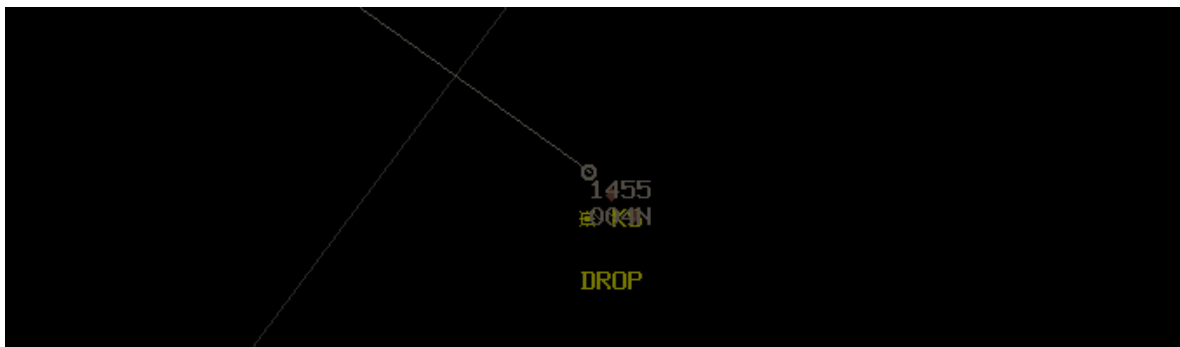
At 18:39:58 UTC, the TWR EPPO controller asked the pilot whether he had the runway lights in sight. The pilot replied negative. He informed the controller that he had landed on a wrong airfield (EPKS) and requested assistance to take off again to fly to Poznań-Ławica (EPPO).
