Report A-015/2011

Accident involving
a CIRRUS SR-22,
registration SP-AVD,
on the extension of runway 29
at the Asturias airport,
on 6 June 2011

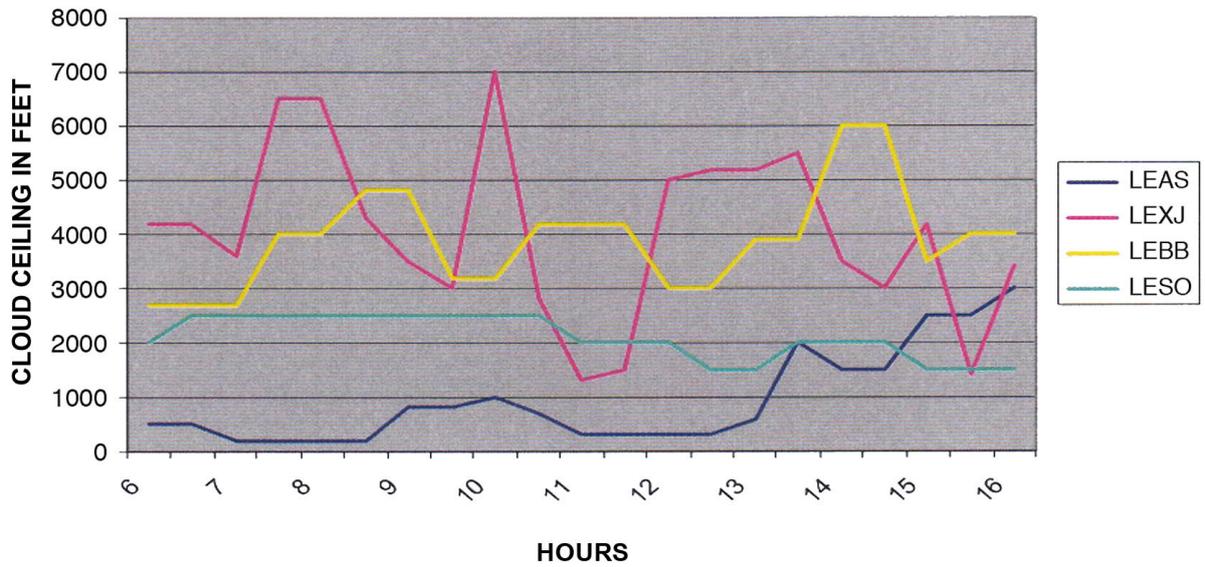
Figure 2. Cloud ceiling at the various airports

The graph in Figure 2 shows the cloud ceiling present at the various airports along the aircraft's path from 06:00 (UTC) until 16:00 (UTC).

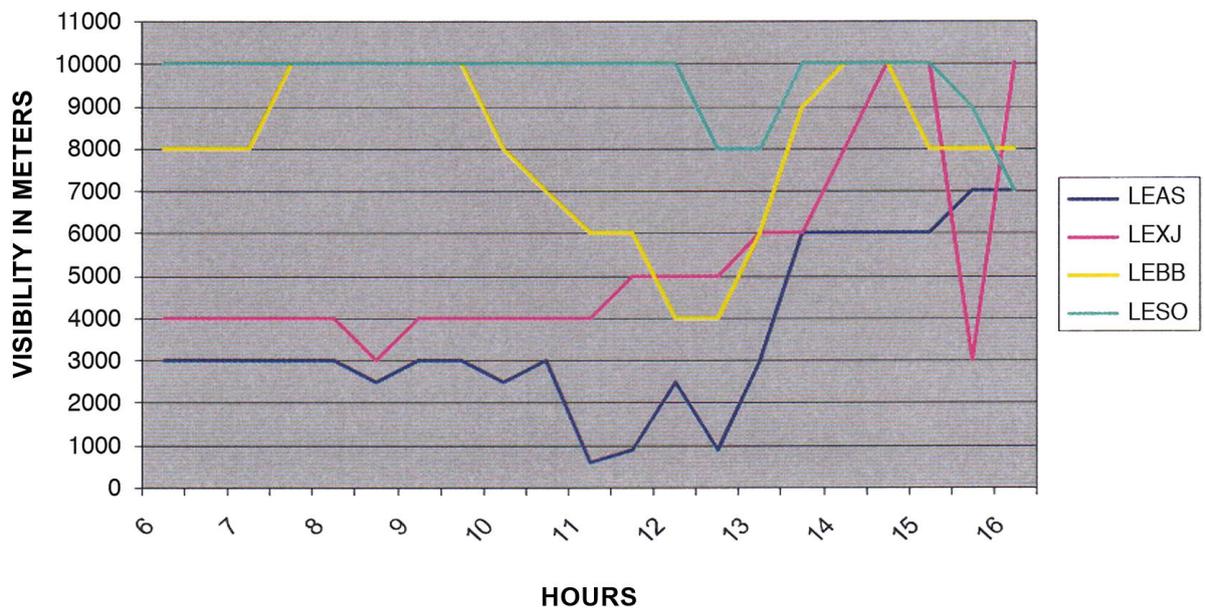
Figure 3. Visibility at the various airports

The graph in Figure 3 shows the visibility at the various airports along the aircraft's flight path from 06:00 (UTC) until 16:00 (UTC).

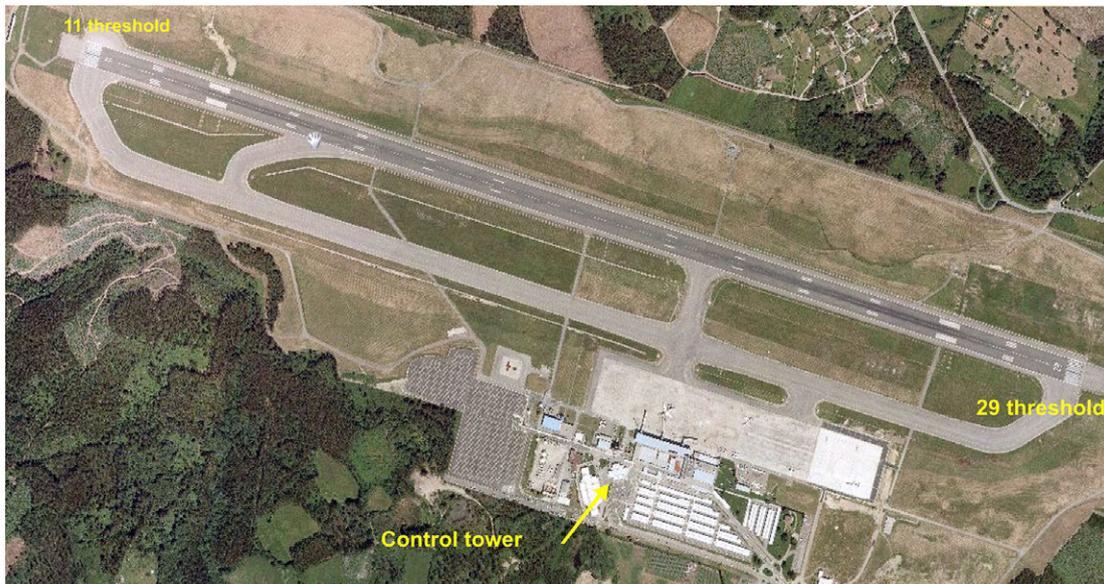
Figure 4. Aerial view of the airport

It has one 2,200-m long runway in an 11-29 orientation (Fig. 4).

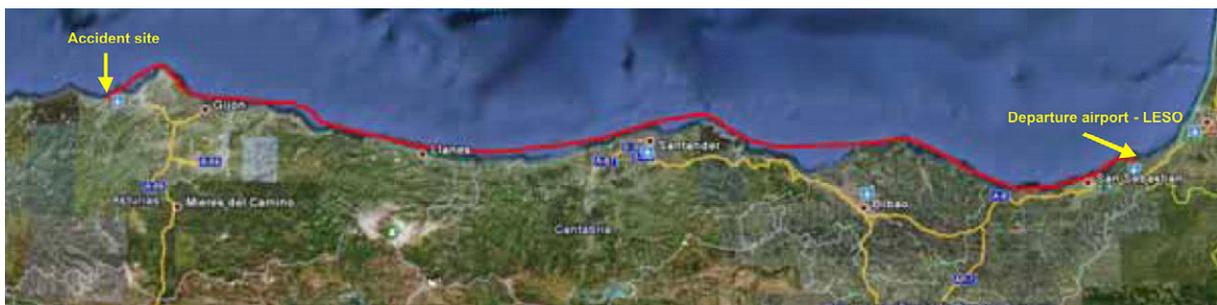
Figure 5. Complete route taken from the MFD

Figures 5 and 6 show the complete route and the path flown just before the accident, as taken from the MFD. Appendix A shows the last five minutes of the flight. Figure 7 shows the altitude profile.
