ACCIDENT 2020/1574

# FINAL REPORT

# ACCIDENT

OCCURRENCE NO – 2020/1574 AIRCRAFT – Airplane Piper PA-46-500TP, SP-EVA DATE AND PLACE OF OCCURRENCE – 1 July 2020, EPBC

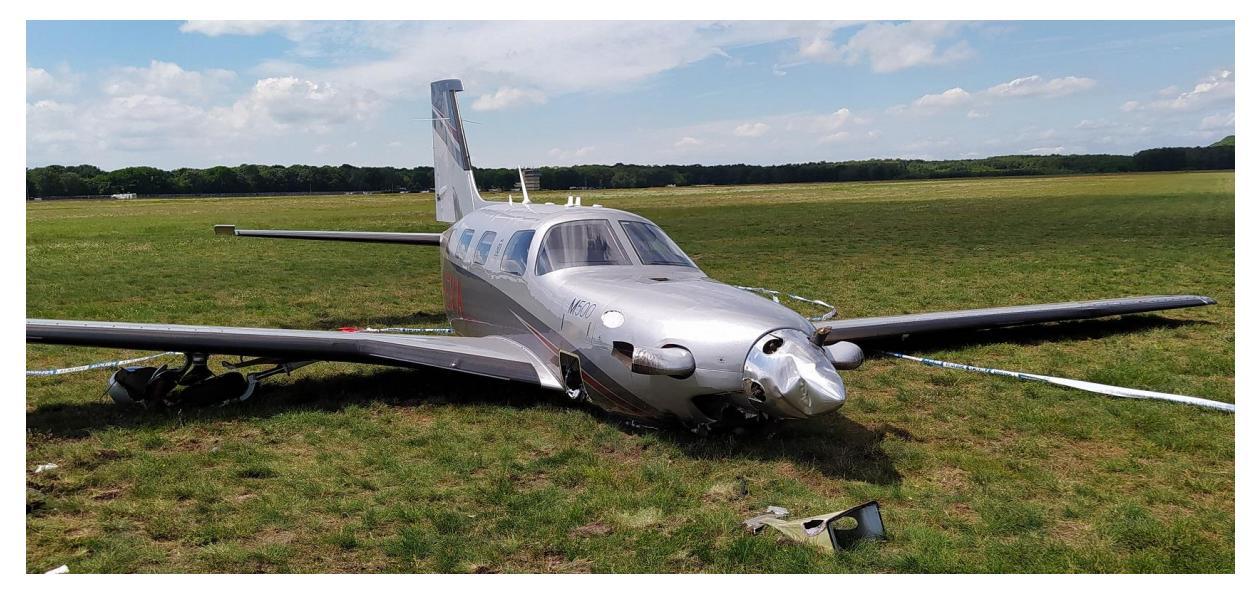
The accident aircraft was substantially damaged. The nose landing gear strut broke off and together with the wheel and the retraction actuator detached from the airplane. The main landing gear struts folded to the right, i.e. in the case of the left strut in the direction of its retraction, and in the case of the right strut, opposite to the direction of its retraction. As a result of the airframe contact with the runway surface, the fivebladed propeller and the lower fairings of the engine and nose landing gear were damaged. The lower fuselage below the cabin was damaged to a lesser extent. Local deformations and cracks in the wings skin were observed, including the upper skin of the left wing being punctured by the broken fitting of the main landing gear left strut.

Fig. 4. PA-46, SP-EVA, at the accident site [Source: PKBWL]
